# Mt Keith Satellite Statement 1087 Compliance Assessment Report BHP Nickel West

29 March 2022

This CAR outlines the implementation and compliance status of the Project for the period of 28 December 2020 to 31 December 2021, and aligns with the requirements of the approved Compliance Assessment Plan (BHP Nickel West 2020a) under Condition 4-1 of the Statement 1087 approval.

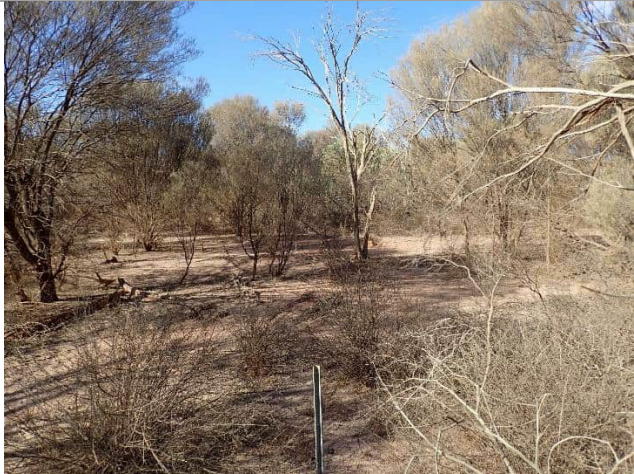
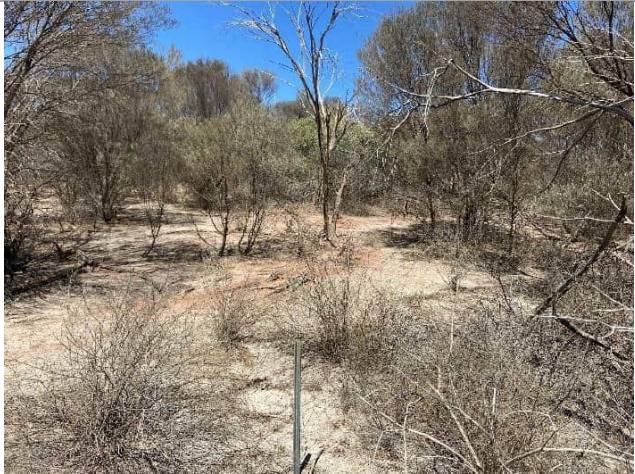
Site ID: MKS EIA 2		Co-ordinates: 51 J 261089 6972365	
<b>Location:</b> ~ 40 m west of MKS haul road	<b>Comments:</b> Water stressed vegetation. Multiple dead shrubs. Heavy dust cover over plants. Kangaroo scats and termite mounds present. Internal drainage in Grove.		
<b>Veg. Type:</b> Groved Mulga shrubland			
<b>Veg. Condition:</b> Degraded			
<b>Grazing:</b> Light, historic			
<b>Weed cover:</b> Nil			
<b>Photo direction:</b> NW			
Species	Cover (%)	Plant Health Score	Comments
<i>Acacia aneura</i>	50	7b	Okay, but dusty and dry.
<i>Eucalyptus lucasii</i>	2	7b	Mostly outside quadrat.
<i>Acacia tetragonophylla</i>	2	4	Post-flowering. Partially dead canopy.
<i>Sida ectogama</i>	<2	2	Little live foliage remaining.
<i>Eremophila latrobei</i>	<2	3	Little live foliage remaining. Dusty. Yellowing.
<b>Other species:</b> <i>Eragrostis eriopoda</i> , <i>Poaceae sp.</i> , <i>Psydrax latifolia</i> , <i>Eremophila pungens</i> (P4)

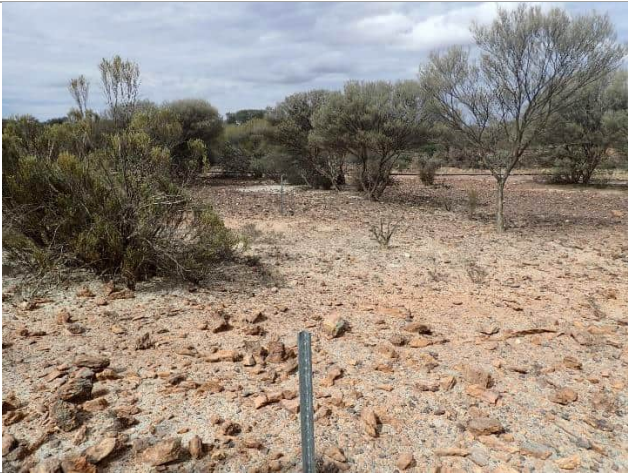
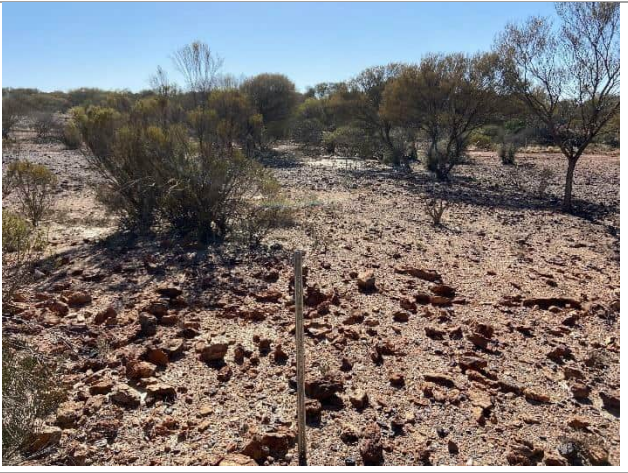
Site ID: MKS EIA 12		Co-ordinates: 51 J 259909 6964937	
<b>Location:</b> ~ 150 m east of Six Mile Well pit		<b>Comments:</b> All <i>Maireana</i> sp. plants stressed, likely reflecting extended dry seasonal conditions. High dust load present on foliage. No annuals. No cryptogams present. Rabbit scats and burrows observed.	
<b>Veg. Type:</b> Weathered basalt, <i>Hakea leucoptera</i> subsp. <i>sericipes</i> / <i>Eremophila pantonii</i> shrubland			
<b>Veg. Condition:</b> Good			
<b>Grazing:</b> Light			
<b>Weed cover:</b> Nil			
<b>Photo direction:</b> NW			
Species	Cover (%)	Plant Health Score	Comments
<i>Eremophila pantonii</i>	8	7c	
<i>Acacia aneura</i> sens. lat.	15	7c	
<i>Maireana triptera</i>	2	2	Very stressed.
<i>Senna artemisioides</i> subsp. <i>helmsii</i>	<2	2	Loss most of canopy.
<i>Grevillea inconspicua</i> (P4) (EIA_12_001)	2	7b	
<b>Other species:</b> <i>Eremophila scoparia</i> , <i>Maireana georgei</i> , <i>Maireana tomentosa</i> , <i>Sclerolaena eurotioides</i> , <i>Lysiana</i> sp.

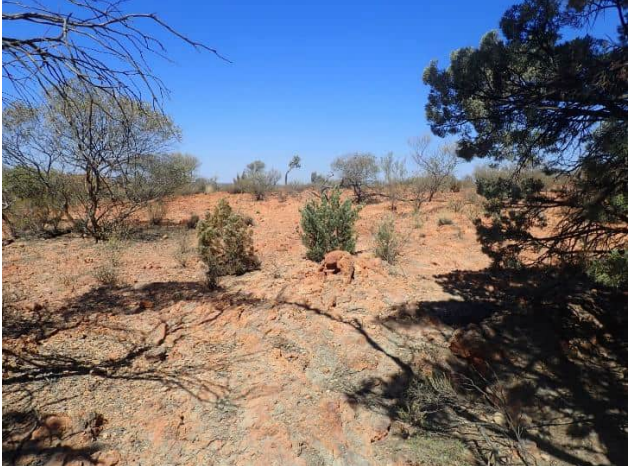
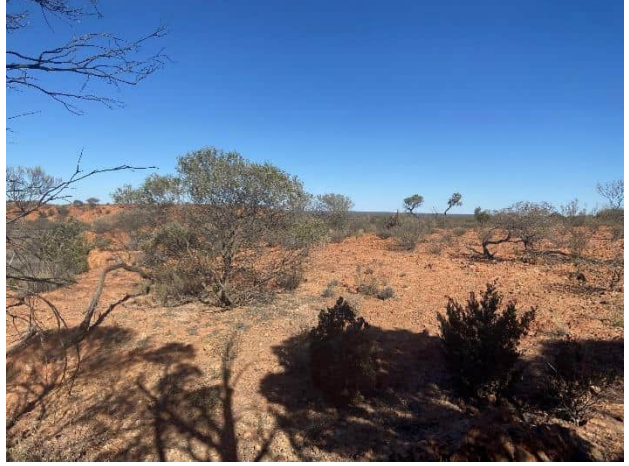
Site ID: MKS EIA 23		Co-ordinates: 51 J 261137 6971361	
<b>Location:</b> ~ 25 m east of haul road		<b>Comments:</b> Previously cleared by haul road, need to move quadrat. Minimal dust load despite close distance from haul road. Foliage vegetative.	
<b>Veg. Type:</b> Granitic Mulga shrubland on Archaean geology			
<b>Veg. Condition:</b> Excellent			
<b>Grazing:</b> Light			
<b>Weed cover:</b> Nil			
<b>Photo direction:</b> NW			
Species	Cover (%)	Plant Health Score	Comments
<i>Acacia quadrimarginea</i>	10	7b	
<i>Callitris columellaris</i>	5	7b	
<i>Thryptomene</i> sp. Leinster (P3)	10	6	Vegetative, post flowering.
<i>Ptilotus obovatus</i>	2	5	Declining, flowering.
<i>Dodonaea petiolaris</i>	2	5	Declining, flowering.
<b>Other species:</b> <i>Eriachne helmsii</i> , <i>Acacia aneura</i> , <i>Hibbertia</i> sp. <i>Sherwood Breakaways</i> (R.J. Cranfield 6771), <i>Eremophila latrobei</i> , <i>Eremophila jucunda</i> subsp. <i>jucunda</i> , <i>Eriachne mucronata</i> , <i>Calytrix uncinata</i> , <i>Olearia stuartii</i>

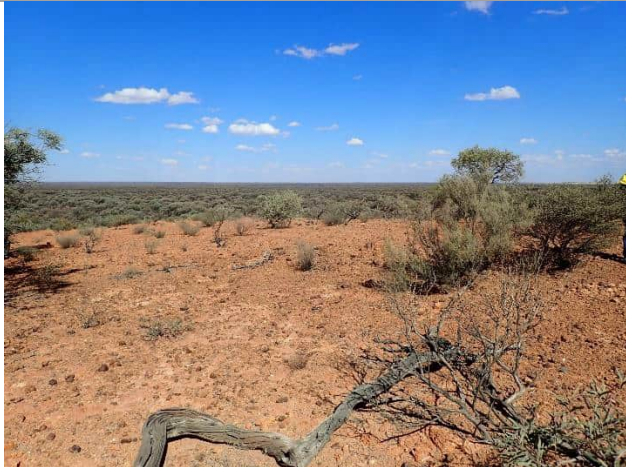
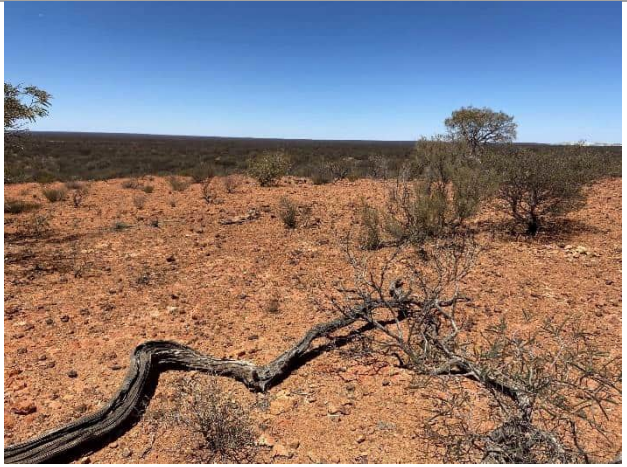
Site ID: MKS EIA 25		Co-ordinates: 51 J 261174 6971135	
<b>Location:</b> ~ 2 m east of haul road	<b>Comments:</b> Looking south, haul road to right. Quadrat moved away from haul road downslope from the MKS haul road. All vegetation in good condition. Light dust impact. No cryptograms.		
<b>Veg. Type:</b> Granitic Mulga shrubland on Archaean geology.			
<b>Veg. Condition:</b> Excellent			
<b>Grazing:</b> Nil			
<b>Weed cover:</b> Nil			
<b>Photo direction:</b> NW			
Species	Cover (%)	Plant Health Score	Comments
<i>Acacia pruinocarpa</i>	5	7b	Good condition.
<i>Acacia rhodophloia</i>	2	7b	Good condition.
<i>Acacia aneura</i>	2	7d	Some minor foliage loss and browning of leaves observed.
<i>Calytrix uncinata</i>	5	7b	Good condition.
<i>Dodonaea petiolaris</i>	<2	3	Some foliage loss of yellowing of leaves.
<b>Other species:</b> <i>Ptilotus obovatus</i> , <i>Ptilotus schwartzii</i> , <i>Thryptomene</i> sp. <i>Leinster</i> (B.J. Lepschi & L.A. Craven 4362), <i>Sclerolaena eriacantha</i>

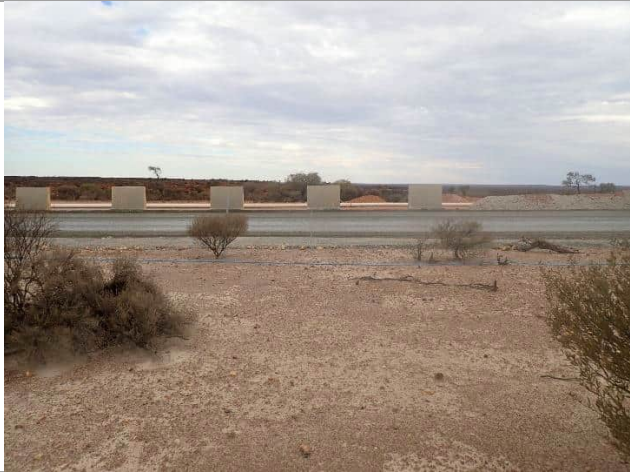
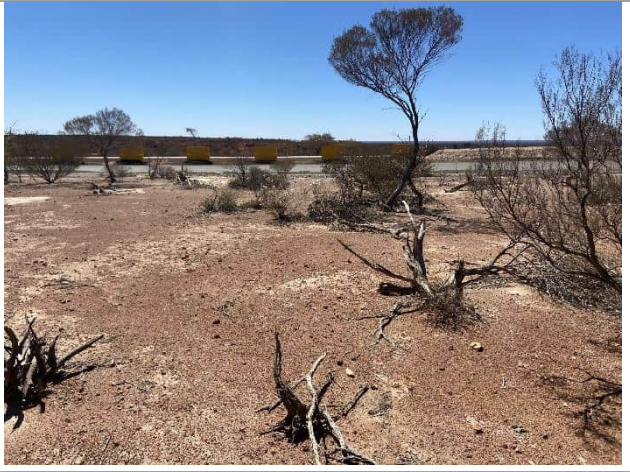
Site ID: MKS EIA 35		Co-ordinates: 51 J 261071 6971248	
<b>Location:</b> ~ 3 m west of haul road	<b>Comments:</b> Half quadrat on haul road boundary, moved 10m west from haul road. Sparse vegetation present. Dust on rocks and soil surface. Foliage loss on <i>Thryptomene</i> sp. Leinster (P3). Cryptograms present but covered in dust and dry.		
<b>Veg. Type:</b> Stony ironstone Mulga shrubland			
<b>Veg. Condition:</b> Good			
<b>Grazing:</b> Light			
<b>Weed cover:</b> Nil			
<b>Photo direction:</b> W			
Species	Cover (%)	Plant Health Score	Comments
<i>Eremophila latrobei</i>	<2	2	Stressed.
<i>Acacia aneura</i>	<2	7c	Dusty.
<i>Ptilotus obovatus</i>	<2	5	Flowering, some foliage loss.
<i>Thryptomene</i> sp. Leinster (P3)	<2	3	Dusty and dry.
<i>Acacia rhodophloia</i>	<2	7b	
<b>Other species:</b> <i>Maireana triptera</i> , <i>Eremophila jucunda</i> subsp. <i>jucunda</i> , <i>Acacia pruinocarpa</i> , <i>Eremophila pungens</i> , <i>Maireana georgei</i> , <i>Dodonaea microzyga</i> , <i>Rhagodia drummondii</i> , <i>Senna</i> sp. <i>Meekatharra</i> ,

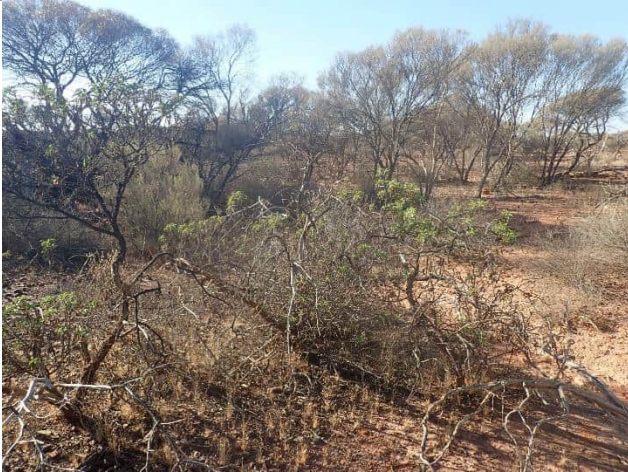
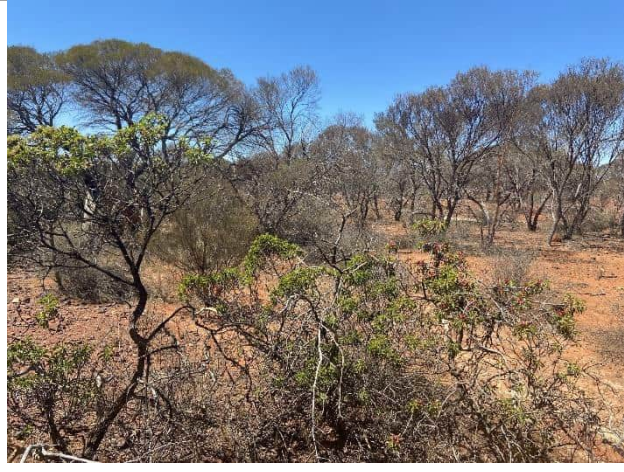
Site ID: MK SEIS 28		Co-ordinates: 51 J 261239 6970770	
<b>Location:</b> ~ 110 m east of haul road, within WNR	<b>Comments:</b> Site lies 100m downstream of the newly constructed road. The WNR fence line track is nearby with a high bund east of the track. Ants and termite mounds were present. Cryptograms on soil surface. Light dust load. At base of drainage line, depression in landscape.		
<b>Veg. Type:</b> Drainage line Mulga shrubland			
<b>Veg. Condition:</b> Very good			
<b>Grazing:</b> Light			
<b>Weed cover:</b> Nil			
<b>Photo direction:</b> NW			
Species	Cover (%)	Plant Health Score	Comments
<i>Sida ectogama</i>	30	2	
<i>Eremophila galeata</i>	5	5	Flowering.
<i>Acacia aneura</i>	25	4	Old pods present.
<i>Acacia quadrimarginea</i>	20	7c	
<i>Eremophila jucunda</i> subsp. <i>jucunda</i>	2	3	
<b>Other species:</b> <i>Ptilotus exaltatus</i> , <i>Enneapogon avenaceus</i> , <i>Senna glaucifolia</i> , <i>Psyrax suaveolens</i> , <i>Eremophila granitica</i> , <i>Dodonaea petiolaris</i> , <i>Lysiana</i> sp., <i>Senna</i> sp. <i>Meekatharra</i> , <i>Ptilotus helipteroides</i> , <i>Eremophila shonae</i> subsp. <i>shonae</i> , <i>Senna artemisioides</i> subsp. <i>xsturtii</i>

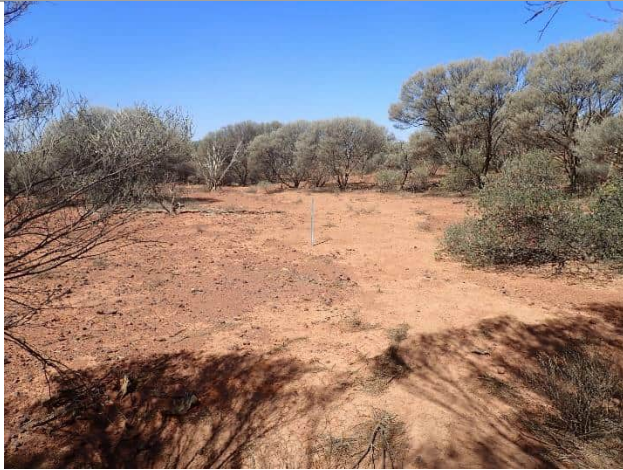
Site ID: MKS EIA 33		Co-ordinates: 51 J 261280 6968863	
<b>Location:</b> ~ 114 m east of haul road, within WNR	<b>Comments:</b> Site is very bare. Multiple dead <i>Maireana</i> sp. individuals. Only middle post present. Cryptograms on soil surface. Some pedestalling erosion present. Dry vegetation with further lower storey shrub deaths.		
<b>Veg. Type:</b> Stony ironstone Mulga shrubland			
<b>Veg. Condition:</b> Good			
<b>Grazing:</b> Light			
<b>Weed cover:</b> Nil			
<b>Photo direction:</b> NW			
Species	Cover (%)	Plant Health Score	Comments
<i>Senna</i> sp. Meekatharra	10	7b	Fallen over tree, living and healthy.
<i>Acacia aneura</i> sens. lat.	15	7b	Some insect galls.
<i>Dodonaea petiolaris</i>	0	1	Dead, not replaced.
<i>Maireana</i> sp.	<2	2	Only few individuals remaining.
<i>Ptilotus obovatus</i>	<2	2	
<b>Other species:</b> <i>Acacia quadrimarginea</i> , <i>Hibiscus</i> sp., <i>Hakea preissii</i> , <i>Aristida</i> sp.

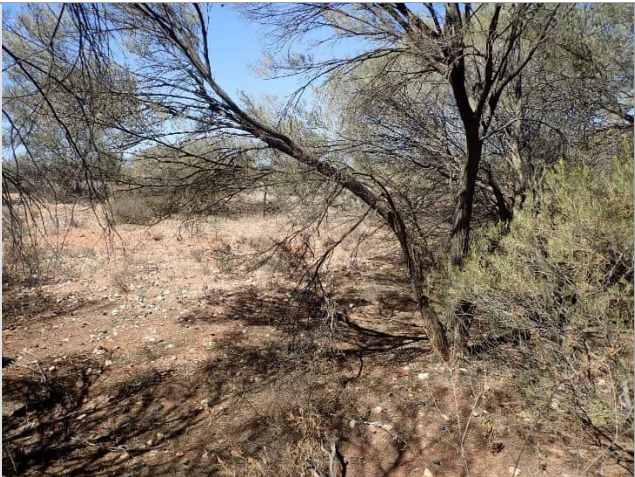
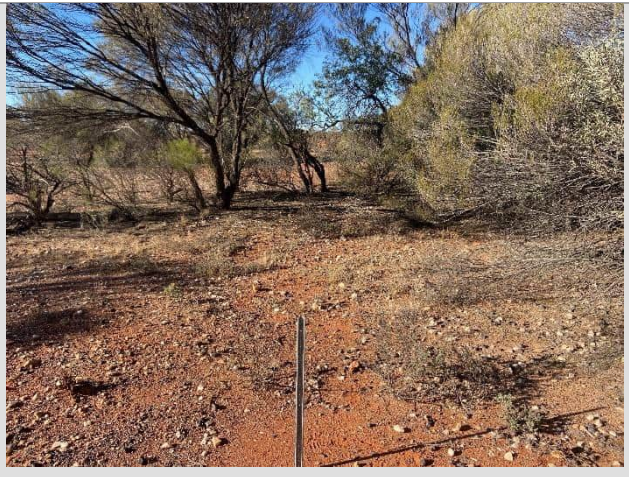
Site ID: MKS EIA 38		Co-ordinates: 51 J 261304 6967527	
<b>Location:</b> ~ 130 m east of haul road	<b>Comments:</b> Dust impacts and flora and vegetation. Ants and multiple rabbit warrens. Litter under trees. <i>Maireana</i> sp. individuals very dry, likely due to extended dry seasonal conditions.		
<b>Veg. Type:</b> Stony ironstone low shrubland.			
<b>Veg. Condition:</b> Very good			
<b>Grazing:</b> Light, historic			
<b>Weed cover:</b> Nil			
<b>Photo direction:</b> NW			
Species	Cover (%)	Plant Health Score	Comments
<i>Maireana triptera</i>	15	2	Few dead individuals.
<i>Acacia burkittii</i>	15	7b	Insect galls.
<i>Acacia aptaneura</i>	10	7b	Browsing line.
<i>Eremophila oldfieldii</i>	5	7b	
<i>Eremophila ?compacta</i> (EIA_38_001)	0	1	Dead and replaced.
<i>Senna artemisioides</i> subsp. <i>?filifolia</i>	<2	6	Replaces <i>Eremophila ?compacta</i> .
<b>Other species:</b> <i>Acacia aneura</i> , <i>Eremophila granitica</i> , <i>Enneapogon caerulescens</i> , <i>Sclerolaena eurotioides</i> , <i>Ptilotus obovatus</i> , <i>Eremophila latrobei</i> , <i>Lysiana</i> sp.

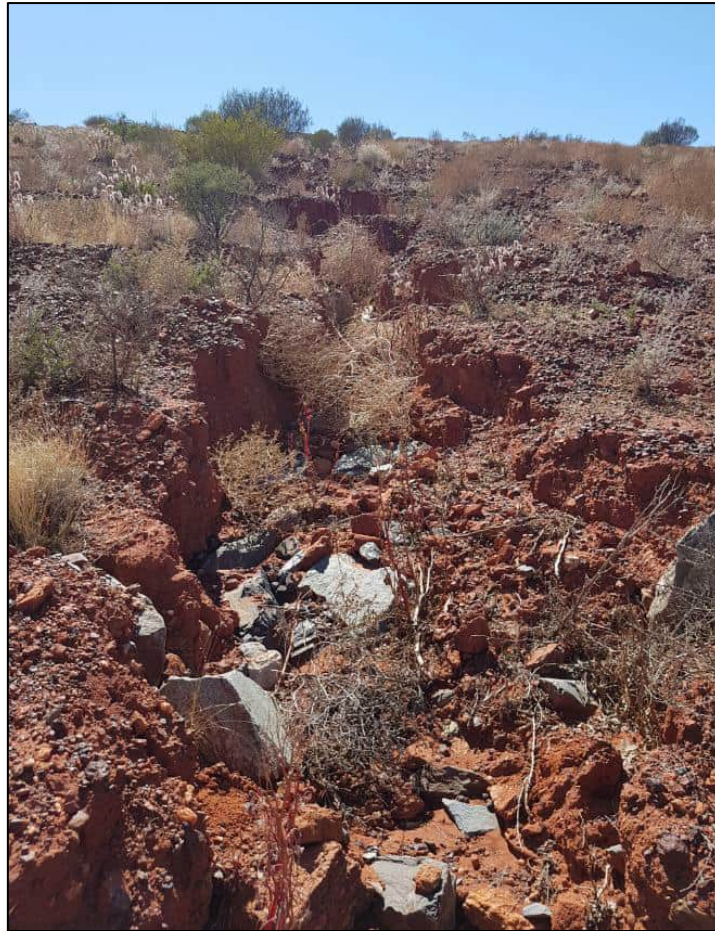
The performance to date of the concave slope has not been in line with expectations, with significant erosion evident in sections (**Plate 7-1**).

**Plate 7-1: Erosion Gullies Observed in Concave Slope Trials**
