APD
ENGINEERING

BHP NEWMAN TOWNSHIP ELECTRICITY SUPPLY
ANNUAL COMPLIANCE REPORT
2021/2022

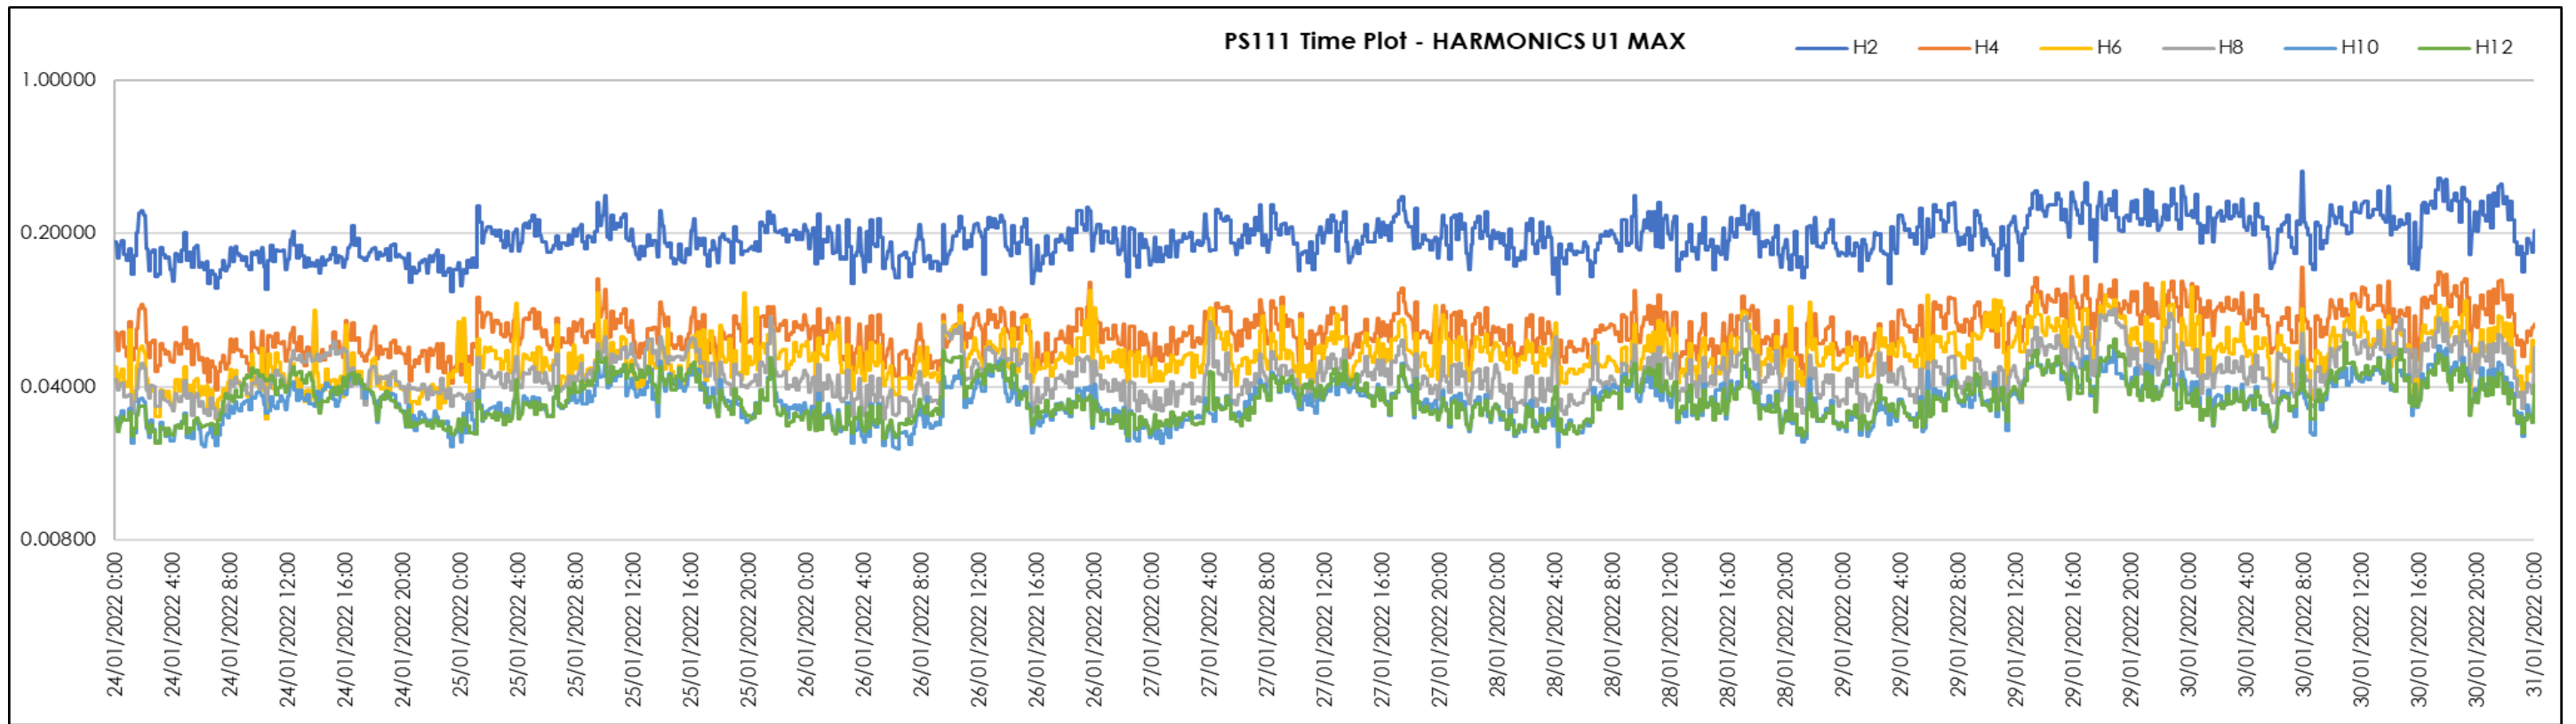
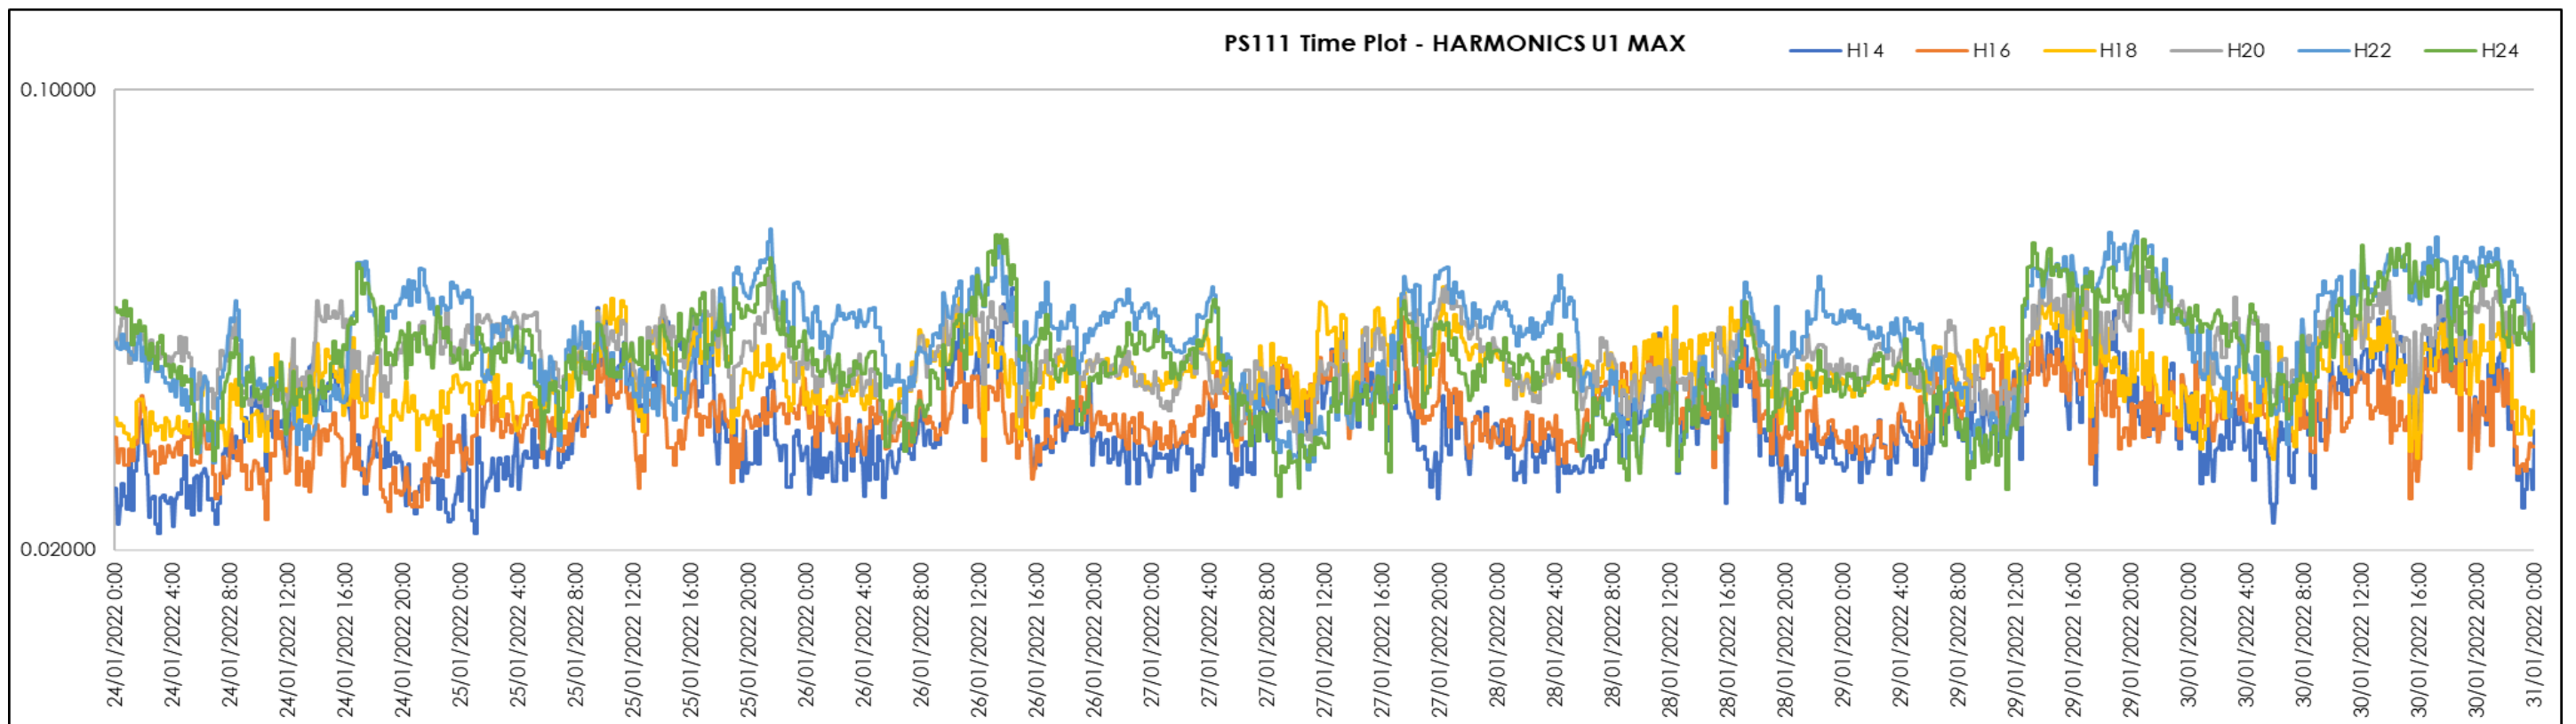
Figure 71 | STS4 Start Harmonics

The recorded individual order harmonic showed a (temporary) breach on Southtown substation feeder STS4 Start (PS 111 Hilditch Avenue Substation). There were 53 incidents observed during the 2021/2022 logging period in which the 21st harmonic level exceeded the allowable limit. This is not considered of a practical concern at this stage but given that this issue also arose in the same location in 2019/20. It is recommended that the situation be monitored and addressed over the year.
