Safety Information Brief

BMA Hay Point Coal Terminal

Released: 18th September 2020

Heaving Lights – Red & Green

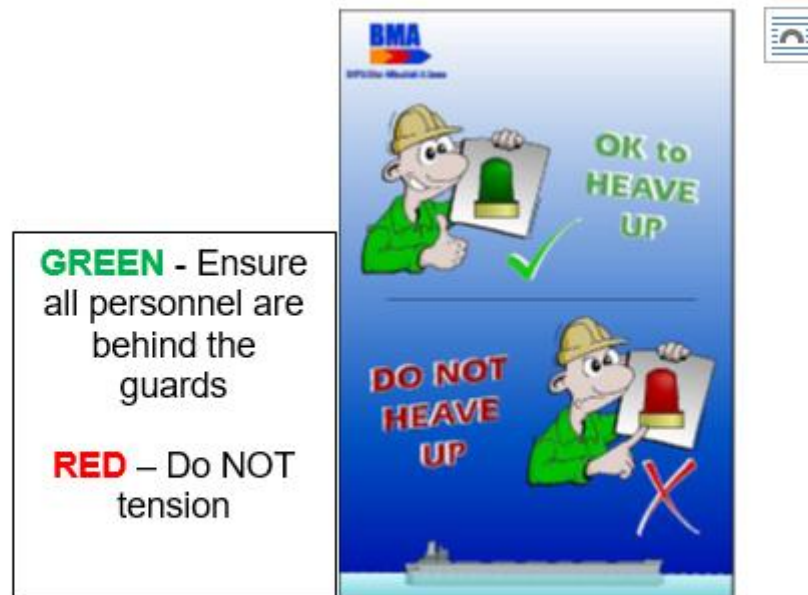
Figure 4: Heaving Lights Definition

Recently there was an incident at Hay Point Coal Terminal (HPCT) where the terminal line handling Crew were placed in the line of fire, of a Line Under tension, because the Ship's crew tensioned lines while the Red (DO NOT TENSION) light was flashing. This placed the terminal line handling crew in the unacceptable position of a snap back zone, due to the vessel crew not following the terminal safety requirements and instructions.

This is a reminder to all Vessels attending HPCT to follow the **Hay Point Procedure – Port Information & Regulations for Vessels arriving (ID 000196672)**, available via your Shipping Agent and in particular the DO NOT Tension Light requirements, during line handling activities.
