Aquatic Ecology Impact Assessment Report

Caval Ridge Mine

Horse Pit Extension Project Aquatic Ecology Assessment

August 2021

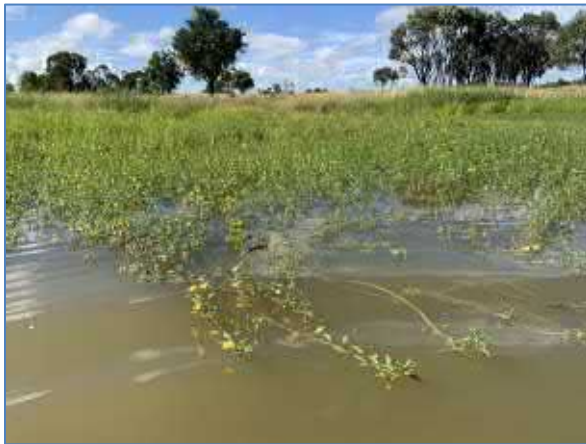
Figure 4.4 Aquatic plant communities at site HT1D in April 2020

Although connectivity to downstream habitats was typically limited due to the construction of dam walls, these sites contained water during the December 2019 (LW1, HT1D and U1D) or November 2020 (LW2) surveys, and would therefore provide dry season refuges for aquatic flora and fauna.

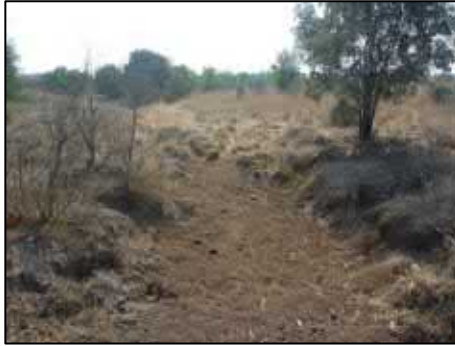
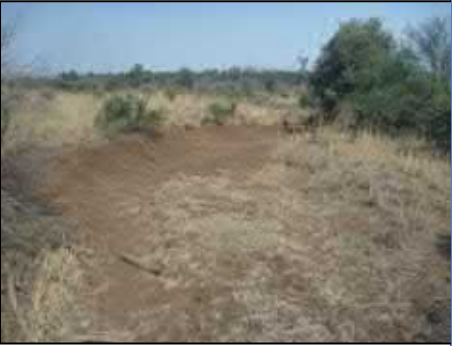
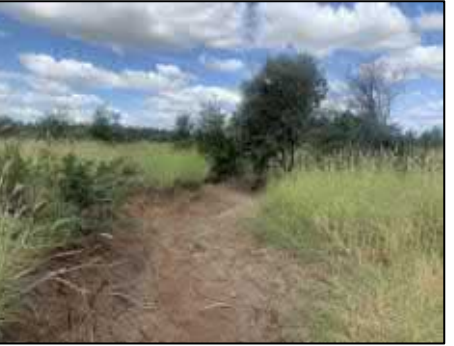
Site: U1		Location: Upstream		Stream Order: 1		Waterway: Unnamed tributary of Horse Creek																						
Upstream: December 2019		Downstream: December 2019		Upstream: April 2020		Downstream: April 2020

Aquatic Ecosystem Value: Low		MNES/MSES: None present or likely to occur		Dry season refuge: No		Connectivity: Limited due to location in catchment and presence of CVM downstream																						
In-stream condition: Fair Key potential habitat features included: <ul style="list-style-type: none"> • small amounts of small and large woody debris and detritus • a limited range of sediment grain sizes (predominately silt/clay with some sand), and • little trailing and overhanging bank vegetation. The site was dry during both the December and April surveys.		Riparian condition: Poor The riparian zone was semi-continuous around the perimeter of the waterway, although the extent of the vegetation had been reduced due to historic clearing. Vegetation consisted of grass, shrubs and some trees (predominantly eucalyptus and casuarina). Banks were low (1 m – 1.5 m high) and gently sloping with minimal erosion. There were some exotic terrestrial riparian species at the site.		External Impacts: High External impacts at the site were mostly associated with the surrounding land-use and included: <ul style="list-style-type: none"> • reduced riparian vegetation as a result of land clearing. 		Water Quality: N/A

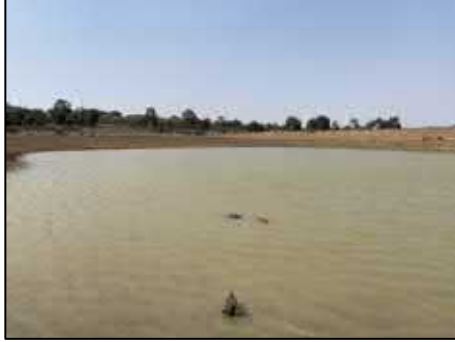
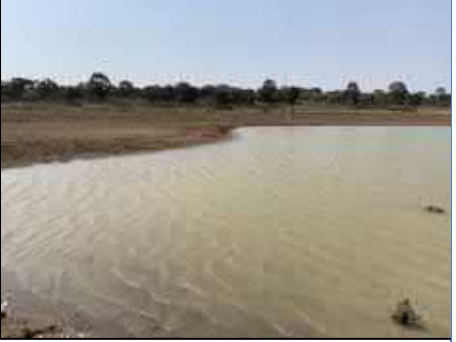
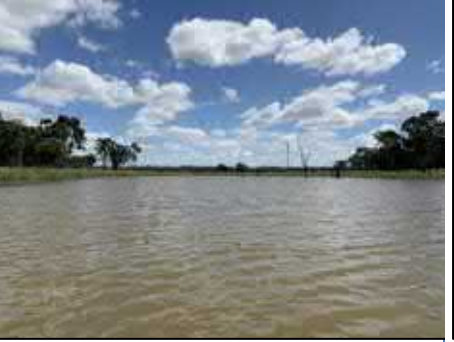
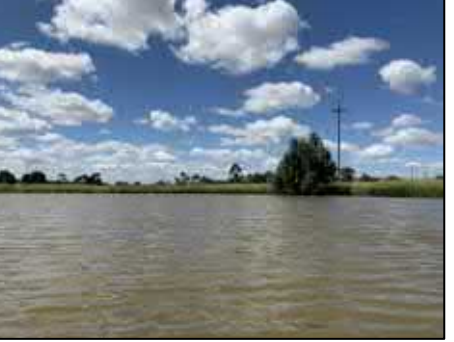
Site: U1D		Location: Upstream		Stream Order: 1		Waterway: Unmapped farm dam																						
Upstream: December 2019		Downstream: December 2019		Upstream: April 2020		Downstream: April 2020

Aquatic Ecosystem Value: Moderate		MNES/MSES: None present or likely to occur		Dry season refuge: Yes		Connectivity: Poor due to high dam walls, location in catchment and presence of CVM downstream																						
In-stream condition: Fair Key habitat features included: <ul style="list-style-type: none"> • diverse and abundant aquatic plants • a variety of woody debris • periphyton • sediment grain sizes predominately silt/clay, and sandy gravel • shallow & deep pools, and • trailing and overhanging bank vegetation. 		Riparian condition: Poor The riparian zone was continuous around the perimeter of the waterway, although the extent of the vegetation had been reduced. Vegetation consisted of grass, ferns and weeds. Banks were low (1.5 m – 2 m high) and gently sloping with some erosion. There were some exotic terrestrial riparian species at the site.		External Impacts: High External impacts at the site were mostly associated with the surrounding land-use and included: <ul style="list-style-type: none"> • reduced riparian vegetation as a result of land clearing • grazing by livestock • feral animals, and • the presence of an artificial dam. 		Water Quality: Poor

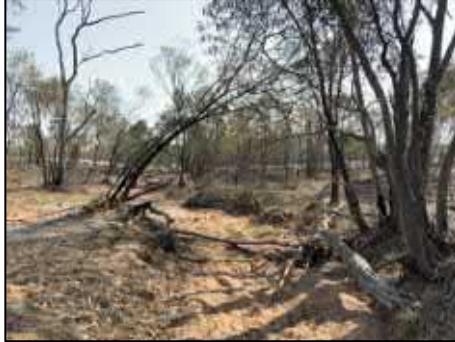
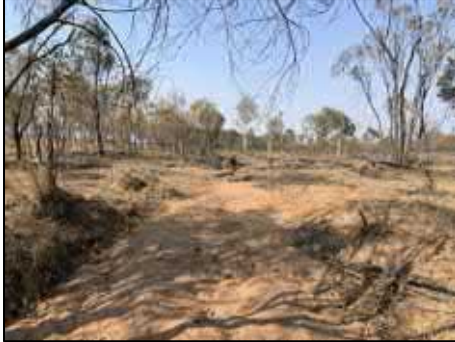
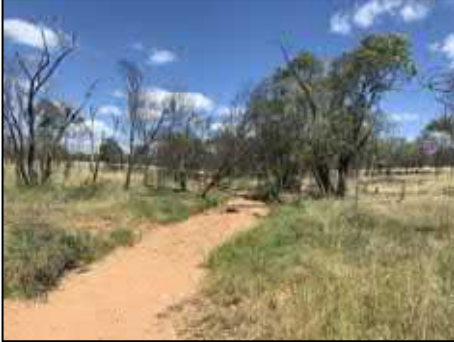
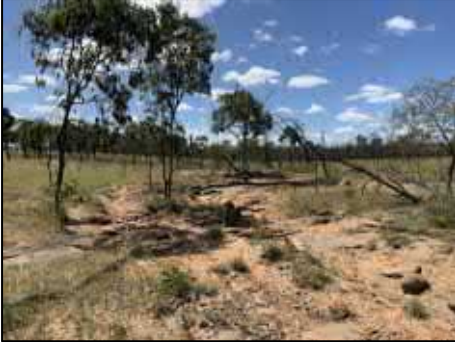
Site: U2		Location: Upstream		Stream Order: 1		Waterway: Unnamed tributary of Caval Creek																						
Upstream: December 2019		Downstream: December 2019		Upstream: April 2020		Downstream: April 2020

Aquatic Ecosystem Value: Low		MNES/MSES: None present or likely to occur		Dry season refuge: No		Connectivity: Limited due to location in catchment and presence of CVM downstream																						
<p>In-stream condition: Fair</p> <p>Key potential habitat features included:</p> <ul style="list-style-type: none"> • ephemeral channel • some woody debris • predominately sandy sediments with some cobbles and boulders, and • little trailing and overhanging bank vegetation. <p>The site was dry during both the December and April surveys.</p>		<p>Riparian condition: Poor</p> <p>The riparian zone was semi-continuous around the perimeter of the waterway, although the extent of the vegetation had been reduced due to historic clearing. Vegetation consisted of trees, grasses and weeds. Banks were low (approximately 1 m high) and gently sloping with some erosion. There were some exotic terrestrial riparian species at the site.</p>		<p>External Impacts: High</p> <p>External impacts at the site were mostly associated with the surrounding land-use and included:</p> <ul style="list-style-type: none"> • reduced riparian vegetation as a result of land clearing • grazing by livestock, and • feral animals. 		<p>Water Quality: N/A</p>

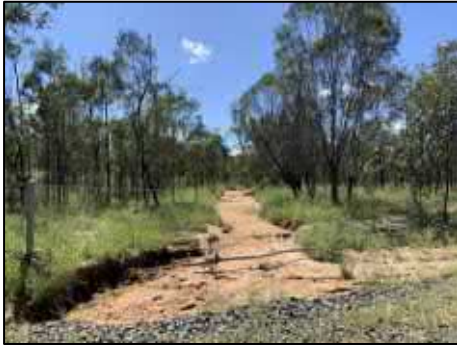
Downstream: April 2020

Aquatic Ecosystem Value: Low		MNES/MSES: None present or likely to occur		Dry season refuge: No		Connectivity: Limited due to location in catchment and presence of CVM downstream																						
In-stream condition: Fair Key potential habitat features in April included: <ul style="list-style-type: none"> • well defined ephemeral channel • some woody debris • predominately sandy sediments with some cobbles and boulders, and • little trailing and overhanging bank vegetation. The site was not sampled during the December survey and was dry during the April survey.		Riparian condition: Fair The riparian zone was continuous around the perimeter of the waterway, although the extent of the vegetation in the broader region had been reduced due to historic clearing. Vegetation consisted of trees, grasses and weeds. Banks were low (approximately 0.5 m high) and gently sloping with some erosion. There were some exotic terrestrial riparian species at the site.		External Impacts: High External impacts at the site were mostly associated with the surrounding land-use and included: <ul style="list-style-type: none"> • grazing by livestock • feral animals, and • vehicle track crossing. 		Water Quality: N/A

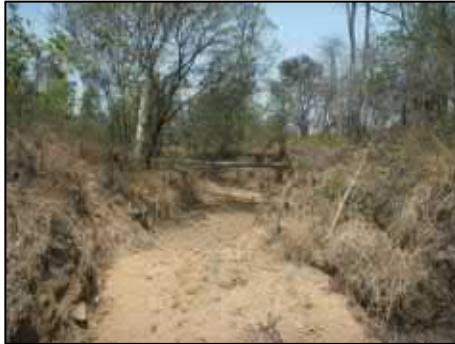
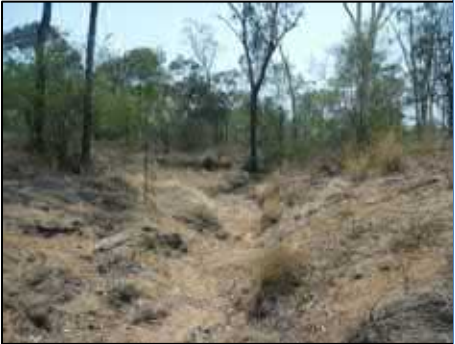
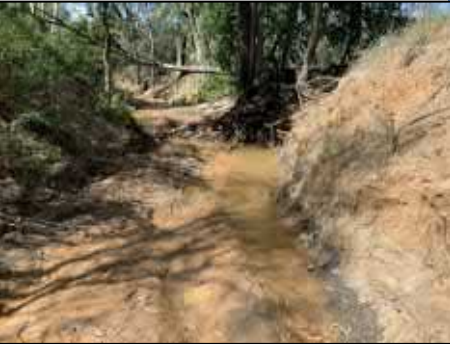
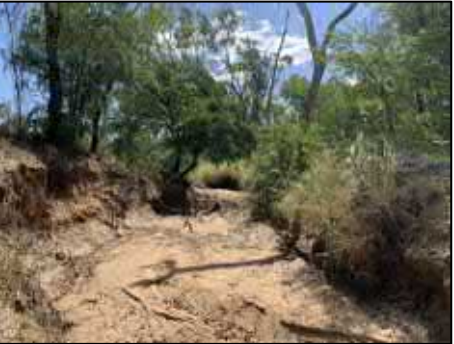
Site: Ca1		Location: Upstream		Stream Order: 2		Waterway: Caval Creek																						
Upstream: December 2019		Downstream: December 2019		Upstream: April 2020		Downstream: April 2020

Aquatic Ecosystem Value: Low		MNES/MSES: None present or likely to occur		Dry season refuge: No		Connectivity: Moderate, during periods of flow																						
In-stream condition: Fair Key habitat features in April included: <ul style="list-style-type: none"> • sandy ephemeral channel • shallow pools • some woody debris & detritus • predominately sand and silt/clay sediments with some pebbles & gravel, and • some trailing and overhanging bank vegetation. The site was dry during the December survey.		Riparian condition: Fair The riparian zone was semi-continuous around the perimeter of the waterway, although the extent of the vegetation had been reduced due to historic clearing. Vegetation consisted of trees, grasses, shrubs, ferns/sedges and weeds. Banks were low (1.8 m – 2 m high) and gently sloping with moderate levels erosion. There were some exotic terrestrial riparian species at the site.		External Impacts: High External impacts at the site were mostly associated with the surrounding land-use and included: <ul style="list-style-type: none"> • reduced riparian vegetation as a result of land clearing • grazing by livestock, and • feral animals. 		Water Quality: Fair

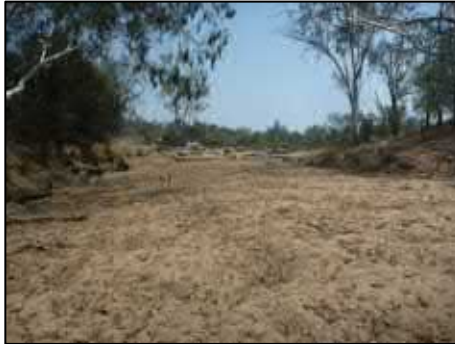
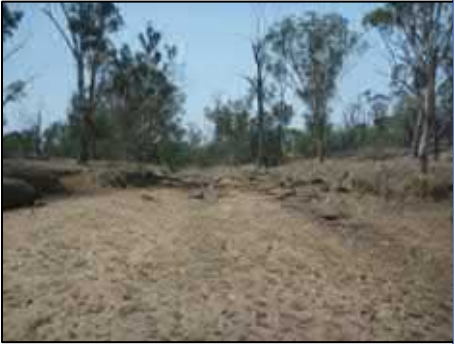
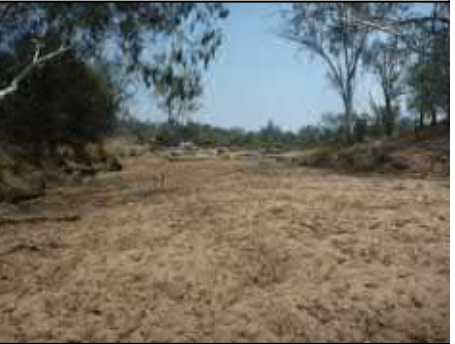
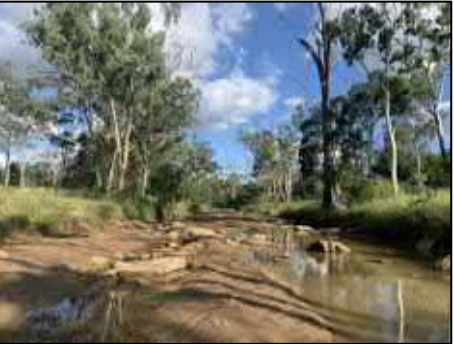
Site: Ch1		Location: Upstream		Stream Order: 4		Waterway: Cherwell Creek																						
Upstream: December 2019		Downstream: December 2019		Upstream: April 2020		Downstream: April 2020

Aquatic Ecosystem Value: Moderate		MNES/MSES: None present or likely to occur		Dry season refuge: No		Connectivity: Good, during periods of flow																						
In-stream condition: Fair Key habitat features in April included: <ul style="list-style-type: none"> • some woody debris • shallow pools • predominately sand and silt/clay sediments with some boulders, and • some trailing and overhanging bank vegetation. The site was dry during the December survey.		Riparian condition: Good The riparian zone was semi-continuous around the perimeter of the waterway, although the extent of the vegetation had been reduced due to historic clearing. Vegetation consisted of trees, grasses, shrubs, ferns and weeds. Banks were low (3.5 m – 2 m high) and gently sloping with some erosion. There were some exotic terrestrial riparian species at the site.		External Impacts: Moderate External impacts at the site were mostly associated with the surrounding land-use and included: <ul style="list-style-type: none"> • reduced riparian vegetation as a result of land clearing • grazing by livestock • feral animals, and • vehicle track crossing. 		Water Quality: Good

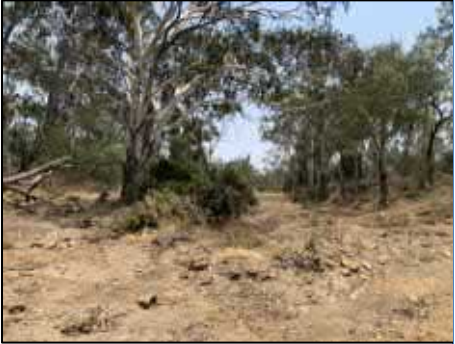
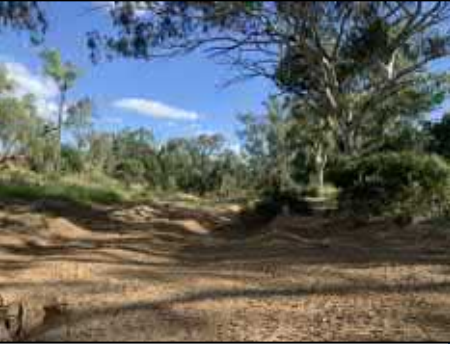
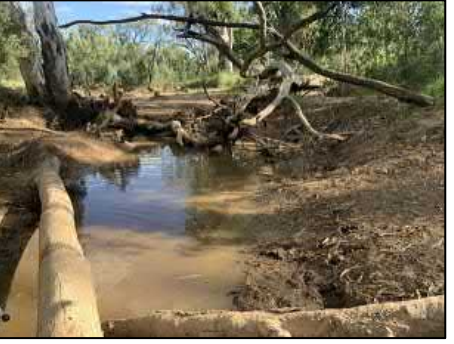
Site: Ch2		Location: Upstream		Stream Order: 5		Waterway: Cherwell Creek																						
Upstream: December 2019		Downstream: December 2019		Upstream: April 2020		Downstream: April 2020

Aquatic Ecosystem Value: Moderate		MNES/MSES: None present or likely to occur		Dry season refuge: No		Connectivity: Good, during periods of flow.																						
In-stream condition: Fair Key habitat features in April included: <ul style="list-style-type: none"> • wide sandy ephemeral channel • some woody debris & detritus • predominately sandy sediments with some silt/clay, and • some overhanging and trailing bank vegetation. The site was dry during the December survey.		Riparian condition: Fair The riparian zone was semi-continuous around the perimeter of the waterway, although the extent of the vegetation had been reduced due to historic clearing. Vegetation consisted of trees, grasses and weeds. Banks were intermediate (3 m – 4 m high) and gently sloping with moderate erosion. There were some exotic terrestrial riparian species at the site.		External Impacts: High External impacts at the site were mostly associated with the surrounding land-use and included: <ul style="list-style-type: none"> • reduced riparian vegetation as a result of land clearing • grazing by livestock, and • feral animals. 		Water Quality: Fair

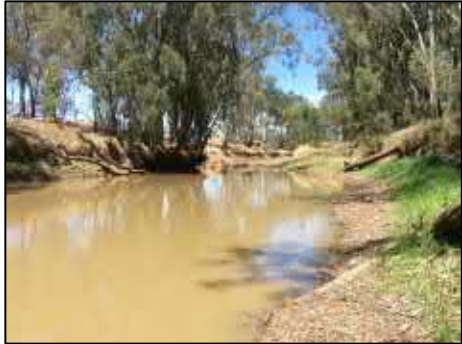
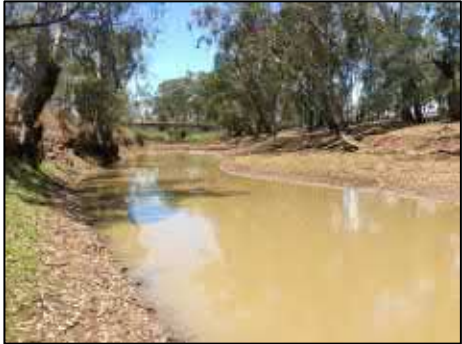
Site: GCO1		Location: Upstream		Stream Order: 5		Waterway: Grosvenor Creek															
Upstream: November 2020

Aquatic Ecosystem Value: Moderate		MNES/MSES: None present or likely to occur		Dry season refuge: Potential		Connectivity: N/A															
<p>In-stream condition: Poor</p> <p>Key habitat features in November 2020 included:</p> <ul style="list-style-type: none"> • wetted channel • silty/clay/muddy sediments • some shading of reach • some snags, woody debris & branches, and • little detritus in stream. <p>The site was wet during the November 2020 survey.</p>		<p>Riparian condition: Good</p> <p>The riparian zone was narrow with surrounding agricultural land upstream. Some sedges were around the perimeter of the waterway. Evidence of deer, pig and horse disturbance was present in the surrounding riparian zone. Left and right bank height was low (approximately 2 m high) and steeply sloping on the left and gently sloping on some areas on the right near the bridge. Site was approximately 10 m wide. The wetted area was a still pool not connected downstream. The water appeared to be receding in subsequent survey days. It was unclear where water was fed from (e.g. upstream farm dam releases, groundwater etc.) and it was also unclear whether downstream earthworks were influencing water levels (e.g. damming water or restricting flow). While the waterway was a dry season refuge during the survey, it was unclear if water consistently endured the entire dry season or whether it was influenced by current land use and earthworks that occurred during the surveys.</p>		<p>External Impacts: Moderate</p> <p>External impacts at the site were mostly associated with the surrounding land-use and included:</p> <ul style="list-style-type: none"> • reduced terrestrial vegetation as a result of land clearing • grazing by livestock, and • feral animals. 		<p>Water Quality: N/A</p>

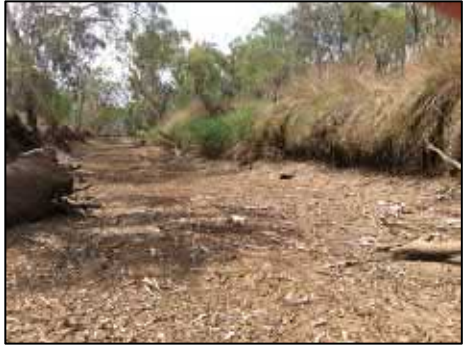
Site: GCO2		Location: Upstream	Stream Order: 5	Waterway: Grosvenor Creek	
Upstream: November 2020		Downstream: November 2020

Aquatic Ecosystem Value: Poor		MNES/MSES: None present or likely to occur		Dry season refuge: N/A	
In-stream condition: Poor Key habitat features in November 2020 included: <ul style="list-style-type: none"> • ephemeral channel • consolidated dry sediments • some shading of reach • some snags, woody debris & branches, and • little detritus. • eroded bank The site was dry during the November 2020 survey.		Riparian condition: Good The riparian zone was a scattered semi-continuous/continuous mix of grasses, trees, and weeds. A dead eel was in the vicinity of the site. There was a road crossing downstream of the site, and there was water present approximately 200 m downstream of the site. Left and right banks were approximately 4 m high and steep. Channel was approximately 10 m wide.		External Impacts: Moderate External impacts at the site were mostly associated with the surrounding land-use and included: <ul style="list-style-type: none"> • reduced terrestrial vegetation as a result of land clearing • grazing by livestock, and • feral animals.

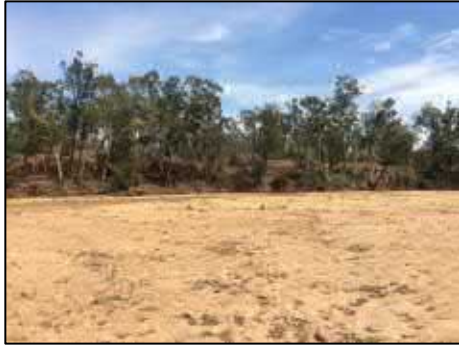
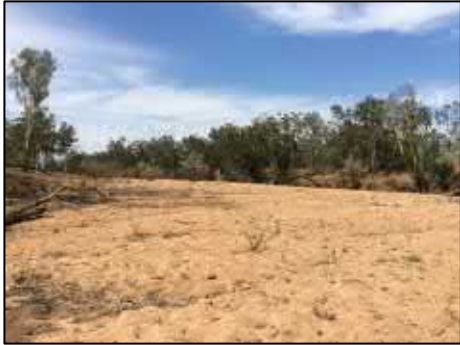
Site: IR01		Location: Upstream		Stream Order: 5		Waterway: Isaac River																						
Upstream: November 2020		Downstream: November 2020

Aquatic Ecosystem Value: Moderate		MNES/MSES: None present or likely to occur		Dry season refuge: N/A		Connectivity: N/A																						
<p>In-stream condition: Poor</p> <p>Key habitat features in November 2020 included:</p> <ul style="list-style-type: none"> • ephemeral channel • predominately sandy sediments with some pebbles, gavel and clay/silt • little shading of reach • no trailing vegetation, and • some large snags, woody debris & branches. <p>The site was dry during the November survey.</p>		<p>Riparian condition: Good</p> <p>The riparian zone was a scattered semi-continuous/continuous mix around the perimeter of the waterway, and the extent of the vegetation had been reduced. Vegetation consisted grasses, trees, and weeds. Left bank height was low (approximately 0.5 m high) and gently sloping; the right bank was higher (approximately 15 m high), steep banks with moderate erosion. There were some exotic terrestrial riparian species at the site. Site was wide (approximately 60 m wide).</p>		<p>External Impacts: Moderate</p> <p>External impacts at the site were mostly associated with the surrounding land-use and included:</p> <ul style="list-style-type: none"> • reduced terrestrial vegetation as a result of land clearing • grazing by livestock, and • feral animals. 		<p>Water Quality: N/A</p>

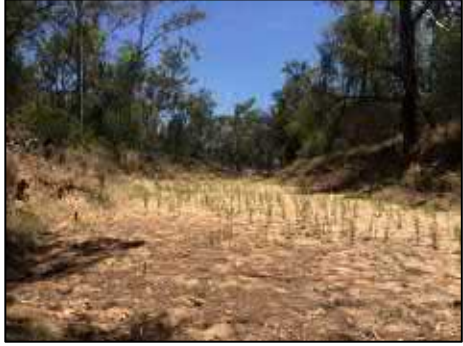
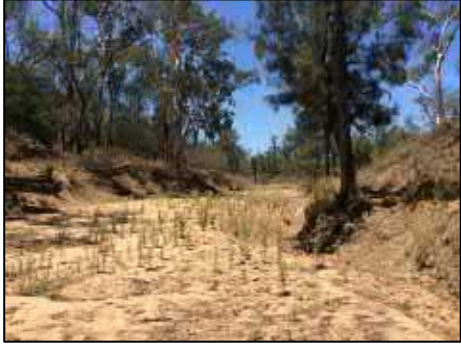
Site: HC01		Location: Downstream	Stream Order: 4	Waterway: Harrow Creek											
Upstream: November 2020

Aquatic Ecosystem Value: Moderate	MNES/MSES: None present or likely to occur	Dry season refuge: N/A	Connectivity: N/A												
In-stream condition: Moderate Key habitat features in November 2020 included: <ul style="list-style-type: none"> • ephemeral channel • unconsolidated sand sediments • established terrestrial weeds in the channel • some shading of reach • little snags, woody debris & branches, and • little detritus. The site was dry during the November 2020 survey.	Riparian condition: Fair The riparian zone was a scattered semi-continuous/continuous mix of grasses, trees, and weeds. Left and right bank height was approximately 5 m high, with moderate sloping on the left bank, and steep slopes on the right. Channel was approximately 20 m wide.	External Impacts: Moderate External impacts at the site were mostly associated with the surrounding land-use and included: <ul style="list-style-type: none"> • reduced terrestrial vegetation as a result of land clearing • grazing by livestock, and feral animals. 	Water Quality: N/A

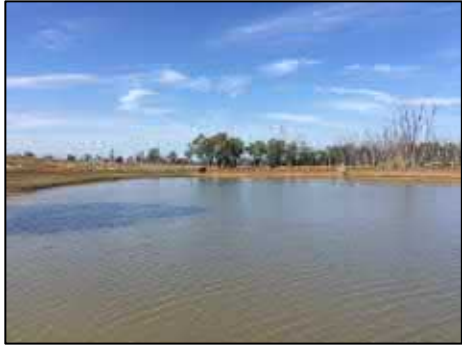
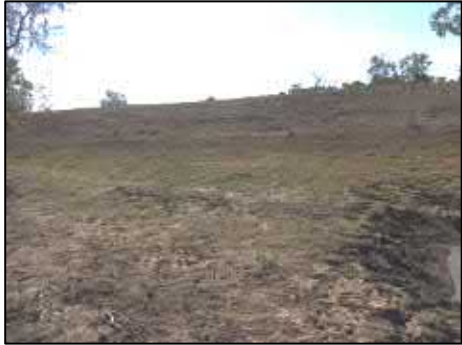
Site: LW2		Location: Upstream		Stream Order: 2		Waterway: Wetland															
Upstream: November 2020		Downstream: November 2020

Aquatic Ecosystem Value: Poor		MNES/MSES: None present or likely to occur		Dry season refuge: Yes		Connectivity: Not connected															
In-stream condition: Fair Key habitat features in November 2020 included: <ul style="list-style-type: none"> • shallow & deep pools • aquatic plants • predominately fine sediments (sand & silt/clay) • little trailing & overhanging vegetation, and • some snags, woody debris & detritus. The site was wet during the November 2020 survey.		Riparian condition: Good The riparian zone was a scattered continuous mix with isolated trees around the perimeter of the waterway, and the extent of the vegetation had been reduced. Vegetation consisted of grasses, shrubs, trees and weeds. Banks were generally low (approximately 1 m high) and gently sloping with moderate erosion. Damming side of the waterway had a more steeply sloping bank, approximately 5 m high. There were some exotic terrestrial riparian species at the site.		External Impacts: Moderate External impacts at the site were mostly associated with the surrounding land-use and included: <ul style="list-style-type: none"> • reduced terrestrial vegetation as a result of land clearing • grazing by livestock, and feral animals. 		Water Quality:

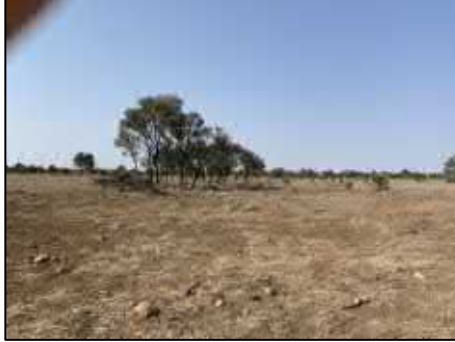
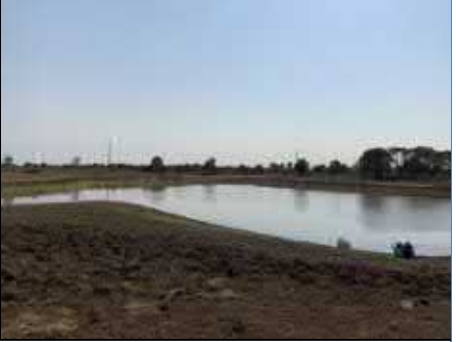
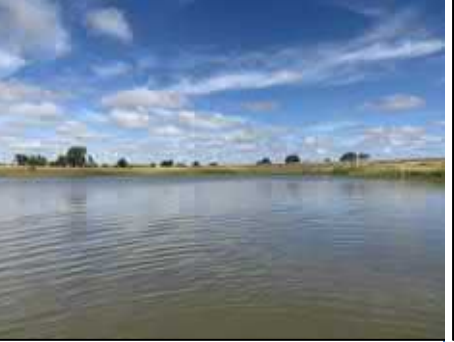
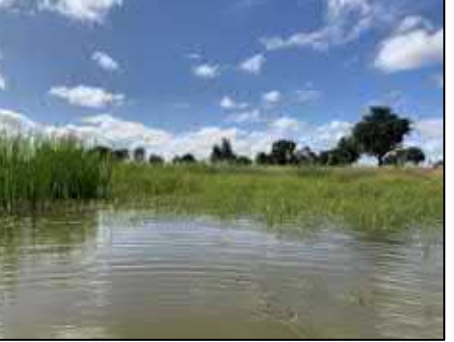
Site: HT1D		Location: Within Project Footprint		Stream Order: 1		Waterway: Unmapped farm dam																						
Upstream: December 2019		Downstream: December 2019		Upstream: April 2020		Downstream: April 2020

Aquatic Ecosystem Value: Moderate		MNES/MSES: None present or likely to occur		Dry season refuge: Yes		Connectivity: Poor, isolated from main watercourse by dam																						
In-stream condition: Fair Key habitat features included: <ul style="list-style-type: none"> • farm dam on ephemeral channel • aquatic plants lining channel • shallow & deep pools • predominately silt/clay sediments • little trailing bank vegetation and woody debris, and • some detritus. 		Riparian condition: Poor The riparian zone was isolated around the perimeter of the waterway, and the extent of the vegetation had been reduced due to historical clearing for agriculture. Vegetation consisted grasses, ferns and weeds. Banks were low (approximately 2.5 m high) and gently sloping with moderate erosion. There were some exotic terrestrial riparian species at the site.		External Impacts: Extreme External impacts at the site were mostly associated with the surrounding land-use and included: <ul style="list-style-type: none"> • reduced riparian vegetation as a result of land clearing • grazing by livestock • feral animals, and • the presence of an artificial dam. 		Water Quality: Poor

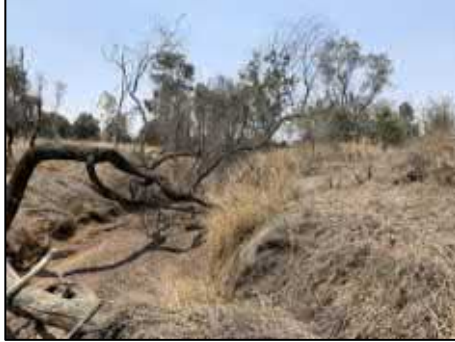
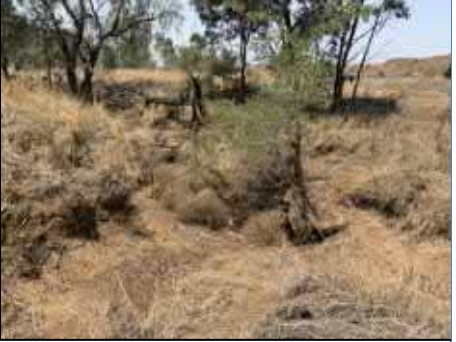
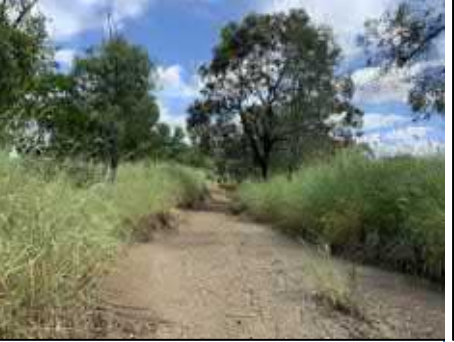
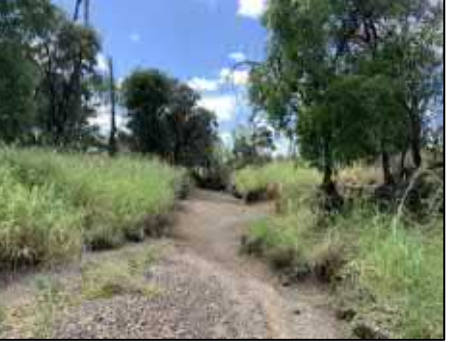
Site: H1		Location: Downstream		Stream Order: 2		Waterway: Horse Creek																						
Upstream: December 2019		Downstream: December 2019		Upstream: April 2020		Downstream: April 2020

Aquatic Ecosystem Value: Low		MNES/MSES: None present or likely to occur		Dry season refuge: No		Connectivity: Limited, during periods of flow																						
In-stream condition: Fair Key potential habitat features included: <ul style="list-style-type: none"> • ephemeral waterway • predominately sandy sediments with some gravel and pebbles, and • moderate snags and woody debris. The site was dry during both the December and April surveys.		Riparian condition: Fair The riparian zone was semi-continuous around the perimeter of the waterway, and the extent of the vegetation had been reduced. Vegetation consisted grasses, trees and weeds. Banks were low (approximately 1.8 m high) and gently sloping with moderate bank and extensive bed erosion. There were some exotic terrestrial riparian species at the site.		External Impacts: High External impacts at the site were mostly associated with the surrounding land-use and included: <ul style="list-style-type: none"> • reduced riparian vegetation as a result of land clearing • grazing by livestock, and • feral animals. 		Water Quality: N/A

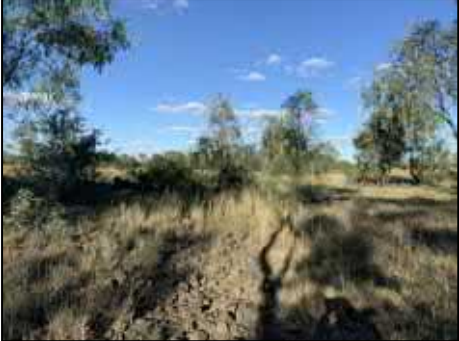
Downstream: April 2020

Aquatic Ecosystem Value: Low		MNES/MSES: None present or likely to occur		Dry season refuge: No		Connectivity: Limited, during periods of flow																						
<p>In-stream condition: Poor</p> <p>Key potential habitat features in April included:</p> <ul style="list-style-type: none"> • ephemeral waterway • rocky narrow channel • predominately cobbled sediments with some sand • little snags and woody debris, and • little trailing & overhanging vegetation. <p>The site was not sampled during the December survey and was dry during the April survey.</p>		<p>Riparian condition: Fair</p> <p>The riparian zone was semi-continuous around the perimeter of the waterway, and the extent of the vegetation had been reduced. Vegetation consisted grasses, trees and weeds. Banks were low (approximately 1 m high) and gently sloping with moderate erosion. There were some exotic terrestrial riparian species at the site.</p>		<p>External Impacts: High</p> <p>External impacts at the site were mostly associated with the surrounding land-use and included:</p> <ul style="list-style-type: none"> • reduced riparian vegetation as a result of land clearing • grazing by livestock, and • feral animals. 		<p>Water Quality: N/A</p>

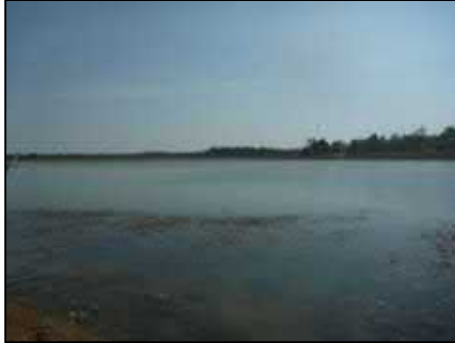
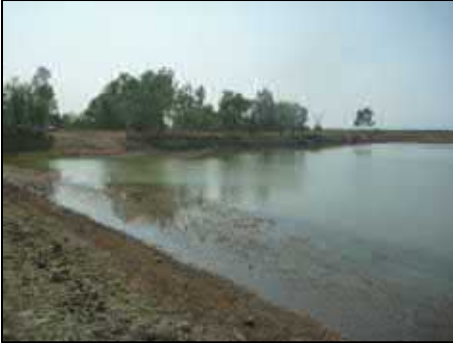
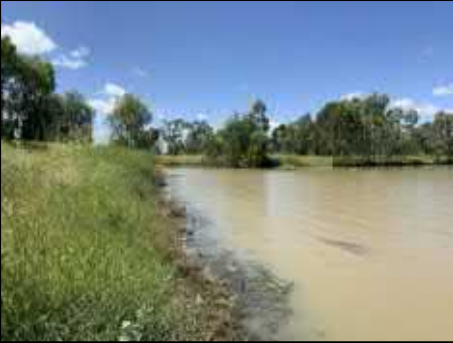
Site: LW1		Location: Downstream		Stream Order: 3		Waterway: Mapped lacustrine wetland on Horse Creek																						
Upstream: December 2019		Downstream: December 2019		Upstream: April 2020		Downstream: April 2020

Aquatic Ecosystem Value: Moderate		MNES/MSES: None present or likely to occur		Dry season refuge: Yes		Connectivity: Limited due to high dam walls																						
In-stream condition: Fair Key habitat features included: <ul style="list-style-type: none"> • shallow & deep pools • aquatic plants • predominately fine sediments (sand & silt/clay) • little trailing & overhanging vegetation, and • some snags, woody debris & detritus. 		Riparian condition: Fair The riparian zone was a scattered continuous mix with isolated trees around the perimeter of the waterway, and the extent of the vegetation had been reduced. Vegetation consisted grasses, shrubs, trees and weeds. Banks were low (approximately 3 m high) and gently sloping with moderate erosion. There were some exotic terrestrial riparian species at the site.		External Impacts: High External impacts at the site were mostly associated with the surrounding land-use and included: <ul style="list-style-type: none"> • reduced riparian vegetation as a result of land clearing • grazing by livestock • feral animals, and • presence of an artificial dam. 		Water Quality: Poor

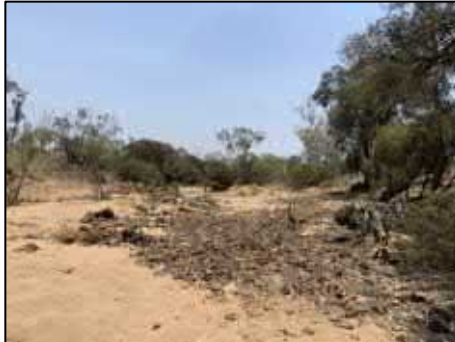
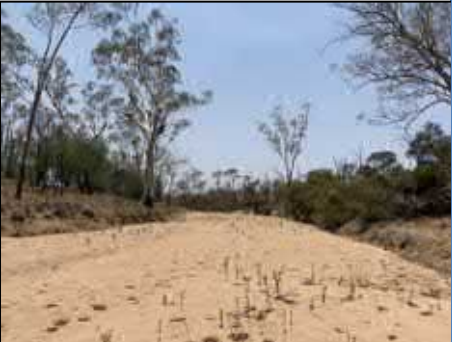
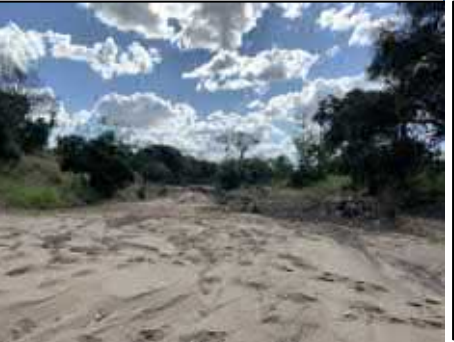
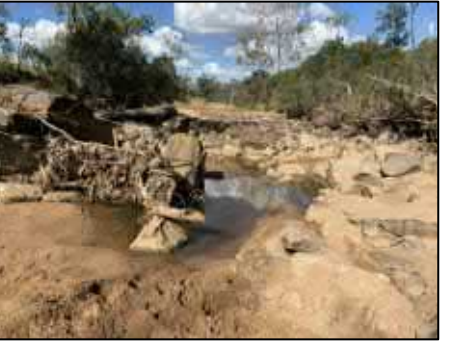
Site: Ch3		Location: Downstream		Stream Order: 5		Waterway: Cherwell Creek																						
Upstream: December 2019		Downstream: December 2019		Upstream: April 2020		Downstream: April 2020

Aquatic Ecosystem Value: Moderate		MNES/MSES: None present or likely to occur		Dry season refuge: No		Connectivity: Good, during periods of flow																						
In-stream condition: Good Key habitat features in April included: <ul style="list-style-type: none"> • ephemeral channel • shallow pools • predominately sandy sediments with some pebbles, gavel and clay/silt • little overhanging & trailing vegetation, and • little snags, woody debris & branches. The site was dry during the December survey.		Riparian condition: Good The riparian zone was a continuous width around the perimeter of the waterway, and the extent of the vegetation had been reduced. Vegetation consisted grasses, shrubs, trees, ferns and weeds. Banks were low (approximately 4 m high) and gently sloping with moderate erosion. There were some exotic terrestrial riparian species at the site.		External Impacts: Moderate External impacts at the site were mostly associated with the surrounding land-use and included: <ul style="list-style-type: none"> • reduced riparian vegetation as a result of land clearing • grazing by livestock, and • feral animals. 		Water Quality: Good

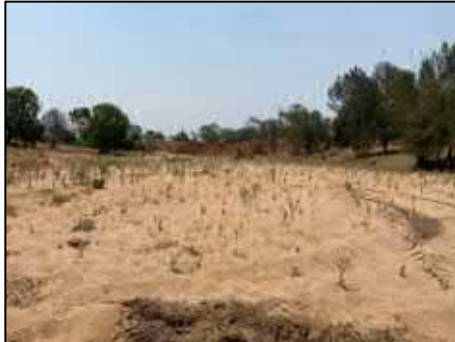
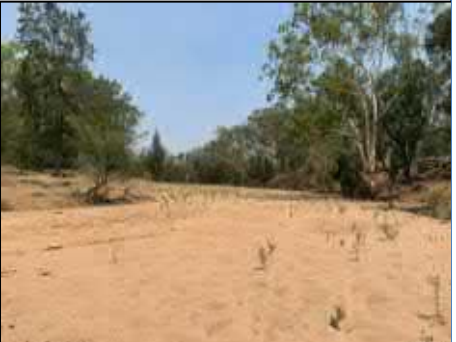
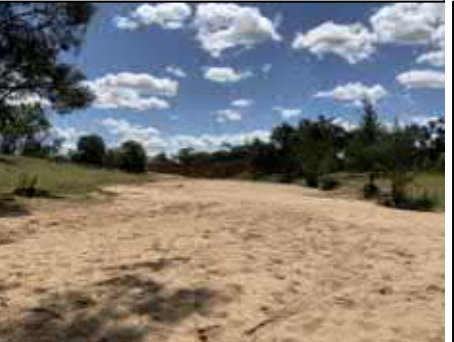
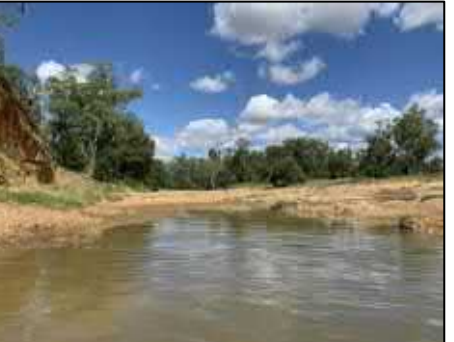
Site: Ch4		Location: Downstream		Stream Order: 5		Waterway: Cherwell Creek																						
Upstream: December 2019		Downstream: December 2019		Upstream: April 2020		Downstream: April 2020

Aquatic Ecosystem Value: Moderate		MNES/MSES: None present or likely to occur		Dry season refuge: No		Connectivity: Good, during periods of flow																						
In-stream condition: Good Key habitat features in April included: <ul style="list-style-type: none"> • ephemeral channel • predominately sandy sediments with some clay/silt • some overhanging vegetation • little snags, woody debris & branches • shallow pool at eroded bend. The site was dry during the December survey.		Riparian condition: Fair The riparian zone was a semi-continuous/ continuous mix around the perimeter of the waterway, and the extent of the vegetation had been reduced. Vegetation consisted grasses, shrubs, trees, ferns and weeds. Banks were low (2.5 m – 3.5 m high) and gently sloping with extensive erosion. There were some exotic terrestrial riparian species at the site.		External Impacts: Moderate External impacts at the site were mostly associated with the surrounding land-use and included: <ul style="list-style-type: none"> • reduced riparian vegetation as a result of land clearing • grazing by livestock, and • feral animals. 		Water Quality: Fair

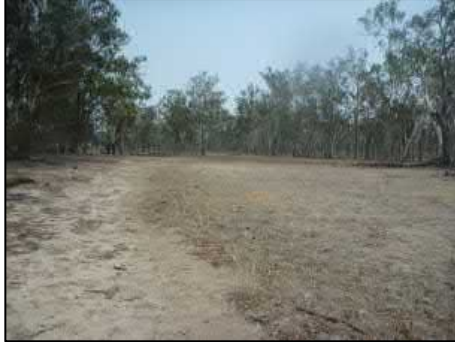
Site: PW1		Location: Downstream		Stream Order: N/A		Waterway: Mapped WPA / HES palustrine wetland																						
December 2019		December 2019		April 2020 N/A		April 2020 N/A

Aquatic Ecosystem Value: Low		MNES/MSES: None present or likely to occur		Dry season refuge: No		Connectivity: Limited, would only hold water during periods of high flow																						
<p>In-stream condition: Poor</p> <p>Key potential habitat features in December included:</p> <ul style="list-style-type: none"> • predominately clay/silt sediments • little overhanging & trailing vegetation • emergent aquatic plants, and • little snags, woody debris & branches. <p>The site was dry during the December survey and was not sampled during the April survey due to property access issues.</p>		<p>Riparian condition: Fair</p> <p>The riparian zone was reduced but continuous around the perimeter of the wetland, and the extent of the vegetation had been reduced. Vegetation consisted trees predominantly eucalyptus, grasses and shrubs. There was some erosion in the dry bed. There were some exotic terrestrial riparian species at the site.</p>		<p>External Impacts: Moderate</p> <p>External impacts at the site were mostly associated with the surrounding land-use and included:</p> <ul style="list-style-type: none"> • reduced riparian vegetation as a result of land clearing • grazing by livestock, and • feral animals. 		<p>Water Quality: N/A</p>

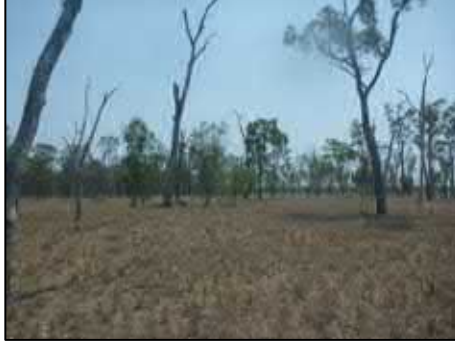
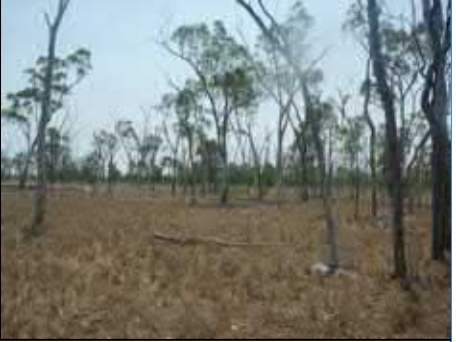
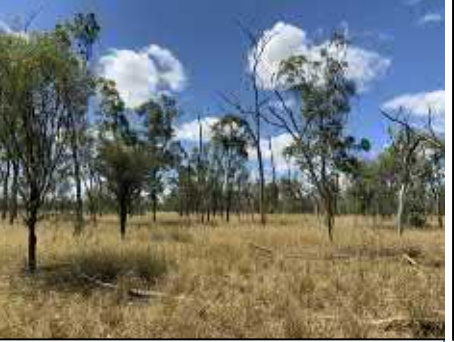
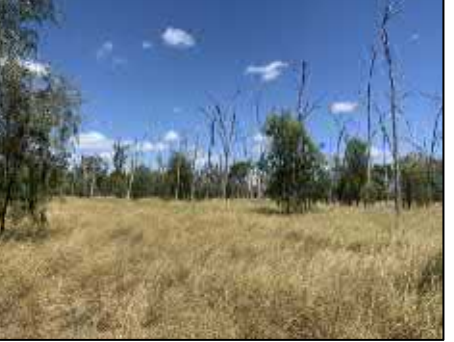
Site: PW2		Location: Downstream		Stream Order: N/A		Waterway: Mapped palustrine wetland																						
December 2019		December 2019		April 2020		April 2020

Aquatic Ecosystem Value: N/A		MNES/MSES: N/A		Dry season refuge: N/A		Connectivity: N/A																						
In-stream condition: N/A No aquatic habitat features recorded at this site. Site is likely incorrectly mapped as a palustrine wetland, with terrestrial ecological values only.		Riparian condition: Fair This site did not feature a riparian zone as no aquatic ecological features were evident, however, terrestrial vegetation in the broader region consisted grasses, shrubs, trees, and weeds. There some exotic terrestrial species at the site.		External Impacts: Moderate External impacts at the site were mostly associated with the surrounding land-use and included: <ul style="list-style-type: none"> • reduced terrestrial vegetation as a result of land clearing • grazing by livestock, and • feral animals. 		Water Quality: N/A

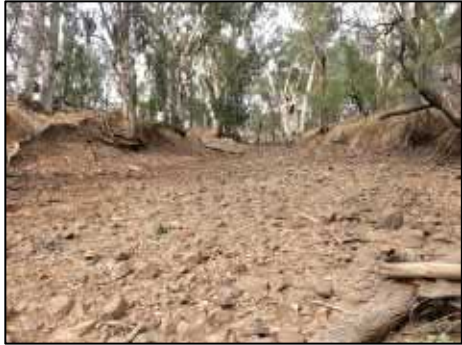
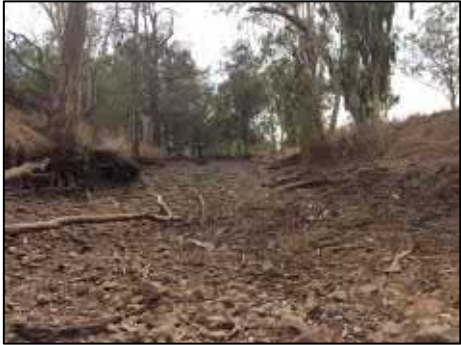
Site: GC03		Location: Downstream		Stream Order: 5		Waterway: Grosvenor Creek															
Upstream: November 2020		Downstream: November 2020

Aquatic Ecosystem Value: Moderate		MNES/MSES: None present or likely to occur		Dry season refuge: N/A		Connectivity: N/A															
In-stream condition: Fair Key habitat features in November 2020 included: <ul style="list-style-type: none"> • substrate predominately sand, rocks and pebbles • moderate shading of reach • extensive snags, woody debris & branches, and • some terrestrial detritus. The site was dry during the November 2020 survey.		Riparian condition: Good The riparian zone was a scattered semi-continuous/continuous mix of grasses, large trees, and weeds. Both banks were approximately 4 m high, with some eroded bank areas around tree roots, providing good habitat for fish and macroinvertebrates. Channel was approximately 10 m wide. Large trees in the riparian zone provided moderate-extensive shading throughout the reach.		External Impacts: Moderate External impacts at the site were mostly associated with the surrounding land-use and included: <ul style="list-style-type: none"> • reduced terrestrial vegetation as a result of land clearing • grazing by livestock, and feral animals. 		Water Quality: N/A

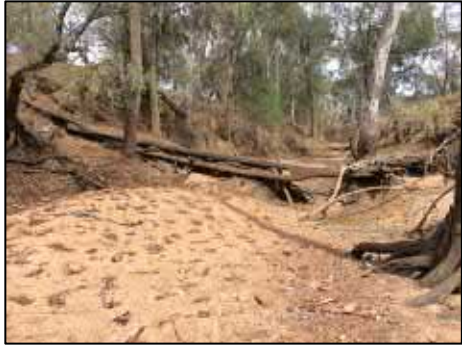
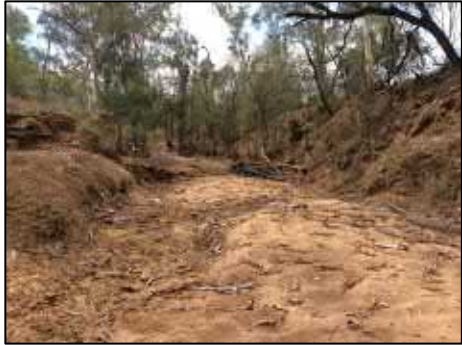
Site: GC04		Location: Downstream	Stream Order: 5	Waterway: Grosvenor Creek	
Upstream: November 2020		Downstream: November 2020

Aquatic Ecosystem Value: Moderate		MNES/MSES: None present or likely to occur		Dry season refuge: N/A	
In-stream condition: Fair Key habitat features in November 2020 included: <ul style="list-style-type: none"> • substrate predominately unconsolidated sand • moderate-extensive shading of reach • extensive snags, woody debris & branches • some large snags, and • extensive terrestrial detritus. The site was dry during the November 2020 survey.		Riparian condition: Good The riparian zone was a scattered continuous mix of grasses, large trees, and weeds. Both banks were approximately 3 m high, with some eroded bank areas around tree roots, providing good habitat for fish and macroinvertebrates. Channel was approximately 10 m wide. Large trees in the riparian zone provided moderate-extensive shading throughout the reach.		External Impacts: Moderate External impacts at the site were mostly associated with the surrounding land-use and included: <ul style="list-style-type: none"> • reduced terrestrial vegetation as a result of land clearing • grazing by livestock, and feral animals.

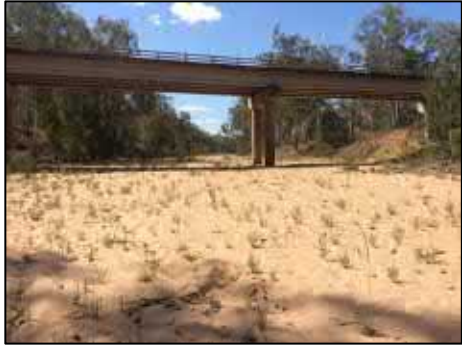
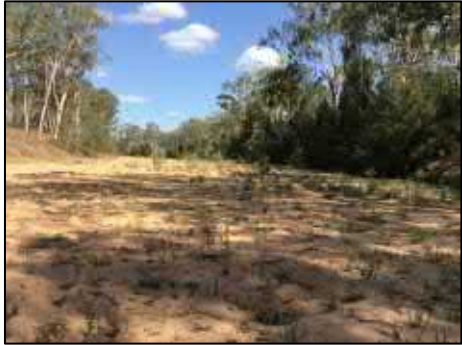
Site: IRO2		Location: Downstream		Stream Order: 6		Waterway: Isaac River	
Upstream: November 2020		Downstream: November 2020

Aquatic Ecosystem Value: Moderate		MNES/MSES: None present or likely to occur		Dry season refuge: N/A		Connectivity: N/A	
In-stream condition: Poor Key habitat features in November 2020 included: <ul style="list-style-type: none"> • ephemeral channel • unconsolidated sand sediments • established terrestrial weeds in the channel • moderate shading of reach • some snags, woody debris & branches, and • little detritus. The site was dry during the November 2020 survey.		Riparian condition: Good The riparian zone was a scattered semi-continuous/continuous mix of grasses, large trees, and weeds. Left bank downstream was gently sloping while right bank was a higher reaching steep bank. The confluence of Grosvenor Creek and Isaac River was approximately 100 m upstream of the bridge. Channel was approximately 40 m wide.		External Impacts: Moderate External impacts at the site were mostly associated with the surrounding land-use and included: <ul style="list-style-type: none"> • reduced terrestrial vegetation as a result of land clearing • grazing by livestock, and • feral animals. 		Water Quality: N/A
