Carrapateena Operation PEPR Compliance Report 2024

28 March 2025

ML 6471	MINERAL LEASE
MPL 149	AIRSTRIP AND WORKERS' ACCOMMODATION VILLAGE, ACCESS ROAD AND ANCILLARY INFRASTRUCTURE
MPL 152	WESTERN INFRASTRUCTURE CORRIDOR
MPL 153	EASTERN RADIAL WELLFIELD
MPL 154	SOUTHERN ACCESS ROAD AND RADIAL WELLFIELD
MPL 156	NORTHERN WELLFIELD

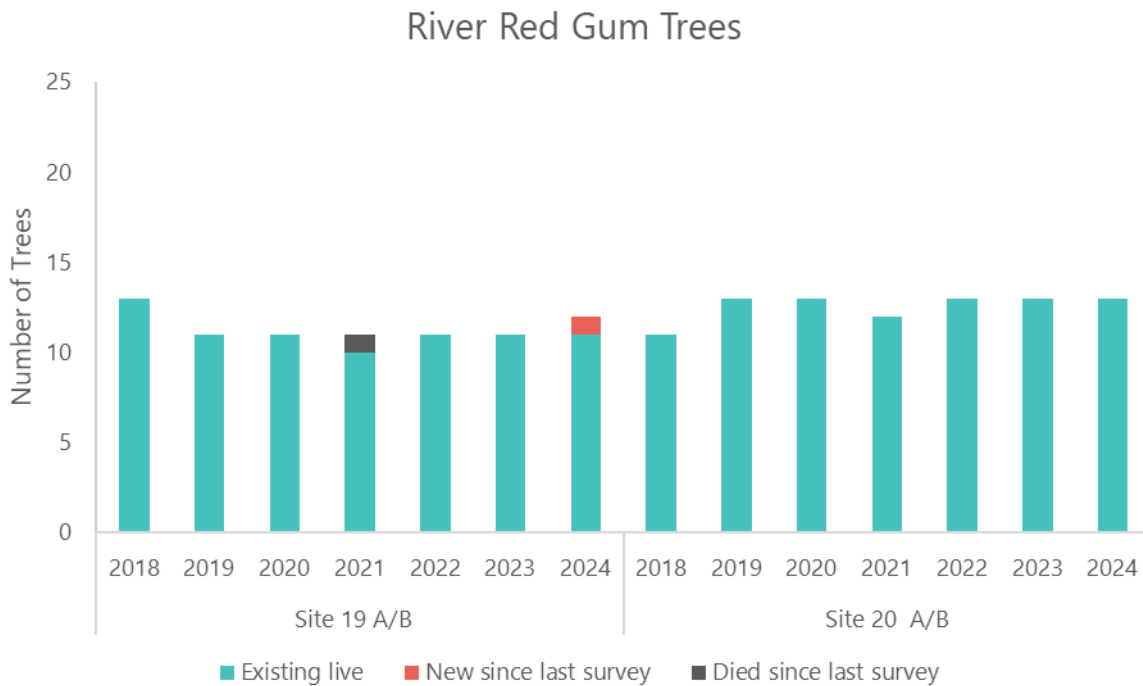
In 2020, loss of a large branch resulted in one tree not intercepting the transect at CC20. However, by 2022, this tree had regained canopy, resulting in it once again being intercepted along the transect, and recorded in 2022, 2023 and 2024. Figure 3.38 shows the number of live Red Gum trees, deaths and new trees for each survey period since 2018.

Figure 3.38: Change in River Red Gum abundance (new = met criteria, not intercepted = tree present, but not intersecting transect yet)

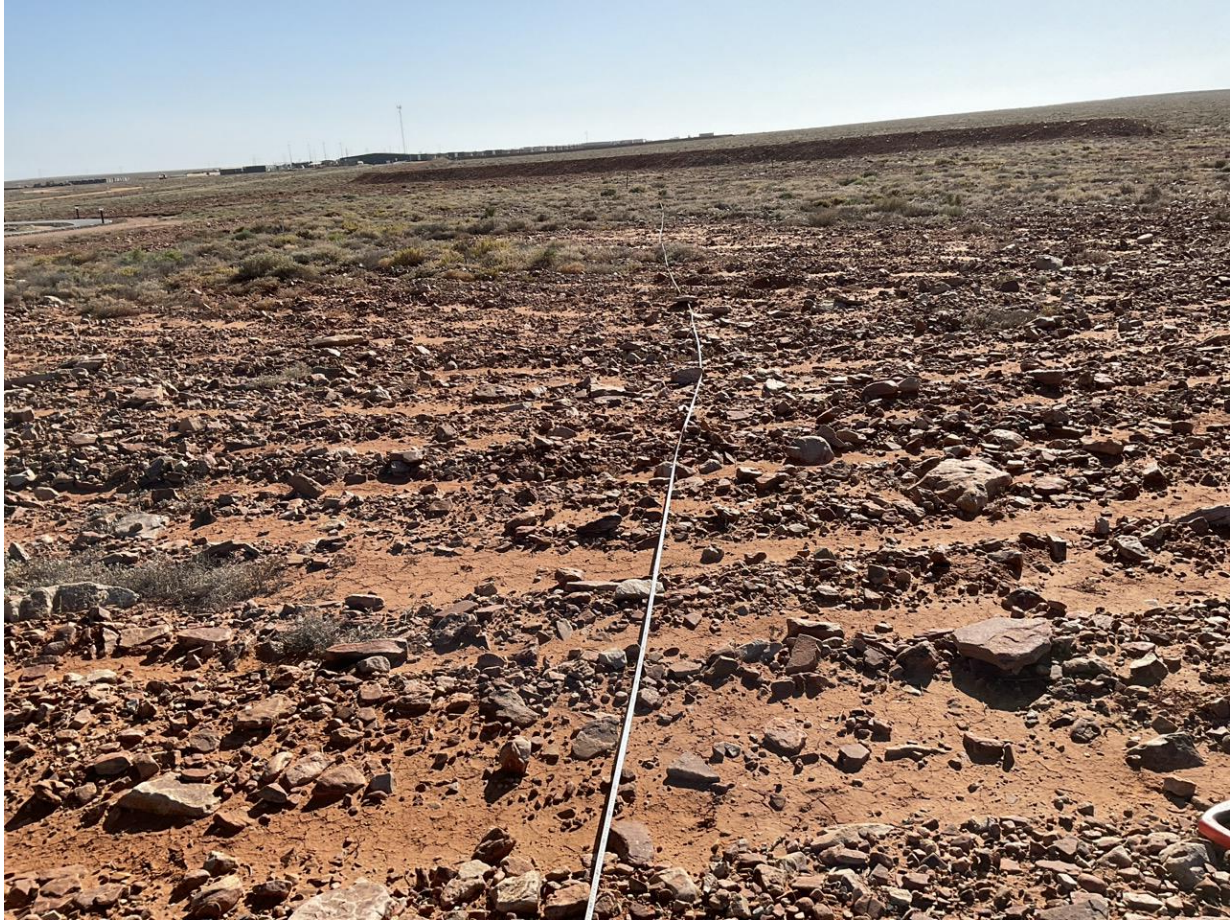
The proportion of transect occupied by patches in 2024 was very similar to 2023 but the width of patches increased by approximately 50%. Vegetation patches comprised 21% of the linear transect in 2022, 29% in 2023 and 30% in 2024 (the remainder being rocky inter patch). The mean patch width increased from 73 cm in 2022 to 135 cm in 2023 to 198 cm in 2024. The number of intercepted plants that were long-lived perennials had increased from 2 plants in 2022, 3 plants in 2023, to 7 plants in 2024. In 2024 long-lived perennial plants comprised 23% of all plants recorded along the transect. The long-lived plant species present in 2024 were: Samphire (*Tecticornia medullosa*) and Bladder Saltbush (*Atriplex vesicaria*), the dominant species in the adjoining non-cleared vegetation, as well as Plains Lantern Bush (*Abutilon halophilum*). The majority of vegetation patches were Salt Sclerolaena, (*Sclerolaena ventricosa*), a prominent component of the Bladder Saltbush community in this region. The first 15 m of the transect, however, remained devoid of vegetation (Plate 3.1). Species recorded along LFA linear transects are shown in Table 3.18.

Plate 3.1: Aerodrome transect 1A showing re-establishment of vegetation largely concentrated in the second half of the transect

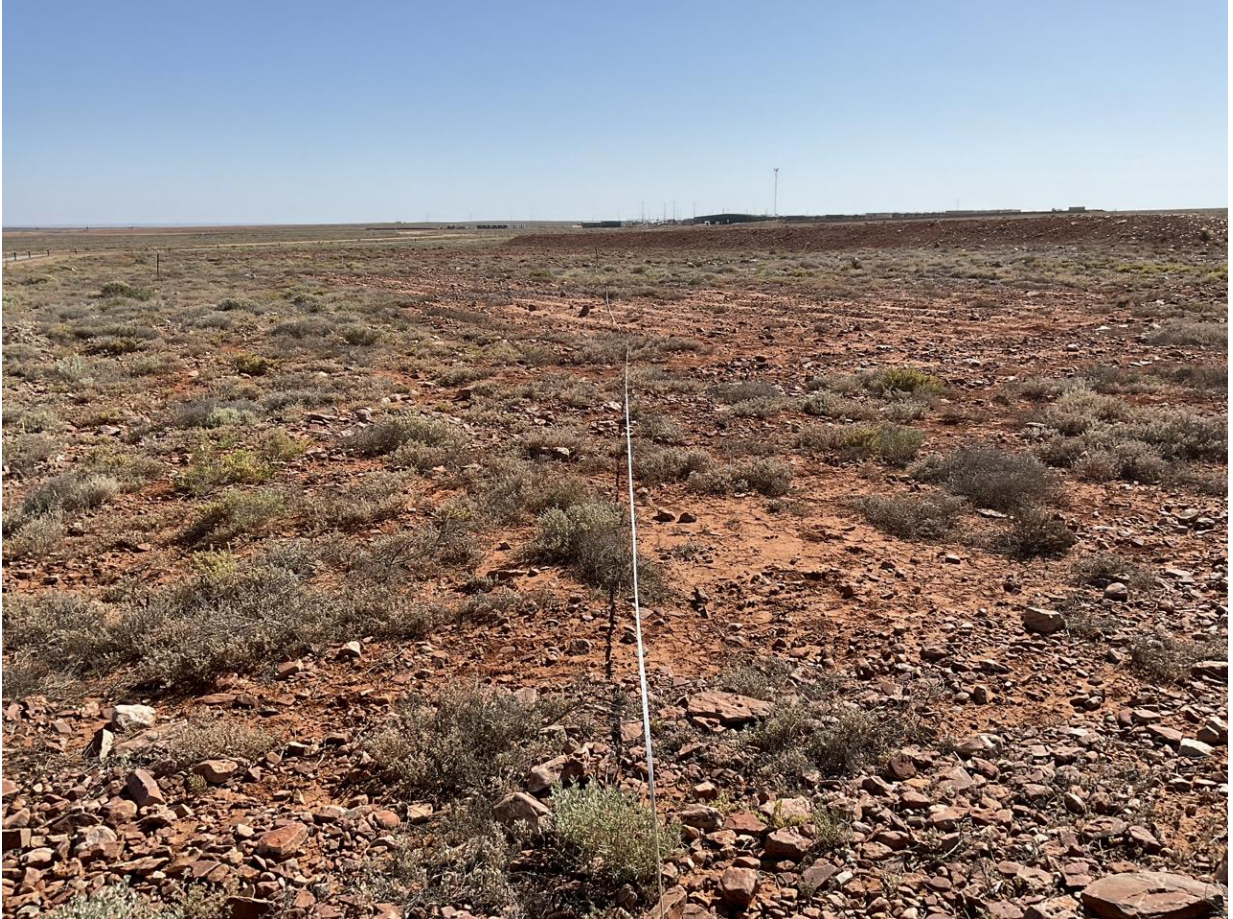
Plate 3.2: Aerodrome transect 1B. From 0 m at start, facing the end. Moderately dense vegetation covers much of the first half of the transect

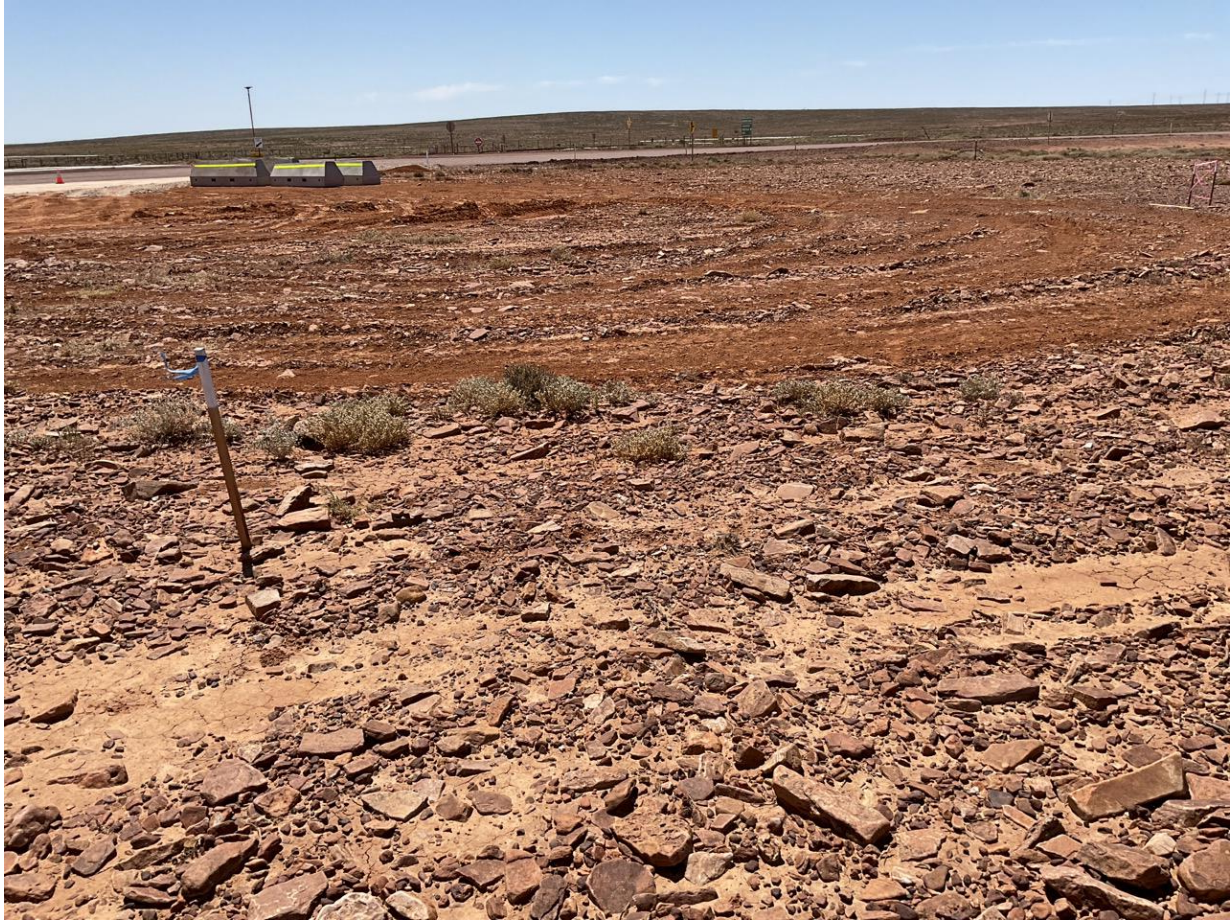
Plate 3.3: Ventia transect 2A. The majority of the transect has been recently graded and no vegetation remains along the alignment

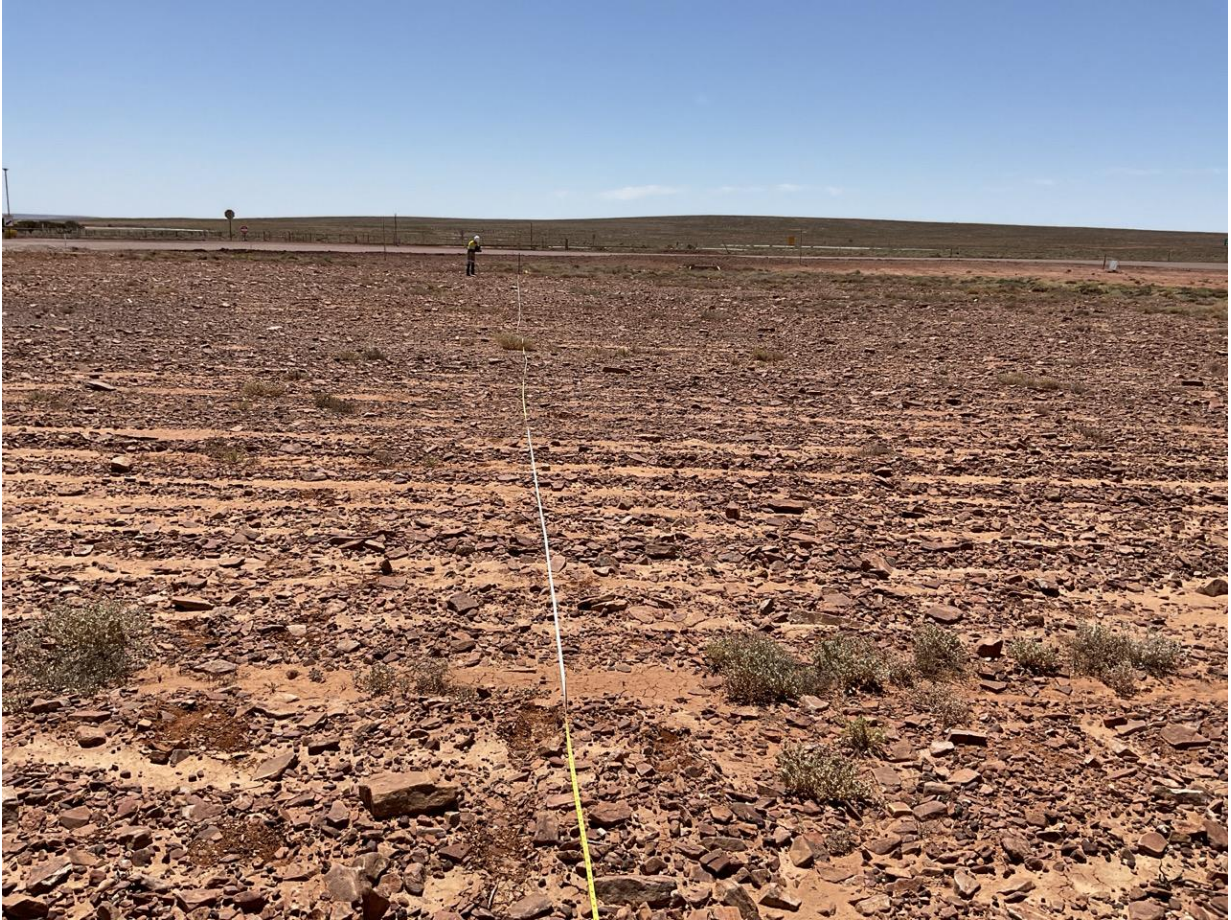
Plate 3.4: Ventia transect 2B: Only one vegetation patch was intercepted along the transect

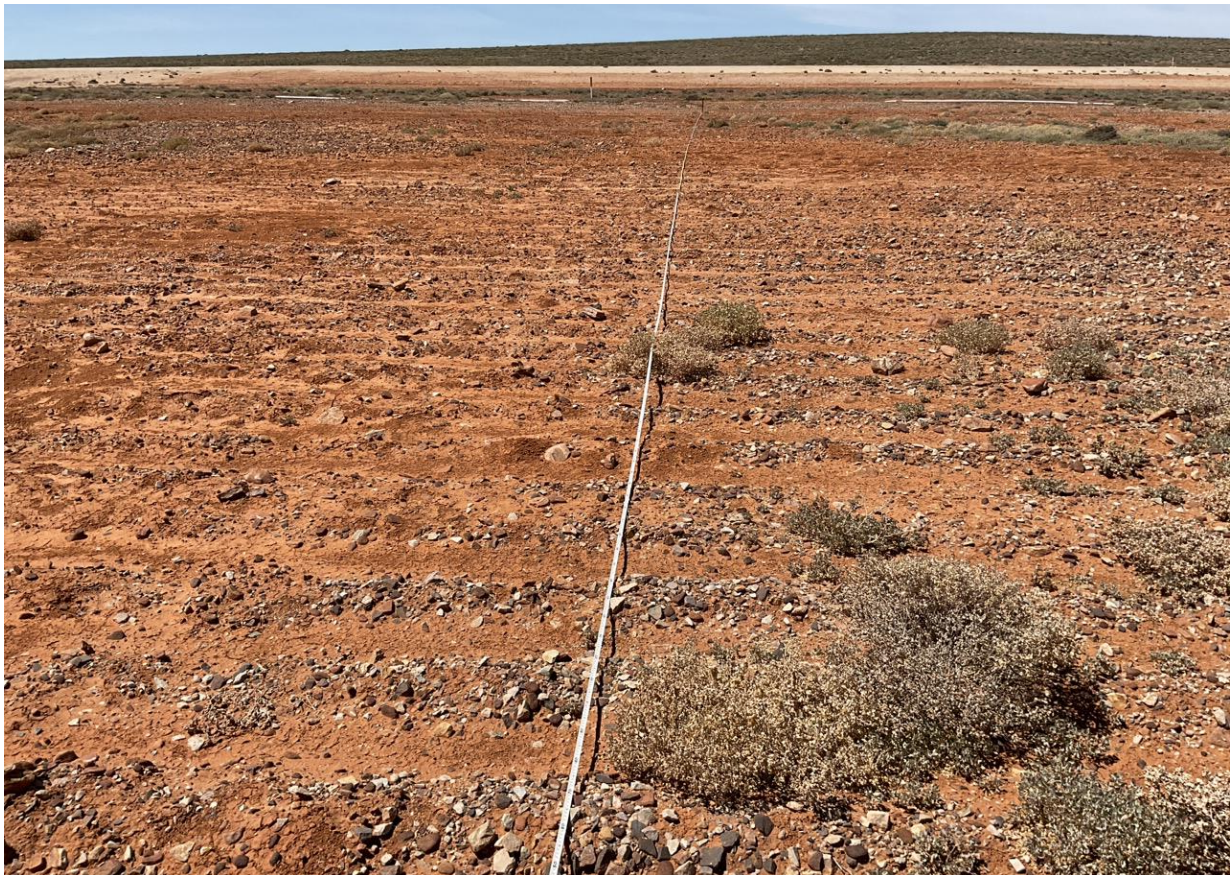
Plate 3.5: Midway Quarry transect 3A from start (0 m) facing end. Most re-establishment of short-lived perennials has occurred near the start of the transect.

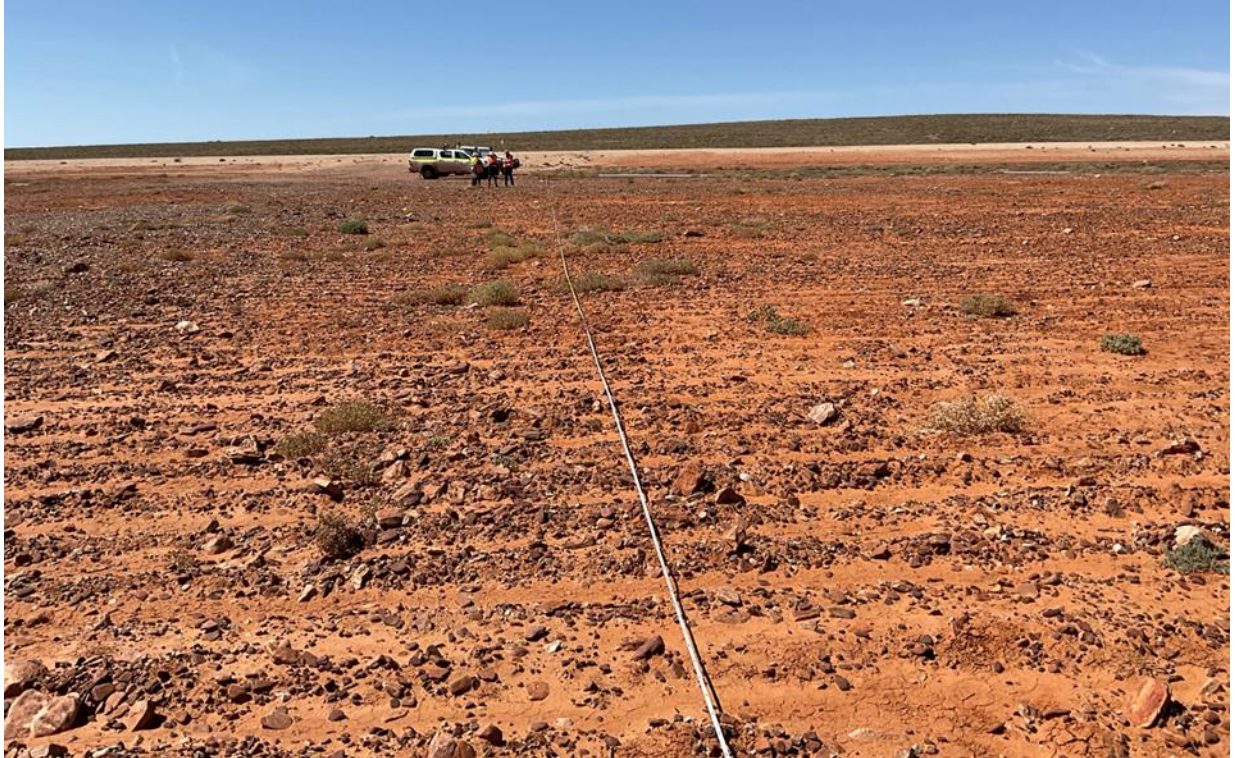
Plate 3.6: Midway quarry transect 3B, the contours have levelled out, now < 10 cm deep and plants have sparsely revegetated. Although still sparse, plant density is notably denser than in 2023

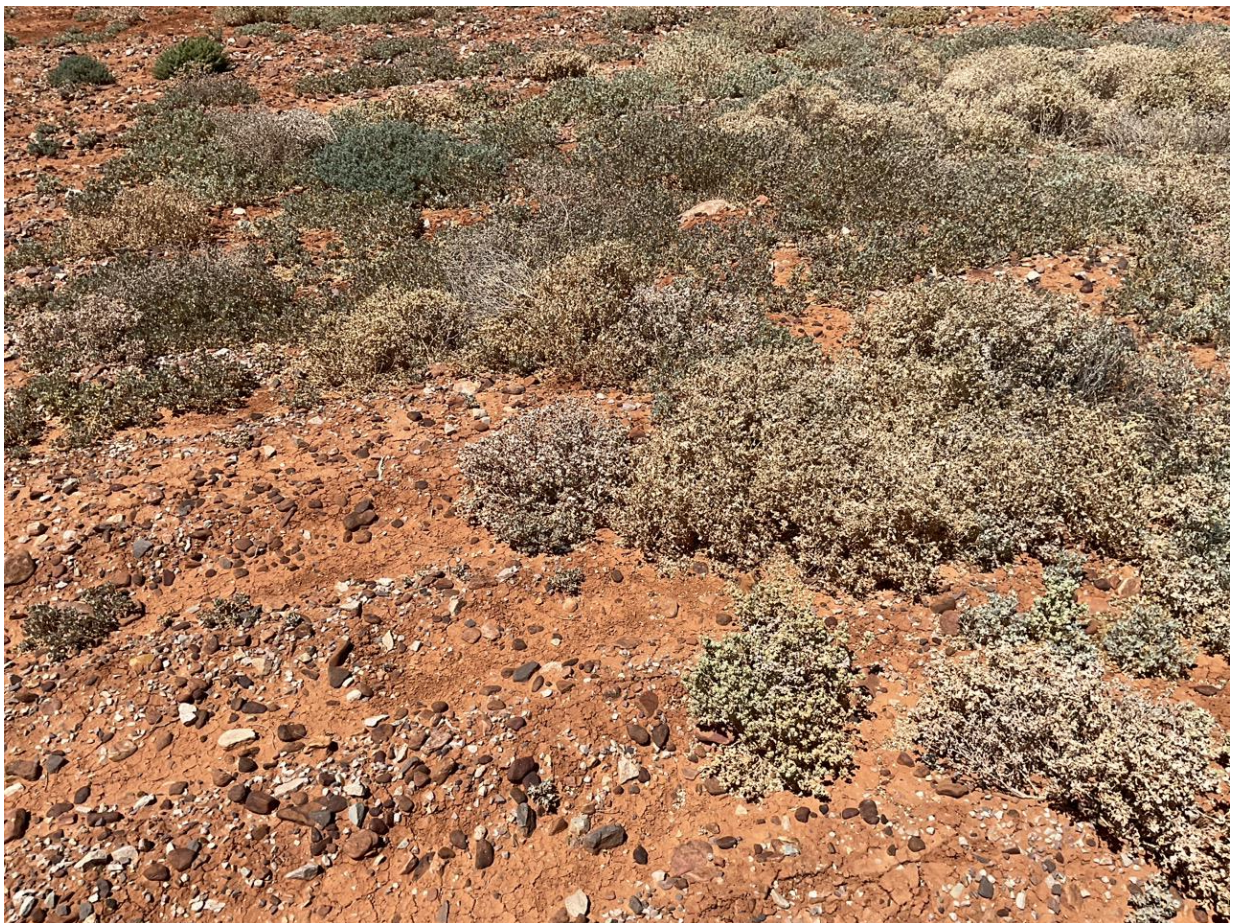
Plate 3.7: Dense patch of vegetation just off Midway Quarry transect 3A

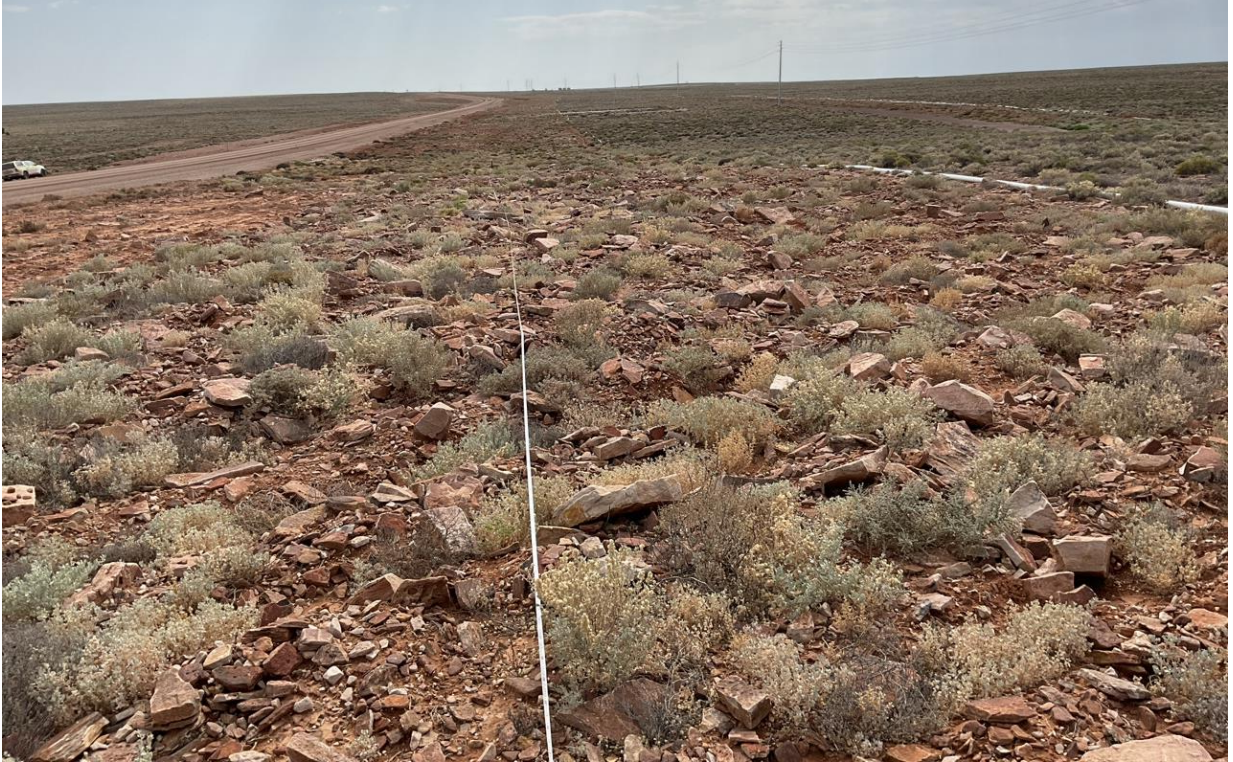
Plate 3.8: Tjungu transect 4A: From start at 0 m facing end. Large and abundant surface rock is present due to the deep ripping and vegetation is densely spaced

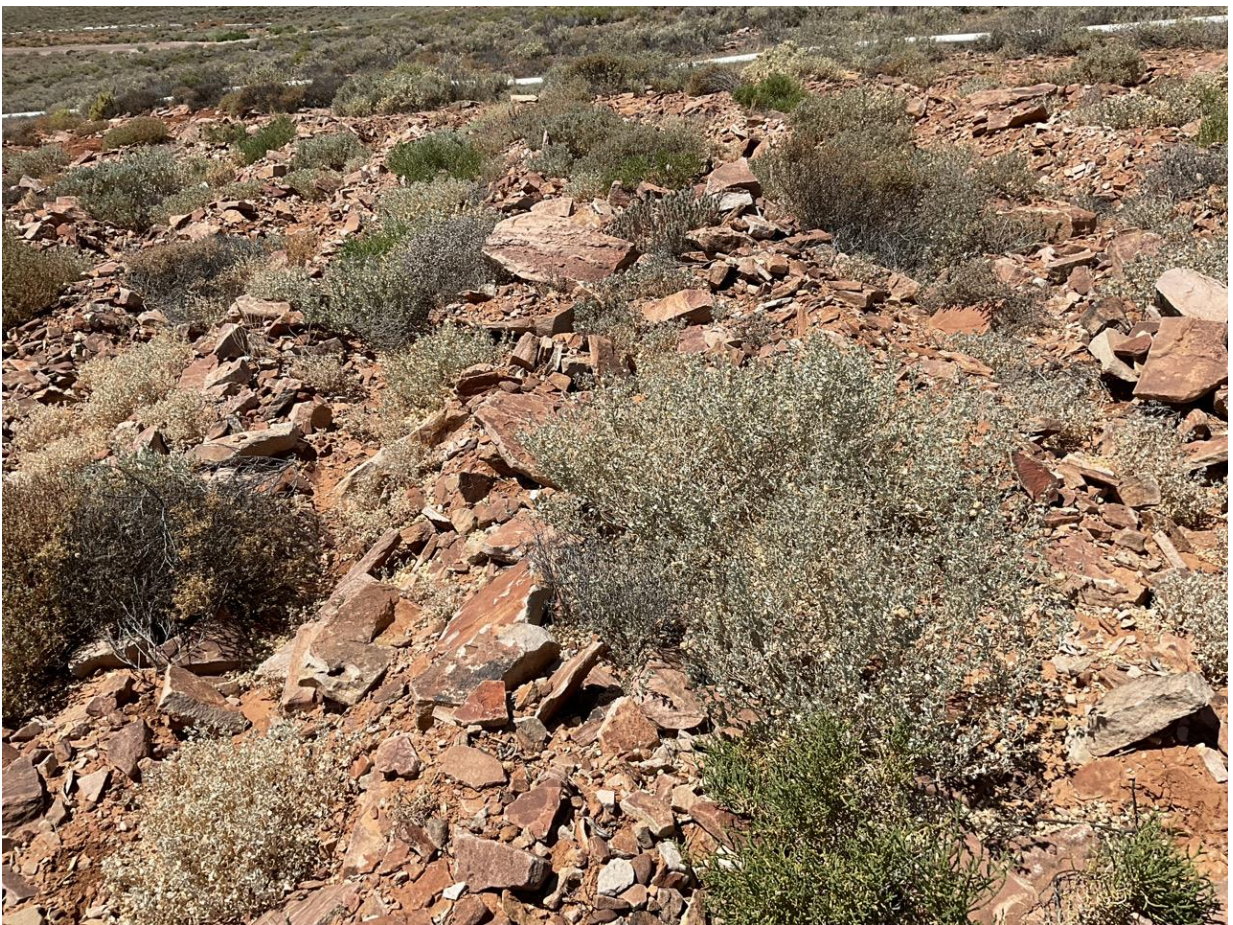
Plate 3.9: Transect 4A close up showing densely spaced vegetation in rip lines

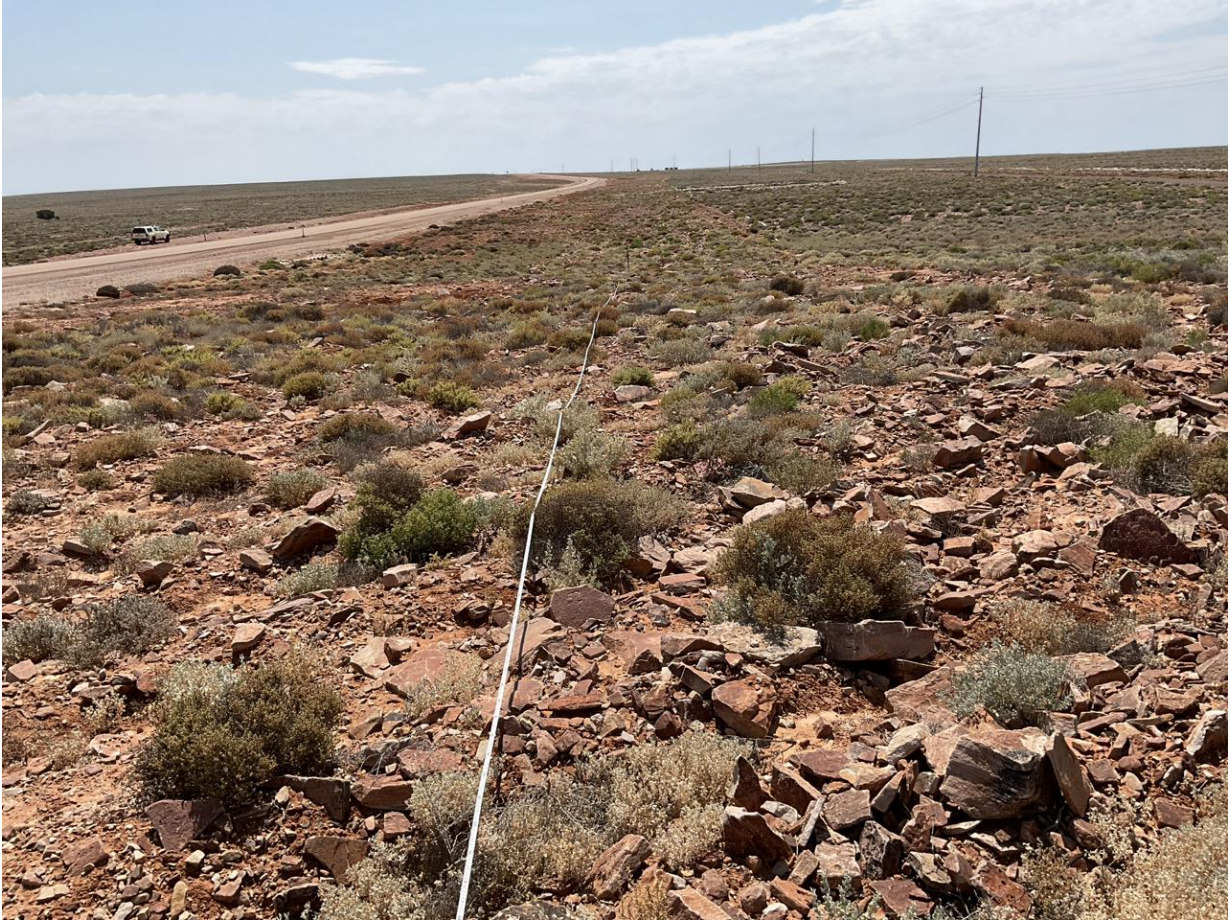
Plate 3.10: Tjungu t transect 4B from start (0m). Densely spaced vegetation. Plant diversity comparable with adjoining non-cleared vegetation

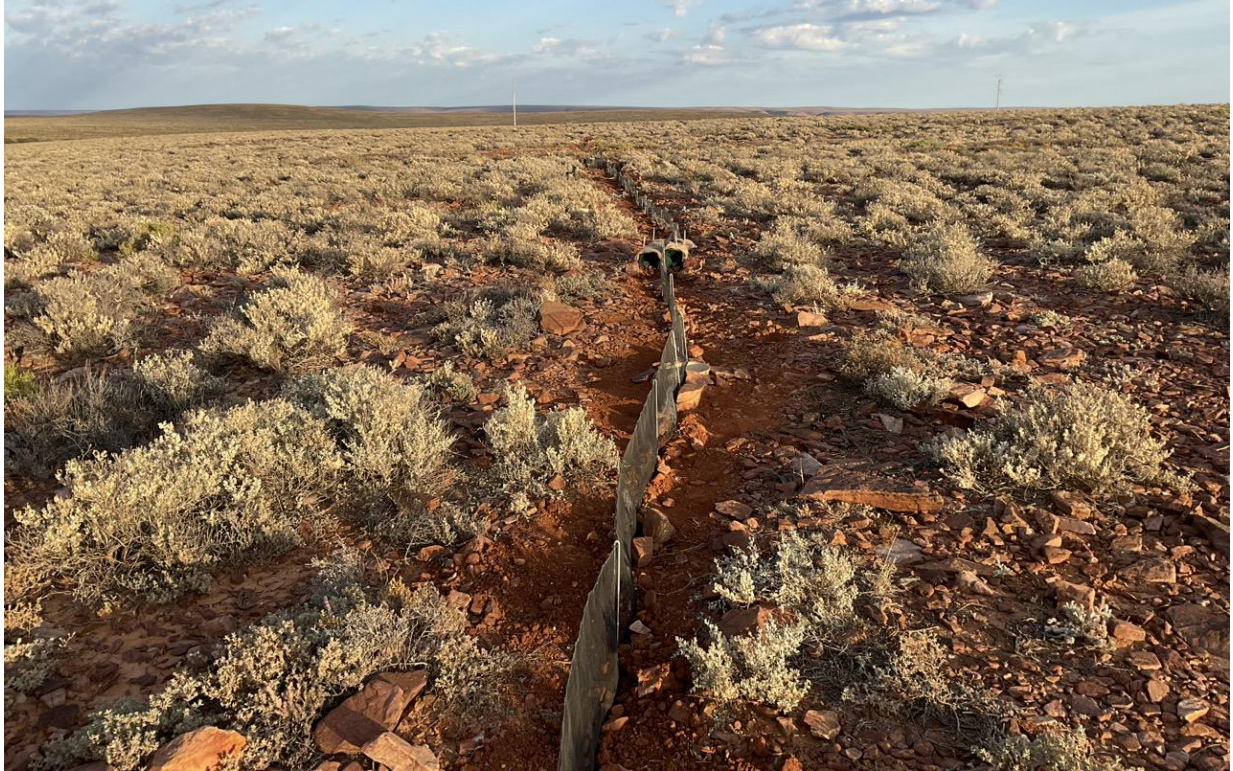
Plate 3.11: Site 16 fauna trapping set up

As per Section 2.6, fauna survey methods during compliance monitoring broadly followed the SA Vertebrate Survey guidelines (Owens 2000), with modifications aligning with the objectives of this survey, and based on recommendations from earlier surveys. The broadly accepted guidelines recommend a minimum of four trapping nights to ensure sufficient trapping effort for the purposes of documenting key faunal assemblages across a study area. A trapping line set up is shown in Plate 3.11.

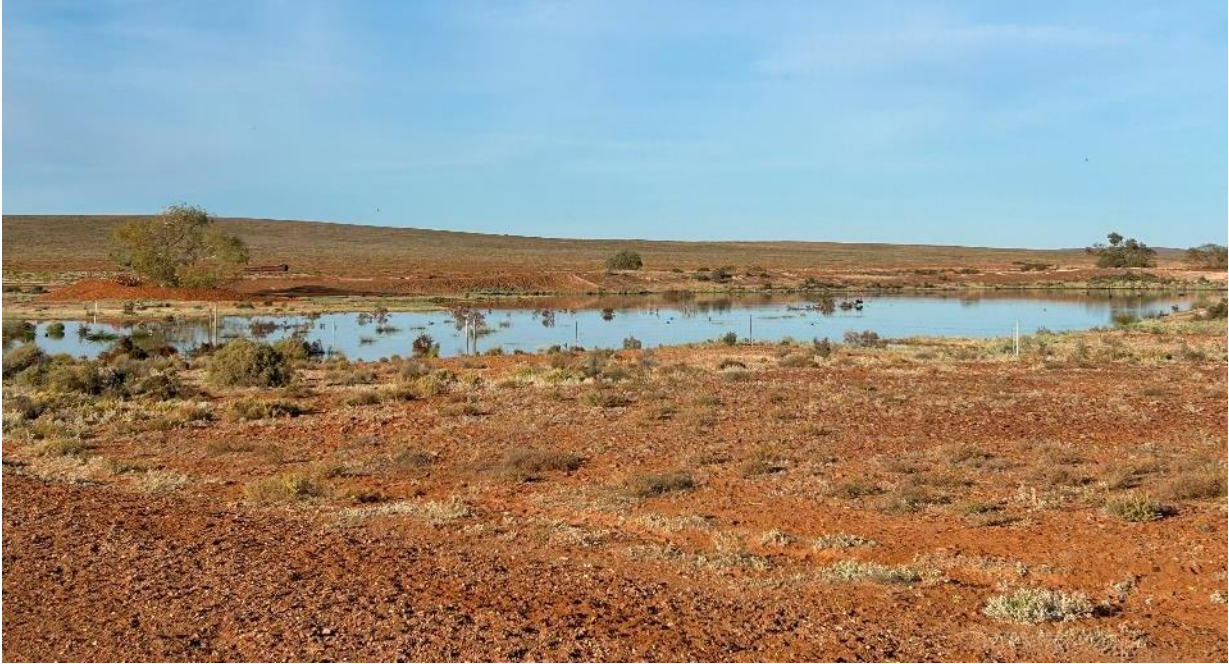
Plate 3.15: South Eliza Dam, excess temporary water source

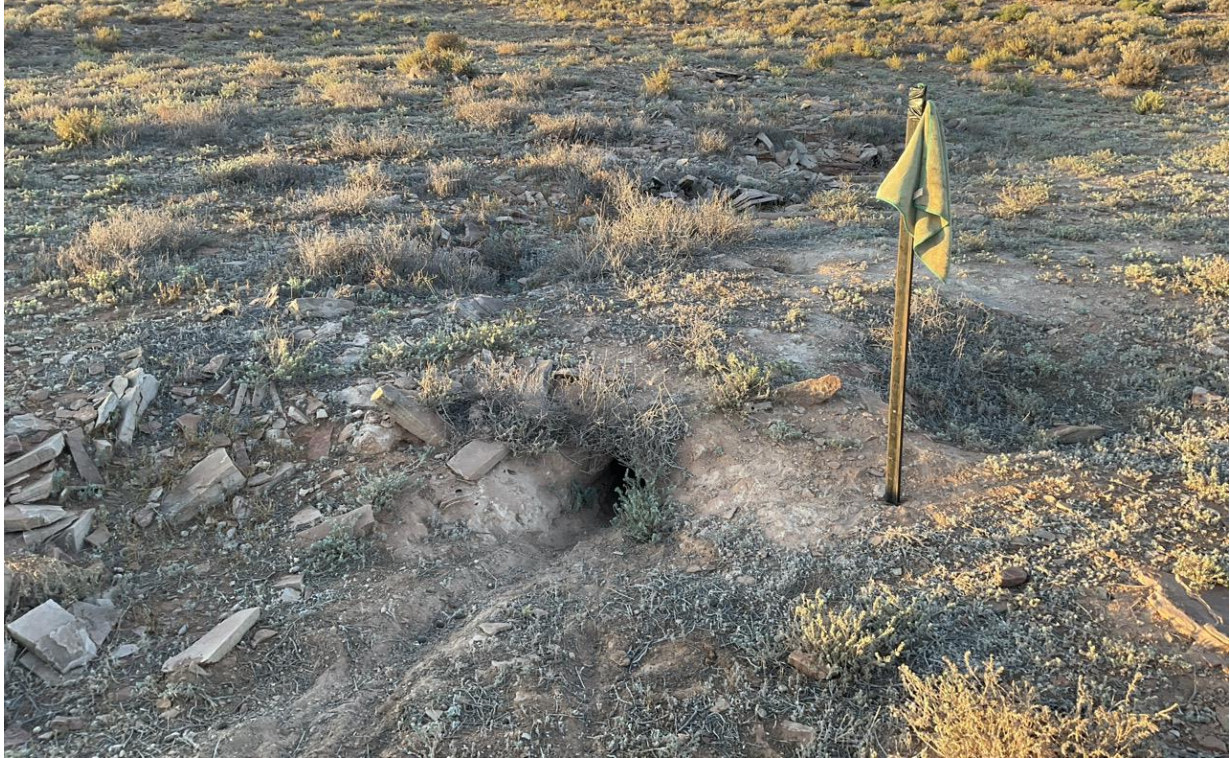
Plate 3.22: Active rabbit warren at Site 15

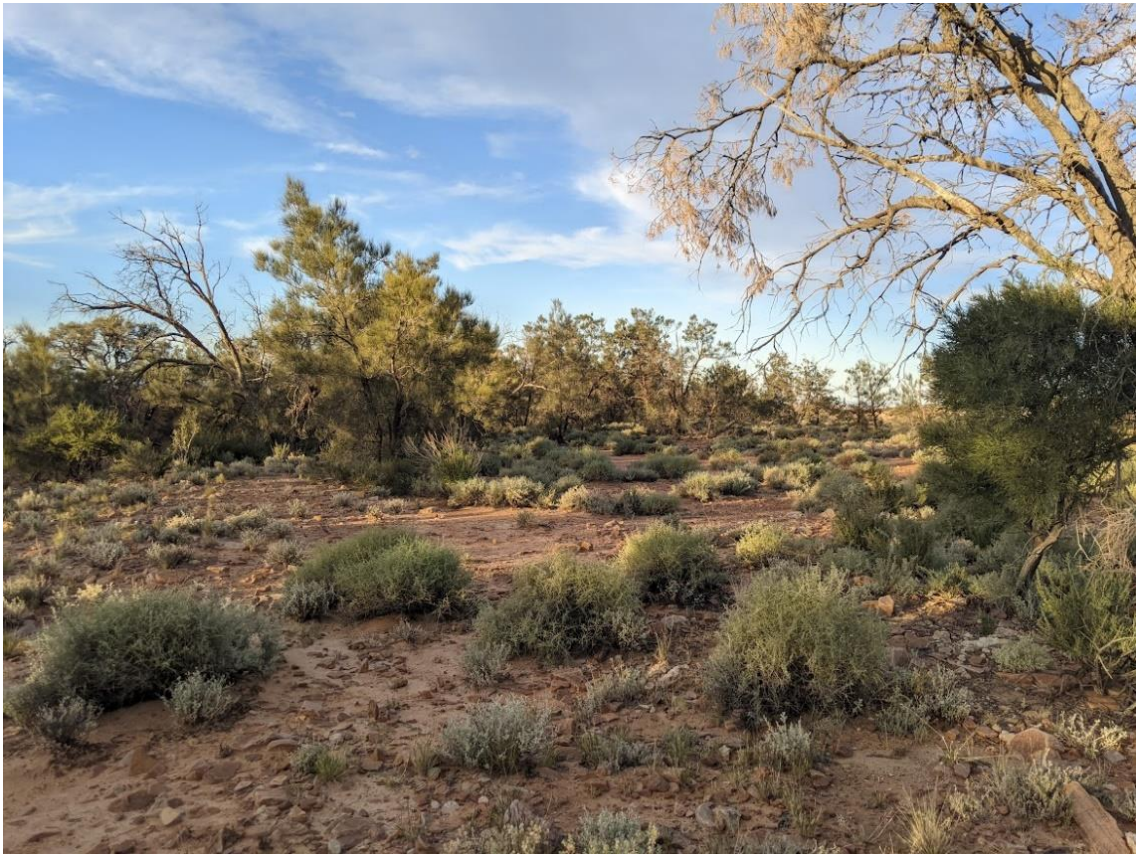
Figure 4. Creekline shrub habitat on the northern South Gap EPBC offset area where a plains mouse was detected in 2024.

During 2024, only one plains mouse was detected. This was a small individual, recorded at a site that was located in creekline habitat dominated by shrubs (Fig. 4). It was possibly not resident at the site. The lack of sightings is part of a general low

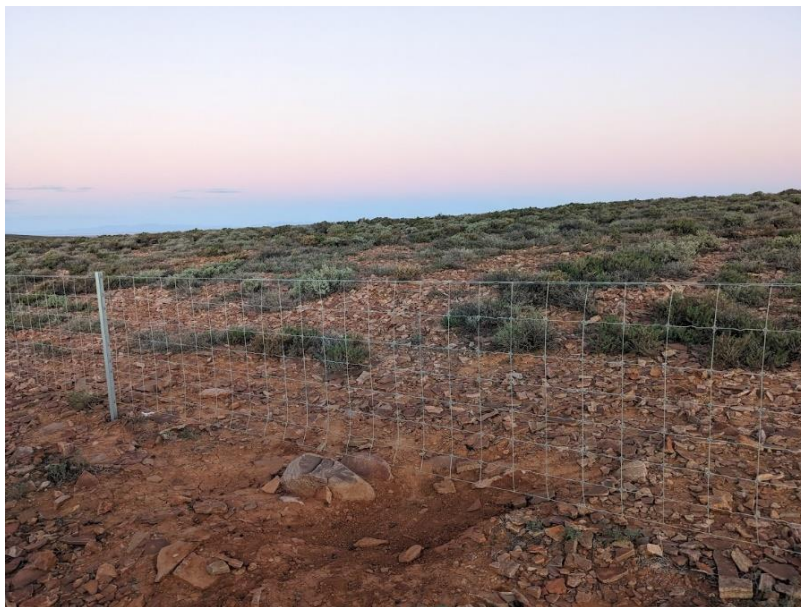
Figure 9. Example of a hole dug underneath the stock exclusion fence by kangaroos. These were patched up each time they were found with either large rocks or mesh wire.

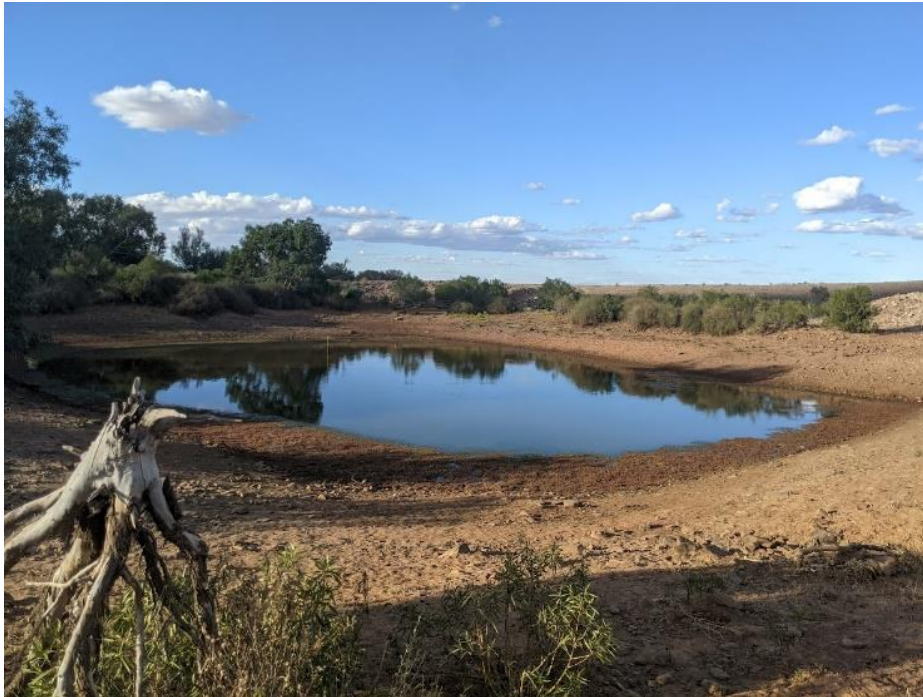
Figure 16. The Gum Dam, located within the southern offset. It is a focal point for both grazing mammals and native birds.

To monitor feral animals, we deployed six remote cameras in August 2024, and another four in November 2024. We acquired data from four of the six cameras. On those four cameras, many goats were detected with mobs of between 50 to 130 observed around Gum dam (Fig. 16). These had likely come in from the south. We also detected numerous feral cats and foxes, at a higher rate than reported on the northern offset (Fig. 17). It should be noted, however, that observations for the southern offset have come from only four sites (in contrast to the northern offset with sixteen), which is too few sites to provide any significant indication of trends.

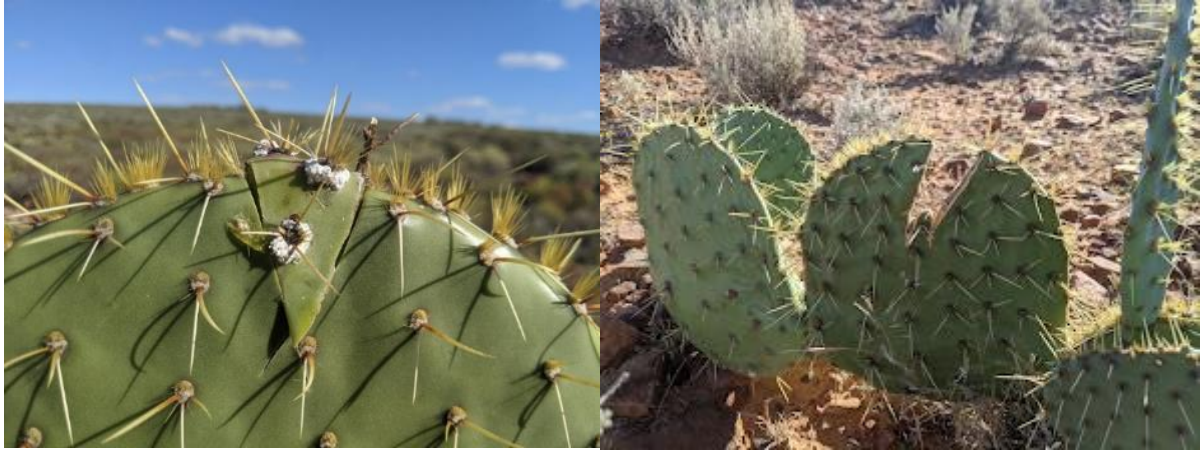
Figure 18. Prickly pear with a small section of cochineal infected pear transplanted into it (left), which did not appear to work by the next trip (right).

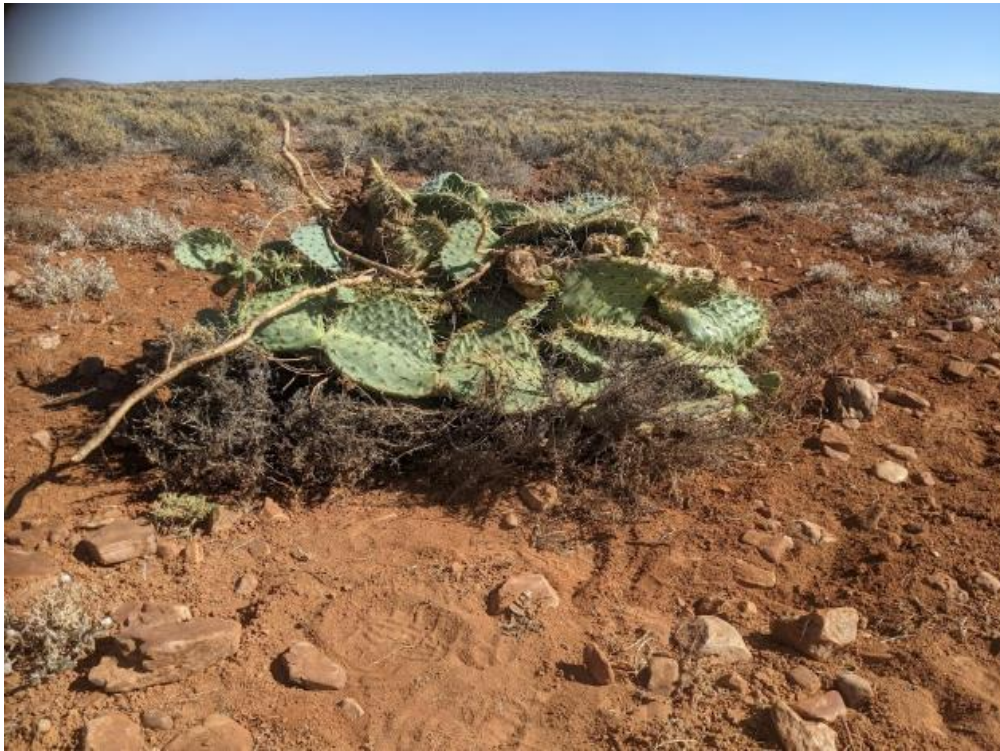
Figure 19. Prickly pear, dug up from the base and placed off the ground.

In contrast to the northern offset, the southern offset had an abundance of recognized weeds. Of note was prickly pear cactus, scattered across the offset. We began monitoring by recording every clump seen near the main track (14.5 km long), estimating its rough size, assigning each a health score (0 = dead to 5 = completely alive), and conducting control if relevant. On the first trip, each healthy (score > 2) cactus had chunks infected by the cochaneil bio-control insect transplanted onto it (see Figure below). Subsequent trips showed there had been little success using this control method (Fig. 18). Instead, the whole plant was dug up, with all bits placed on a rock or saltbush (where they would otherwise be able to rejuvenate). 14 clumps were killed in this way, and the number of healthy cacti has already declined substantially (Fig. 19). We will aim to do this every trip and should thus be able maintain a low cactus presence.

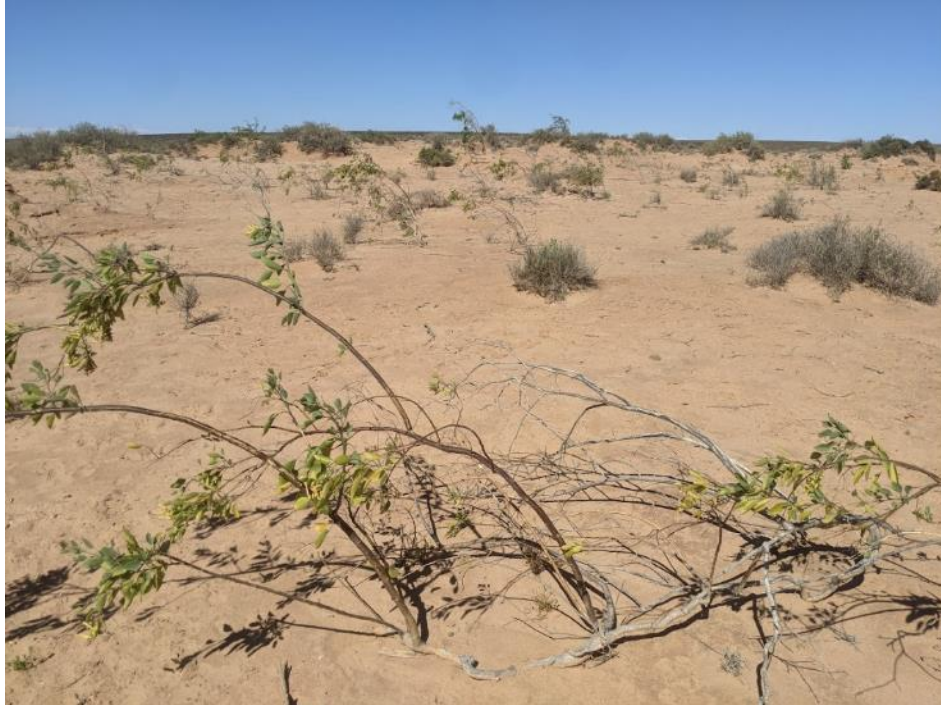
A patch of the declared environmental weed “tree tobacco” (*Nicotiana glauca*) was also found on-site (Fig. 20). This patch was about 140 m x 50 m with around 100 plants. The use of herbicides to control plants is prohibited on South Gap, so these were removed manually. We will continue to monitor this patch in 2025.

Figure 20. The patch of Tree tobacco bush on the southern offset. All were removed.
