# Mt Keith Satellite Statement 1087 Compliance Assessment Report BHP Nickel West

29 March 2022

This CAR outlines the implementation and compliance status of the Project for the period of 28 December 2020 to 31 December 2021, and aligns with the requirements of the approved Compliance Assessment Plan (BHP Nickel West 2020a) under Condition 4-1 of the Statement 1087 approval.

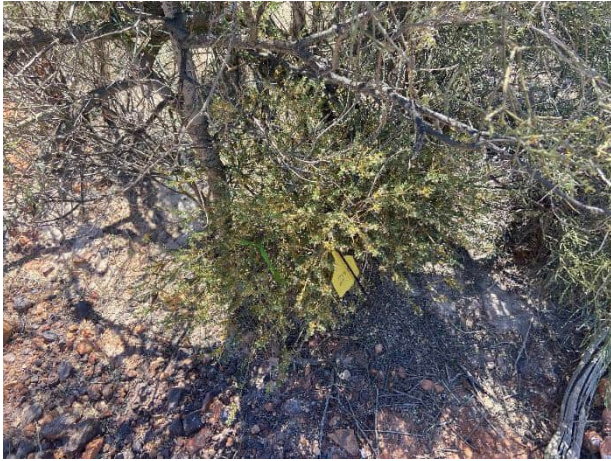
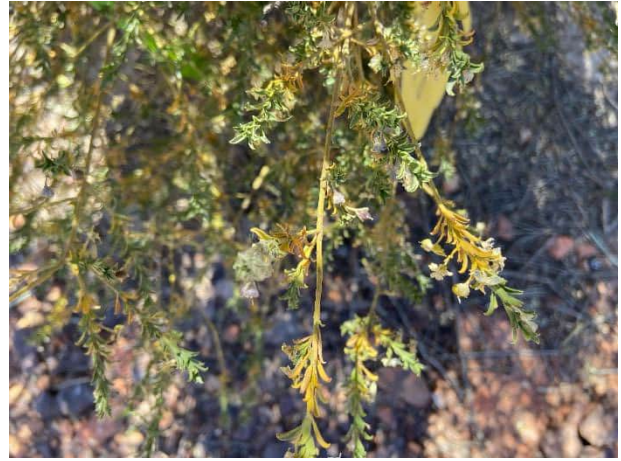
Figure 4-2: *Hybanthus floribundus* subsp. *chloroxanthus* impact individual HFC\_251 flowering in October 2021.

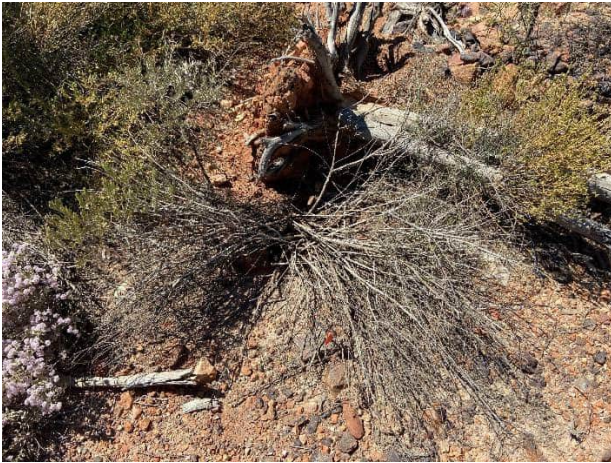
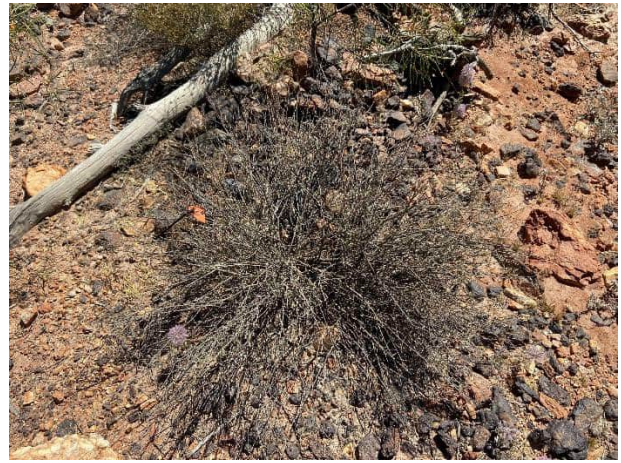
Figure 4-3: *Hybanthus floribundus* subsp. *chloroxanthus* dead individuals at the south-west impact site. HFC\_70 located on the left and HFC\_71 located on the right.

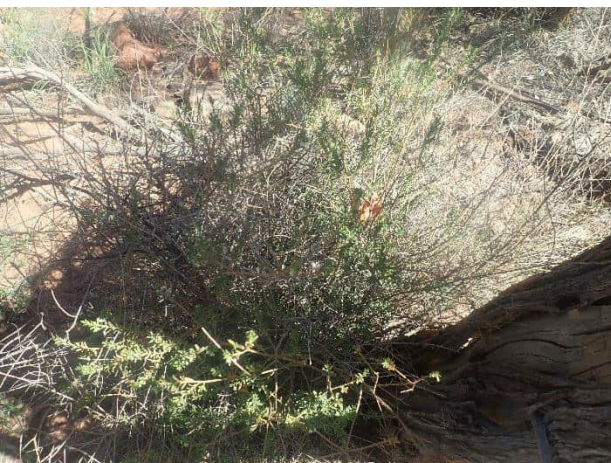
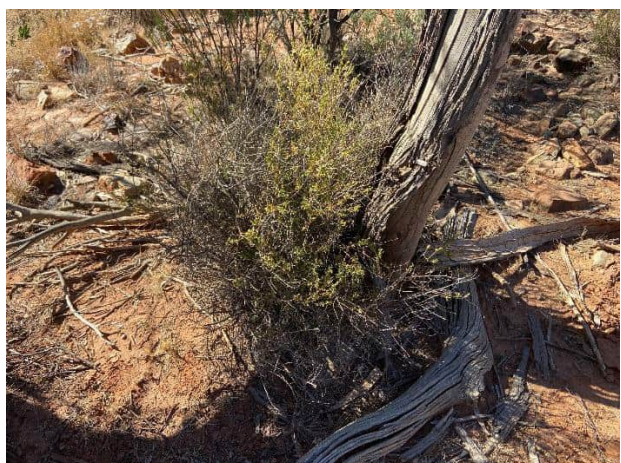
Figure 4-4: *Hybanthus floribundus* subsp. *chloroxanthus* individuals HFC\_54 at the south-west impact site in March 2021 (left) and showing signs of yellowing in October 2021 (right).

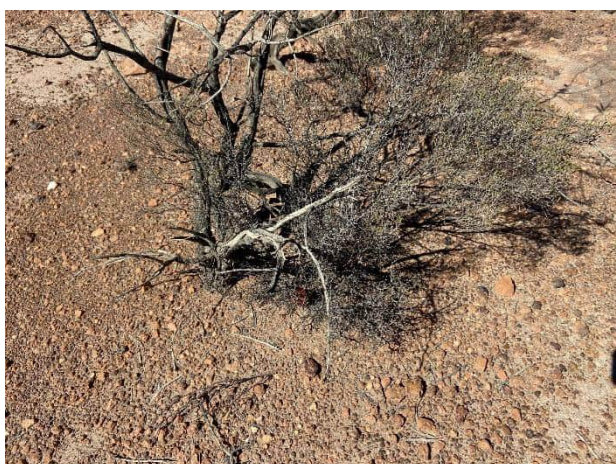
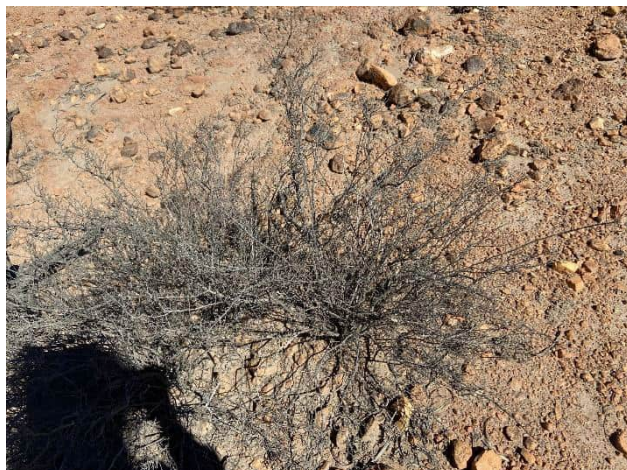
Figure 4-6 Both *Hibbertia* sp. Sherwood Breakaways (R.J. Cranfield 6771) individuals, HSPSB\_141 and HSPSB\_157, assessed as dead in October 2021.

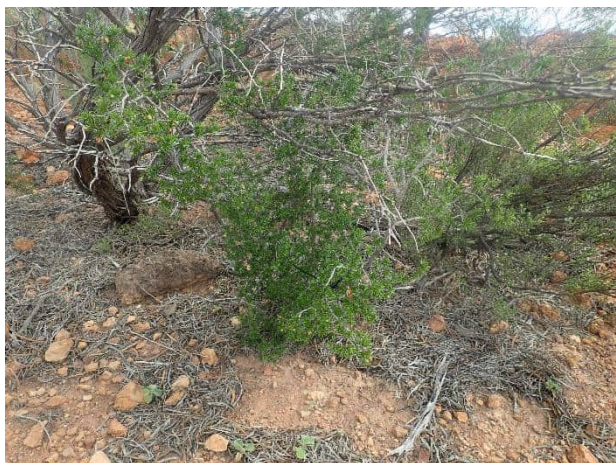
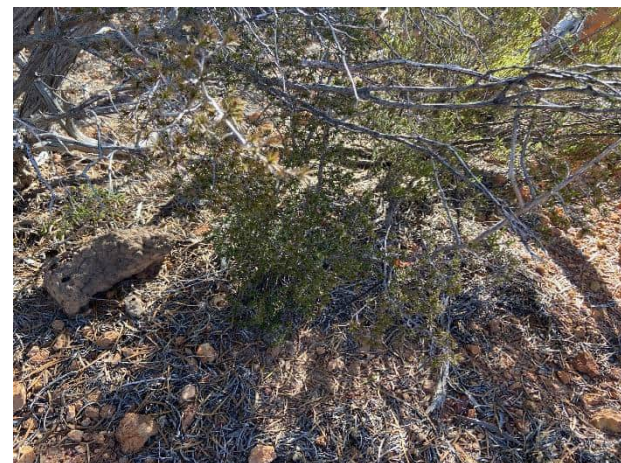
Figure 4-7: *Hibbertia* sp. Sherwood Breakaways (R.J. Cranfield 6771) individual, HSPSB\_98 displaying the influence of rainfall on foliage after the March (left) and October assessments (right).

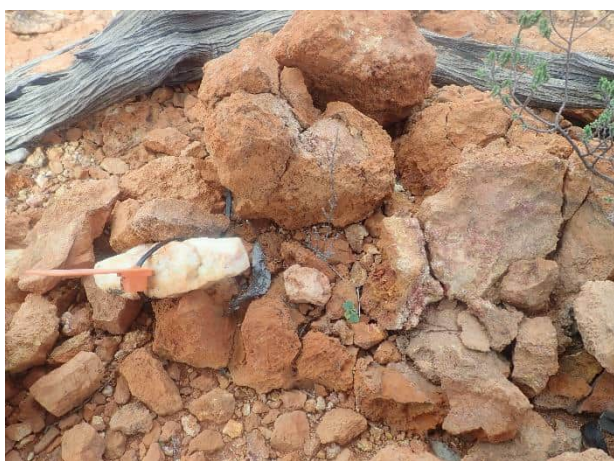
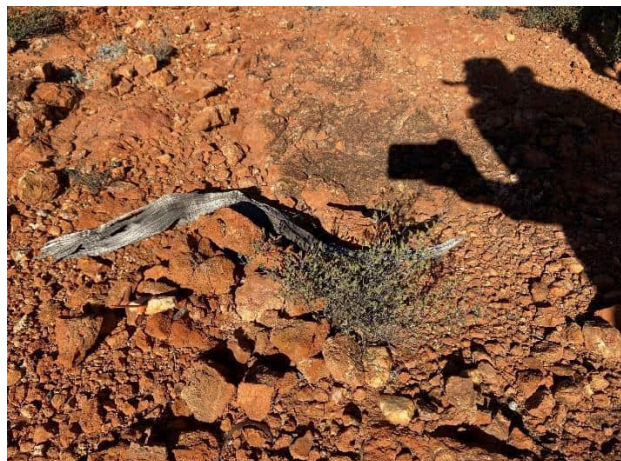
Figure 4-9: *Verticordia jamiesonii* individual VJ\_140, assessed in March 2021 and replaced in October 2021, (left, with a score of 1 and right, with a score of 7a).

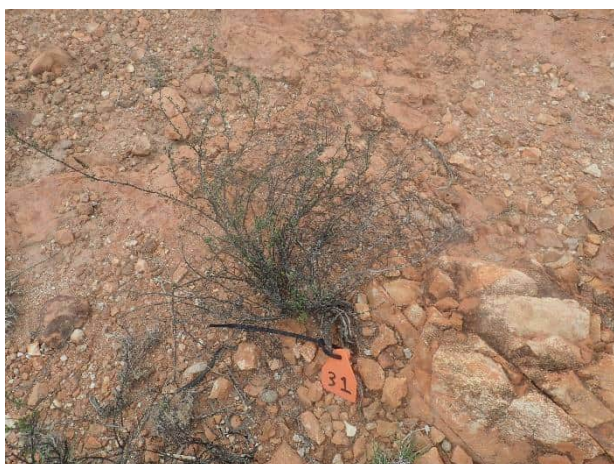
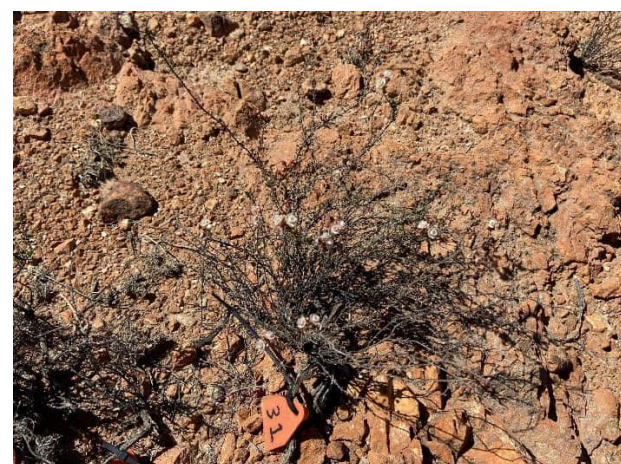
Figure 4-10: East of haul road *Verticordia jamiesonii* individual VJ\_31, assessed in March 2021 as declining (left) and in October 2021, having lost a large proportion of foliage but displaying reproductive morphology.

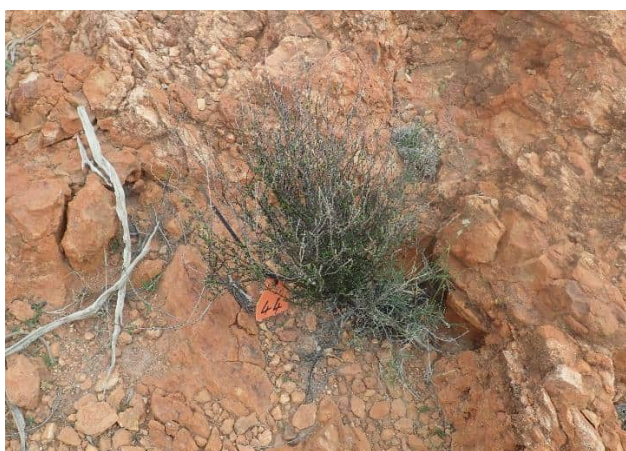
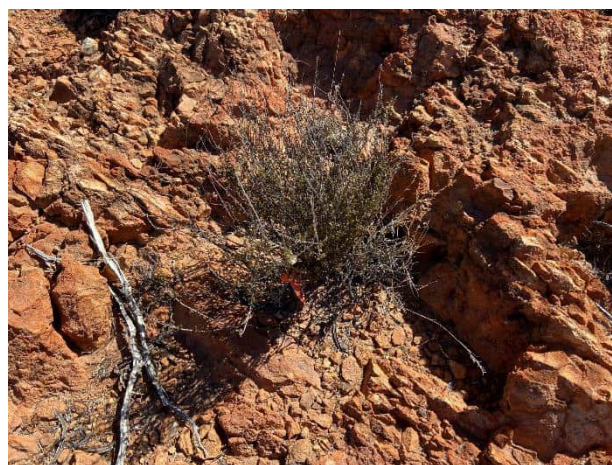
Figure 4-11: *Verticordia jamiesonii* individual VJ\_44, showing greener foliage following high rainfall events in March 2021 compared to October 2021, where the individual experienced below average rainfall for the four months prior.

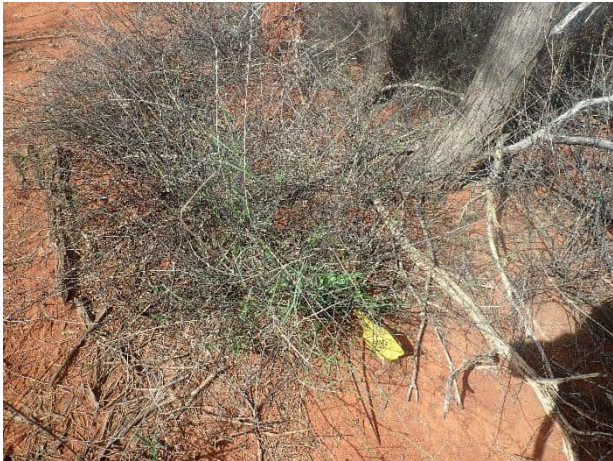
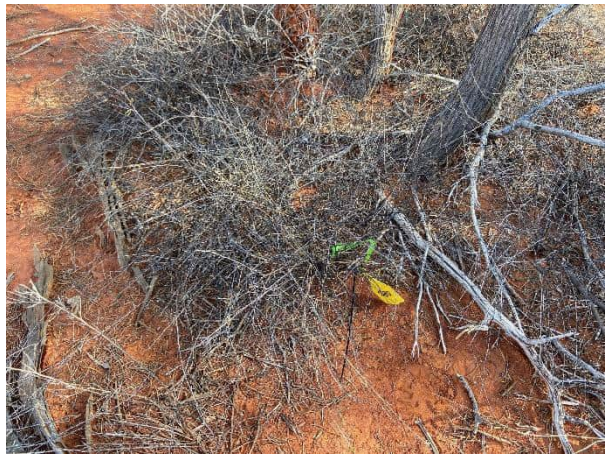
**Figure 4-13: Individual ESPLP\_230, was previously assessed with a score of 2 in December 2020. In March 2021 (left) the foliage began to recover and improved with a score of 3. In October 2021 (right), the individual declined back to a score of 2.**

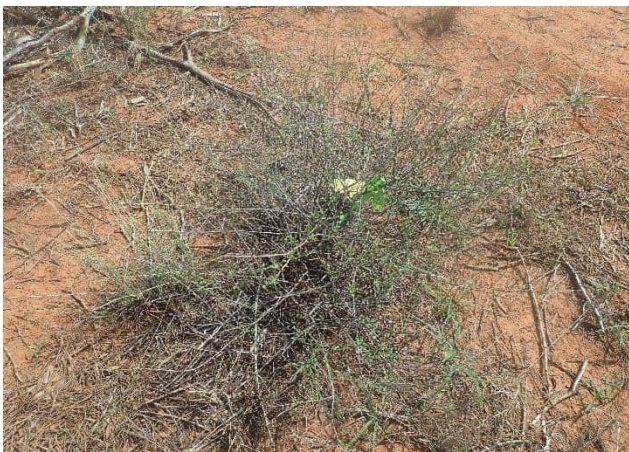
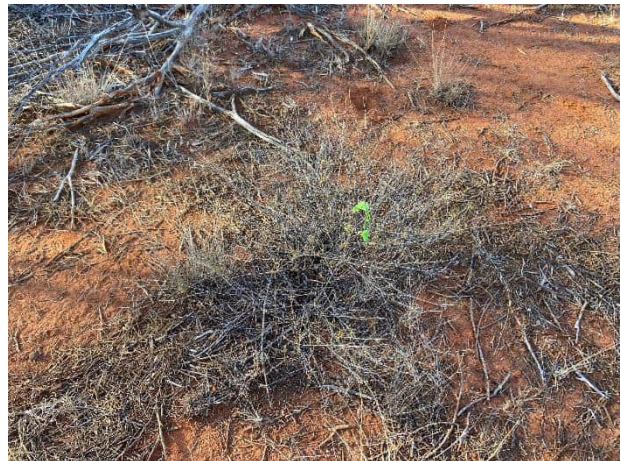
**Figure 4-14: *Eremophila* sp. long pedicels individual ESPLP\_225, in March 2021 and dead in October 2021.**

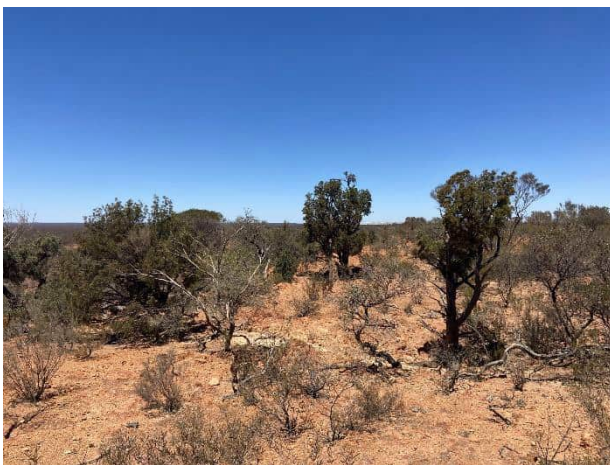
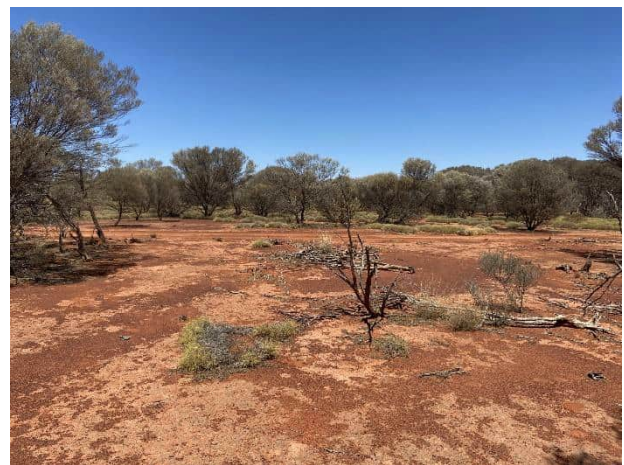
**Figure 4-16 Examples of the range in vegetation condition across the vegetation quadrats assessed in 2021; MKS EIA 26 (left) was rated 'excellent' while MKS EIA 14 (right) was rated 'degraded'.**

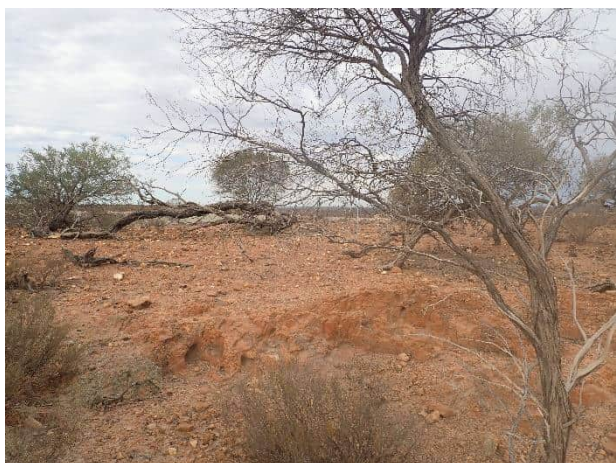
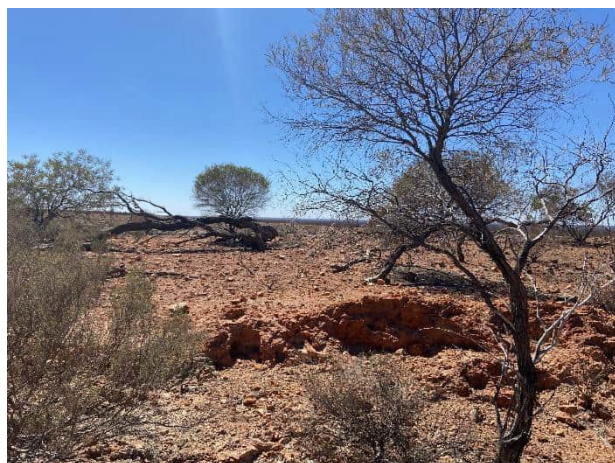
**Figure 4-17: MKS EIA 37 increased from 'good' in 2020 (left) to 'very good' in 2021 (right). The increase in vegetation condition rating shown in the increases in plant cover and health.**

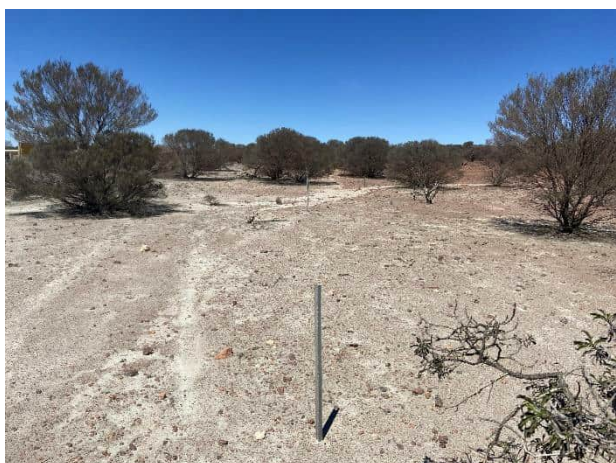
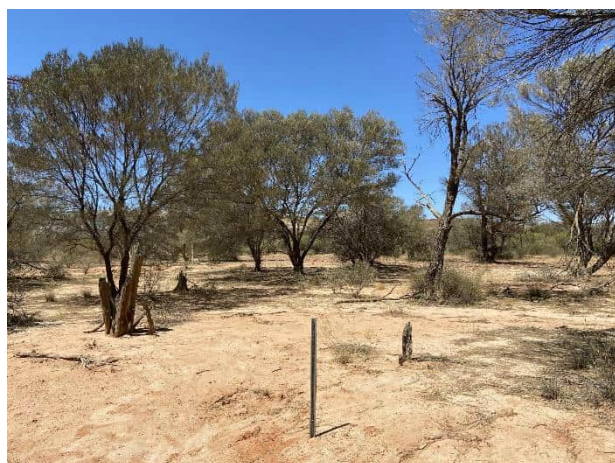
**Figure 4-18 Examples of heavy dust deposition at infrastructure impact quadrats MKS EIA 4 (left) and MKS EIA 18 (right)**

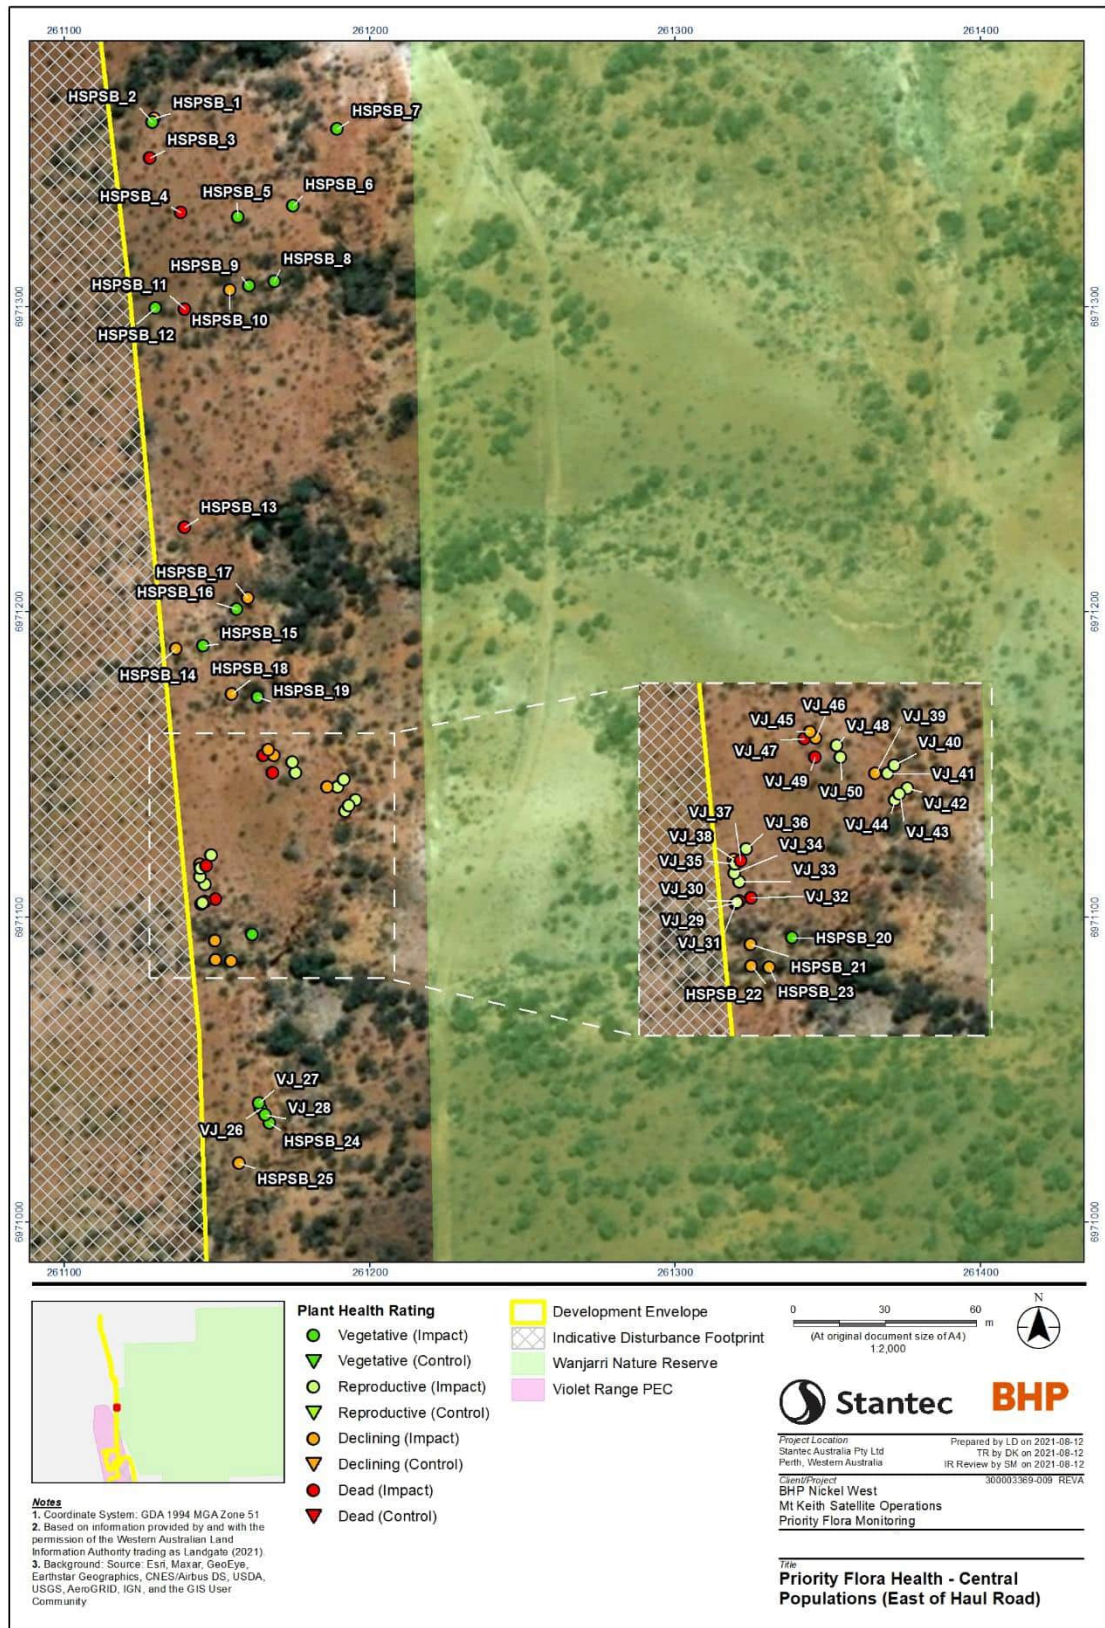
Figure 0-1 Visual representation of the plant health scores of all *Hybanthus floribundus* subsp. *chloroxanthus* individuals assessed in October 2021

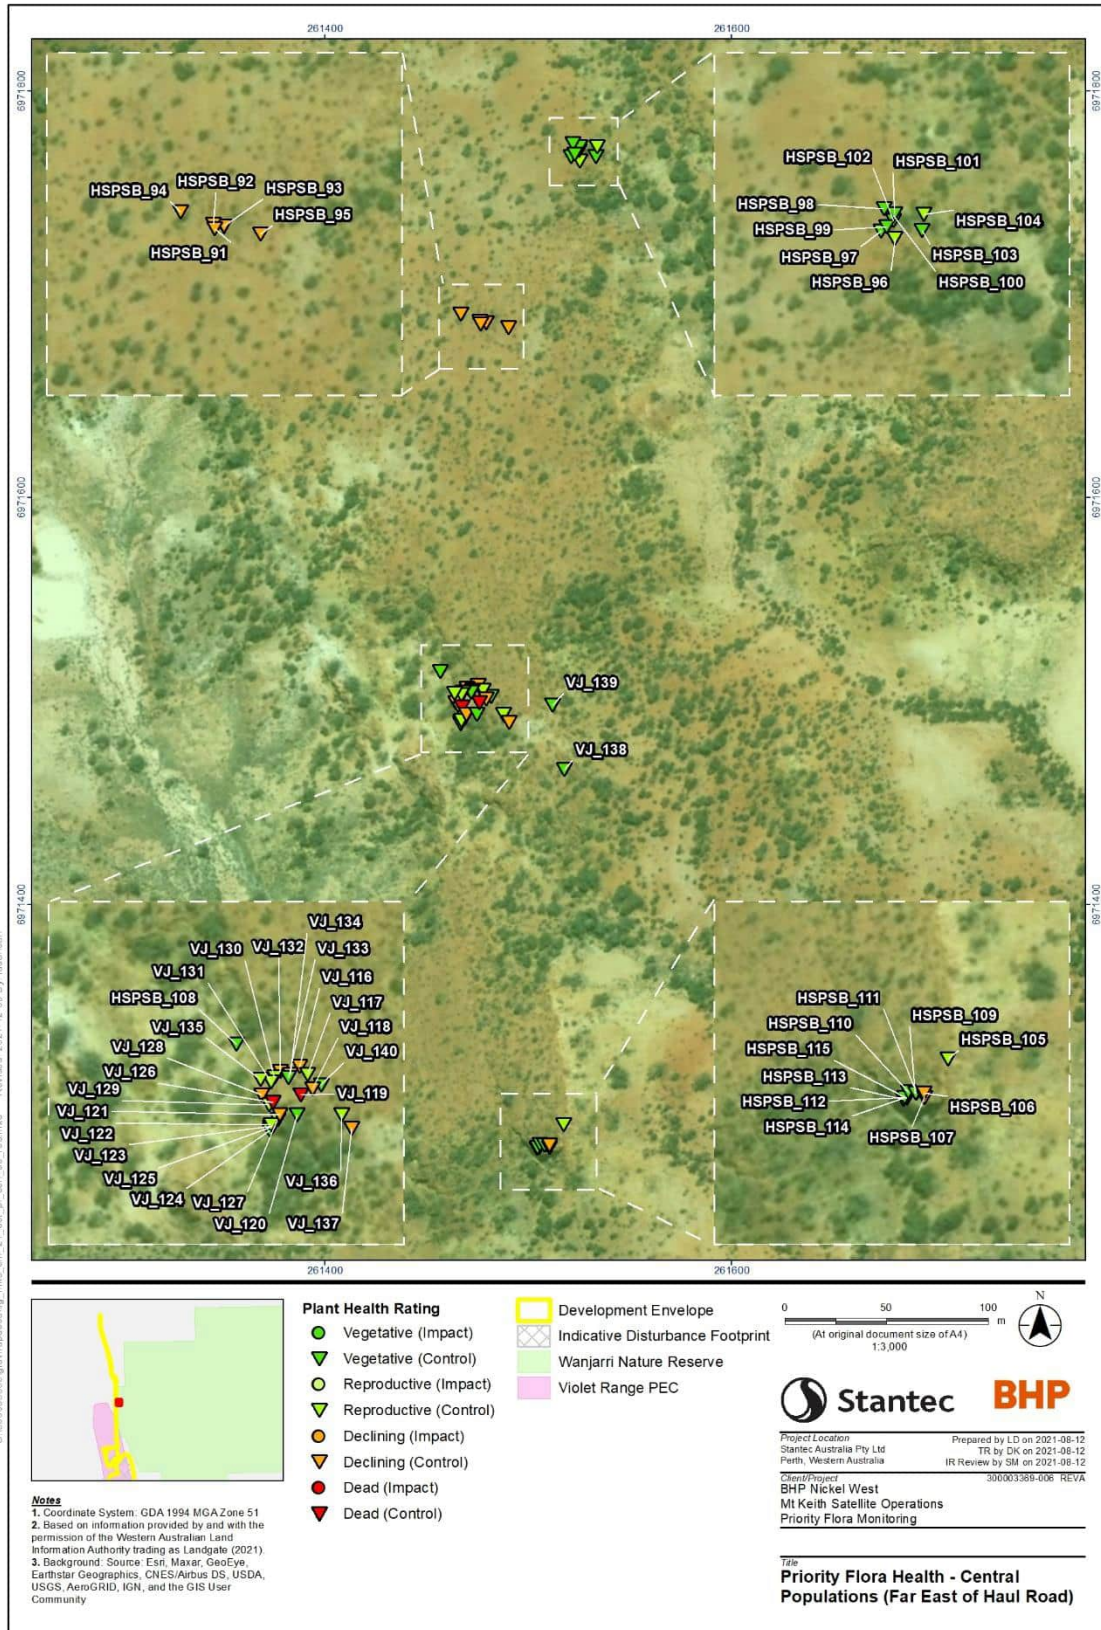
Figure 0-2 Visual representation of the plant health scores of *Hibbertia sp.* Sherwood Breakaways and *Verticordia jamiesonii* individuals east of the haul road, assessed in October 2021

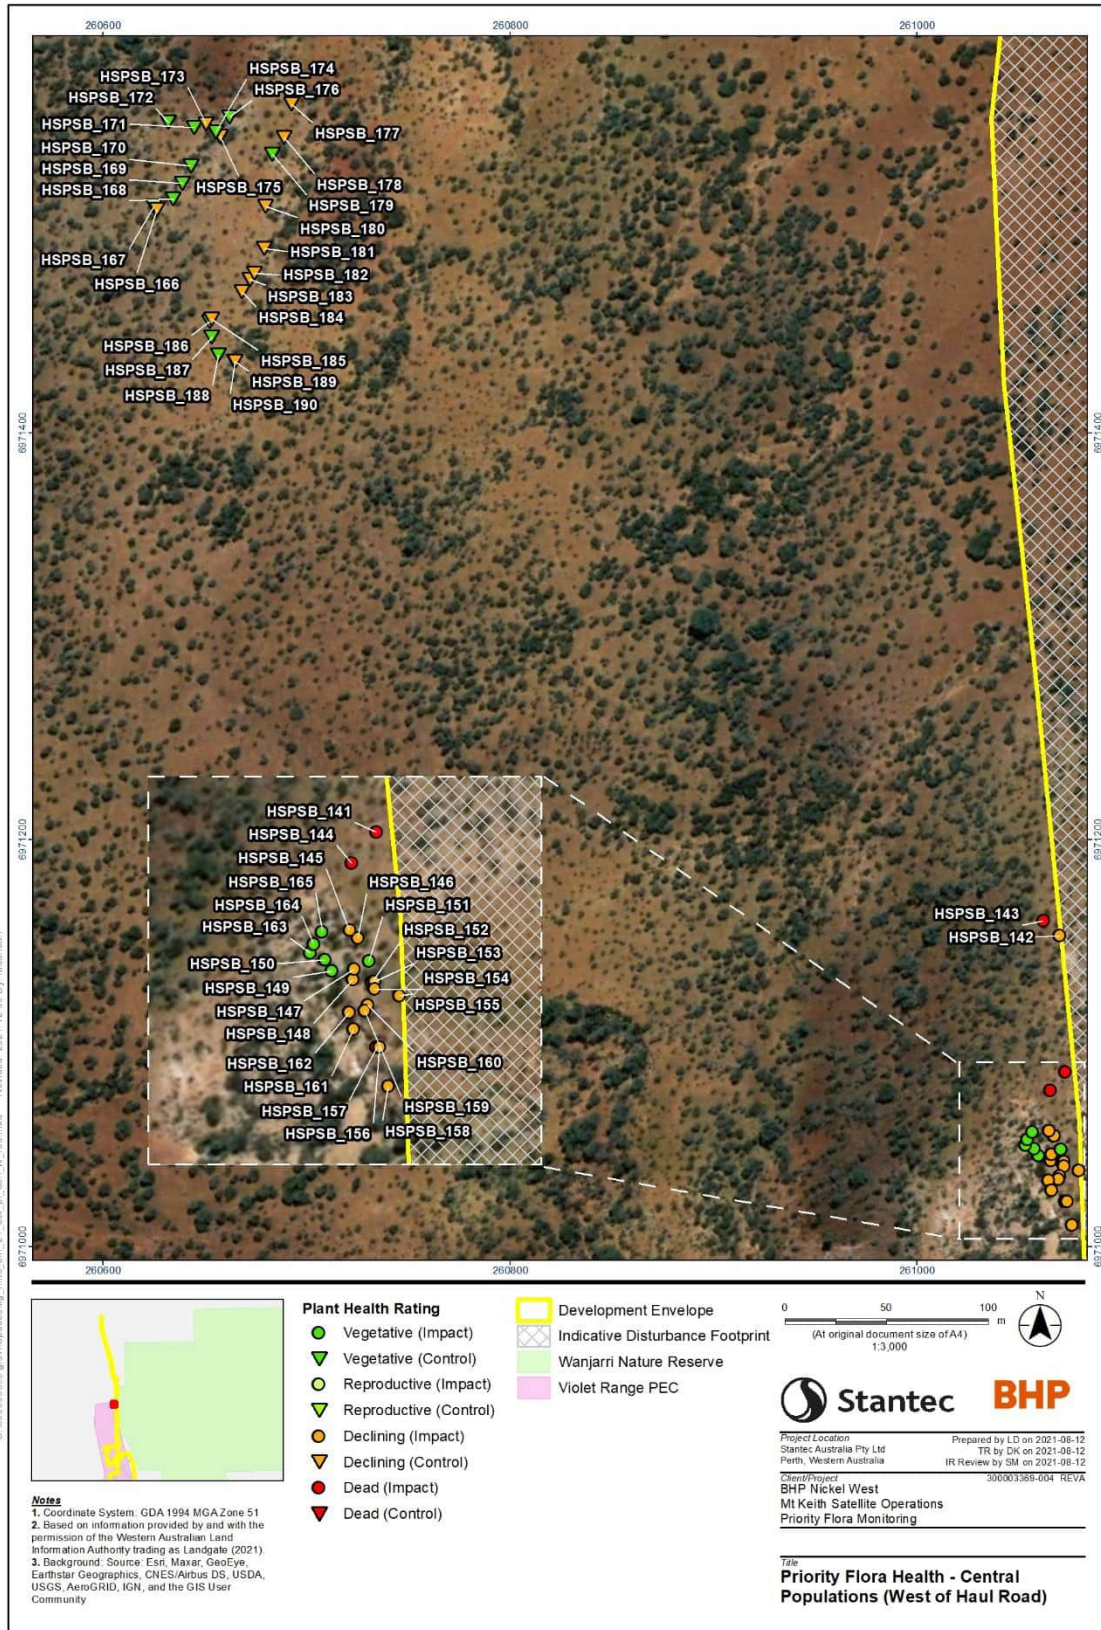
**Figure 0-3 Visual representation of the plant health scores of *Hibbertia sp.* Sherwood Breakaways and *Verticordia jamiesonii* individuals far east of the haul road, assessed in October 2021**

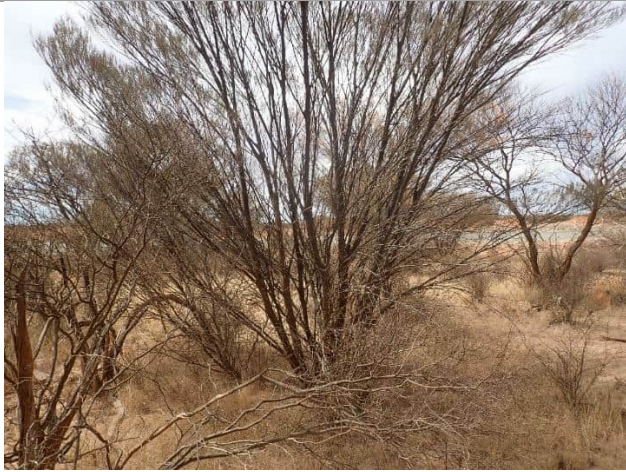
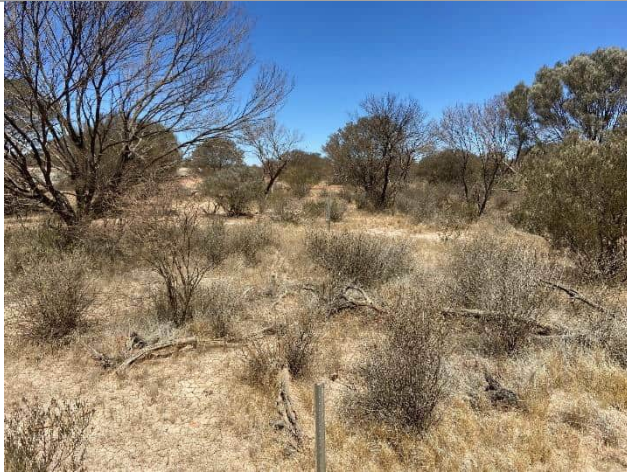
Site ID: MKS EIA 1		Co-ordinates: 51 J 261082 6973489	
<b>Location:</b> ~ 40 m west of haul road		<b>Comments:</b> Drainage at this site is from south-east to north-west. Previous plant deaths. Heavily impacted by dust due to proximity to haul road. Loss of foliage on Acacia trees. Stressed vegetation, particularly <i>S. ectogama</i> which has lost most of its foliage. Ants present. Cryptograms present but covered in dust. Rabbit warrens observed. Subject peg had to be reinstated, removed in grading of fence line track.	
<b>Veg. Type:</b> Drainage line Mulga shrubland			
<b>Veg. Condition:</b> Good			
<b>Grazing:</b> Light			
<b>Weed cover:</b> Nil			
<b>Photo direction:</b> N			
Species	Cover (%)	Plant Health Score	Comments
<i>Aristida jerichoensis</i>	60	3	Dry. Good cover.
<i>Sida ectogama</i>	12	7d	Covered in dust. Loss of foliage.
<i>Acacia aneura</i>	30	7b	Covered in dust. Loss of foliage.
<i>Eremophila latrobei</i>	2	4	Dusty. Stressed.

<i>Eremophila galeata</i>	2	5	Dusty. Stressed.
<b>Other species:</b> <i>Acacia ramulosa</i> var. <i>linophylla</i> , <i>Acacia quadrimarginea</i> , <i>Solanum lasiophyllum</i> , <i>Sclerolaena eurotioides</i> , <i>Ptilotus exaltatus</i> , <i>Poaceae</i> sp.

<b>2020</b>		<b>2021</b> Photo shifted to northern most post.

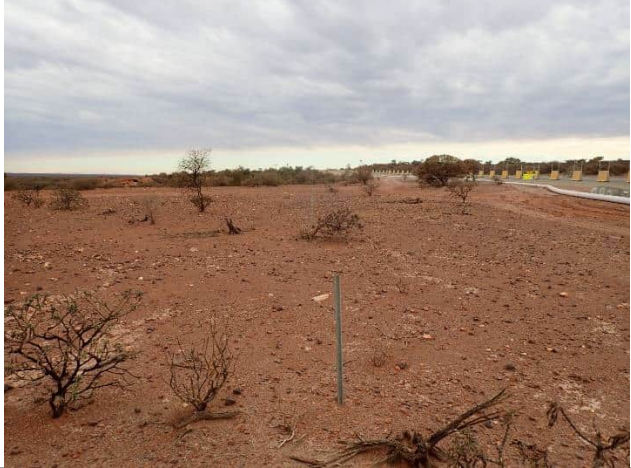
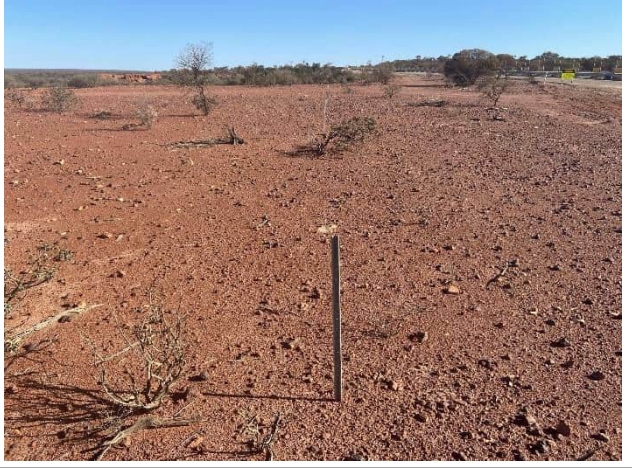
## F.3 MKS EIA 3 - Haul Road Impact

Site ID: MKS EIA 3		Co-ordinates: 51 J 261117 6971563	
<b>Location:</b> ~ 9 m west of haul road	<b>Comments:</b> Soil surface 95% gravelly stones, 5% silty sand and clay. All plants are water stressed. Some dead shrubs present, including all upper storey shrubs and trees. Dust affected. Track runs through the quadrat.		
<b>Veg. Type:</b> Groved Mulga shrubland / Archaean granite geology			
<b>Veg. Condition:</b> Degraded			
<b>Grazing:</b> Nil			
<b>Weed cover:</b> Nil			
<b>Photo direction:</b> NW			
Species	Cover (%)	Plant Health Score	Comments
<i>Eremophila galeata</i>	5	5	Partially dead canopy.
<i>Acacia pruinocarpa</i>	2	7b	Good condition.
<i>Ptilotus obovatus</i>	2	5	Partially dead canopy.
<i>Senna glaucifolia</i>	2	7c	Good condition.
<i>Solanum lasiophyllum</i>	0	1	Dead.
<i>Ptilotus schwartzii</i>	2	5	Replaces <i>Solanum lasiophyllum</i>
<b>Other species:</b> <i>Hibbertia</i> sp. Sherwood Breakaways (R.J. Cranfield 6771), <i>Poaceae</i> sp.

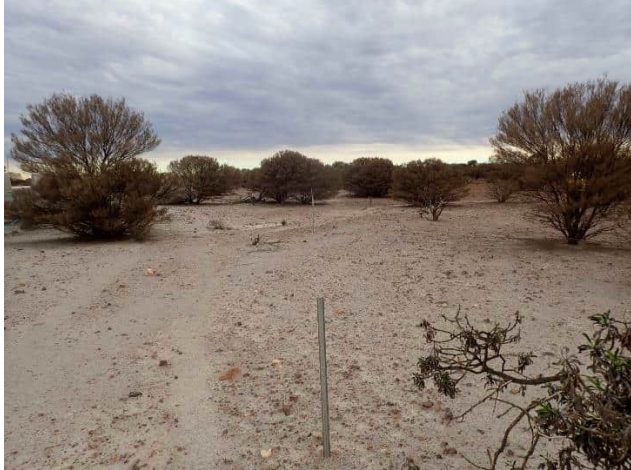
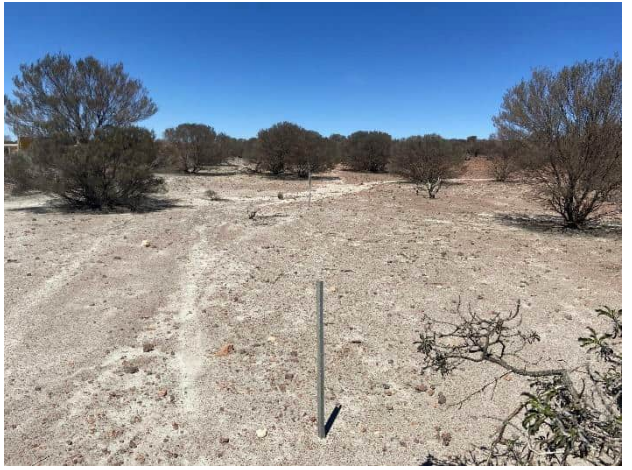
## F.4 MKS EIA 4 - Haul Road Impact

Site ID: MKS EIA 4		Co-ordinates: 51 J 261049 6971565	
<b>Location:</b> ~ 75 m west of haul road	<b>Comments:</b> Cleared road and soil bund. This area gets a lot of dust from vehicular traffic and this is clearly visible on <i>Mulga</i> , <i>Senna</i> and <i>Eremophila</i> species. Drainage is west to south west so it is expected that the haul road may have minimal impact on sheet flow. No cryptograms. Historical Acacia deaths. Directly adjacent to haul road. Soil surface has high dust coverage.		
<b>Veg. Type:</b> Groved Mulga shrubland/ Stony ironstone Mulga shrubland			
<b>Veg. Condition:</b> Good			
<b>Grazing:</b> Nil			
<b>Weed cover:</b> Nil			
<b>Photo direction:</b> NW			
Species	Cover (%)	Plant Health Score	Comments
<i>Acacia aneura</i>	15	5	Dust affected.
<i>Eremophila galeata</i>	2	2	Very stressed.
<i>Ptilotus obovatus</i>	0	1	Dead
<i>Eremophila latrobei</i>	<2	2	Very stressed.
<i>Senna glaucifolia</i>	<2	2	Replaces <i>Ptilotus obovatus</i>

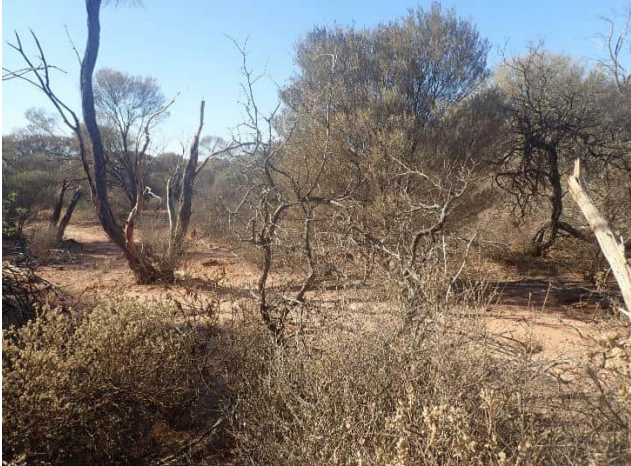
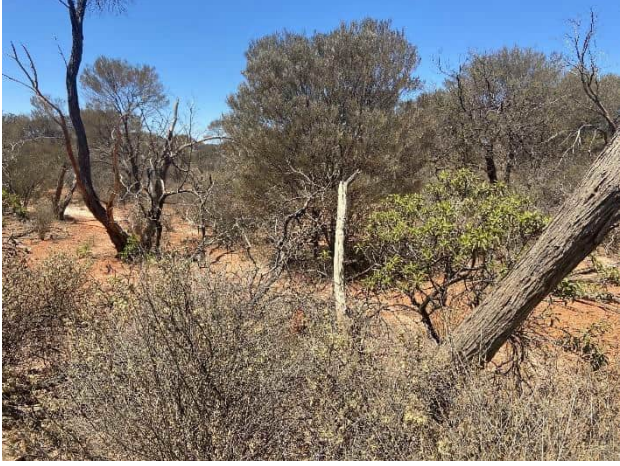
## F.5 MKS EIA 5 - Haul Road Impact

Site ID: MKS EIA 5		Co-ordinates: 51 J 261204 6970774	
<b>Location:</b> ~ 80 m east of haul road	<b>Comments:</b> Site lies 100m downstream from the MKS haul road and about 15m west of the WNR track. Minor drainage line drains from southern end of the breakaway in a south-east direct into the Wanjarri Nature Reserve. The haul road interrupts that drainage path. Cryptograms on soil surface. Litter present under trees. Pedestalling erosion present. Vegetation is water stressed and dust affected. Historical <i>Acacia</i> deaths recorded. Termite mounds and kangaroo scats observed.		
<b>Veg. Type:</b> Drainage line Mulga shrubland			
<b>Veg. Condition:</b> Very good			
<b>Grazing:</b> Light, historic			
<b>Weed cover:</b> Nil			
<b>Photo direction:</b> N			
Species	Cover (%)	Plant Health Score	Comments
<i>Acacia aneura</i>	15	7b	Good condition.
<i>Acacia tetragonophylla</i>	10	4	Old flowers still attached to plant.

<i>Sida ectogama</i>	20	3	Dry, foliage loss observed.
<i>Eremophila pungens</i> (P4)	3	7c	Good condition.
<i>Eremophila forrestii</i>	2	3	Dry, foliage loss observed.
<b>Other species:</b> <i>Acacia craspedocarpa</i> , <i>Eremophila galeata</i> , <i>Eremophila jucunda</i> subsp. <i>jucunda</i> , <i>Psyrax latifolia</i> , <i>Enneapogon avenaceus</i> , <i>Eremophila compacta</i> , <i>Ptilotus exaltatus</i> , <i>Sclerolaena eurotioides</i> , <i>Eremophila latrobei</i> , <i>Dodonaea petiolaris</i> , <i>Ptilotus obovatus</i> , <i>Ptilotus helipteroides</i> , <i>Aristida jerichoensis</i> , <i>Senna</i> sp. <i>Meekatharra</i>

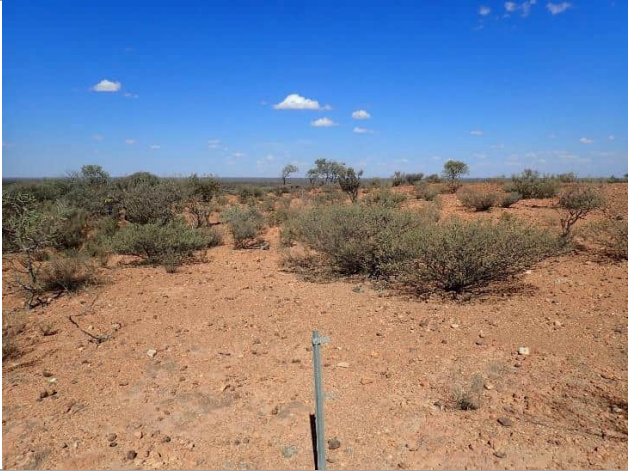
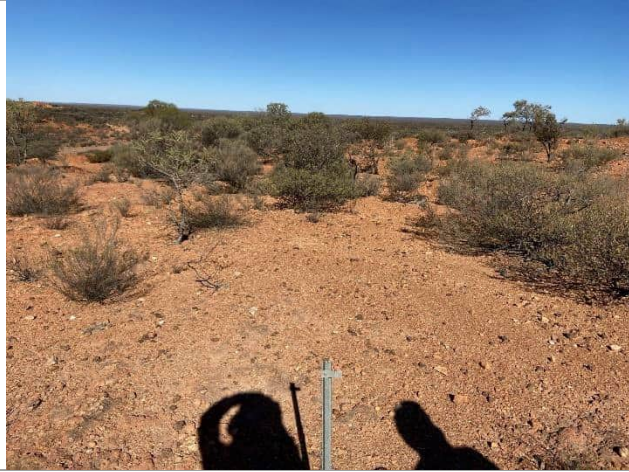
## F.6 MKS EIA 6 - Haul Road Impact

Site ID: MKS EIA 6		Co-ordinates: 51 J 261139 6971172	
<b>Location:</b> ~13 m east of haul road	<b>Comments:</b> Post has WB 30 on it and all four posts are installed. All vegetation is in good condition considering dry seasonal conditions. Minimal dust impact. Area protected by large bund along the edge of the haul road, in previous assessment but was not observed in 2021.		
<b>Veg. Type:</b> Archaean granite geology			
<b>Veg. Condition:</b> Excellent			
<b>Grazing:</b> Light			
<b>Weed cover:</b> Nil			
<b>Photo direction:</b> NW			
Species	Cover (%)	Plant Health Score	Comments
<i>Callitris columellaris</i>	10	7d	Good condition.
<i>Thryptomene</i> sp. <b>Leinster (P3)</b>	15	7d	Good condition.
<i>Acacia pruinocarpa</i>	2	7b	Good condition.
<i>Acacia quadrimarginea</i>	10	7b	Good condition.
<i>Eriachne mucronata</i>	2	3	Dry, with dead patches.
<b>Other species:</b> <i>Acacia rhodophloia</i> , <i>Acacia aneura</i> , <i>Hibbertia</i> sp. <i>Sherwood Breakaways</i> (R.J. Cranfield 6771), <i>Hakea leucoptera</i> subsp. <i>sericipes</i> , <i>Acacia tetragonophylla</i> , <i>Dodonaea petiolaris</i> , <i>Verticordia jamiesonii</i> , <i>Poaceae</i> sp., <i>Calytrix uncinata</i>

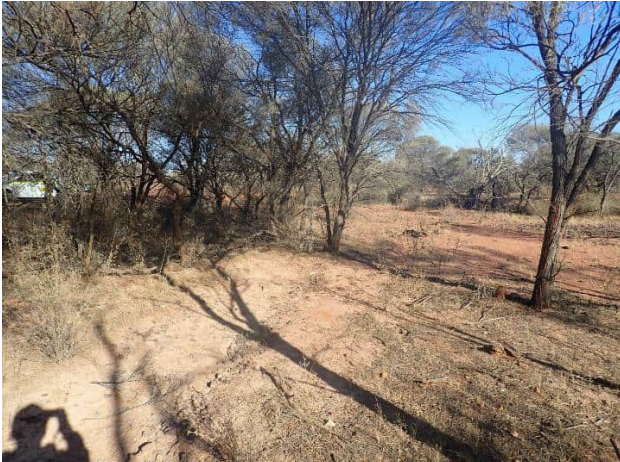
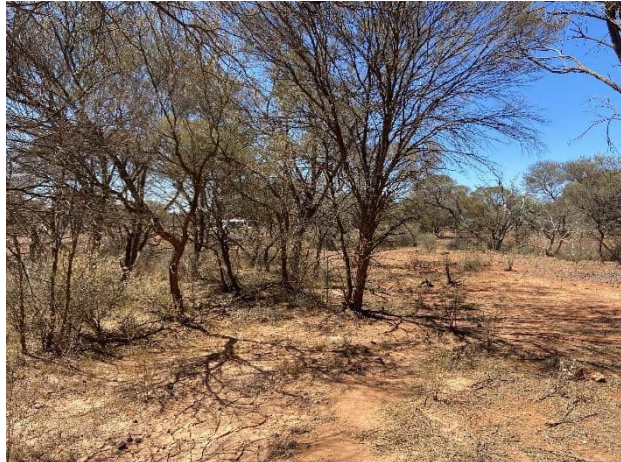
## F.7 MKS EIA 7 - Haul Road Impact

Site ID: MKS EIA 7		Co-ordinates: 51 J 261216 6970204	
<b>Location:</b> ~ 90 m east of haul road		<b>Comments:</b> Drainage from the west, interrupted by haul road. Two posts installed. Kangaroo scats and termite mounds were present. Litter present under large <i>Acacia</i> shrubs. Half of quadrat dominated by vegetation, but other half is almost bare. Historic shrub deaths to the west of the quadrat. Upper storey healthy while lower storey was water stressed. Dust affected.	
<b>Veg. Type:</b> Drainage line Mulga shrubland			
<b>Veg. Condition:</b> Very good			
<b>Grazing:</b> Light, historic			
<b>Weed cover:</b> Nil			
<b>Photo direction:</b> N			
Species	Cover (%)	Plant Health Score	Comments
<i>Acacia aneura</i>	30	7b	Lower branches have reduced foliage. Previously grazed.
<i>Eremophila compacta</i>	<2	3	Stressed adult beneath Mulgas.
<i>Sida ectogama</i>	20	3	Dusty and stressed. Some foliage loss.

<i>Eremophila granitica</i>	<2	3	Dusty and stressed. Some foliage loss.
<i>Acacia thoma</i>	20	7b	Good condition.
<b>Other species:</b> <i>Enneapogon caerulescens</i> , <i>Ptilotus obovatus</i> , <i>Ptilotus exaltatus</i> , <i>Eremophila galeata</i> , <i>Eremophila forrestii</i> , <i>Ptilotus helipteroides</i> , <i>Senna sp.</i> Meekatharra, <i>Aristida sp.</i>

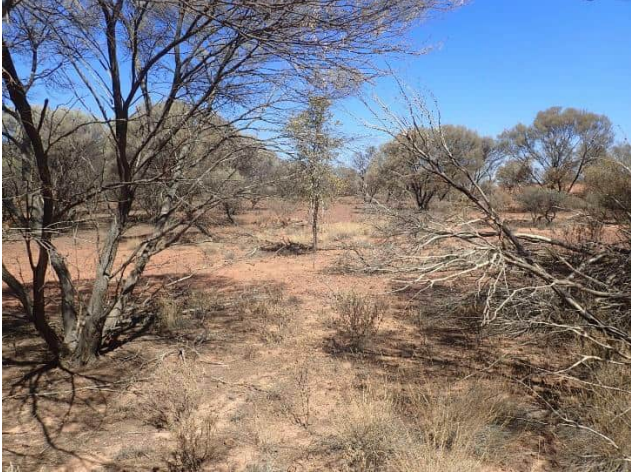
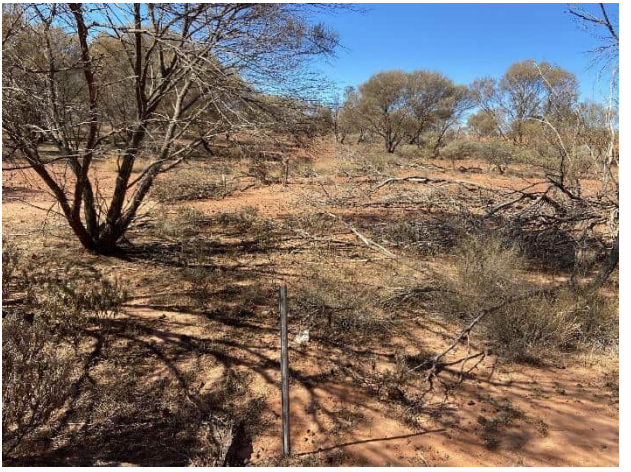
## F.8 MKS EIA 8 - Haul Road Impact

Site ID: MKS EIA 8		Co-ordinates: 51 J 261231 6969060	
<b>Location:</b> ~ 60 m east of haul road	<b>Comments:</b> This site may dependent on sheet flow from the west. Site is covered in stony ferruginous rocks and boulders. No annuals at time of assessment. Evidence of grazing, possibly historic. Dust present on vegetation. Termite mounds and rabbit warrens present. Dead grasses and shrubs observed. Litter present under Acacias.		
<b>Veg. Type:</b> Stony ironstone Mulga shrubland			
<b>Veg. Condition:</b> Very good			
<b>Grazing:</b> Light			
<b>Weed cover:</b> Nil			
<b>Photo direction:</b> N			
Species	Cover (%)	Plant Health Score	Comments
<i>Acacia aneura</i>	20	7b	Healthy adult individuals.
<i>Psyrax suaveolens</i>	<2	3	
<i>Eremophila spectabilis</i>	10	6	Dry, but full canopy.
<i>Eremophila latrobei</i>	<2	6	Stressed individuals under <i>Acacias</i> .
<i>Senna glaucifolia</i>	<2	7c	
<b>Other species:</b> <i>Ptilotus schwartzii</i> , <i>Eriachne helmsii</i> , <i>Eremophila jucunda subsp. jucunda</i> , <i>Eragrostis eriopoda</i> , <i>Sida sp. Golden calyces glabrous</i> (H.N. Foote 32)

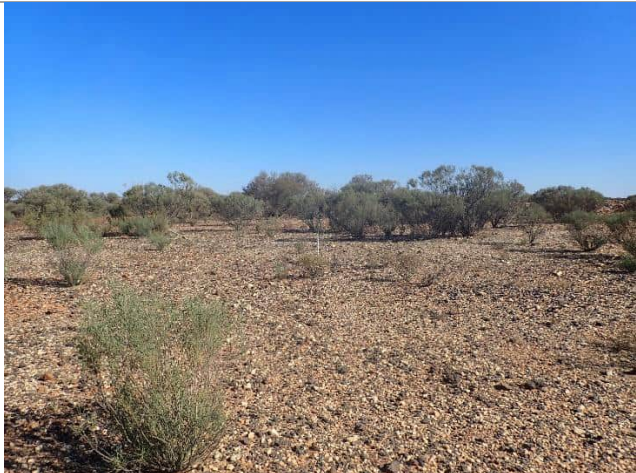
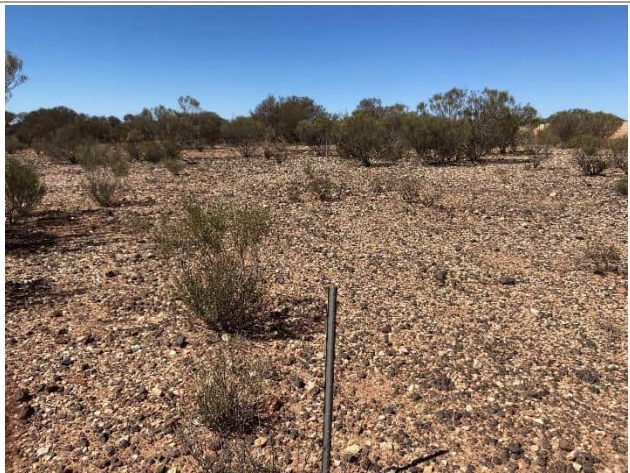
## F.9 MKS EIA 9 - Haul Road Impact

Site ID: MKS EIA 9		Co-ordinates: 51 J 261218 6969942	
<b>Location:</b> ~95 m east of haul road	<b>Comments:</b> Soil surface is 95% quartz, ironstone rocks and gravel with 5% silty sand. No cryptogams observed. Site is on a low rise, higher than surrounding landscape and unlikely to be affected by interruption to drainage due to the haul road. Many young <i>Hakea leucoptera</i> observed. Many Maireanas stressed. No annuals. Less impacted by dust than other quadrats observed despite being closer to the haul road.		
<b>Veg. Type:</b> Weathered basalt, <i>Hakea leucoptera</i> subsp. <i>sericipes</i> / <i>Eremophila pantonii</i> shrubland			
<b>Veg. Condition:</b> Excellent			
<b>Grazing:</b> Nil			
<b>Weed cover:</b> Nil			
<b>Photo direction:</b> N			
Species	Cover (%)	Plant Health Score	Comments
<i>Hakea leucoptera</i> subsp. <i>sericipes</i>	10	4	Healthy. Old seed pods present. Many juveniles.
<i>Maireana triptera</i>	<2	3	Stressed. Loss of foliage.

<i>Senna</i> sp. <i>Meekatharra</i>	<2	7b	Dusty, but healthy. Juveniles present.
<i>Eremophila pantonii</i>	<2	5	Healthy. Flowering.
-	-	-	-
<b>Other species:</b> <i>Atriplex semilunaris</i> , <i>Ptilotus obovatus</i> , <i>Maireana georgei</i>

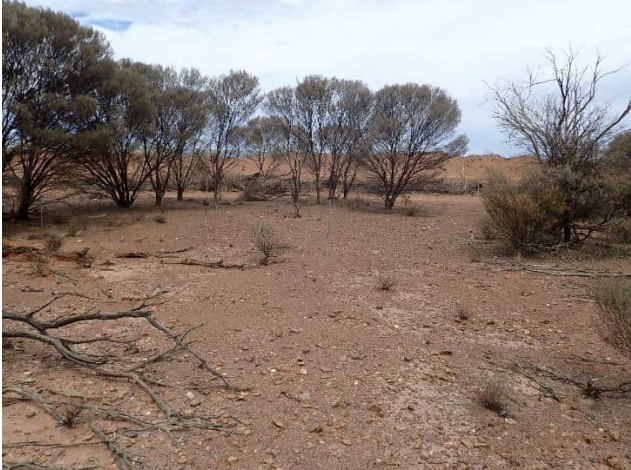
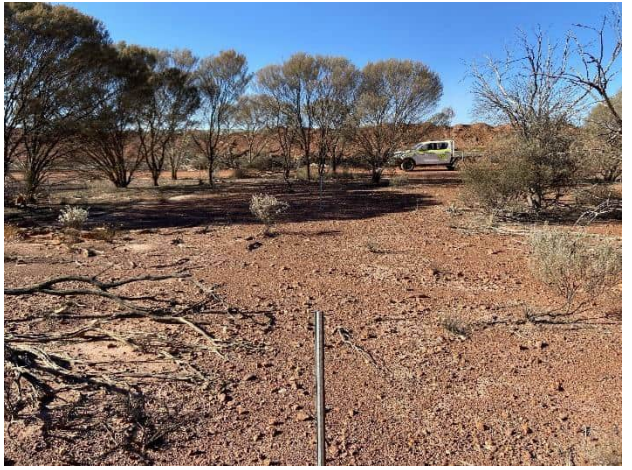
## F.10 MKS EIA 10 - Infrastructure Impact

Site ID: MKS EIA 10		Co-ordinates: 51 J 260553 6966093	
<b>Location:</b> ~ 320 m north of Run-of-mine	<b>Comments:</b> Topsoil stockpile in the background of photo. Note east peg is 8m from center peg (closer than standard 10m distance). Drainage comes from the west, the Run-of-mine is north of the quadrat so drainage may not be interrupted. Very bare quadrat. Low cover of cryptograms present. Some understorey shrub death. No annuals. Litter present under Acacias. Dust present on vegetation. Vegetation is dry, reflecting extended dry seasonal conditions. Old rabbit warrens present.		
<b>Veg. Type:</b> Stony ironstone Mulga shrubland			
<b>Veg. Condition:</b> Good			
<b>Grazing:</b> Light			
<b>Weed cover:</b> Nil			
<b>Photo direction:</b> NW			
Species	Cover (%)	Plant Health Score	Comments
<i>Acacia aneura</i>	5	7b	Some dust, full canopy.
<i>Ptilotus schwartzii</i>	<2	5	Actively flowering.
<i>Eremophila forrestii</i>	<2	3	Some loss of foliage. Lots of dust present.

<i>Eremophila spectabilis</i>	<2	7d	Very dry. Yellowing leaves. Dusty.
<i>Ptilotus obovatus</i>	<2	5	Very dry, foliage loss. Flowering.
<b>Other species:</b> <i>Eremophila latrobei</i> , <i>Psydrax suaveolens</i> , <i>Eriachne helmsii</i> , <i>Enneapogon caeruleus</i> , <i>Acacia pruinocarpa</i>
