# Mt Keith Satellite Statement 1087 Compliance Assessment Report BHP Nickel West

29 March 2022

This CAR outlines the implementation and compliance status of the Project for the period of 28 December 2020 to 31 December 2021, and aligns with the requirements of the approved Compliance Assessment Plan (BHP Nickel West 2020a) under Condition 4-1 of the Statement 1087 approval.

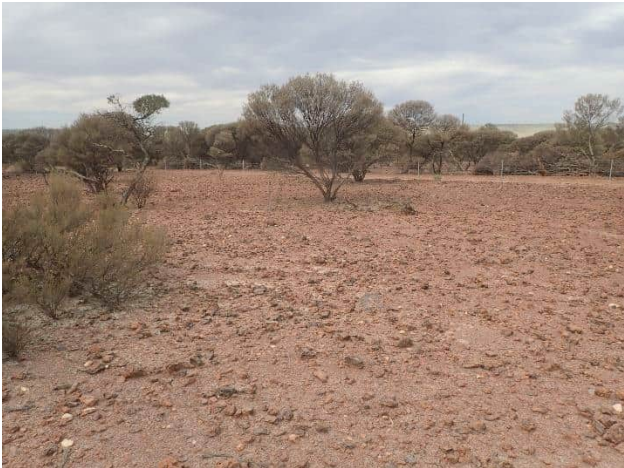
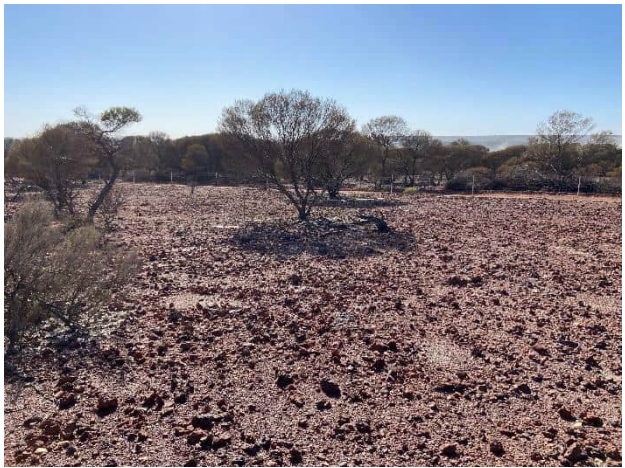
## F.11 MKS EIA 11 - Infrastructure Impact

Site ID: MKS EIA 11		Co-ordinates: 51 J 260029 6965525	
<b>Location:</b> ~ 250 m east of Run-of-mine	<b>Comments:</b> Six mile well pit and run-of-mine in background. 100% rocky laterite with quartz stones and gravel. Lichens present on rocks. Light dust layer visible on rocks.		
<b>Veg. Type:</b> Stony ironstone low/Mulga shrubland	Dry vegetation, with sparse cover. Many dead understorey plants, particularly <i>P. schwartzii</i> . Likely affected by extended dry seasonal conditions. Note: This site is positioned perpendicular to the MKS clearing edge and transversely across the slope.		
<b>Veg. Condition:</b> Good			
<b>Grazing:</b> Light, historic			
<b>Weed cover:</b> Nil			
<b>Photo direction:</b> NW			
Species	Cover (%)	Plant Health Score	Comments
<i>Acacia aneura</i>	2	7c	Healthy. Previously grazed, with browse line observed.
<i>Acacia quadrimarginea</i>	<2	2	Loss of 70% foliage.
<i>Thryptomene</i> sp. Leinster (P3) (EIA_11_001)	<2	3	Stressed individuals.

<i>Eremophila latrobei</i>	<2	2	Stressed and dry.
<i>Ptilotus obovatus</i>	<2	3	Dry. Some foliage loss.
<b>Other species:</b> <i>Hamieria kempeana</i> , <i>Senna glaucifolia</i> , <i>Ptilotus schwartzii</i>

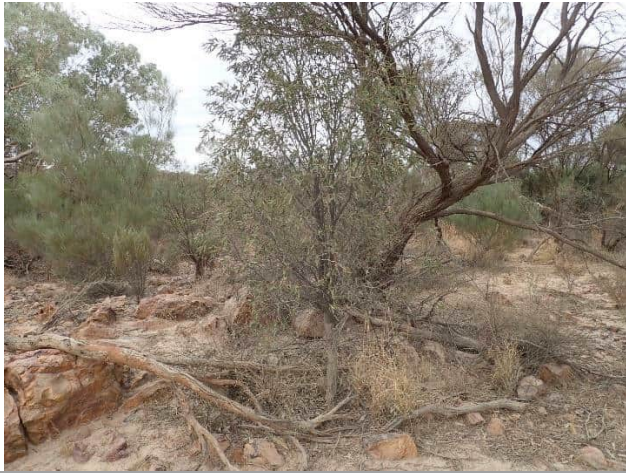
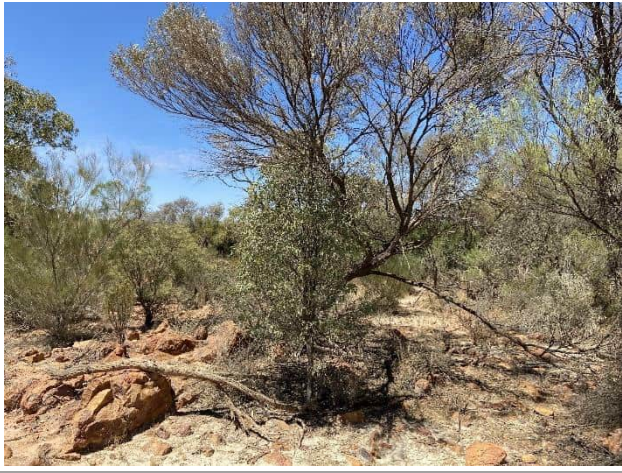
Site ID: MKS EIA 13		Co-ordinates: 51 J 260866 6964098	
<b>Location:</b> ~ 80 m from Six Mile Well pit		<b>Comments:</b> Creek bed at the site is normal with healthy fringing grasses and a sandy creek bed. On western bank of Jones Creek. Creek banks composed of silty sand overlaying polymictic rocks including weather sandstone and concreted Wiluna hardpan. All vegetation in good condition, most are vegetative. <i>Eucalyptus camaldulensis</i> in healthy condition. Some historic shrub death. Heavy dust deposition on vegetation and soil surface. Ants present. Only middle post present.	
<b>Veg. Type:</b> Drainage line Mulga shrubland			
<b>Veg. Condition:</b> Very good			
<b>Grazing:</b> Light			
<b>Weed cover:</b> Nil			
<b>Photo direction:</b> NW			
Species	Cover (%)	Plant Health Score	Comments
<i>Acacia caesaneura</i>	10	5	Seeding. Vegetative.
<i>Acacia burtikii</i>	15	4	Budding. Vegetative.
<i>Themeda triandra</i>	15	4	Budding. Declining.

<i>Dodonaea viscosa</i>	5	4	Budding. Vegetative.
<i>Dodonaea rigida</i> (EIA_13_012)	5	4	Budding. Vegetative.
<b>Other species:</b> <i>Ptilotus exaltatus</i> , <i>Ptilotus obovatus</i> , <i>Duperreya sericea</i> , <i>Grevillea inconspicua</i> , <i>Santalum spicatum</i> , <i>Eucalyptus camaldulensis</i> subsp. <i>obtusum</i> , <i>Eremophila granitica</i> , <i>Hemigenia exilis</i> , <i>Eremophila pantonii</i> , <i>Eremophila oldfieldii</i> subsp. <i>angustifolia</i> , <i>Hybanthus floribundus</i> subsp. <i>chloroxanthus</i>

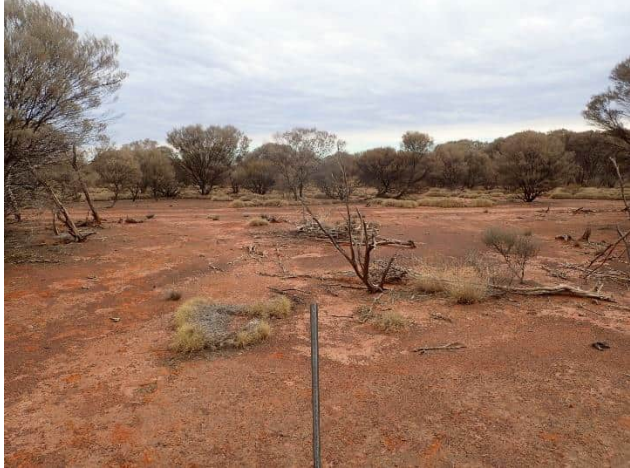
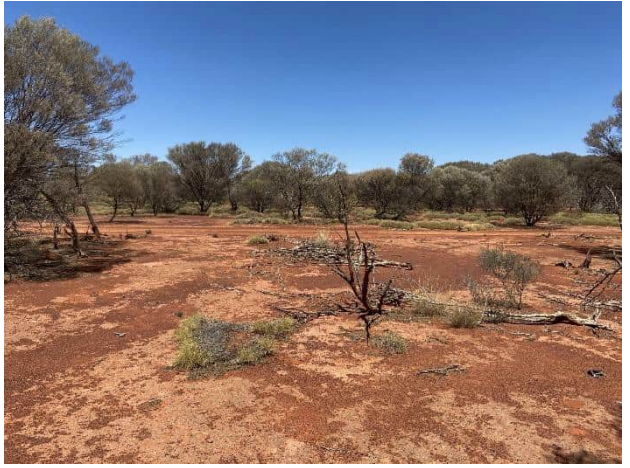
## F.14 MKS EIA 14 - Infrastructure Impact

Site ID: MKS EIA 14		Co-ordinates: 51 J 263217 6963155	
<b>Location:</b> ~ 400 m south-east of WRL		<b>Comments:</b> Eastern side of MKS, outside clearing margin. Track runs through quadrat. Previous Acacia deaths observed as well as recent plant deaths. Vegetation is dry. Post missing.	
<b>Veg. Type:</b> Sandplain Mulga spinifex shrubland/ Hardpan Mulga shrubland			
<b>Veg. Condition:</b> Degraded			
<b>Grazing:</b> Light			
<b>Weed cover:</b> Nil			
<b>Photo direction:</b> NW			
Species	Cover (%)	Plant Health Score	Comments
<i>Acacia caesaneura</i>	10	7b	
<i>Acacia ramulosa</i> var. <i>linophylla</i>	5	7b	
<i>Triodia basedowii</i>	2	7d	
<i>Eragrostis eriopoda</i>	<2	7b	
-	-	-	-
<b>Other species:</b> <i>Eremophila spectabilis</i>

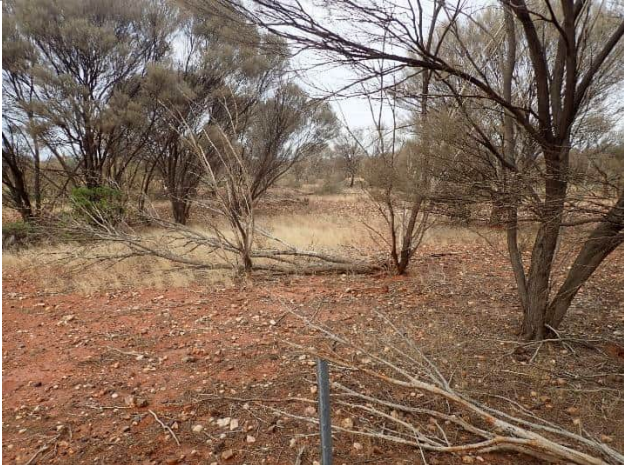
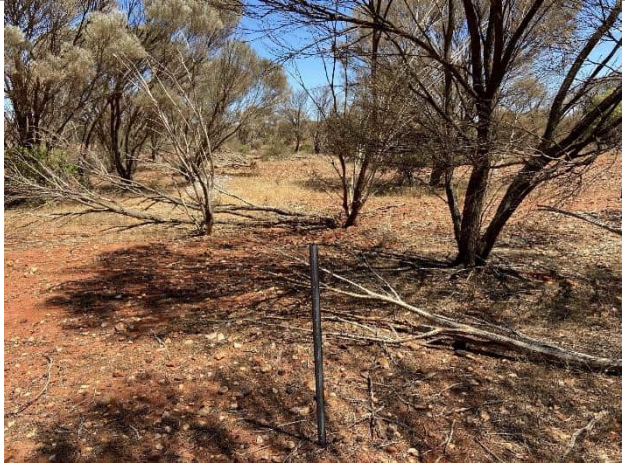
## F.15 MKS EIA 15 - Infrastructure Impact

Site ID: MKS EIA 15		Co-ordinates: 51 J 260412 6961163	
<b>Location:</b> ~ 2.2 km south west of WRL, ~ 450 m from Jones Creek track		<b>Comments:</b> Historical Acacia deaths. Kangaroo scats present. Several dead <i>Maireana</i> individuals. Annual grass cover. Dust affected Acacias. This site is a minor drainage line within a stony plain. Drainage here is from the east, from the south-western corner of the MKS development envelope.	
<b>Veg. Type:</b> Mulga over <i>Maireana triptera</i> shrubland/ Drainage line Mulga shrubland			
<b>Veg. Condition:</b> Very good			
<b>Grazing:</b> Light			
<b>Weed cover:</b> Nil			
<b>Photo direction:</b> NW			
Species	Cover (%)	Plant Health Score	Comments
<i>Ptilotus obovatus</i>	5	5	Some foliage loss but flowering.
<i>Acacia aneura</i>	40	5	Historic browsing lines. Vegetative. Flowering.
<i>Eremophila galeata</i>	5	5	Green foliage on end of stems, browning at base. Vegetative. Flowering.

<i>Aristida jerichoensis</i>	40	7d	High cover.
<i>Senna artemisioides</i> subsp. <i>helmsii</i>	2	2	Little foliage remaining.
<b>Other species:</b> <i>Solanum lasiophyllum</i> , <i>Ptilotus schwartzii</i> , <i>Maireana georgei</i> , <i>Ptilotus helipteroides</i>

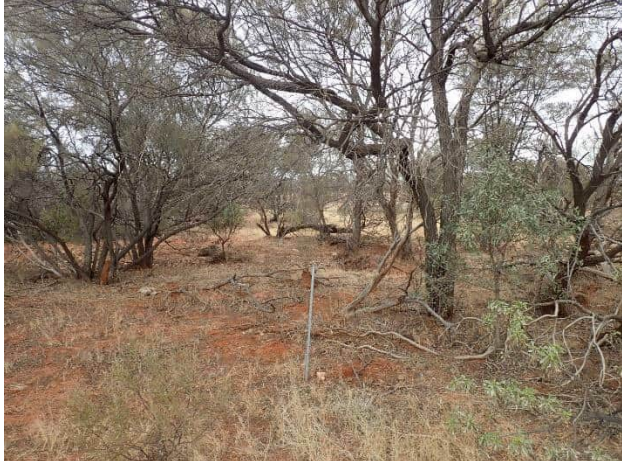
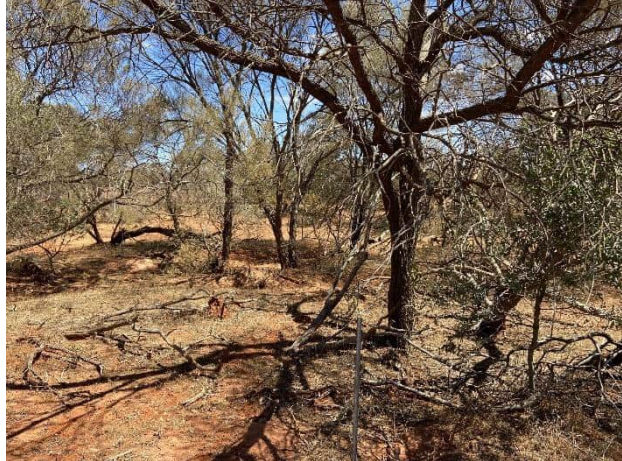
## F.16 MKS EIA 16 - Infrastructure Impact

Site ID: MKS EIA 16		Co-ordinates: 51 J 260261 6961683	
<b>Location:</b> ~ 1.8 km south west of WRL, ~ 250 m from Jones Creek track	<b>Comments:</b> All vegetation in good condition for dry extended seasonal conditions. Cryptograms are present but dry. High grass cover. Dead <i>Acacia tetragonophylla</i> present and annual species. Dust on foliage of most species. Stream channel showing clayey sand on banks and stony stream bed. This site lies downslope of the MKS development with a large proportion of its catchment interrupted by MKS. Dust on foliage. Risk of water starvation or increased sedimentation from adjacent mining operations.		
<b>Veg. Type:</b> Drainage line Mulga shrubland			
<b>Veg. Condition:</b> Very good			
<b>Grazing:</b> Light, historic			
<b>Weed cover:</b> Nil			
<b>Photo direction:</b> NW			
Species	Cover (%)	Plant Health Score	Comments
<i>Sida ectogama</i>	5	5	Dusty. Vegetative.

<i>Eremophila granitica</i>	5	5	Browning of stem ends. Vegetative.
<i>Eremophila galeata</i>	5	7d	Browning foliage and foliage loss.
<i>Acacia ?craspedocarpa (hybrid) (EIA_16_001)</i>	25	7c	
<i>Acacia aptaneura (EIA_16_002)</i>	60	7c	
<b>Other species:</b> <i>Eriachne helmsii</i> , <i>Psydrax suaveolens</i> , <i>Solanum lasiophyllum</i> , <i>Ptilotus obovatus</i> , <i>Eremophila latrobei</i> , <i>Ptilotus exaltatus</i> , <i>Senna artemisioides subsp. filifolia</i> , <i>Aristida jerichoensis</i> , <i>Santalum ?lanceolatum</i> , <i>Ptilotus helipteroides</i>

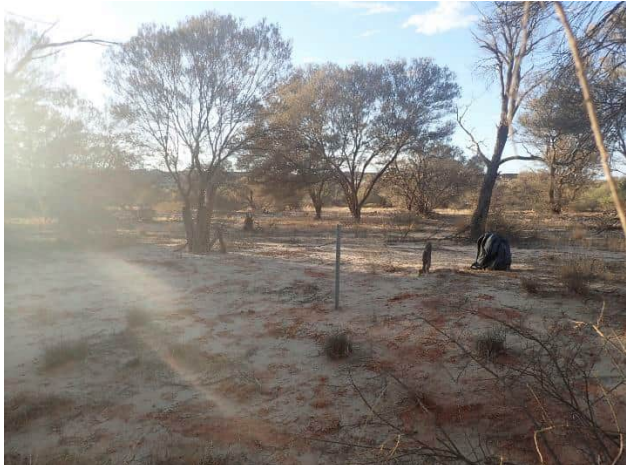
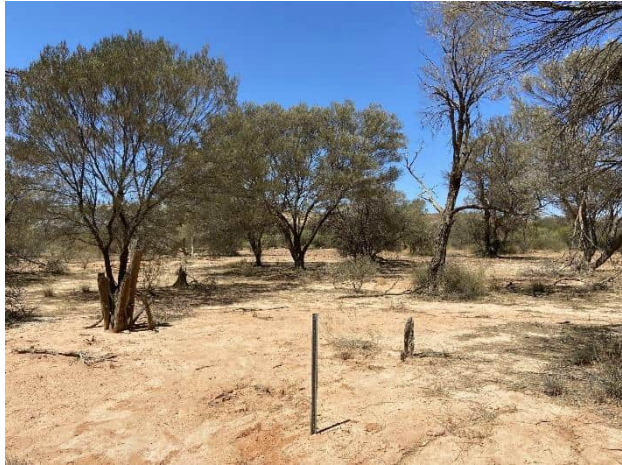
## F.17 MKS EIA 18 - Infrastructure Impact

Site ID: MKS EIA 18		Co-ordinates: 51 J 261285 6964460	
<b>Location:</b> ~ 195 m south east of Run-of-Mine/ Six Mile Well	<b>Comments:</b> Jones Creek, upstream of bridge crossing on the eastern bank. Grasses on edge of the creek are stressed, dusty and grazed. <i>Eucalyptus camaldulensis</i> are healthy. Heavy dust load on most shrubs and grasses. Soil surface also covered in dust. Ants present.		
<b>Veg. Type:</b> Drainage line Mulga shrubland			
<b>Veg. Condition:</b> Very Good			
<b>Grazing:</b> Light, historic			
<b>Weed cover:</b> Nil			
<b>Photo direction:</b> NW			
Species	Cover (%)	Plant Health Score	Comments
<i>Acacia aneura</i>	25	5	Flowering and vegetative.
<i>Santalum spicatum</i>	20	5	Flowering and declining.
<i>Aristida jerichoensis</i>	10	7b	
<i>Acacia burkittii</i>	10	5	Pods on plants.
<i>Themeda triandra</i>	5	7d	
<b>Other species:</b> <i>Santalum lanceolatum</i> , <i>Acacia aneura</i> , <i>Eucalyptus camaldulensis</i> subsp. <i>obtusa</i> , <i>Eragrostis eriopoda</i> , <i>Eremophila gilesii</i> , <i>Sida ectogama</i> , <i>Maireana tomentosa</i> , <i>Ptilotus obovatus</i> , <i>Eremophila latrobei</i> , <i>Teucrium teucriiflorum</i> , <i>Rhagodia drummondii</i> , <i>Ptilotus exaltatus</i>

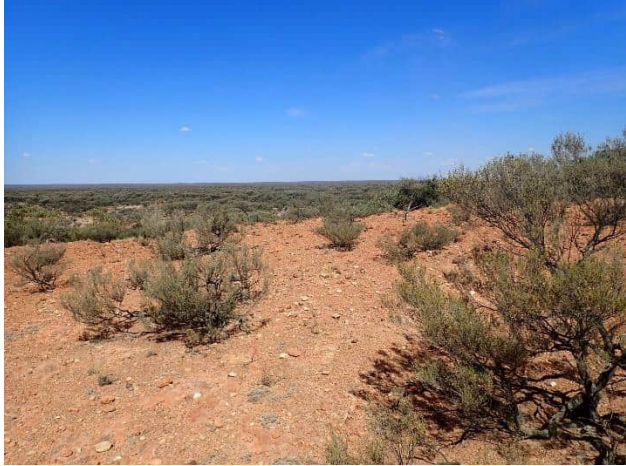
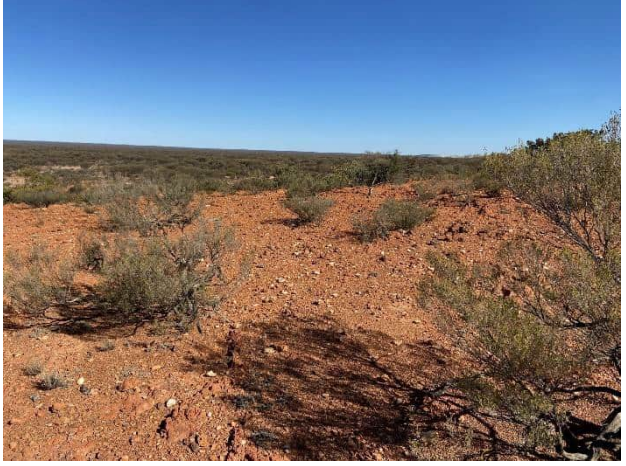
## F.19 MKS EIA 24 - Haul Road Impact

Site ID: MKS EIA 24		Co-ordinates: 51 J 261187 6971273	
<b>Location:</b> ~ 10 m west from haul road		<b>Comments:</b> Looking southwards parallel to the haul road. No annuals. Most shrubs are vegetative, but dry. Recent foliage loss on <i>Thryptomene</i> sp. Leinster and <i>Calytrix uncinata</i> shrubs. Minimal dust load on vegetation. Quadrat re-established due to quadrat being too close to haul road.	
<b>Veg. Type:</b> Granitic Mulga shrubland on Archaean geology.			
<b>Veg. Condition:</b> Excellent			
<b>Grazing:</b> Light			
<b>Weed cover:</b> Nil			
<b>Photo direction:</b> NW			
Species	Cover (%)	Plant Health Score	Comments
<i>Thryptomene</i> sp. Leinster (P3)	15	7c	
<i>Dodonaea petiolaris</i>	<2	7d	Yellowing and foliage loss.
<i>Eriachne mucronata</i>	<2	2	
<i>Calytrix uncinata</i>	5	7d	-
<i>Verticordia jamiesonii</i>	2	7d	-
<b>Other species:</b> <i>Hibbertia</i> sp. Sherwood Breakaways (R.J. Cranfield 6771), <i>Poaceae</i> sp.

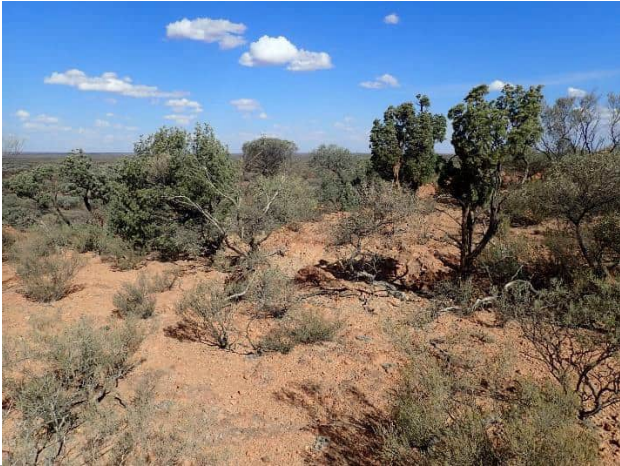
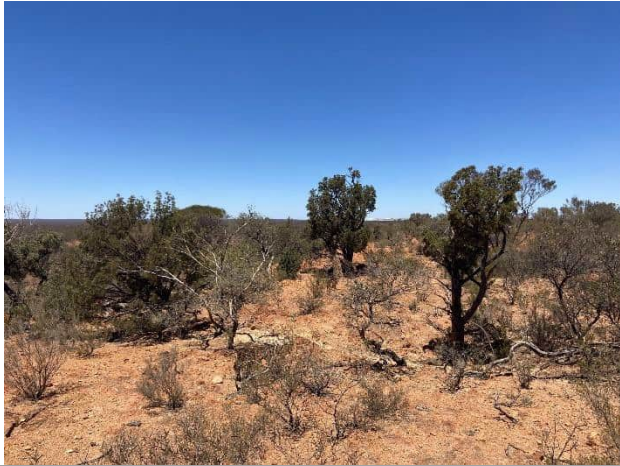
## F.21 MKS EIA 26 - Haul Road Impact

Site ID: MKS EIA 26		Co-ordinates: 51 J 261162 6971094	
<b>Location:</b> ~ 7 m east of haul road		<b>Comments:</b> Moved quadrat away from haul road. Most plants are vegetative, but smaller lower storey shrubs are losing foliage. Small dust load.	
<b>Veg. Type:</b> Granitic Mulga shrubland on Archaean geology.			
<b>Veg. Condition:</b> Excellent			
<b>Grazing:</b> Nil			
<b>Weed cover:</b> Nil			
<b>Photo direction:</b> NW			
Species	Cover (%)	Plant Health Score	Comments
<i>Callitris columellaris</i>	15	7b	
<i>Thryptomene</i> sp. Leinster (P3)	15	7d	
<i>Dodonaea petiolaris</i>	5	3	
<i>Acacia pruinoarpa</i>	5	7b	
<i>Acacia rhodophloia</i>	2	7b	
<b>Other species:</b> <i>Acacia aneura</i> , <i>Hakea leucoptera</i> subsp. <i>sericipes</i> , <i>Verticordia jamiesonii</i> , <i>Hibbertia</i> sp. <i>Sherwood Breakaways</i> (R.J. Cranfield 6771), <i>Ptilotus obovatus</i> , <i>Eriachne mucronata</i> , <i>Calytrix uncinata</i>

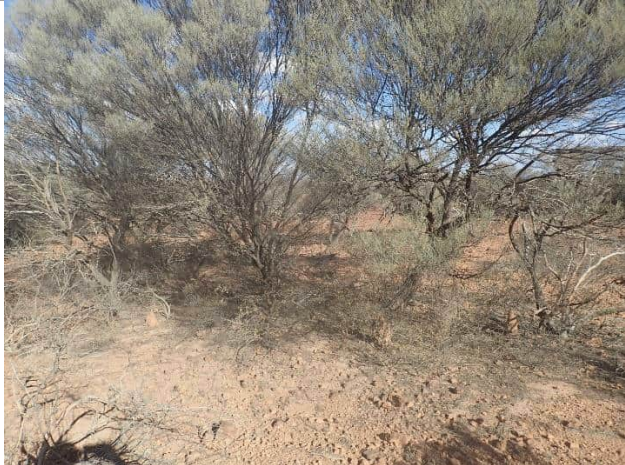
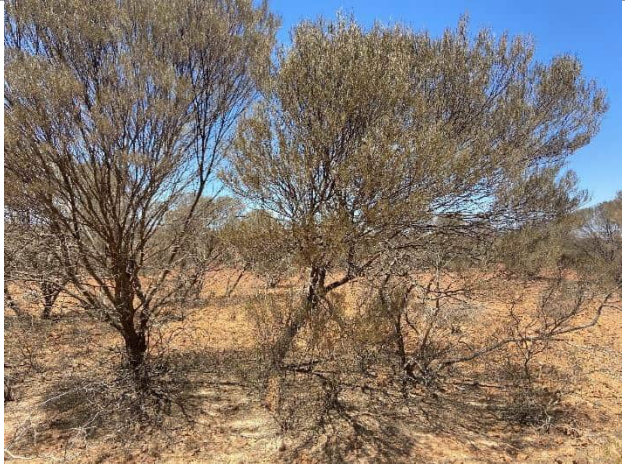
## F.22 MKS EIA 27 - Haul Road Impact

Site ID: MKS EIA 27		Co-ordinates: 51 J 261177 6970972	
<b>Location:</b> ~ 4 m west of haul road	<b>Comments:</b> Southern edge of Breakaway landform. Haul interrupts surface drainage from west to east. Mid slope from MKS haul road. Lichens present. Little under trees. Light dust load. Dry but vegetative shrubs.		
<b>Vegetation Type:</b> Granitic Mulga shrubland on Archaean geology.			
<b>Veg. Condition:</b> Very good			
<b>Grazing:</b> Nil			
<b>Weed cover:</b> Nil			
<b>Photo direction:</b> NW			
Species	Cover (%)	Plant Health Score	Comments
<i>Acacia aneura</i>	40	7b	
<i>Dodonaea petiolaris</i>	<2	3	
<i>Scaevola spinescens</i>	2	7b	
<i>Sida ectogama</i>	<2	7d	
<i>Eremophila pungens</i> (P4)	2	7a	
<b>Other species:</b> <i>Psydrax suaveolens</i> , <i>Ptilotus schwartzii</i> , <i>Thryptomene</i> sp. <i>Leinster</i> , <i>Eremophila shonae</i> subsp. <i>shonae</i> , <i>Poaceae</i> sp.

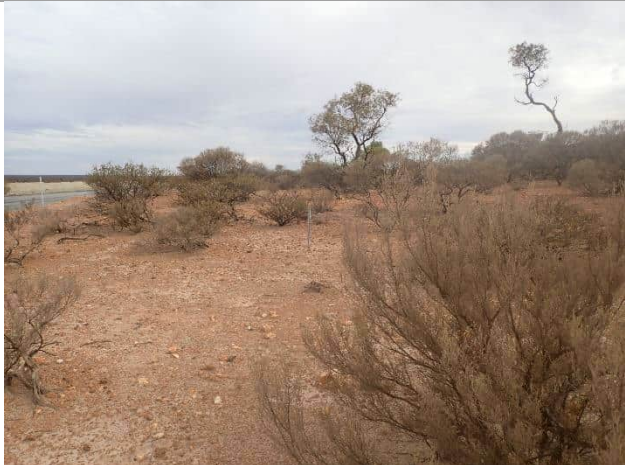
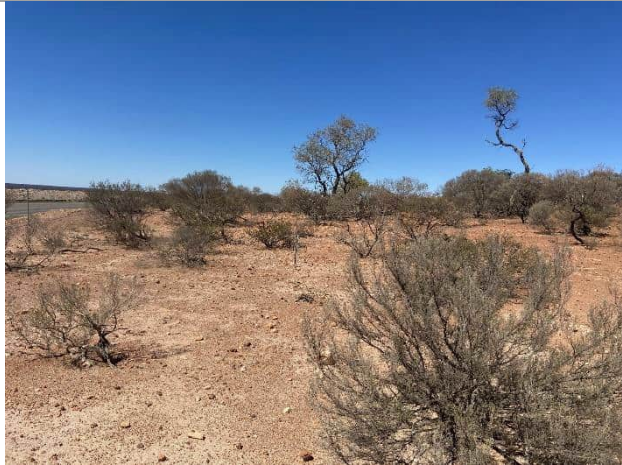
Site ID: MKS EIA 36		Co-ordinates: 51 J 261071 6971159	
<b>Location:</b> ~ 52 m west of haul road	<b>Comments:</b> Dust impacts on flora and vegetation. Soil is firm silty with abundant discontinuous lag gravel of angular quartz and subangular ironstone. Site slope towards the new haul road, which intercepts drainage from the easterly direction. Shrubs in good condition, except for some <i>Thryptomene</i> sp. Leinster (P3) deaths. Light browsing present. Some cryptograms and ants present.		
<b>Veg. Type:</b> Stony ironstone Mulga shrubland			
<b>Veg. Condition:</b> Very good			
<b>Grazing:</b> Light			
<b>Weed cover:</b> Nil			
<b>Photo direction:</b> N			
Species	Cover (%)	Plant Health Score	Comments
<i>Acacia aneura</i>	<2	5	Grazing lines, flowering.
<i>Acacia rhodophloia</i>	10	7b	Grazing line,
<i>Thryptomene</i> sp. Leinster (P3)	5	6	Declining.
<i>Acacia pruinocarpa</i>	<2	7c	Large adult outside quadrat, but juvenile within.

<i>Dodonaea petiolaris</i>	<2	3	Dry.
<b>Other species:</b> <i>Eremophila jucunda</i> subsp. <i>jucunda</i> , <i>Hibbertia</i> sp. <i>Sherwood Breakaways</i> (R.J. Cranfield 6771), <i>Eriachne mucronata</i>

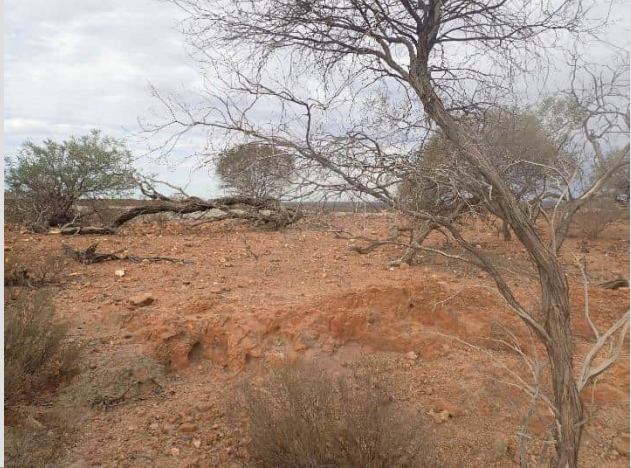
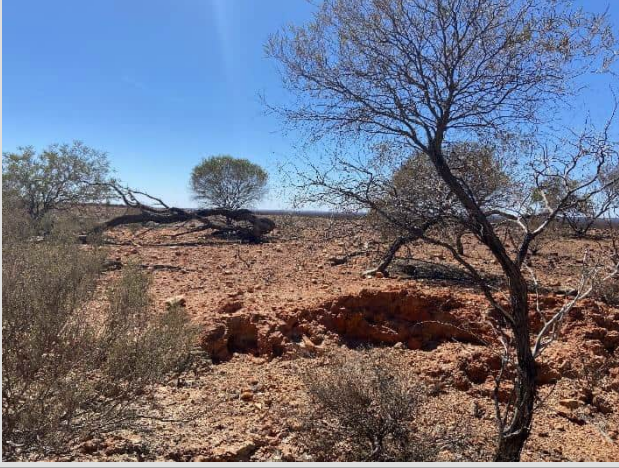
## F.25 MKS EIA 37 - Haul Road Impact

Site ID: MKS EIA 37		Co-ordinates: 51 J 261077 6971050	
<b>Location:</b> ~ 48 m west of the haul road	<b>Comments:</b> Dust impacts likely on flora and vegetation, with dust covering soil surface. Site has shallow silty sand over extensive outcropping and sub cropping weather granite. Area subject to dust from vehicular movement on MKS haul road. Historic shrubs death observed. Acacia in good condition considering extended dry seasonal conditions and proximity to haul road. Scats, termite mounds and lichen present.		
<b>Vegetation Type:</b> Stoney ironstone low shrubland			
<b>Veg. Condition:</b> Very Good			
<b>Grazing:</b> Light, historic			
<b>Weed cover:</b> Nil			
<b>Photo direction:</b> N			
Species	Cover (%)	Plant Health Score	Comments
<i>Acacia pruinocarpa</i>	8	7b	
<i>Acacia quadrimarginea</i>	8	7b	
<i>Dodonaea petiolaris</i>	<2	7b	Dust present.
<i>Thryptomene</i> sp. Leinster (P3)	0	1	Dead and replaced.

<i>Eremophila jucunda</i> subsp. <i>jucunda</i>	<2	3	Dust present.
<i>Calytrix uncinata</i>	<2	5	Replaces <i>Thryptomene</i> sp. Leinster. Flowering.
<b>Other species:</b> <i>Acacia aneura</i> , <i>Acacia rhodophloia</i> , <i>Hibbertia</i> sp. <i>Sherwood Breakaways</i> (R.J. Cranfield 6771), <i>Hakea leucoptera</i> subsp. <i>sericipes</i>

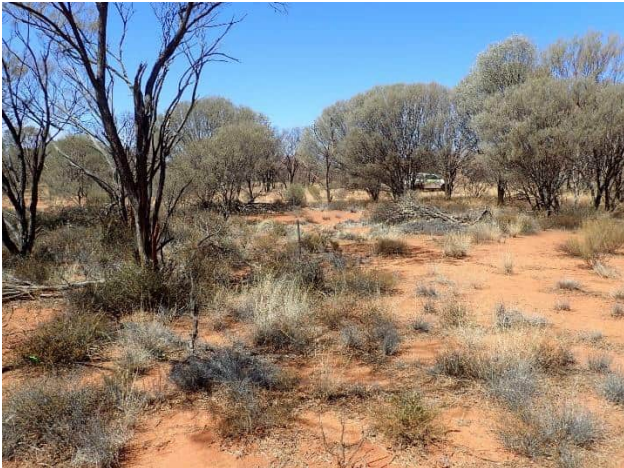
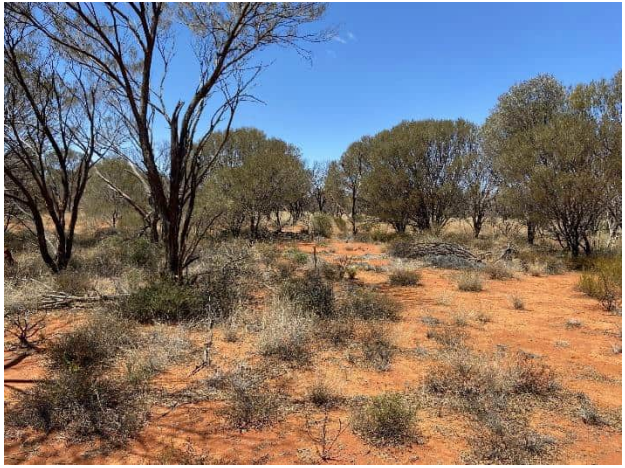
## F.26 MKS EIA 19 - Control

Site ID: MKS EIA 19		Co-ordinates: 51 J 270893 6981469	
<b>Location:</b> ~12 km from haul road in Wanjarri Nature Reserve		<b>Comments:</b> Along fence line of Wanjarri Nature Reserve. <i>Triodia</i> is stressed, likely from dry seasonal conditions. Grazing impacting individual species including <i>Eremophila</i> sp. long pedicels (P2). Cattle and kangaroo scats present.	
<b>Veg. Type:</b> Sandplain Mulga spinifex shrubland/ Hardpan Mulga shrubland			
<b>Veg. Condition:</b> Excellent			
<b>Grazing:</b> Light,			
<b>Weed cover:</b> Nil			
<b>Photo direction:</b> NW			
Species	Cover (%)	Plant Health Score	Comments
<i>Triodia basedowii</i>	10	3	
<i>Acacia aneura</i>	20	7b	
<i>Acacia burkittii</i>	5	7b	
<i>Eragrostis eriopoda</i>	2	4	Post flowering.
<i>Grevillea deflexa</i>	5	7c	
<b>Other species:</b> <i>Eremophila spectabilis</i> , <i>Psydrax suaveolens</i> , <i>Eremophila</i> sp. long pedicels (G. Cockerton 1975)

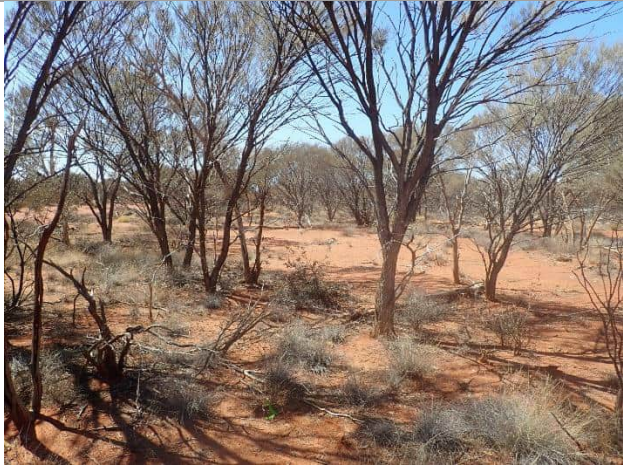
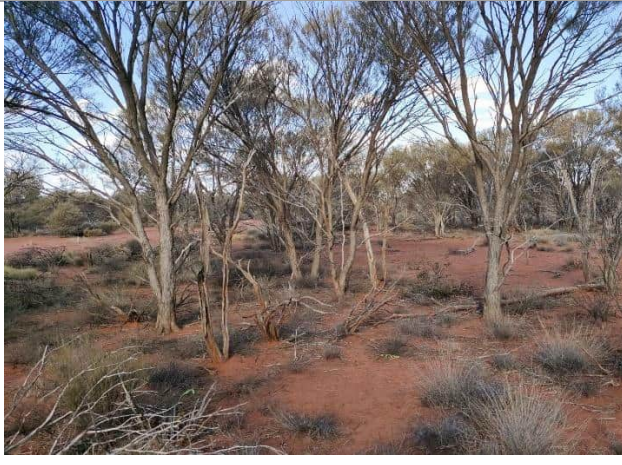
## F.27 MKS EIA 20 - Control

Site ID: MKS EIA 20		Co-ordinates: 51 J 272524 6982988	
<b>Location:</b> ~15 km from haul road in Wanjarri Nature Reserve		<b>Comments:</b> <i>Eremophila</i> sp. long pedicels occurring in patches under Mulga with older seed pods present. Very dry vegetation. Cryptograms present but dry. Grasses are dry. No impacts from MKS, but nearby WNR track and grazing observed.	
<b>Veg. Type:</b> Sandplain Mulga spinifex shrubland/ Hardpan Mulga shrubland			
<b>Veg. Condition:</b> Very good			
<b>Grazing:</b> Light, historic			
<b>Weed cover:</b> Nil			
<b>Photo direction:</b> NW			
Species	Cover (%)	Plant Health Score	Comments
<i>Eragrostis eriopoda</i>	10	4	
<i>Triodia basedowii</i>	10	4	
<i>Acacia incurvaneura</i>	20	7c	
<i>Grevillea deflexa</i>	2	3	
<i>Eremophila spectabilis</i>	2	3	
<b>Other species:</b> <i>Acacia caesaneura</i> , <i>Ptilotus obovatus</i> , <i>Eremophila</i> sp. long pedicels

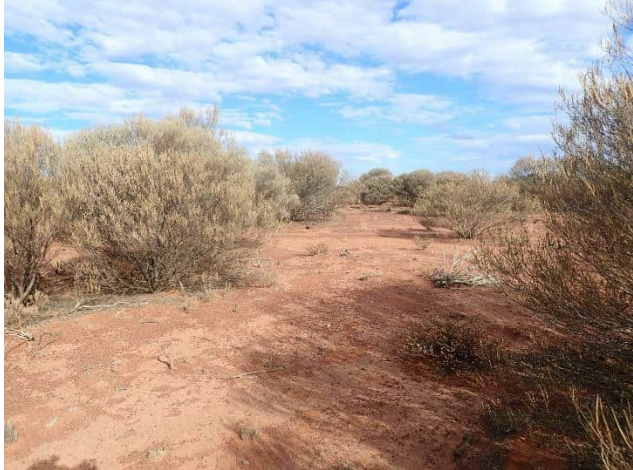
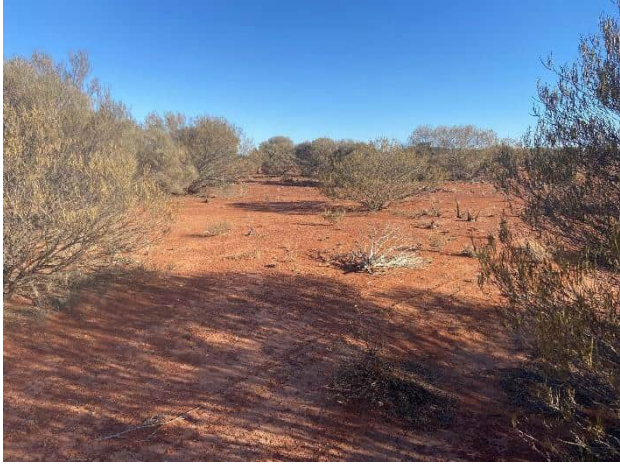
## F.28 MKS EIA 21 - Control

Site ID: MKS EIA 21		Co-ordinates: 51 J 261186 6973491	
<b>Location:</b> ~ 60m from haul road, within WNR	<b>Comments:</b> Old 4WD track nearby. No posts established at quadrat. Heavy dust load. Almost all plants are vegetative, but dry and dusty. Grazing of grasses evident. Soil is a red silty sand with abundant but discontinuous ferruginous pizolitic gravel.		
<b>Vegetation Type:</b> Hardpan Mulga shrubland with <i>Acacia thoma</i> co- dominant			
<b>Veg. Condition:</b> Very good			
<b>Grazing:</b> Medium			
<b>Weed cover:</b> Nil			
<b>Photo direction:</b> NW			
Species	Cover (%)	Plant Health Score	Comments
<i>Acacia thoma</i>	30	7b	Healthy but smothered in dust.
<i>Acacia aneura</i>	10	7b	High dust load.
<i>Eremophila jucunda</i> subsp. <i>jucunda</i>	5	7d	
<i>Eremophila spectabilis</i>	5	7d	
<i>Eragrostis eriopoda</i>	2	7d	
<b>Other species:</b> <i>Solanum lasiophyllum</i> , <i>Eriachne mucronata</i> , <i>Ptilotus schwartzii</i>

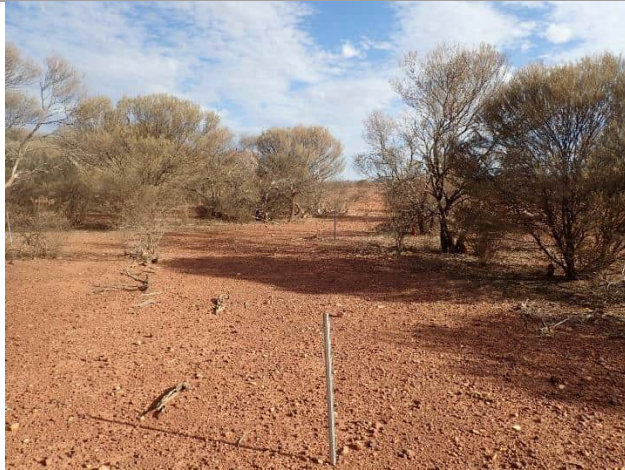
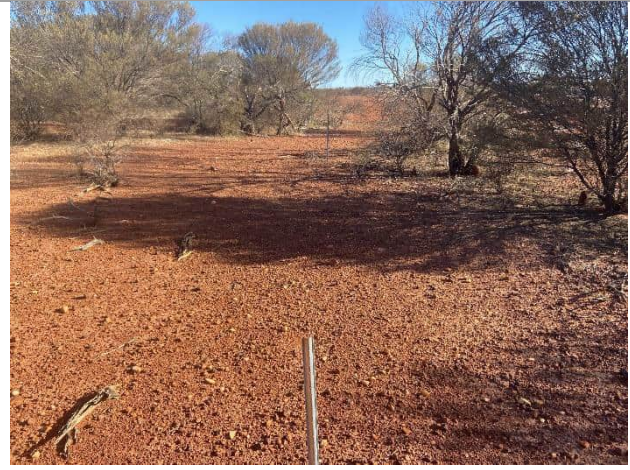
## F.29 MKS EIA 22 - Control

Site ID: MKS EIA 22		Co-ordinates: 51 J 261218 6972404	
<b>Location:</b> ~ 87 m from haul road, within WNR	<b>Comments:</b> Almost all plants are water stressed. Control quadrat is close to MKS haul road and receives dust from the road. 10 m away from the WNR track. Historical <i>Acacia</i> deaths observed.		
<b>Vegetation Type:</b> Groved Mulga woodland			
<b>Veg. Condition:</b> Very good			
<b>Grazing:</b> Light, historic			
<b>Weed cover:</b> Nil			
<b>Photo direction:</b> N			
Species	Cover (%)	Plant Health Score	Comments
<i>Acacia aneura</i>	10	3	
<i>Sida ectogama</i>	5	7d	
<i>Aristida jerichoensis</i>	<2	2	
<i>Eremophila latrobei</i>	<2	2	
<i>Acacia tetragonophylla</i>	5	5	-
<b>Other species:</b> <i>Acacia thoma</i>

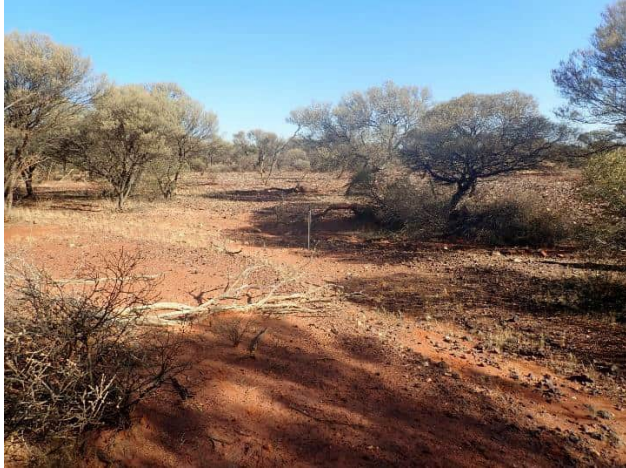
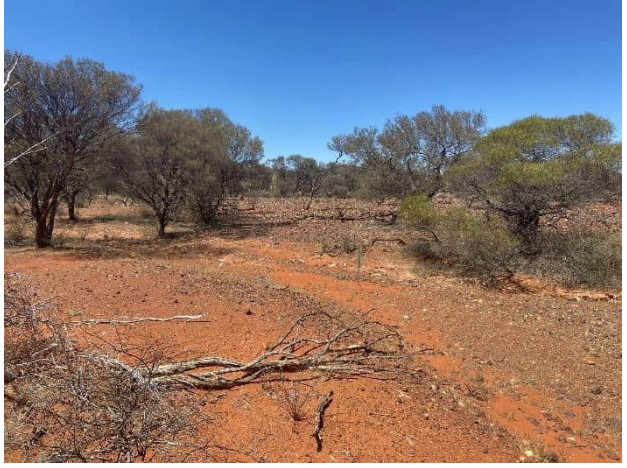
Site ID: MKS EIA 29		Co-ordinates: 51 J 261255 6970160	
<b>Location:</b> ~ 100 m east of haul road, within WNR	<b>Comments:</b> Monitoring peg is approximately 15 m east of the WNR track in a minor drainage. Vegetation in good condition, but dry. Centre post installed. Minor pedestalling western side of quadrat. Lower dust load than the other quadrats. Historic <i>Acacia</i> deaths. Ants present. Dead <i>Maireana</i> shrubs in center of quadrat.		
<b>Veg. Type:</b> Drainage line Mulga shrubland			
<b>Veg. Condition:</b> Very good			
<b>Grazing:</b> Light			
<b>Weed cover:</b> Nil			
<b>Photo direction:</b> NW			
Species	Cover (%)	Plant Health Score	Comments
<i>Acacia quadrimarginea</i>	20	7c	Browsing lines across lower branches.
<i>Sida ectogama</i>	5	7d	
<i>Acacia aneura</i>	15	7b	
<i>Eremophila jucunda</i> subsp. <i>jucunda</i>	<2	2	Dusty. Stressed.

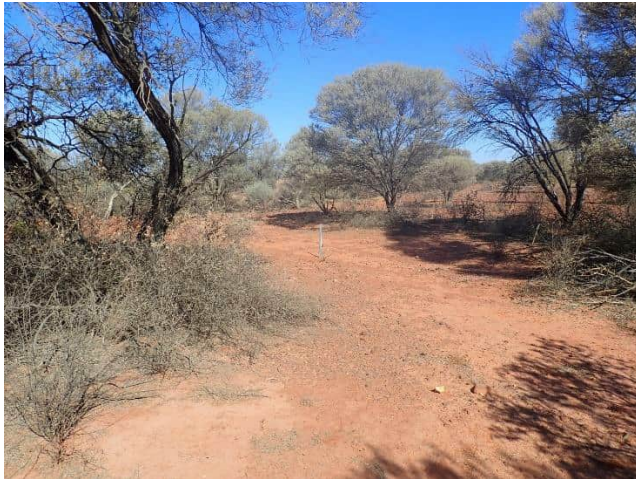
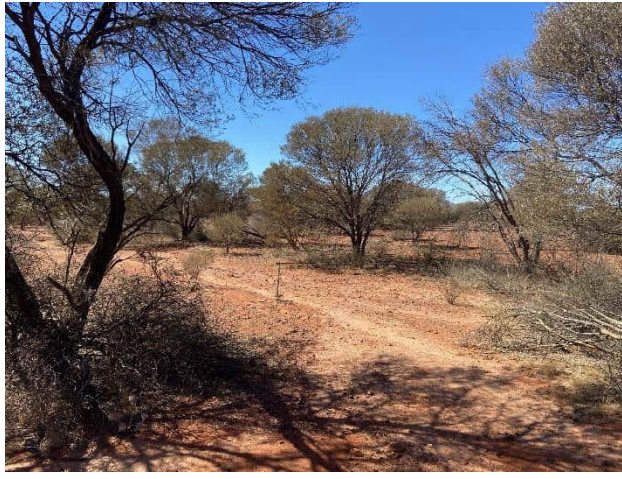
## F.32 MKS EIA 30 - Control

Site ID: MKS EIA 30		Co-ordinates: 51 J 261261 6969699	
<b>Location:</b> ~ 125 m east of haul road, within WNR	<b>Comments:</b> Monitoring peg is approximately 15m east of the WNR track a minor drainage line. Dusty vegetation.		
<b>Veg. Type:</b> Drainage line Mulga shrubland			
<b>Veg. Condition:</b> Very good			
<b>Grazing:</b> Light			
<b>Weed cover:</b> Nil			
<b>Photo direction:</b> NW			
Species	Cover (%)	Plant Health Score	Comments
<i>Sida ectogama</i>	15	2	
<i>Acacia caesaneura</i>	30	7b	
<i>Dodonaea petiolaris</i>	0	1	Dead. Not Replaced.
<i>Eremophila galeata</i>	<2	3	
-	-	-	-
<b>Other species:</b> <i>Ptilotus exaltatus</i> , <i>Ptilotus obovatus</i> , <i>Eremophila compacta</i> , <i>Psydrax suaveolens</i> , <i>Enneapogon caeruleus</i> , <i>Lysiana</i> sp

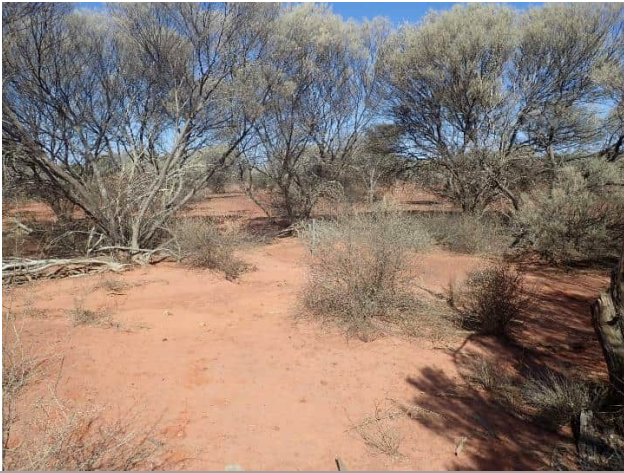
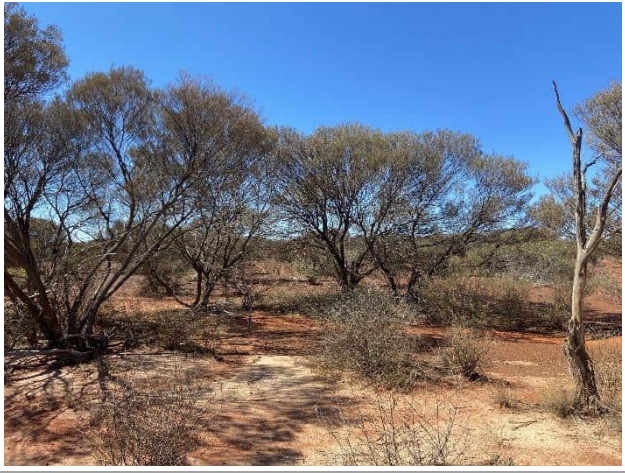
## F.33 MKS EIA 31 - Control

Site ID: MKS EIA 31		Co-ordinates: 51 J 261263 6969421	
<b>Location:</b> ~ 114 m east of haul road, within WNR	<b>Comments:</b> Monitoring peg is approximately 10m east of the WNR track in a minor drainage line. Soil surface is intact with a clay and cryptogam crust. No annuals. All vegetation in good condition considering extended dry seasonal conditions. Insect galls on vegetation. Only middle post installed. Some dust present on vegetation. Grazing observed with browsing lines across Acacia shrubs/trees.		
<b>Veg. Type:</b> Drainage line Mulga shrubland			
<b>Veg. Condition:</b> Very good			
<b>Grazing:</b> Light, historic			
<b>Weed cover:</b> Nil			
<b>Photo direction:</b> NW			
Species	Cover (%)	Plant Health Score	Comments
<i>Sida ectogama</i>	10	2	Dusty. Stressed.
<i>Eremophila latrobei</i>	<2	3	
<i>Acacia caesaneura</i>	40	6	
<i>Eremophila spectabilis</i>	<2	2	Small individual under Mulgas.
<i>Eriachne helmsii</i>	<2	7c

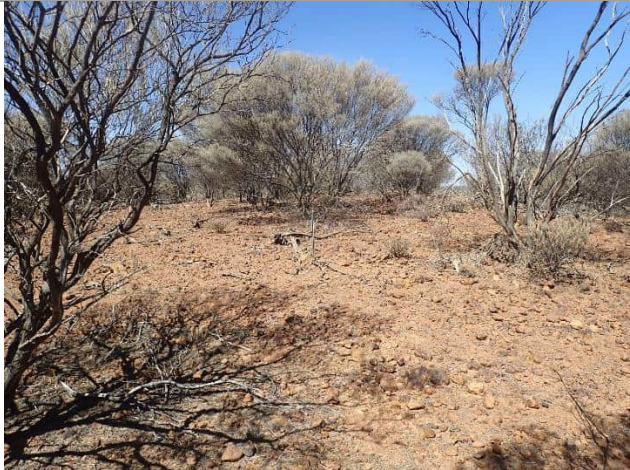
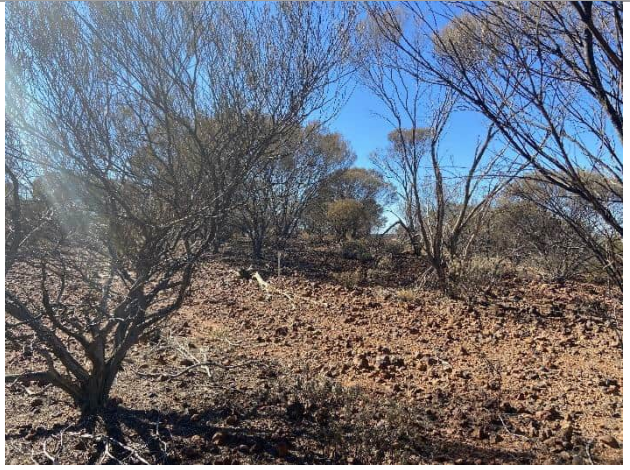
## F.34 MKS EIA 32 - Control

Site ID: MKS EIA 32		Co-ordinates: 51 J 261277 6968983	
<b>Location:</b> ~ 110 m east of haul road, within WNR	<b>Comments:</b> Site is 100% covered in stony ferruginous rocks and boulders. No annuals at time of assessment. Only middle post installed. Grasses grazed to butts. Vegetation dry, likely due to extended dry seasonal conditions. Leaf litter present under Acacias.		
<b>Veg. Type:</b> Stony ironstone Mulga shrubland			
<b>Veg. Condition:</b> Excellent			
<b>Grazing:</b> Light			
<b>Weed cover:</b> Nil			
<b>Photo direction:</b> NW			
Species	Cover (%)	Plant Health Score	Comments
<i>Acacia aneura</i>	15	7b	
<i>Acacia thoma</i>	10	7b	
<i>Eremophila spectabilis</i>	<2	6	
<i>Eremophila latrobei</i>	<2	7c	Insect damage.
<i>Senna glaucifolia</i>	<2	7b	One healthy individual.
<b>Other species:</b> <i>Acacia aneura sens. lat.</i> , <i>Eriachne mucronata</i> , <i>Eremophila jucunda</i> subsp. <i>jucunda</i> , <i>Ptilotus schwartzii</i> , <i>Eragrostis eriopoda</i>

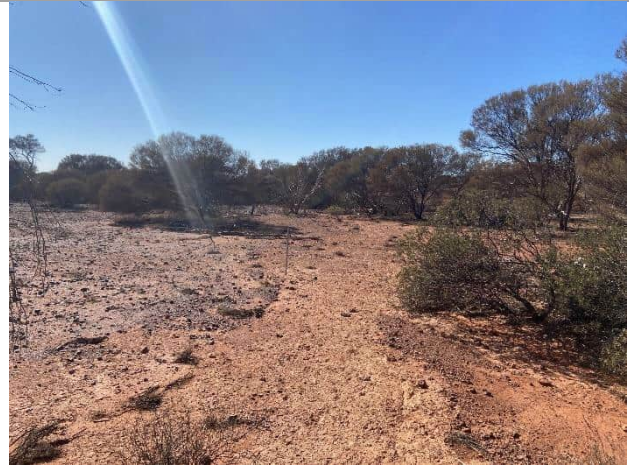
## F.35 MKS EIA 33 - Control

Site ID: MKS EIA 33		Co-ordinates: 51 J 261280 6968863	
<b>Location:</b> ~ 114 m east of haul road, within WNR	<b>Comments:</b> Site is very bare. Multiple dead <i>Maireana</i> sp. individuals. Only middle post present. Cryptograms on soil surface. Some pedestalling erosion present. Dry vegetation with further lower storey shrub deaths.		
<b>Veg. Type:</b> Stony ironstone Mulga shrubland			
<b>Veg. Condition:</b> Good			
<b>Grazing:</b> Light			
<b>Weed cover:</b> Nil			
<b>Photo direction:</b> NW			
Species	Cover (%)	Plant Health Score	Comments
<i>Senna</i> sp. Meekatharra	10	7b	Fallen over tree, living and healthy.
<i>Acacia aneura</i> sens. lat.	15	7b	Some insect galls.
<i>Dodonaea petiolaris</i>	0	1	Dead, not replaced.
<i>Maireana</i> sp.	<2	2	Only few individuals remaining.
<i>Ptilotus obovatus</i>	<2	2	
<b>Other species:</b> <i>Acacia quadrimarginea</i> , <i>Hibiscus</i> sp., <i>Hakea preissii</i> , <i>Aristida</i> sp.

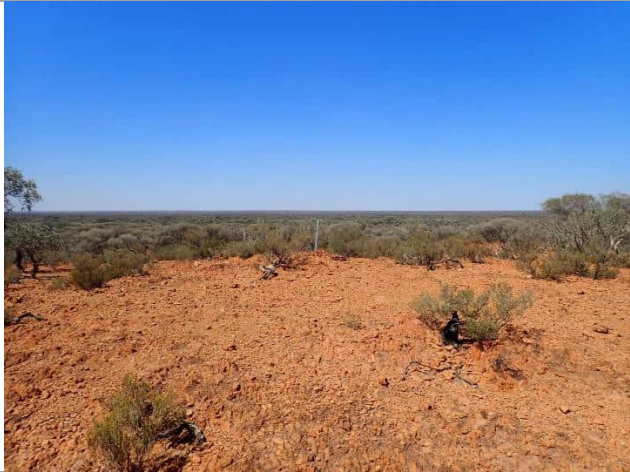
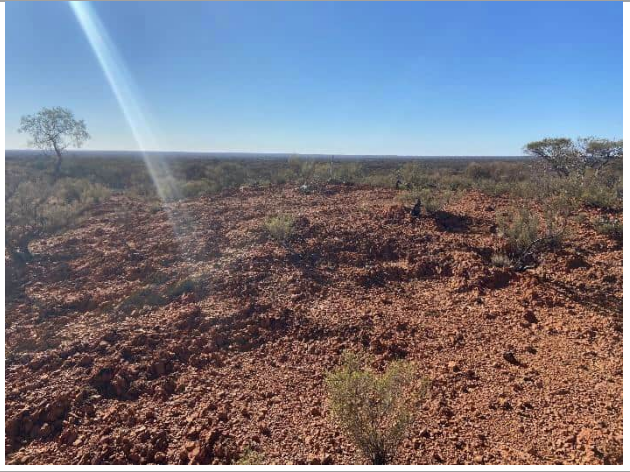
## F.36 MKS EIA 34 - Control

Site ID: MKS EIA 34		Co-ordinates: 51 J 261298 6968771	
<b>Location:</b> ~ 114 m east of haul road, within WNR	<b>Comments:</b> Quadrat situated on a rocky outcrop next to WNR track. Dominated by <i>Thryptomene</i> sp. Leinster (P3). Lichens present on rocks. Some vegetation affected by extended dry seasonal conditions ( <i>P. schwartzii</i> , <i>D. rigida</i> ).		
<b>Veg. Type:</b> Stony ironstone low shrubland			
<b>Veg. Condition:</b> Excellent			
<b>Grazing:</b> Light			
<b>Weed cover:</b> Nil			
<b>Photo direction:</b> E			
Species	Cover (%)	Plant Health Score	Comments
<i>Thryptomene</i> sp. Leinster (P3)	20	4	Budding.
<i>Acacia pruinocarpa</i>	5	7b	Few adolescent trees.
<i>Dodonaea rigida</i> (EIA_13_012)	<2	6	Post flowering.
<i>Ptilotus schwartzii</i>	<2	2
