# Mt Keith Satellite Statement 1087 Compliance Assessment Report BHP Nickel West

29 March 2022

This CAR outlines the implementation and compliance status of the Project for the period of 28 December 2020 to 31 December 2021, and aligns with the requirements of the approved Compliance Assessment Plan (BHP Nickel West 2020a) under Condition 4-1 of the Statement 1087 approval.

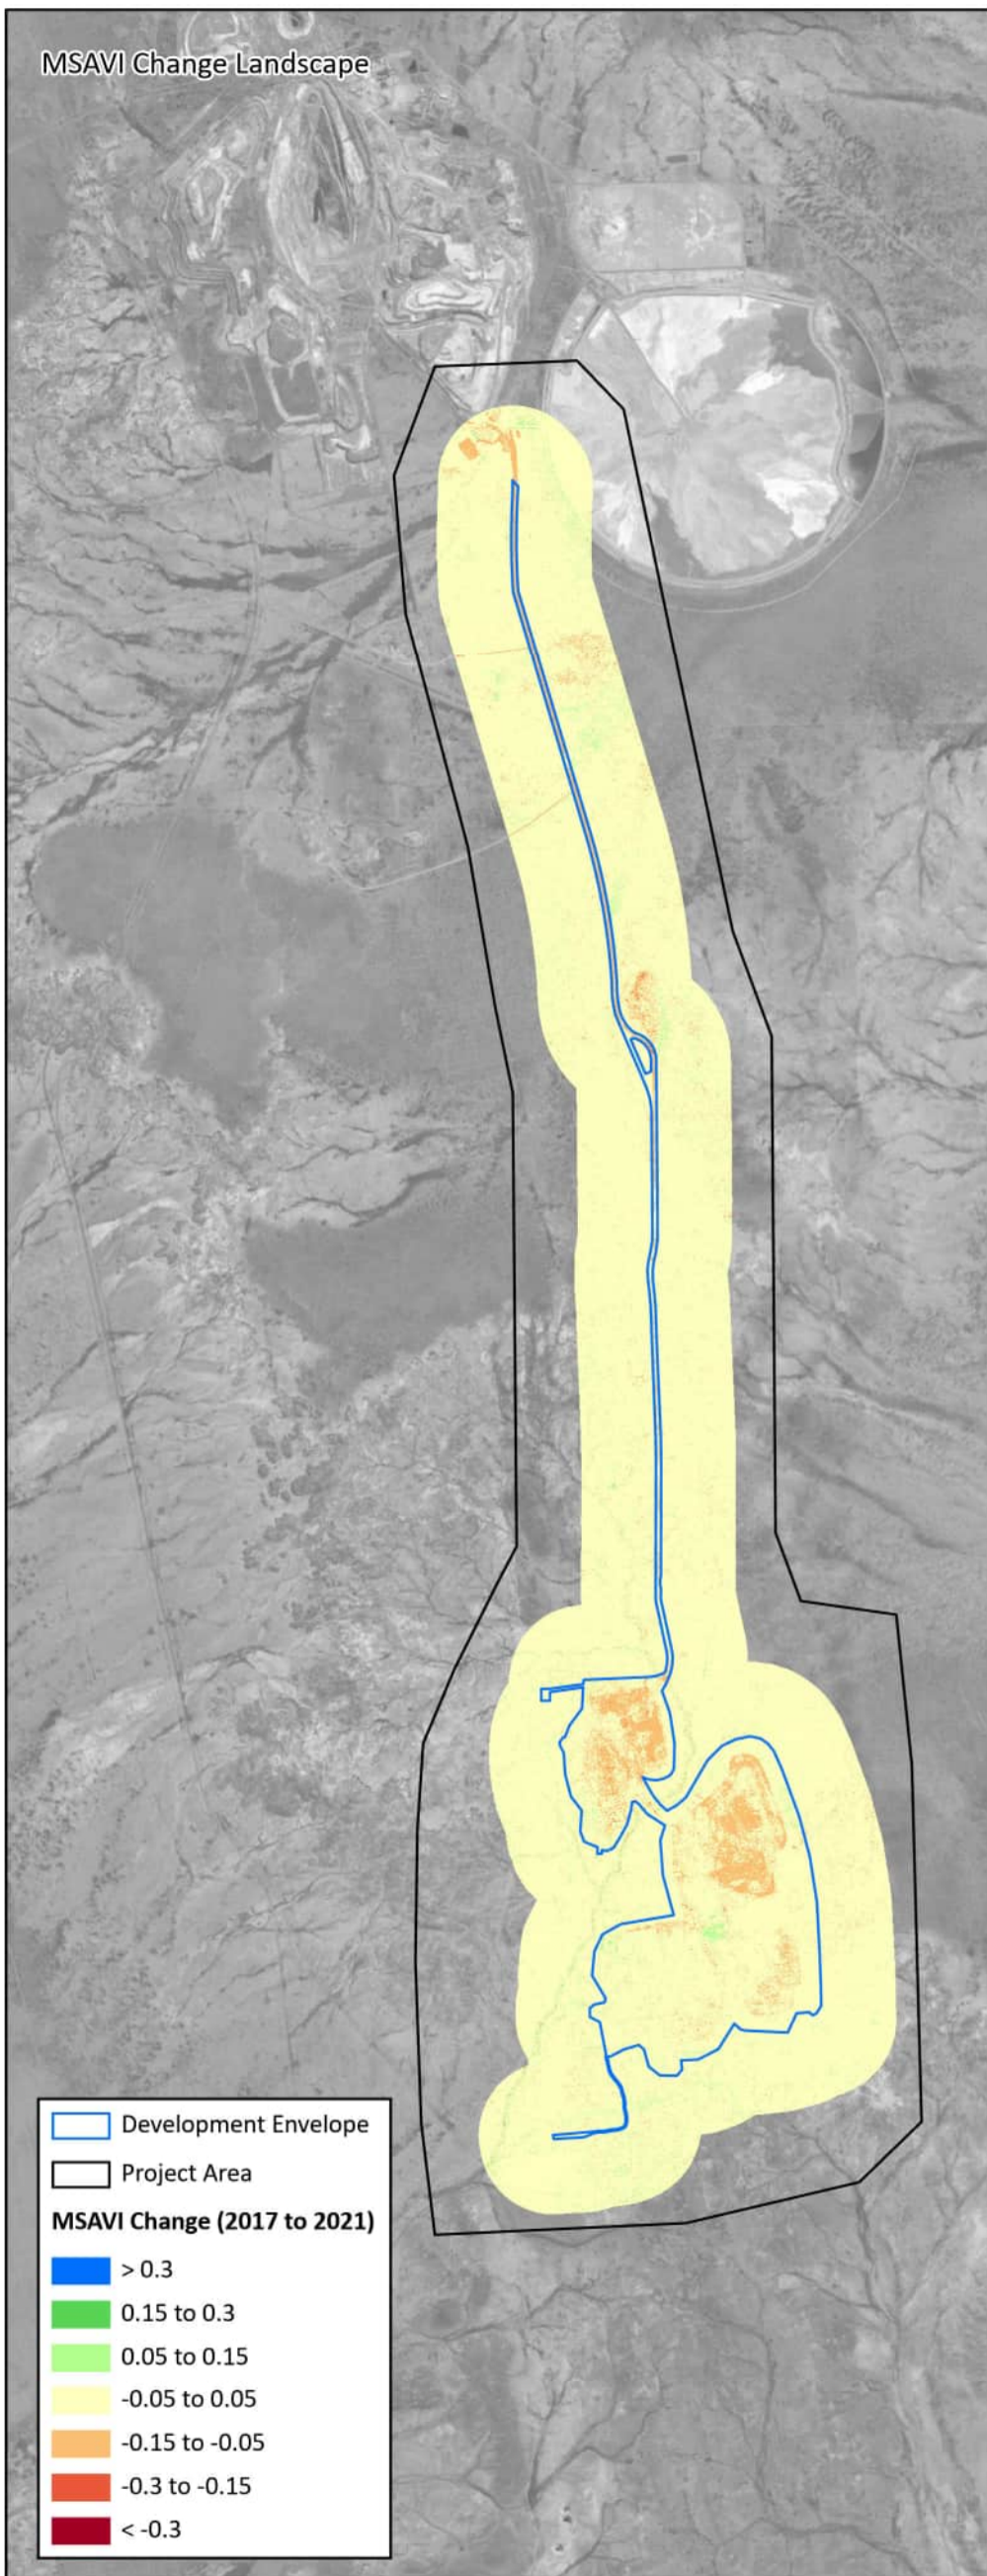
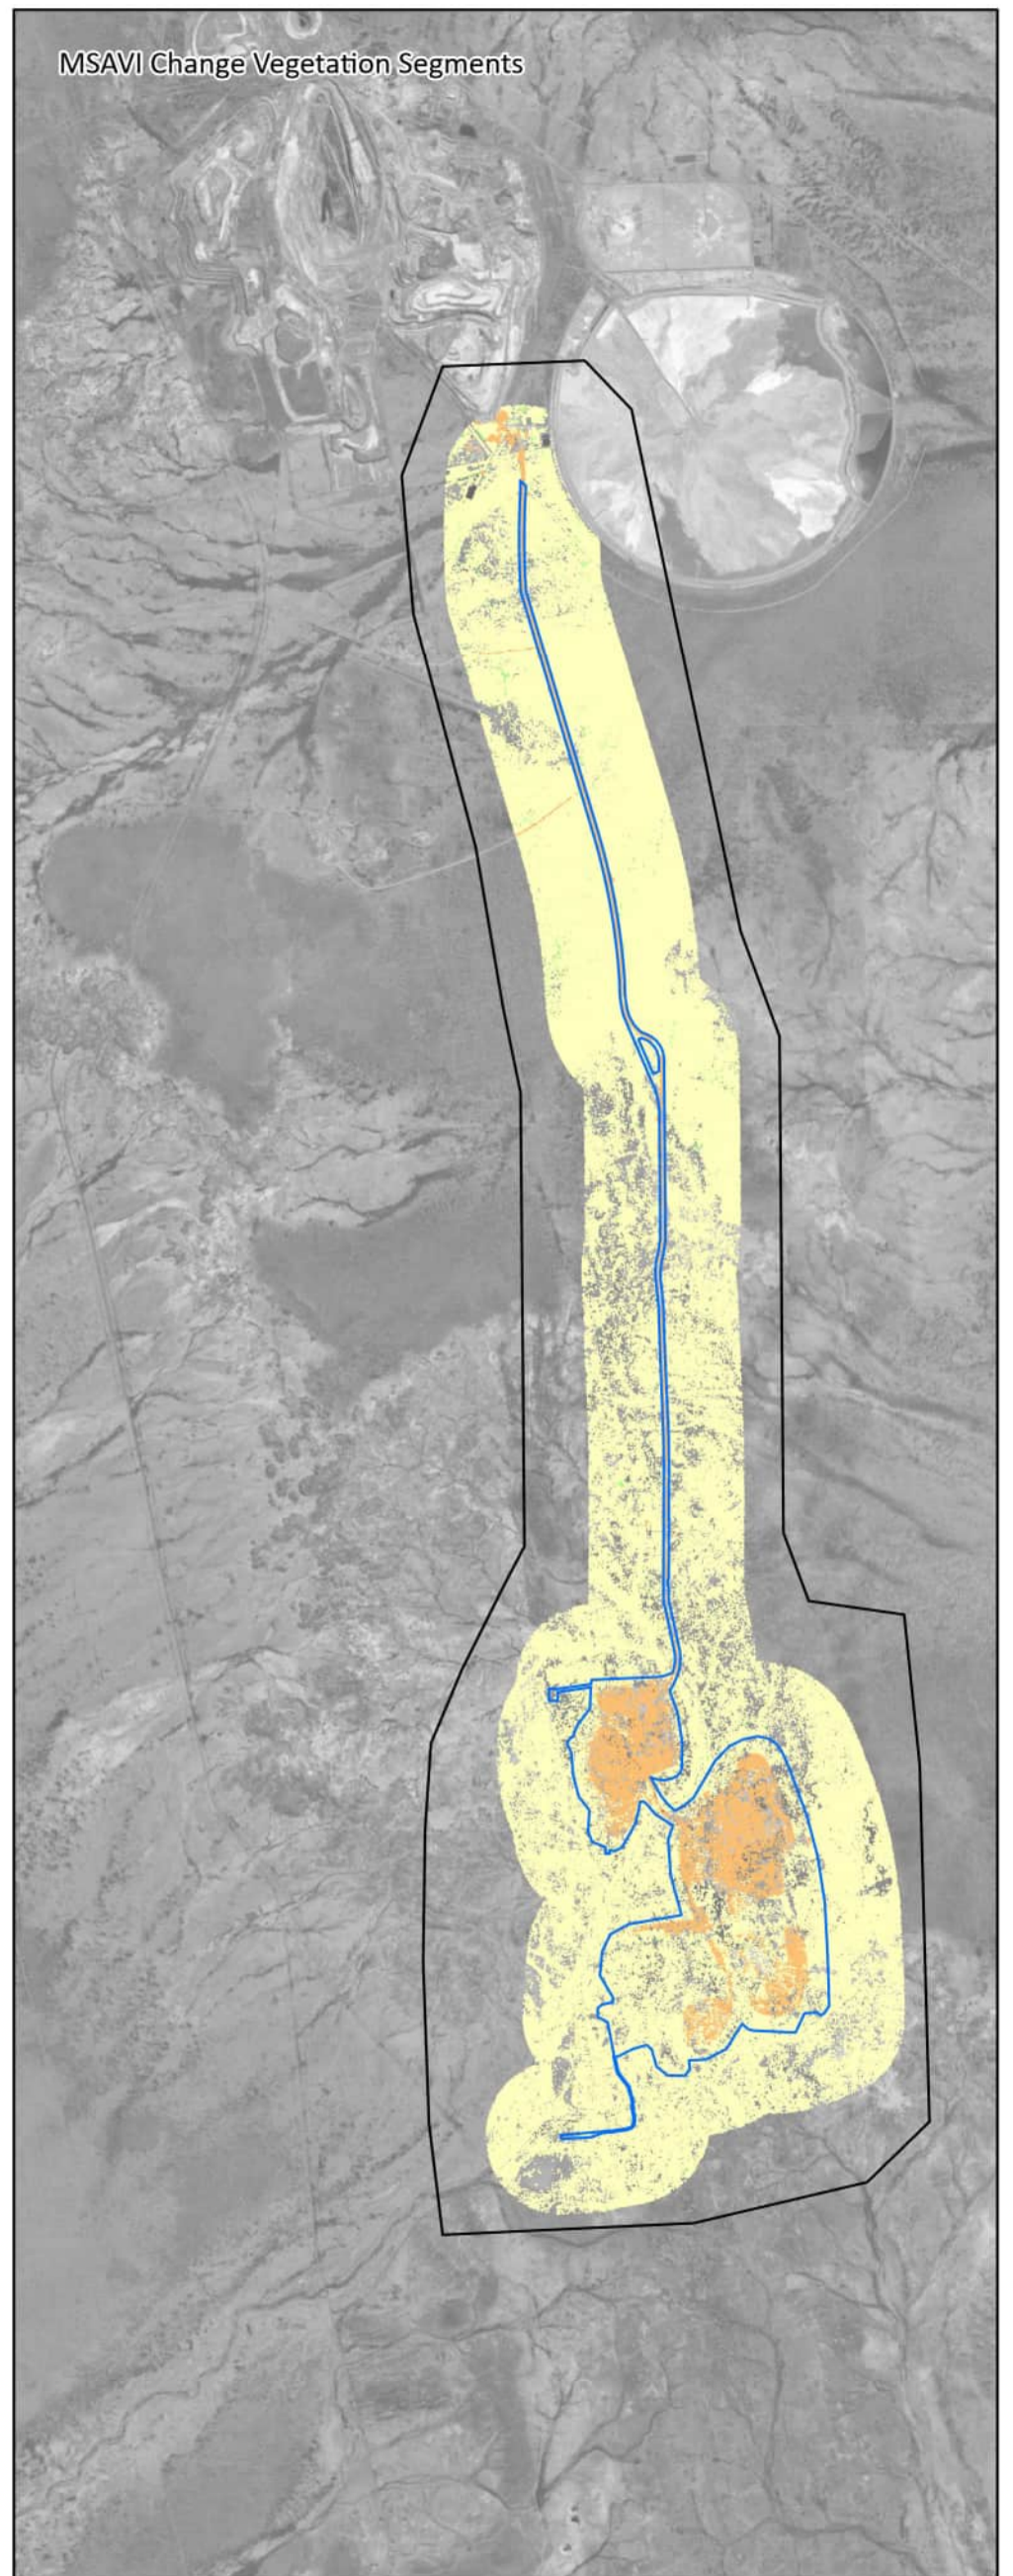
**Figure 4: WorldView Modified Soil Adjusted Vegetation Index change September 2017 to October 2021**

The MSAVI change statistics (Table 3) and change map (Figure 4) show a decrease in mean MSAVI in the case of vegetation segments, but no change in the case of the landscape. The majority of negative change in the study area appears to coincide with the mining footprint changes between 2017 and 2021, and this is particularly noticeable in the imagery and landscape MSAVI change layer. However, there are areas of decrease on the eastern side of the study area that appear to be related to a decline in vegetation condition. Some of this decrease in mean MSAVI may be partially attributed to the difference in annual rainfall between 2017 and 2021 (Figure 2). However, project impacts such as disruptions to surface flow could also be a factor in some areas.

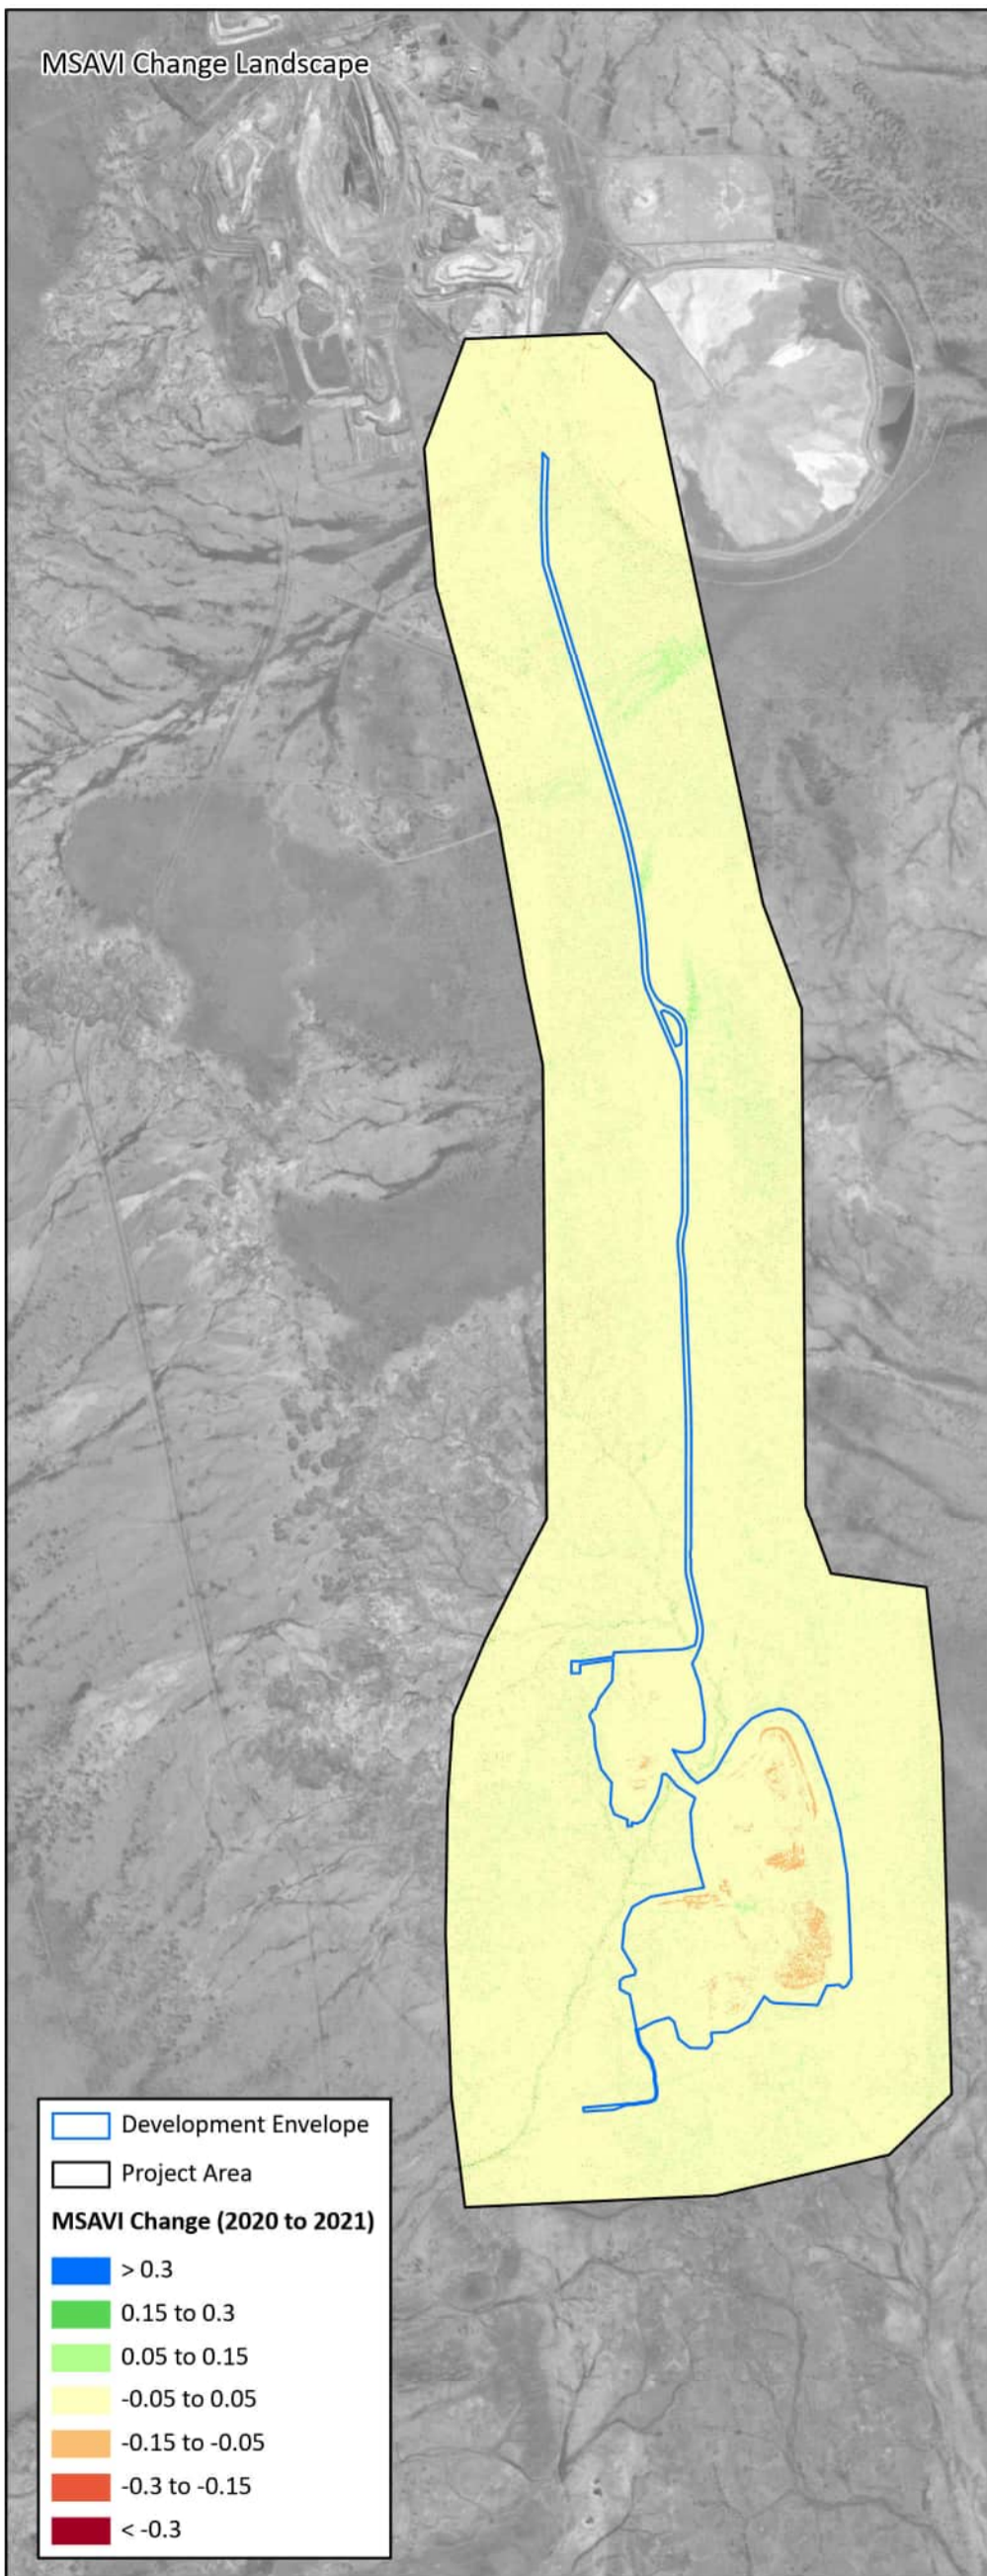
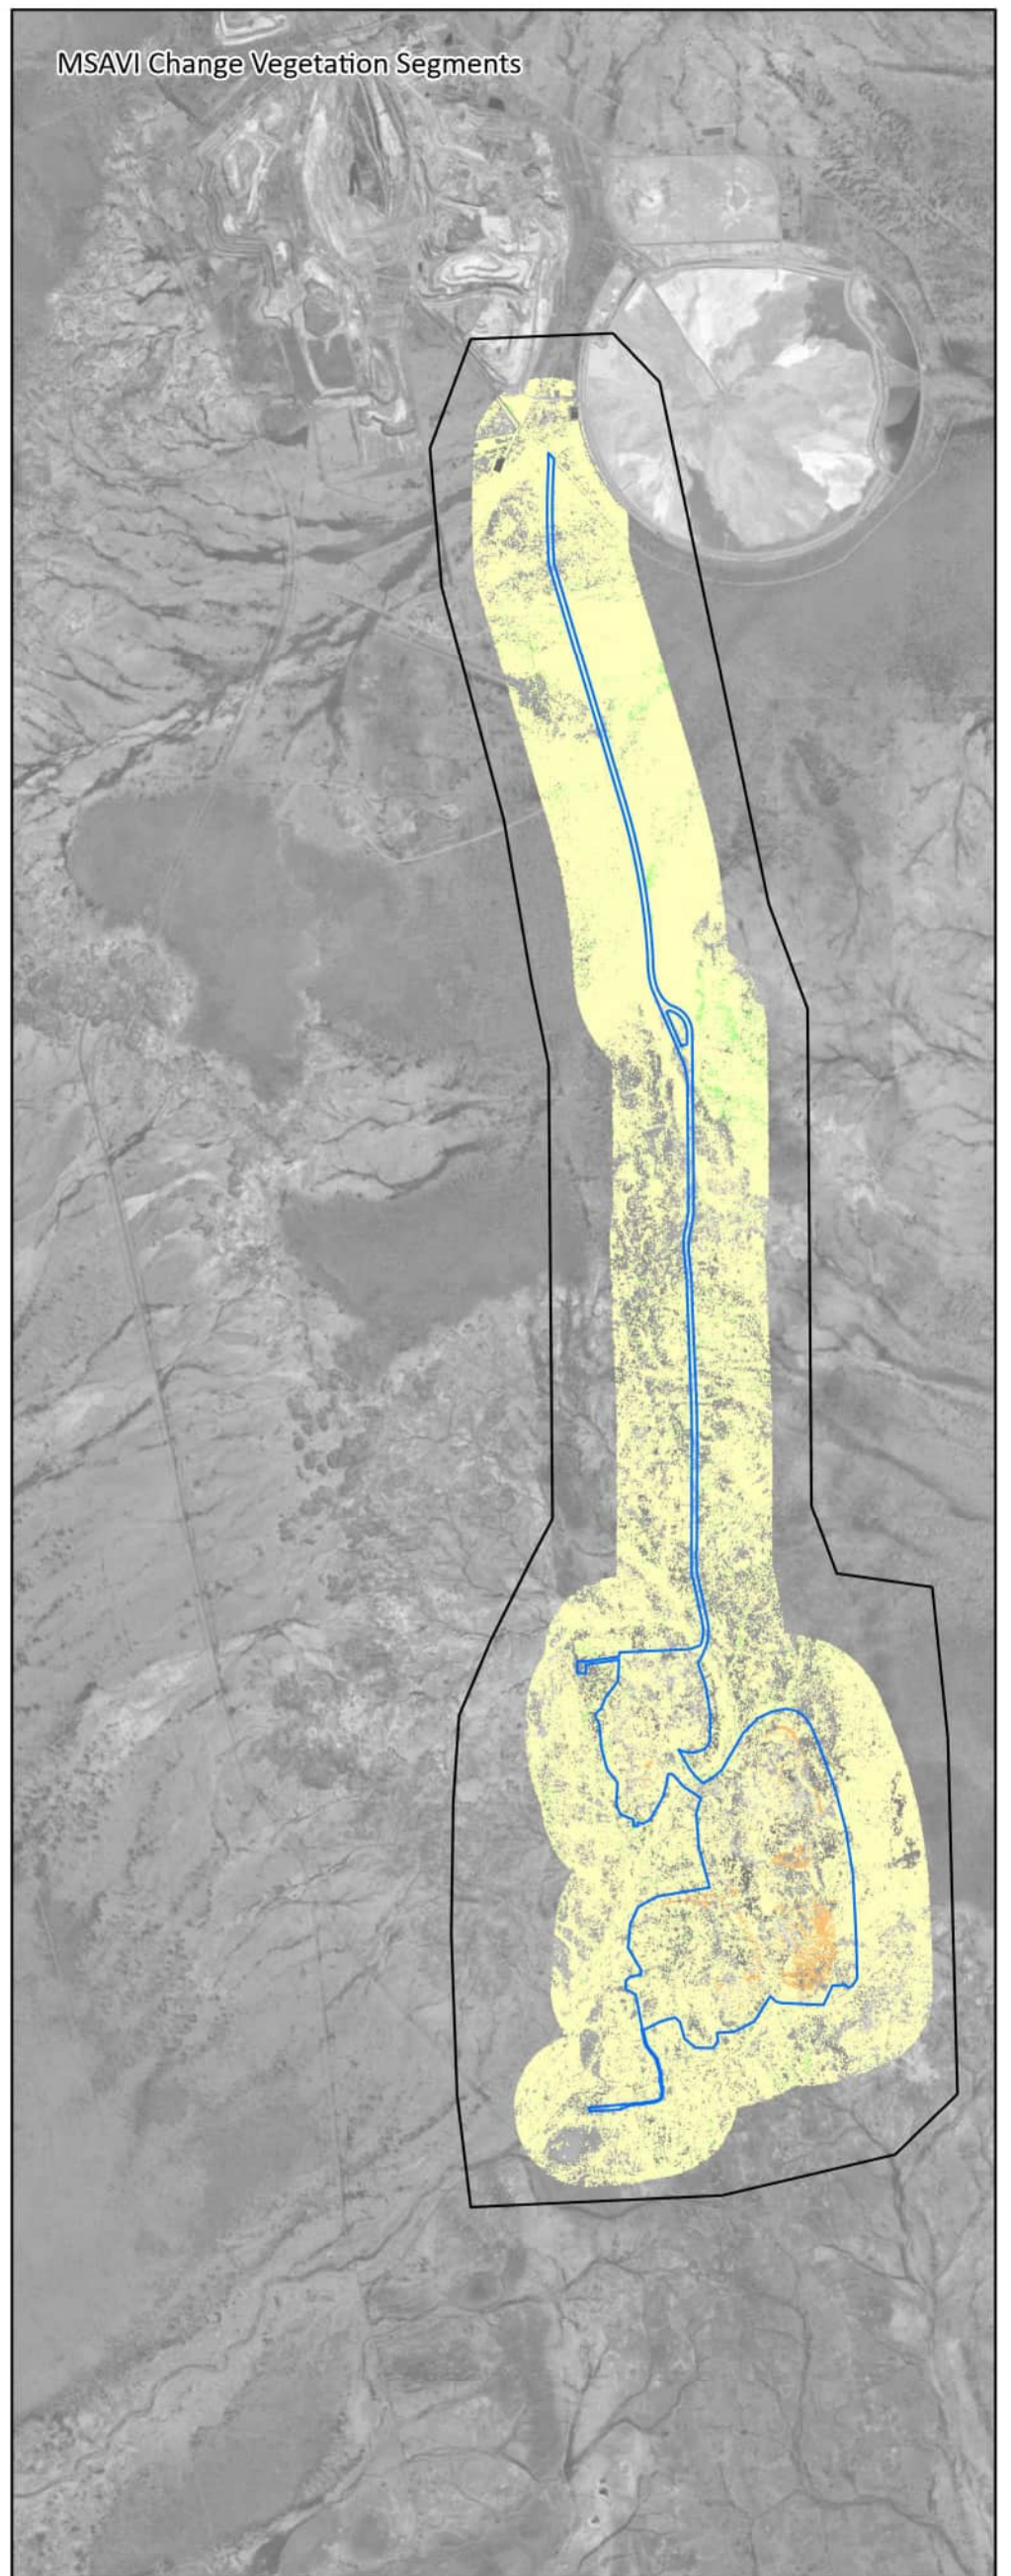
**Figure 5: WorldView Modified Soil Adjusted Vegetation Index change September 2020 to October 2021**

The mean MSAVI change between 2020 and 2021 is minimal for both the landscape and vegetation segments (Table 3), although the MSAVI change map (Figure 5) reveals slight positive changes in the case of vegetation cover along the main creek lines. Negative change is associated with the mine footprint and extension of the mine footprint to the southeast.

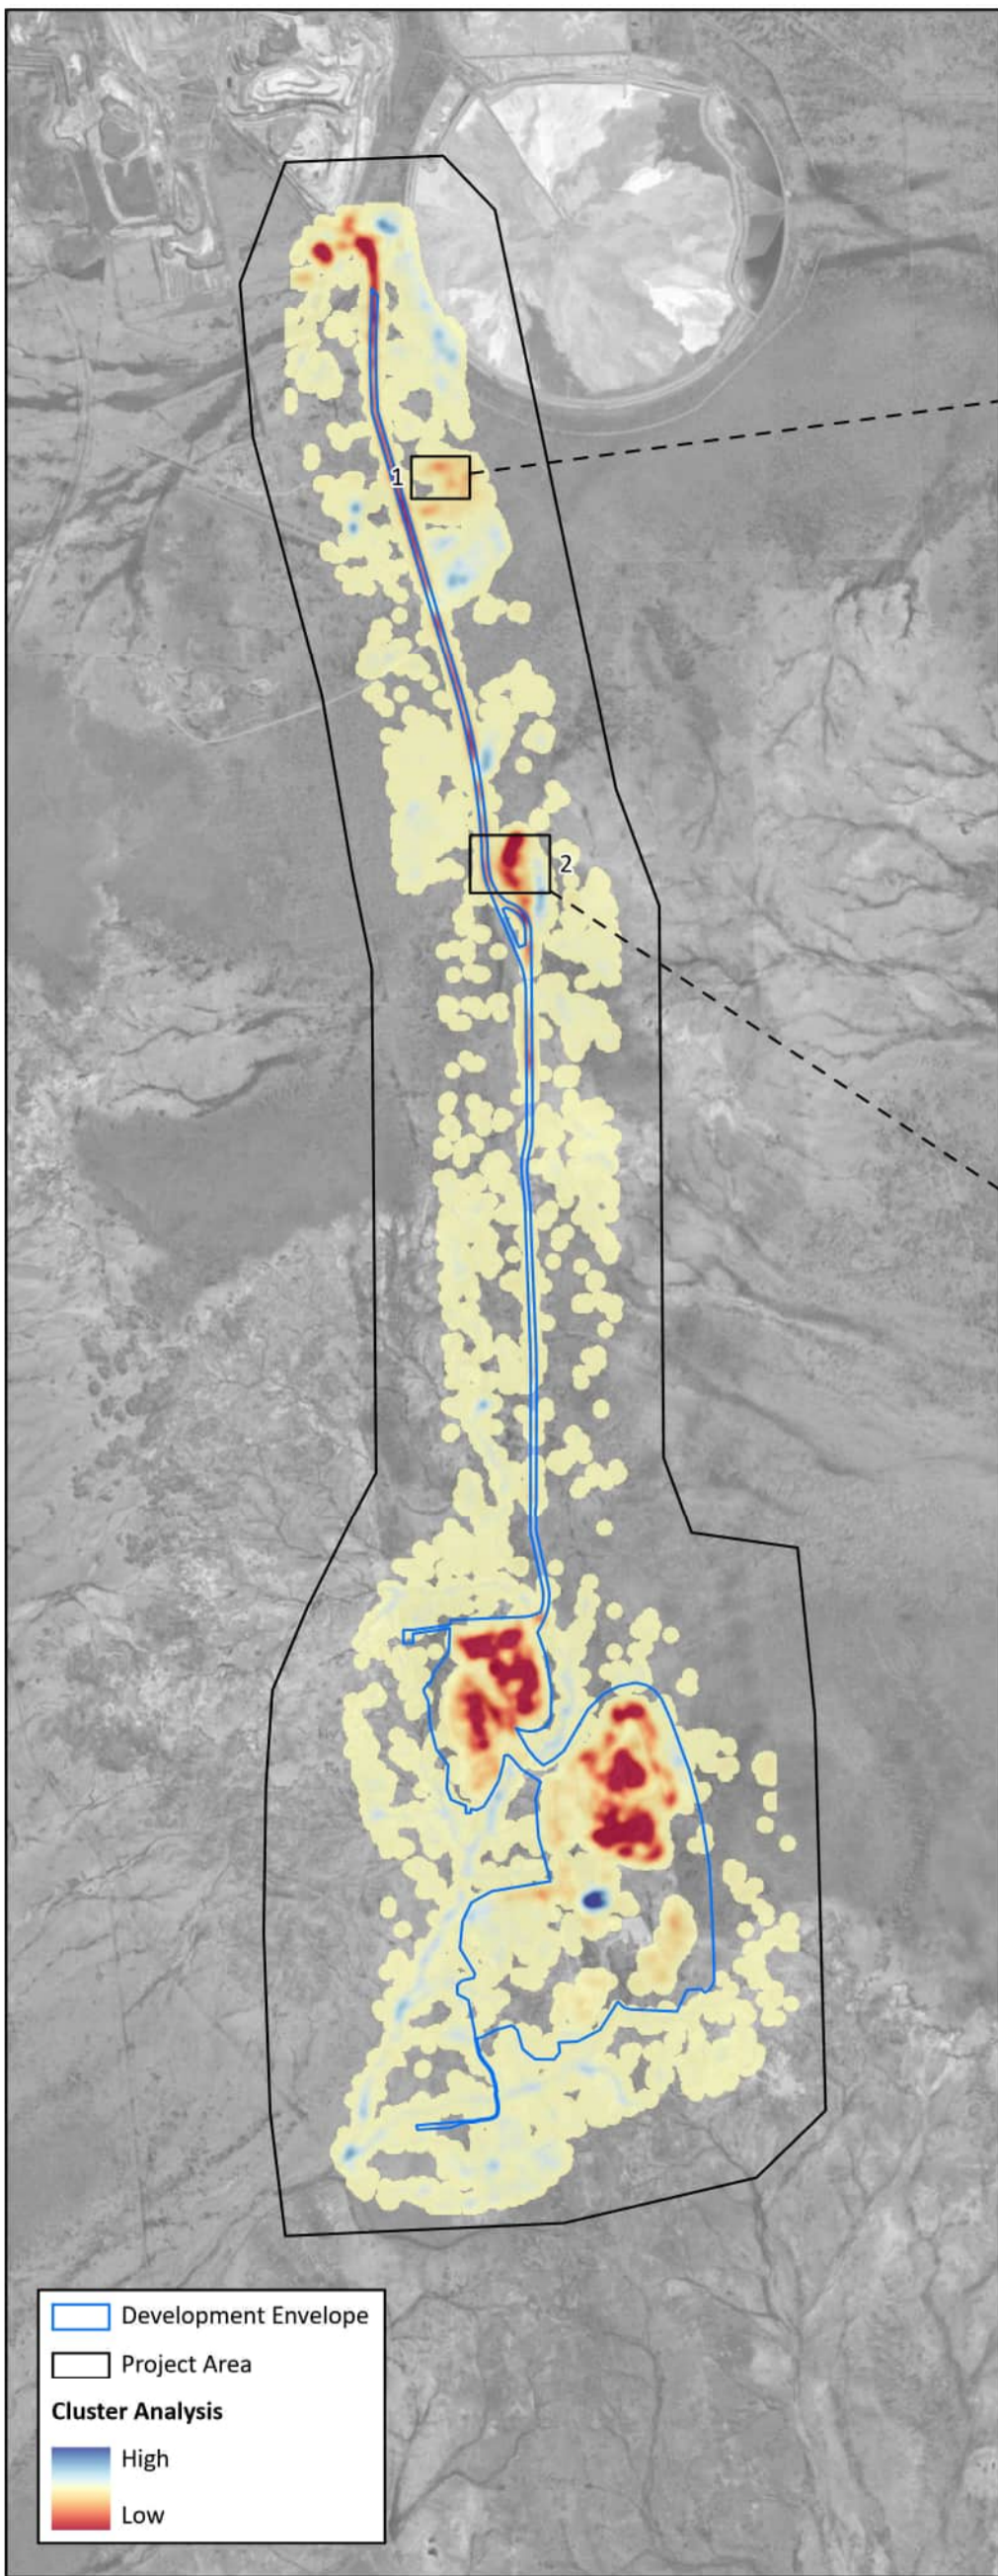
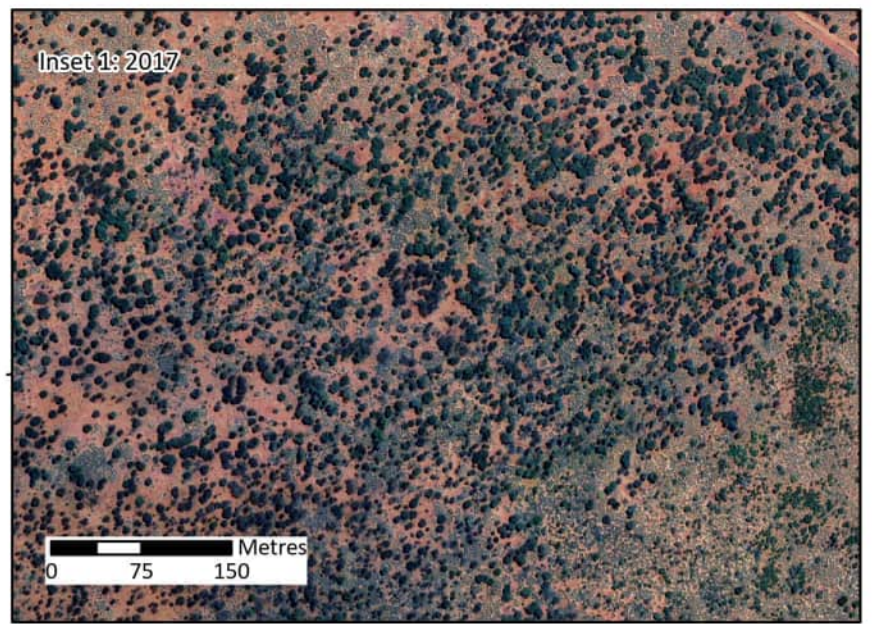
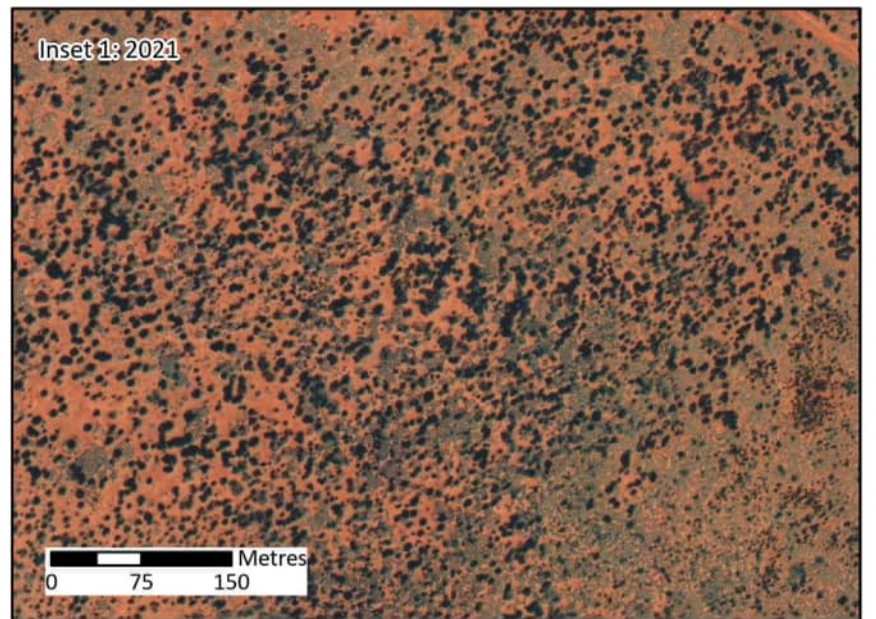
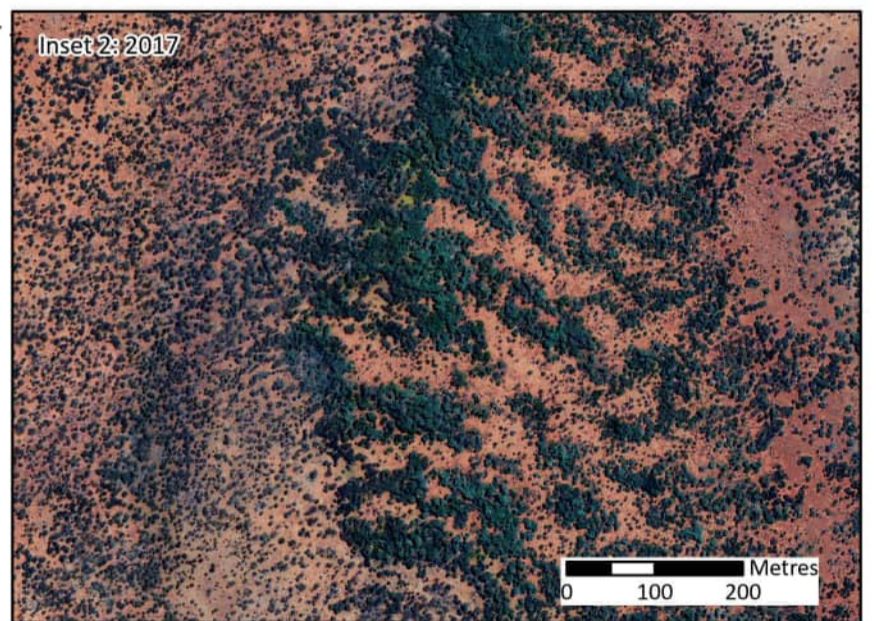
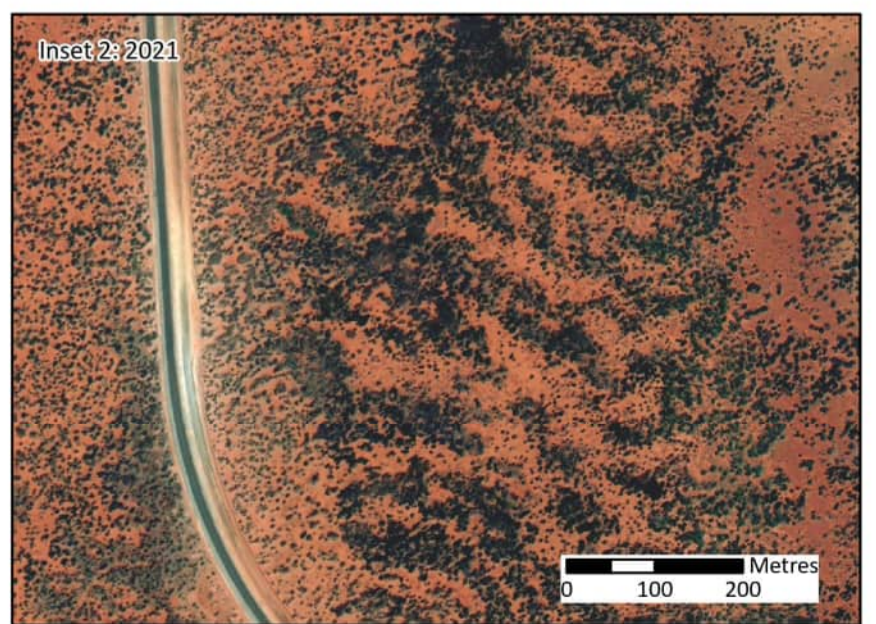
**Figure 6: WorldView cluster analysis September 2017 to October 2021**

The results of the cluster analysis derived from the 2017 to 2021 and 2020 to 2021 MSAVI change layers highlight areas of statistically significant change (Figure 6 and Figure 7). For the 2017 to 2021 period, the decline hotspots related to vegetation appear to be due to a reduction in canopy cover as well as a general decline in vegetation condition as shown by the lack of greenness in the 2021 imagery (Figure 6, Inset 1 and Inset 2). Possible disruption to surface flows arising from construction of roads may be a cause of the decline in the condition of banded mulga as shown in Figure 6, Inset 2. Areas of increase appear to be caused in part by cover other than vegetation.

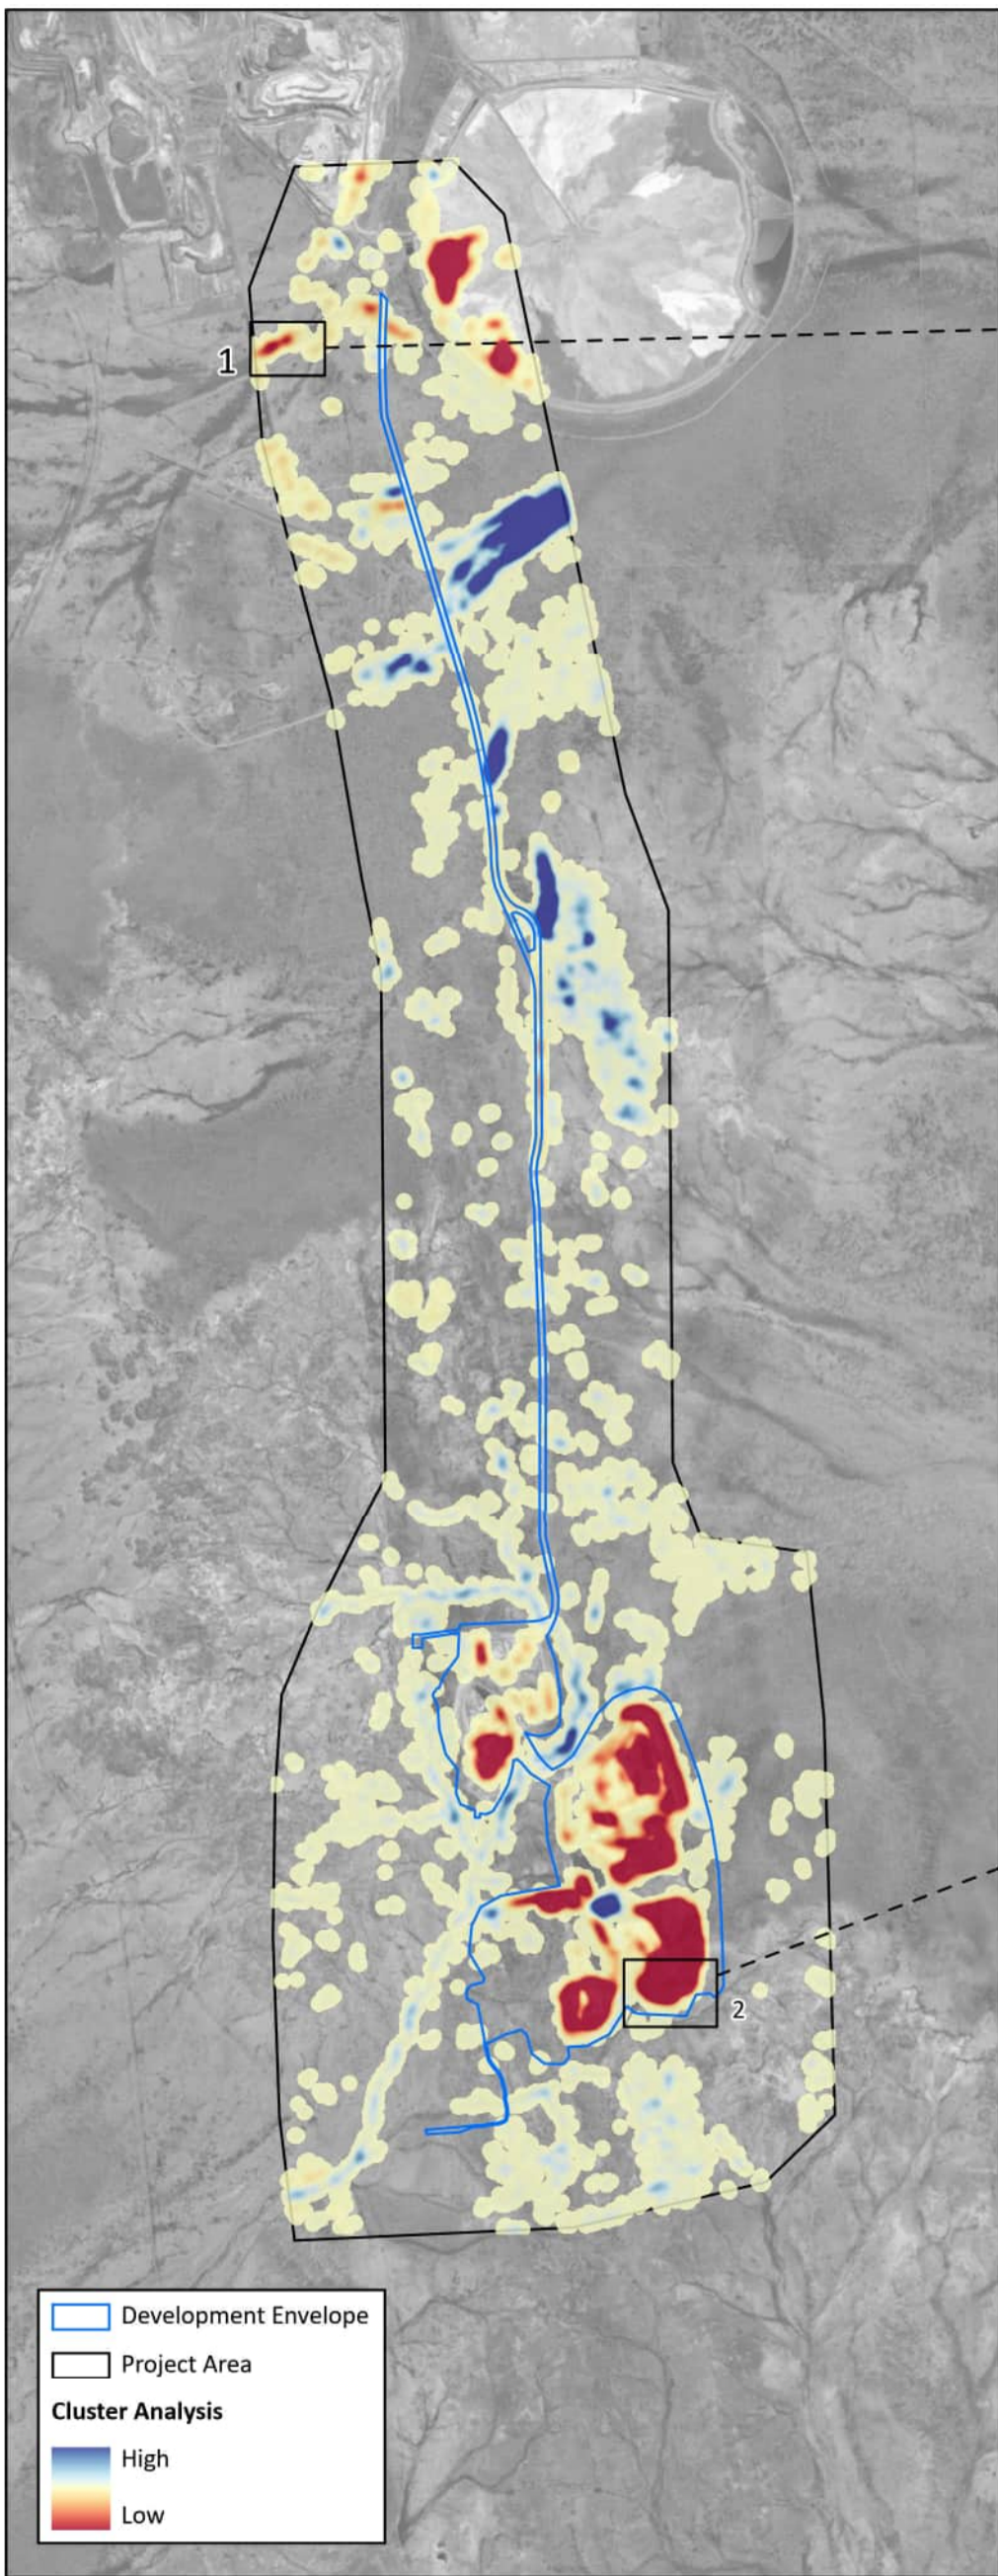
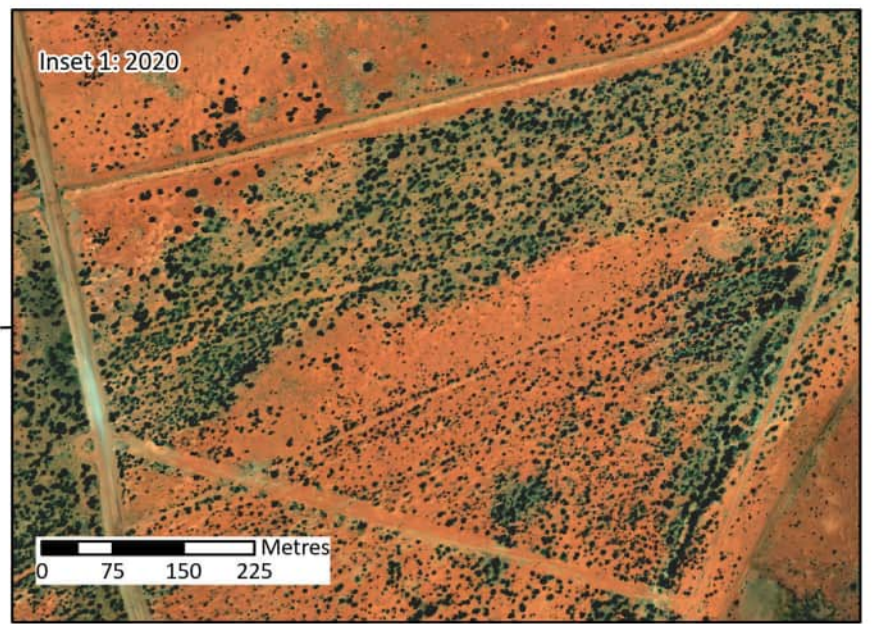
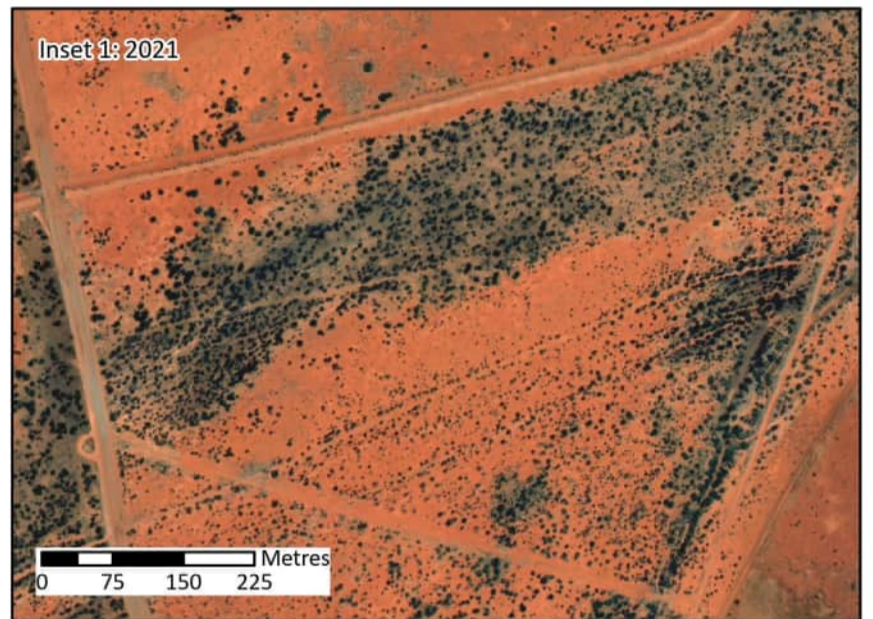
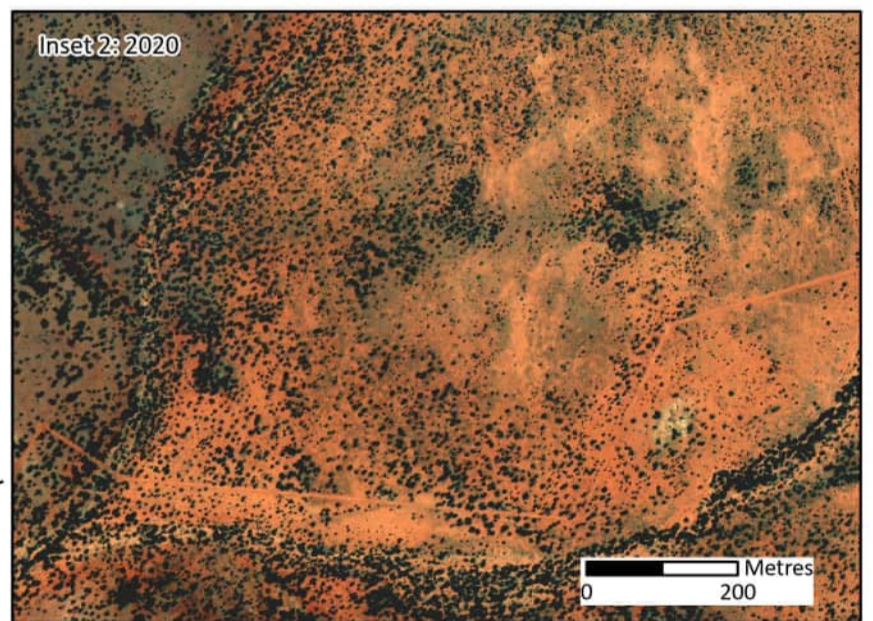
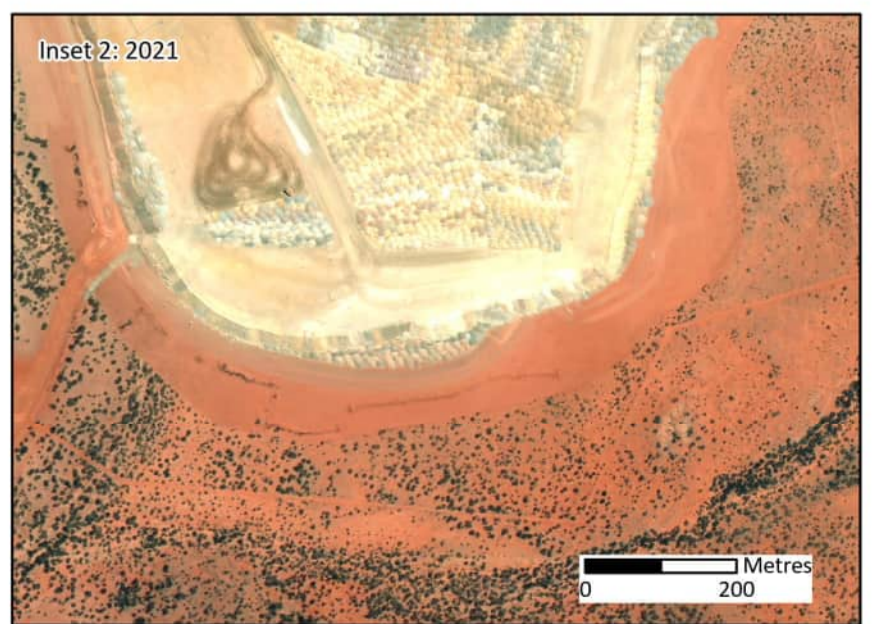
**Figure 7: WorldView cluster analysis September 2020 to October 2021**

For the 2020 to 2021 period, clusters of positive MSAVI change appeared along the main creek lines within the project area (Figure 7). These can be attributed to a slight increase in vegetation condition, with areas of increase in northern sections, which appear to be caused in part by the establishment of vegetation on what was previously bare ground. Clusters of negative MSAVI change were sometimes associated with vegetation condition (Figure 7, Inset 1), but were for the most part due to clearing for the extension of the mine (Figure 7, Inset 2) or changes in soil surface rather than vegetation.
