APD
ENGINEERING

BHP NEWMAN TOWNSHIP ELECTRICITY SUPPLY
ANNUAL COMPLIANCE REPORT
2021/2022

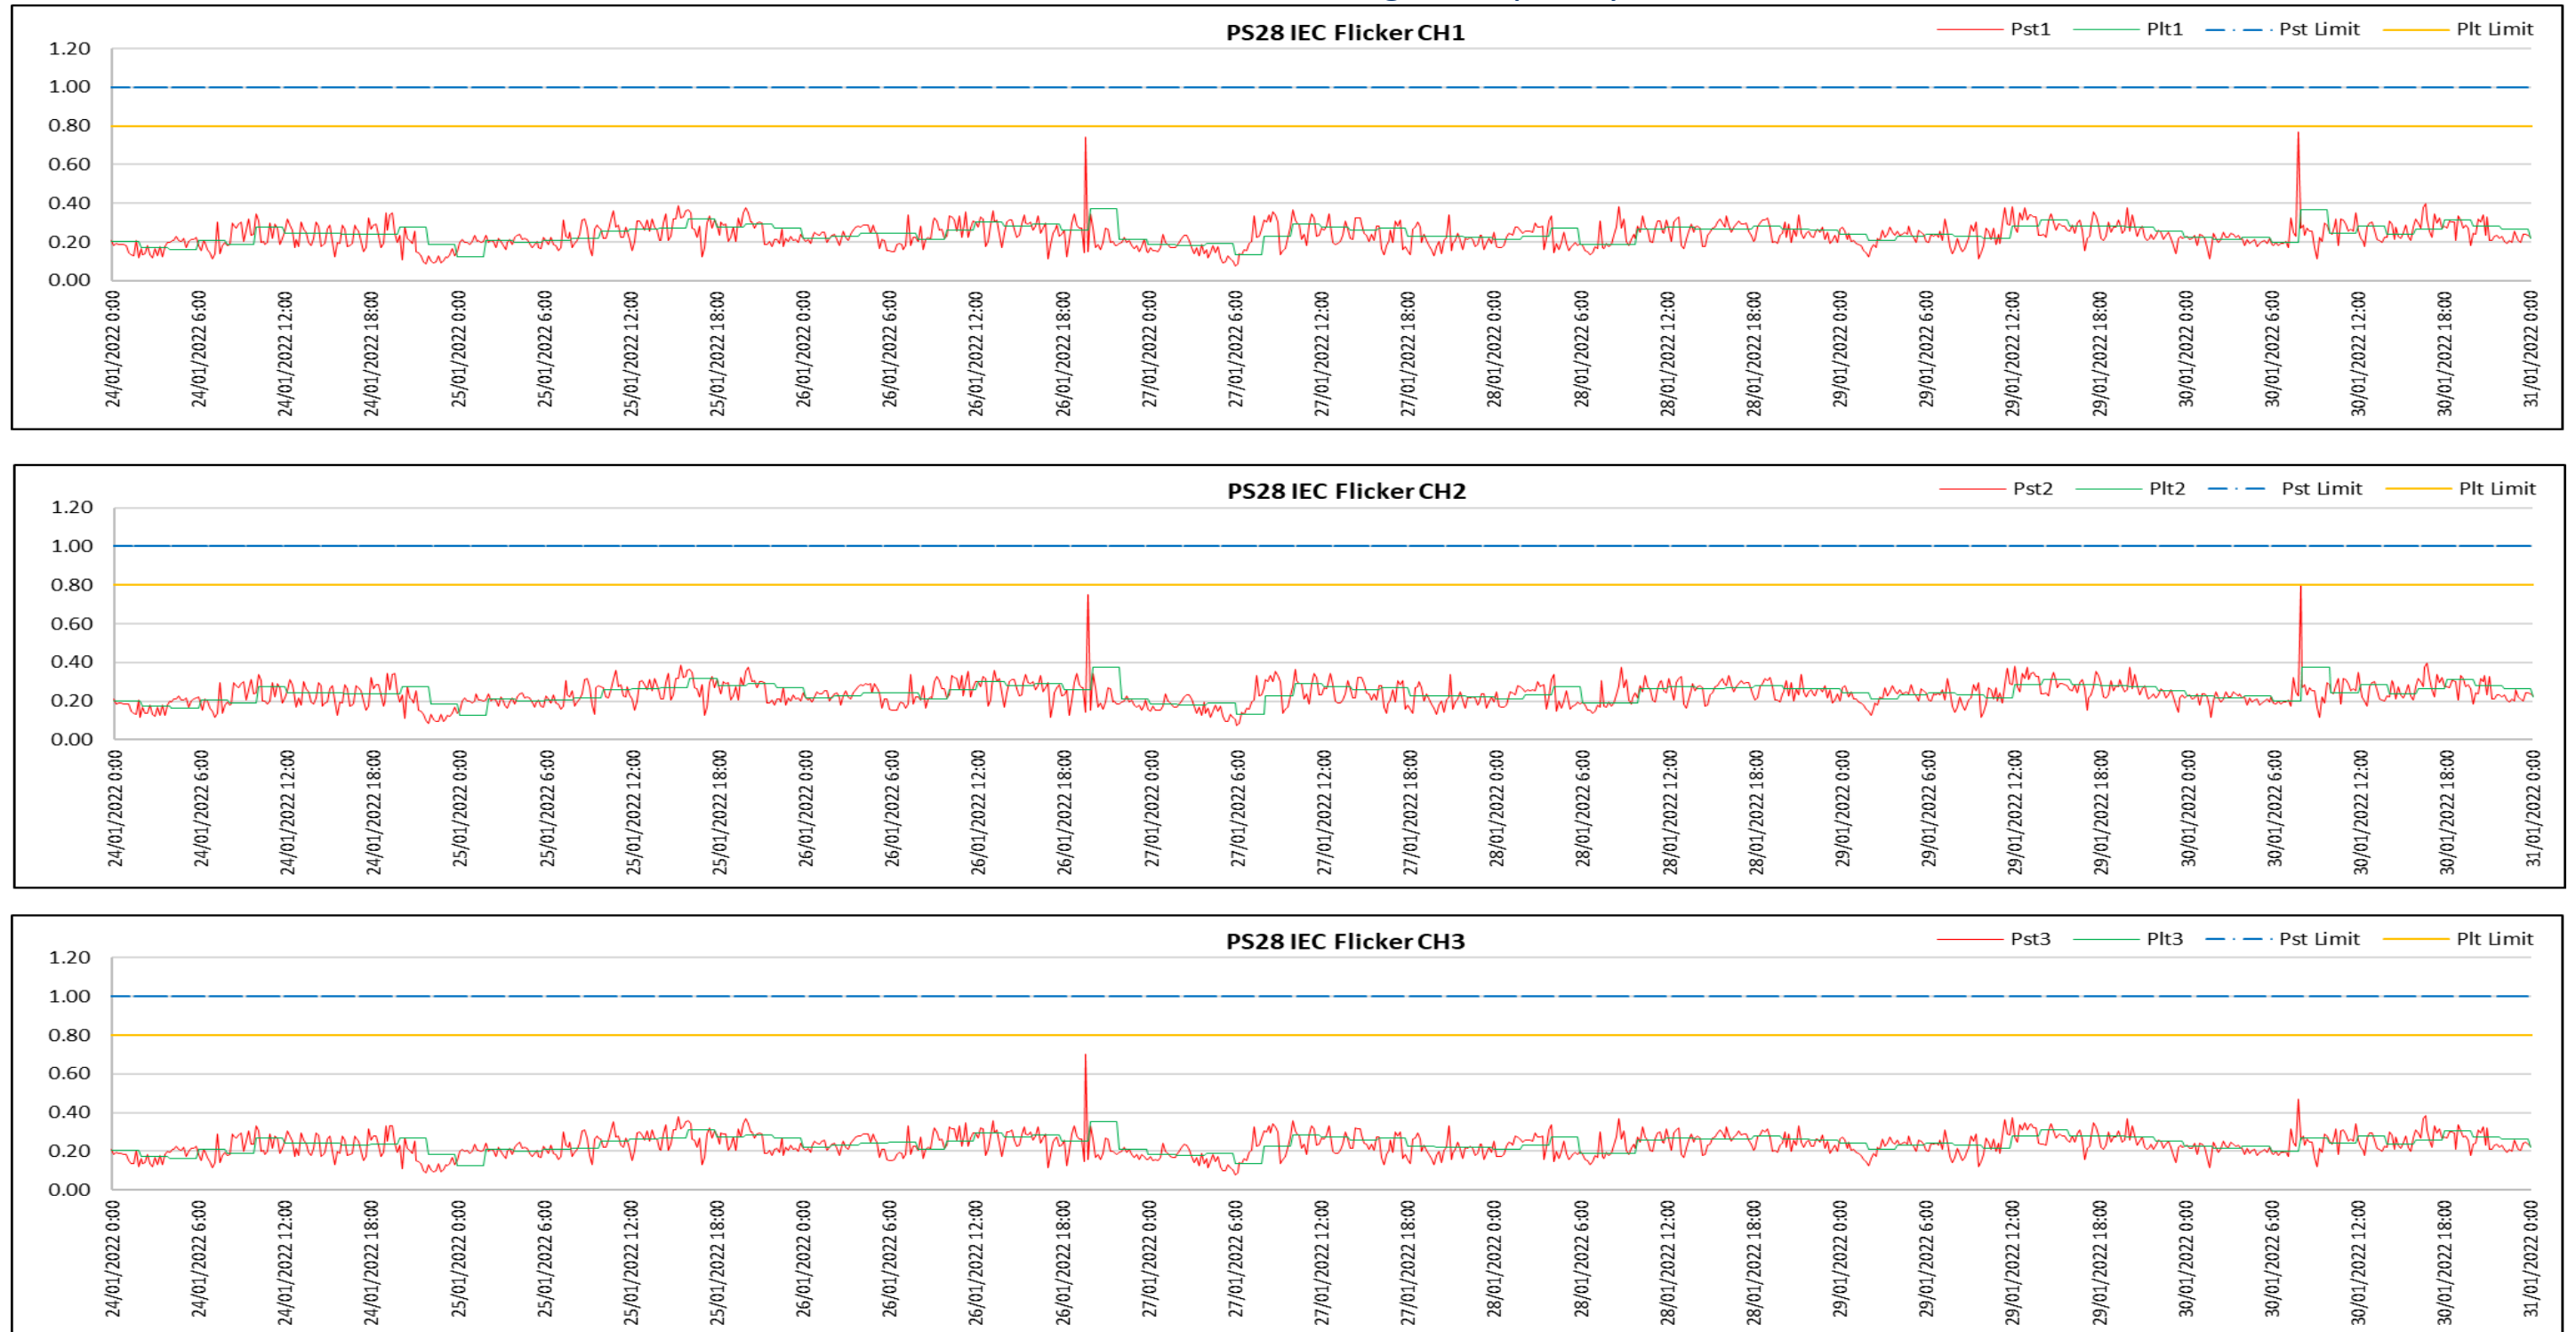
Figure 3 | TC1 Start Flicker measurements

The logged flicker data for the start and end of the TC1 feeder is shown from Figure 3 to figure 4 in Appendix A.2. There were no recorded flicker limit events causing the flicker level to breach the Code's limits (i.e., full compliance with the Code requirements).

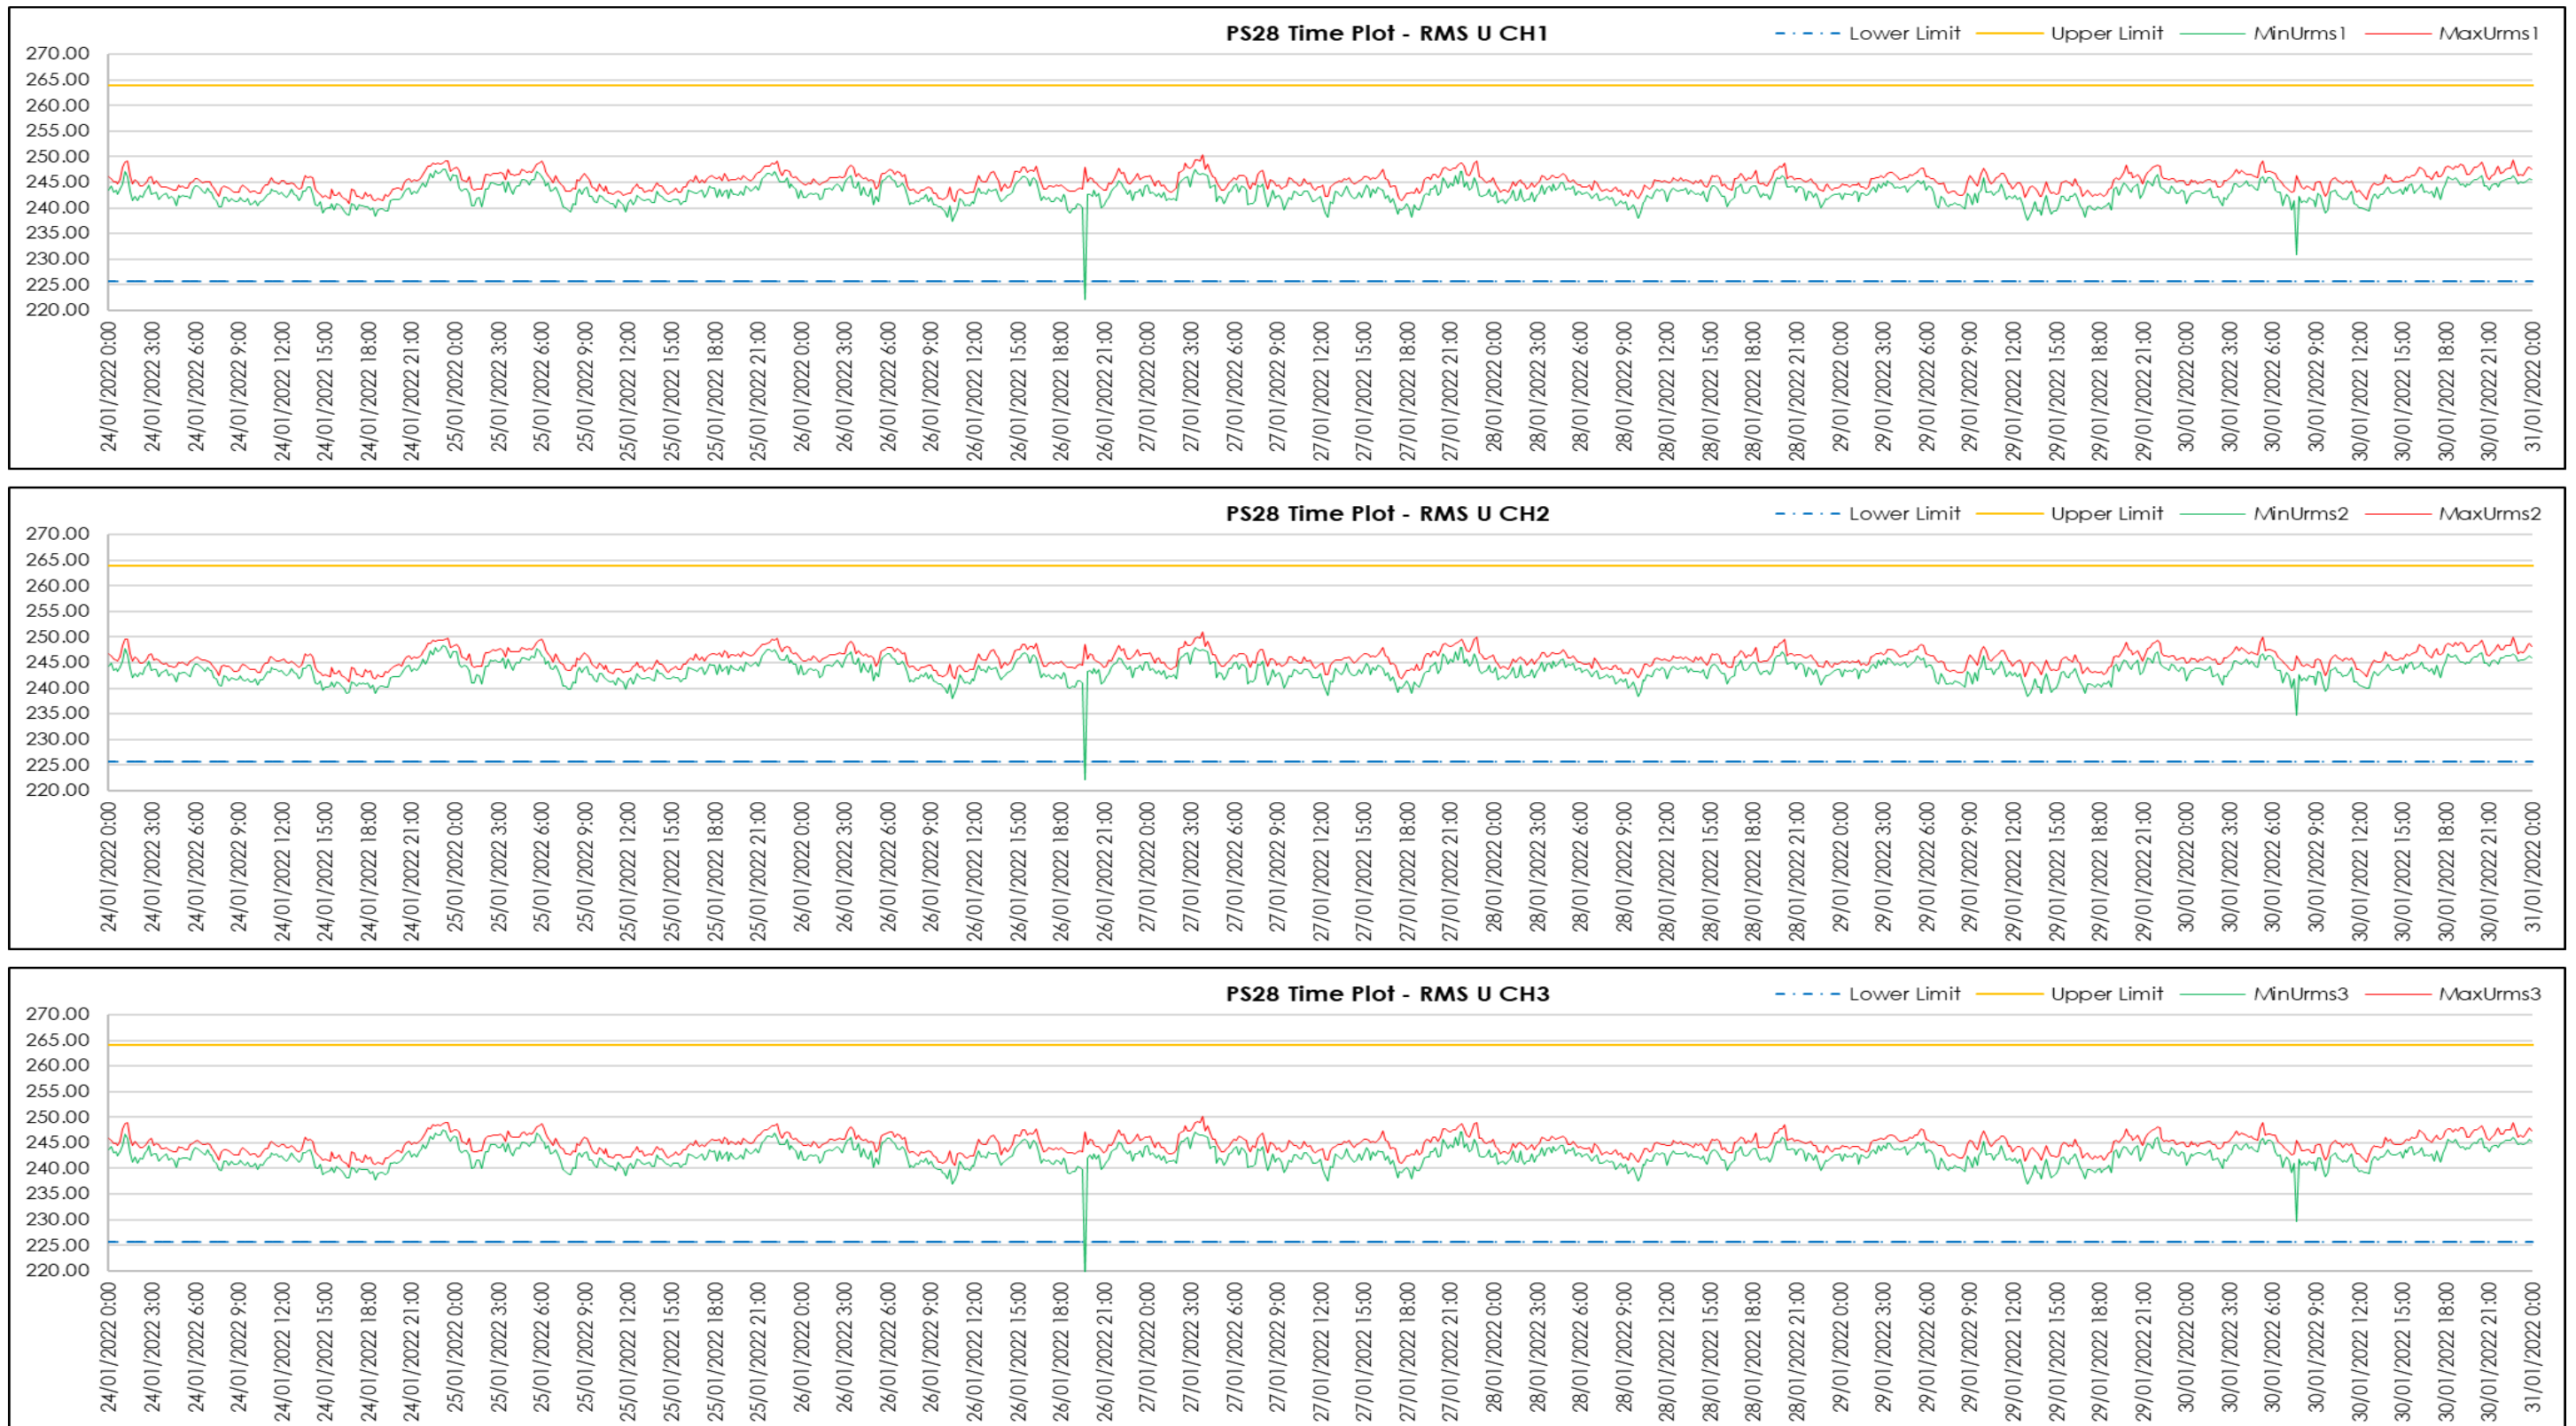
Figure 5 | TC1 Start Voltage measurements

The logged voltage level data for the start and end of the TC1 feeder is shown from Figure 3 to figure 4 in Appendix A.2. **Table 4** below shows the recorded breach events during the logging period.

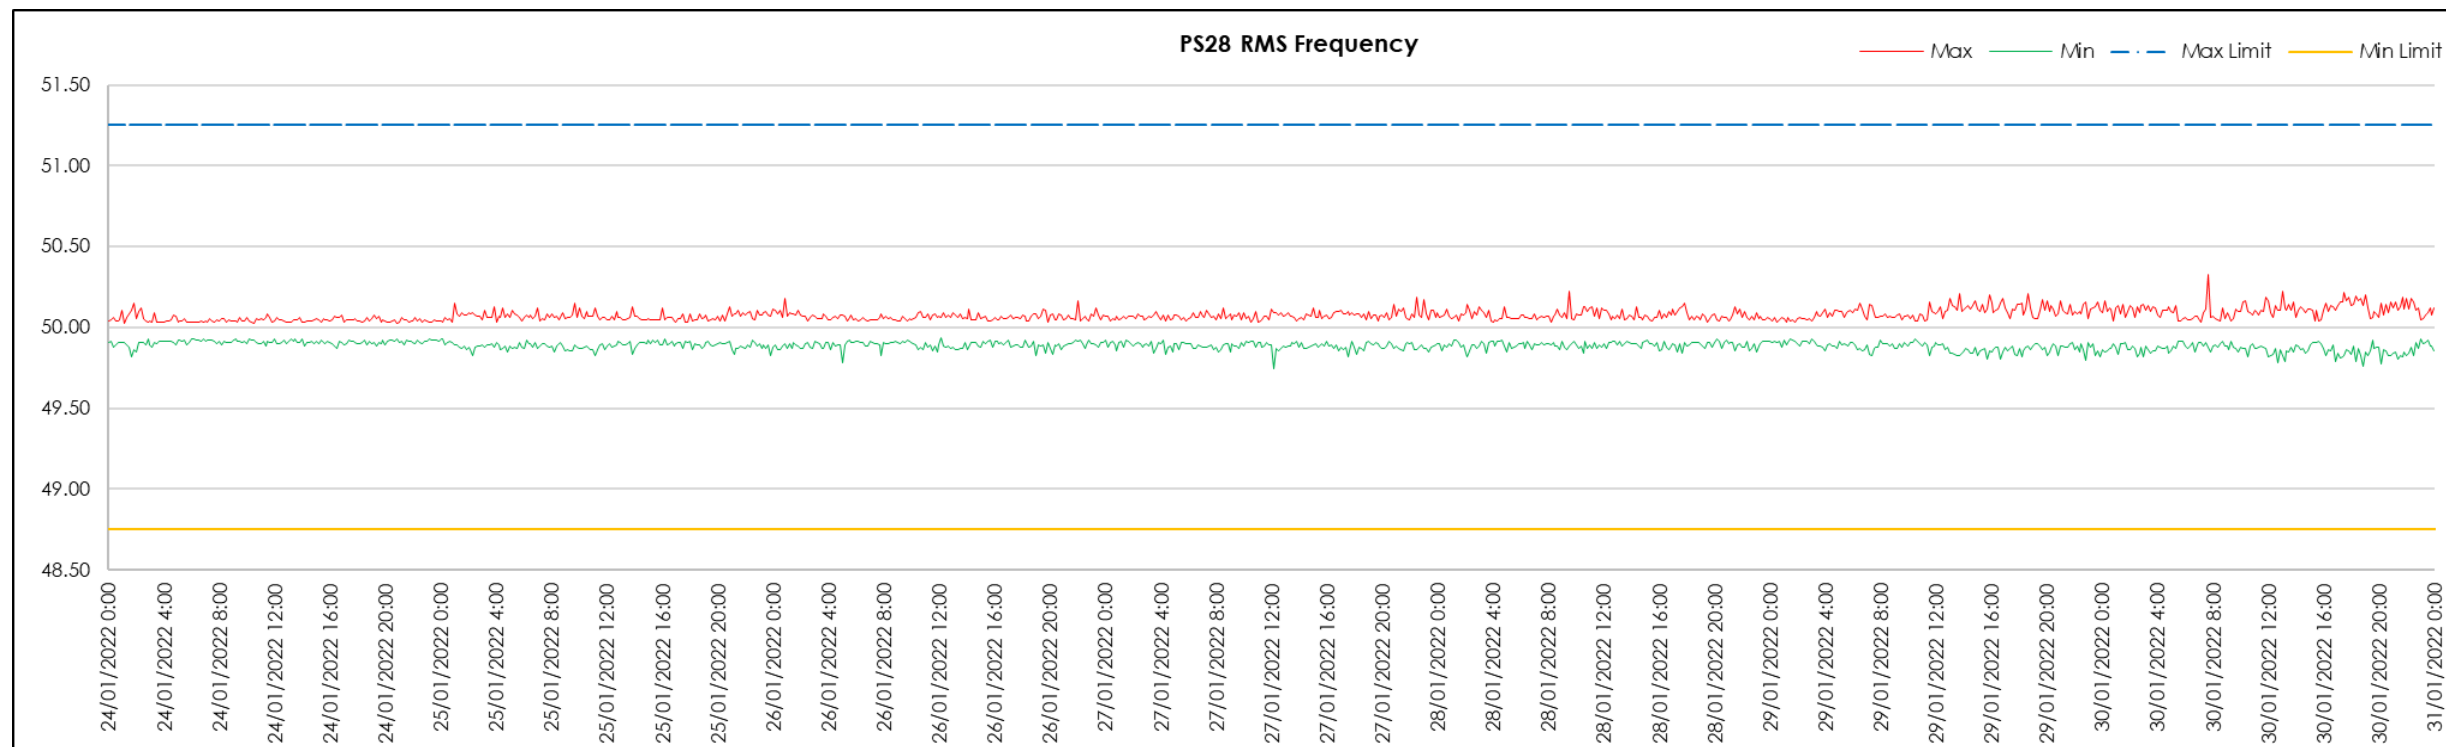
Figure 7 | TC1 Start Frequency measurements

The logged frequency data for the start and end of the TC1 feeder is shown from Figure 7 to Figure 8 in Appendix A.1. There were no recorded frequency limit events causing the frequency level to breach the Code's limits (i.e., full compliance with the Code requirements).

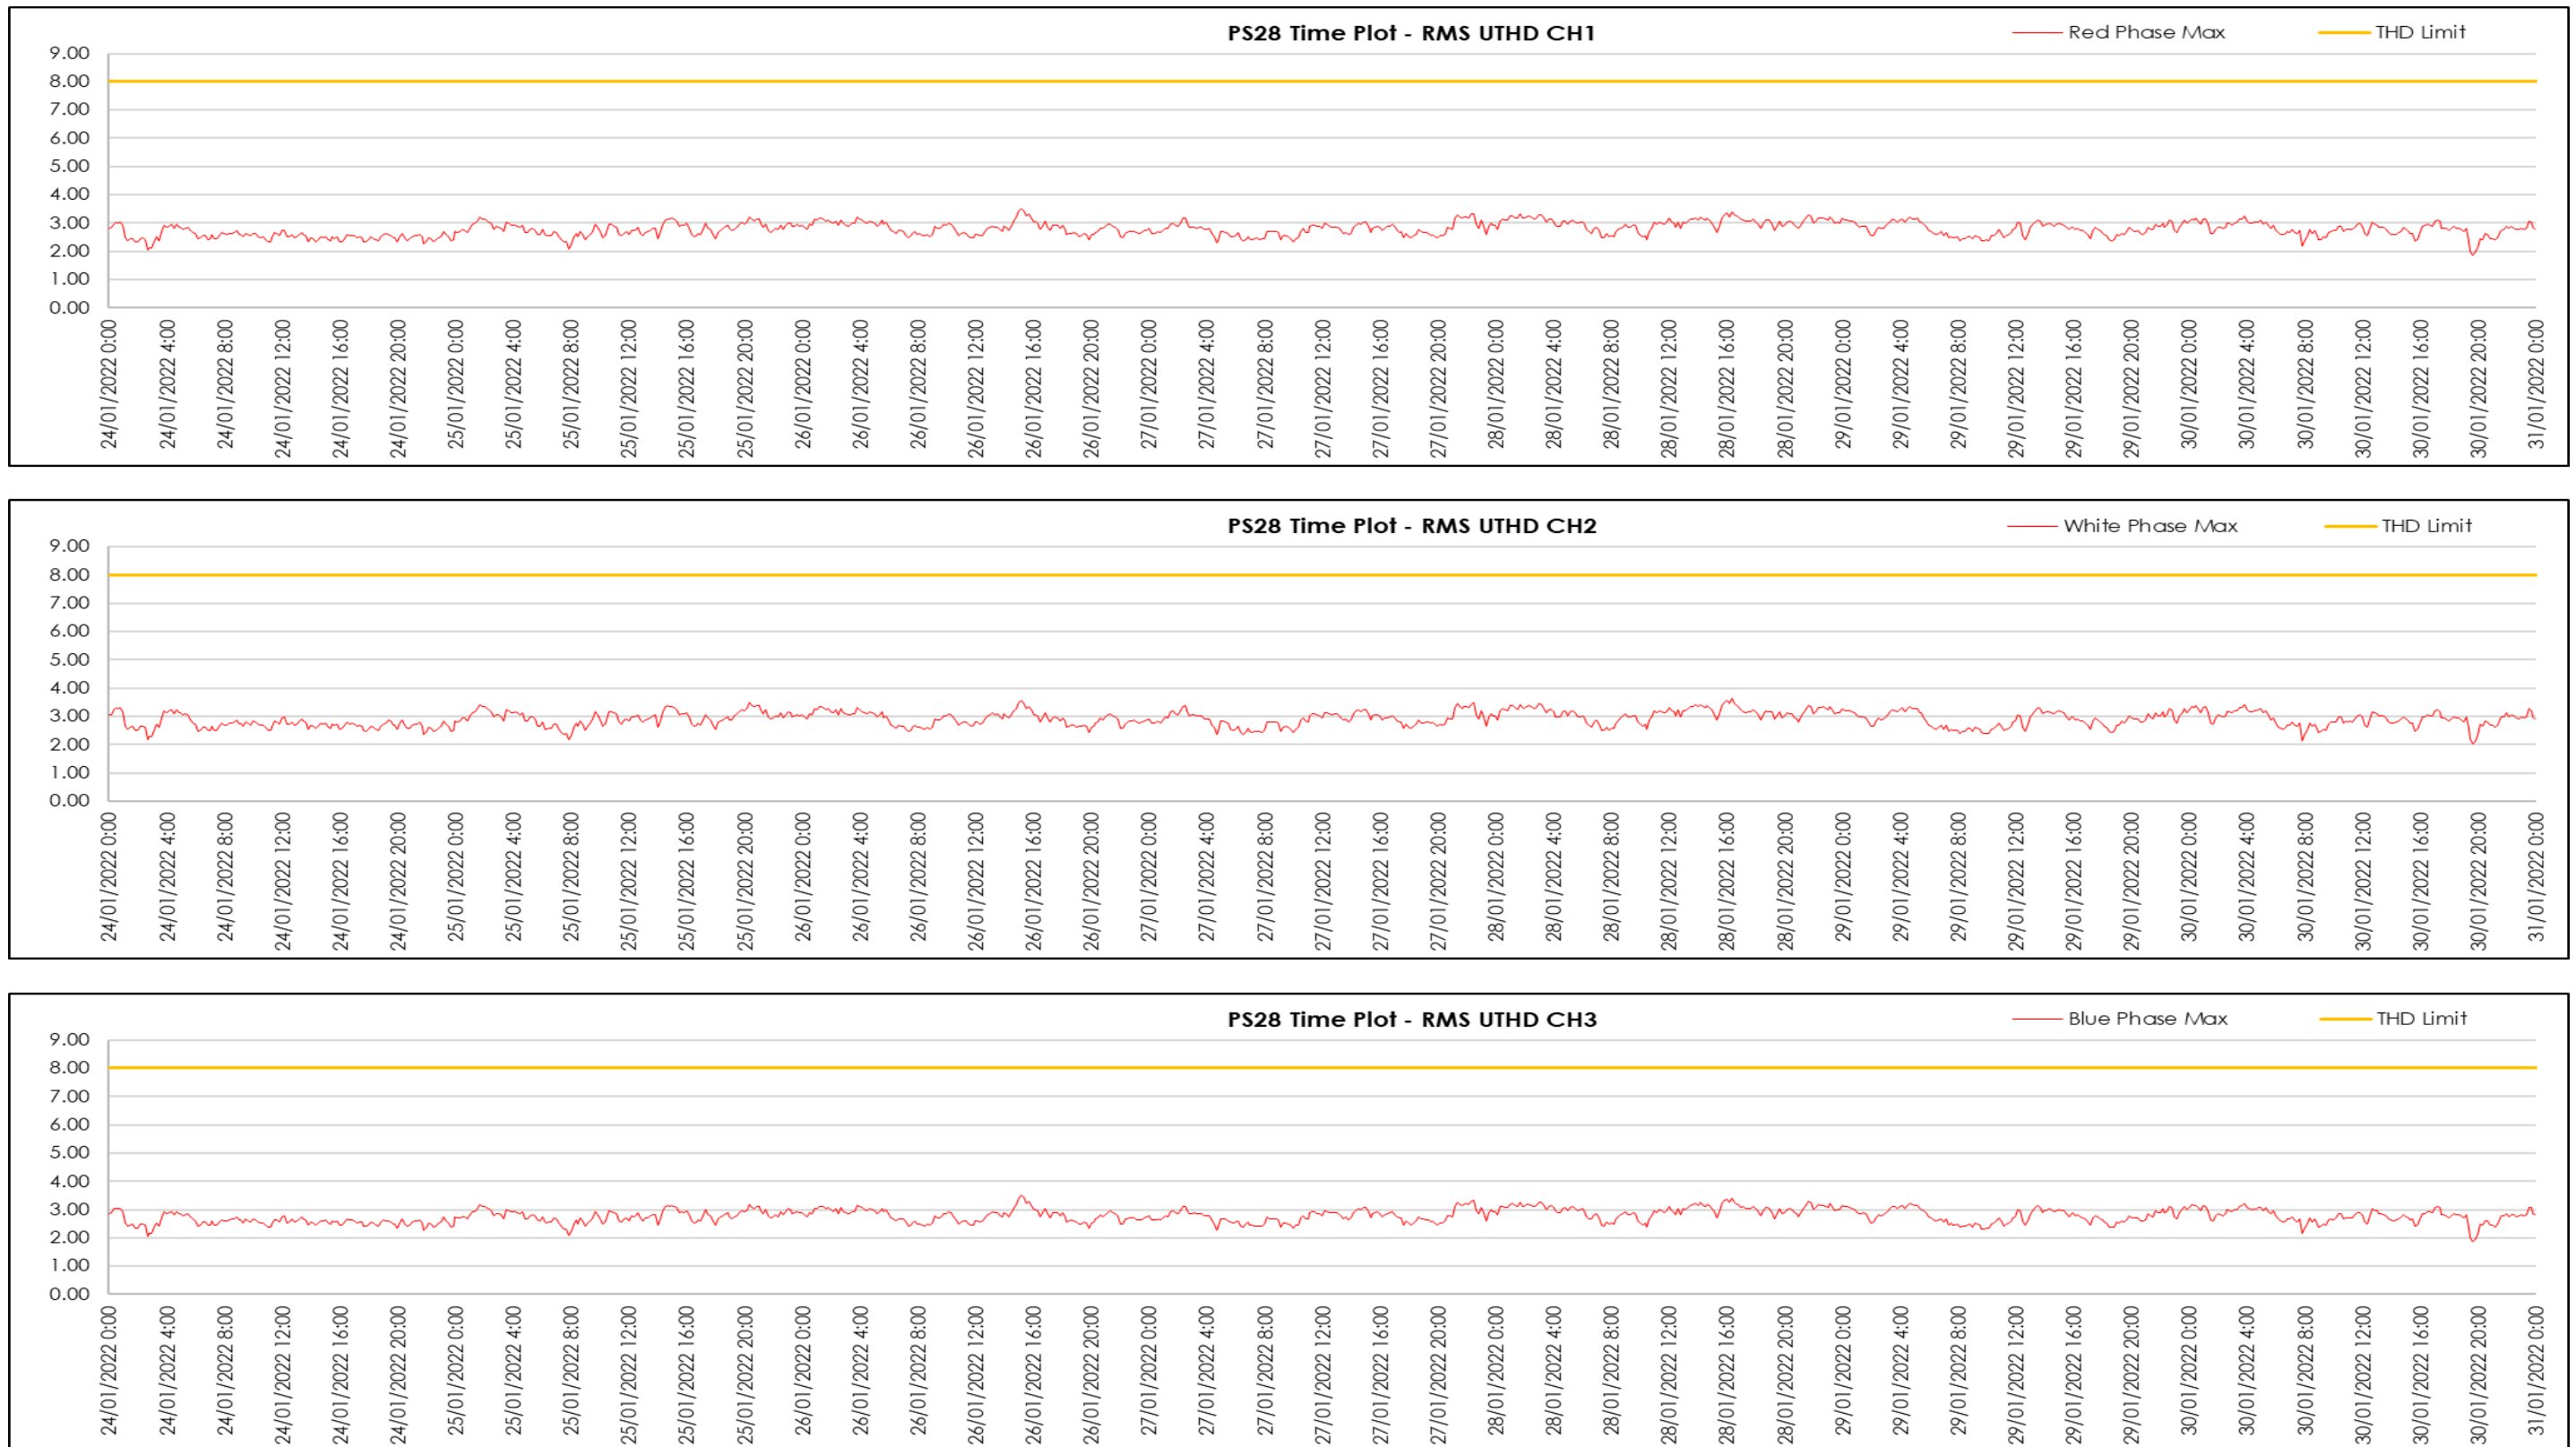
Figure 9 | TC1 Start U-THD measurements

The logged voltage THD level data for the start and end of the TC1 feeder is shown from Figure 9 to Figure 10 in Appendix A.2. There were no recorded voltage THD limit events causing the voltage THD level to breach the Code's limits (i.e., full compliance with the Code requirements).

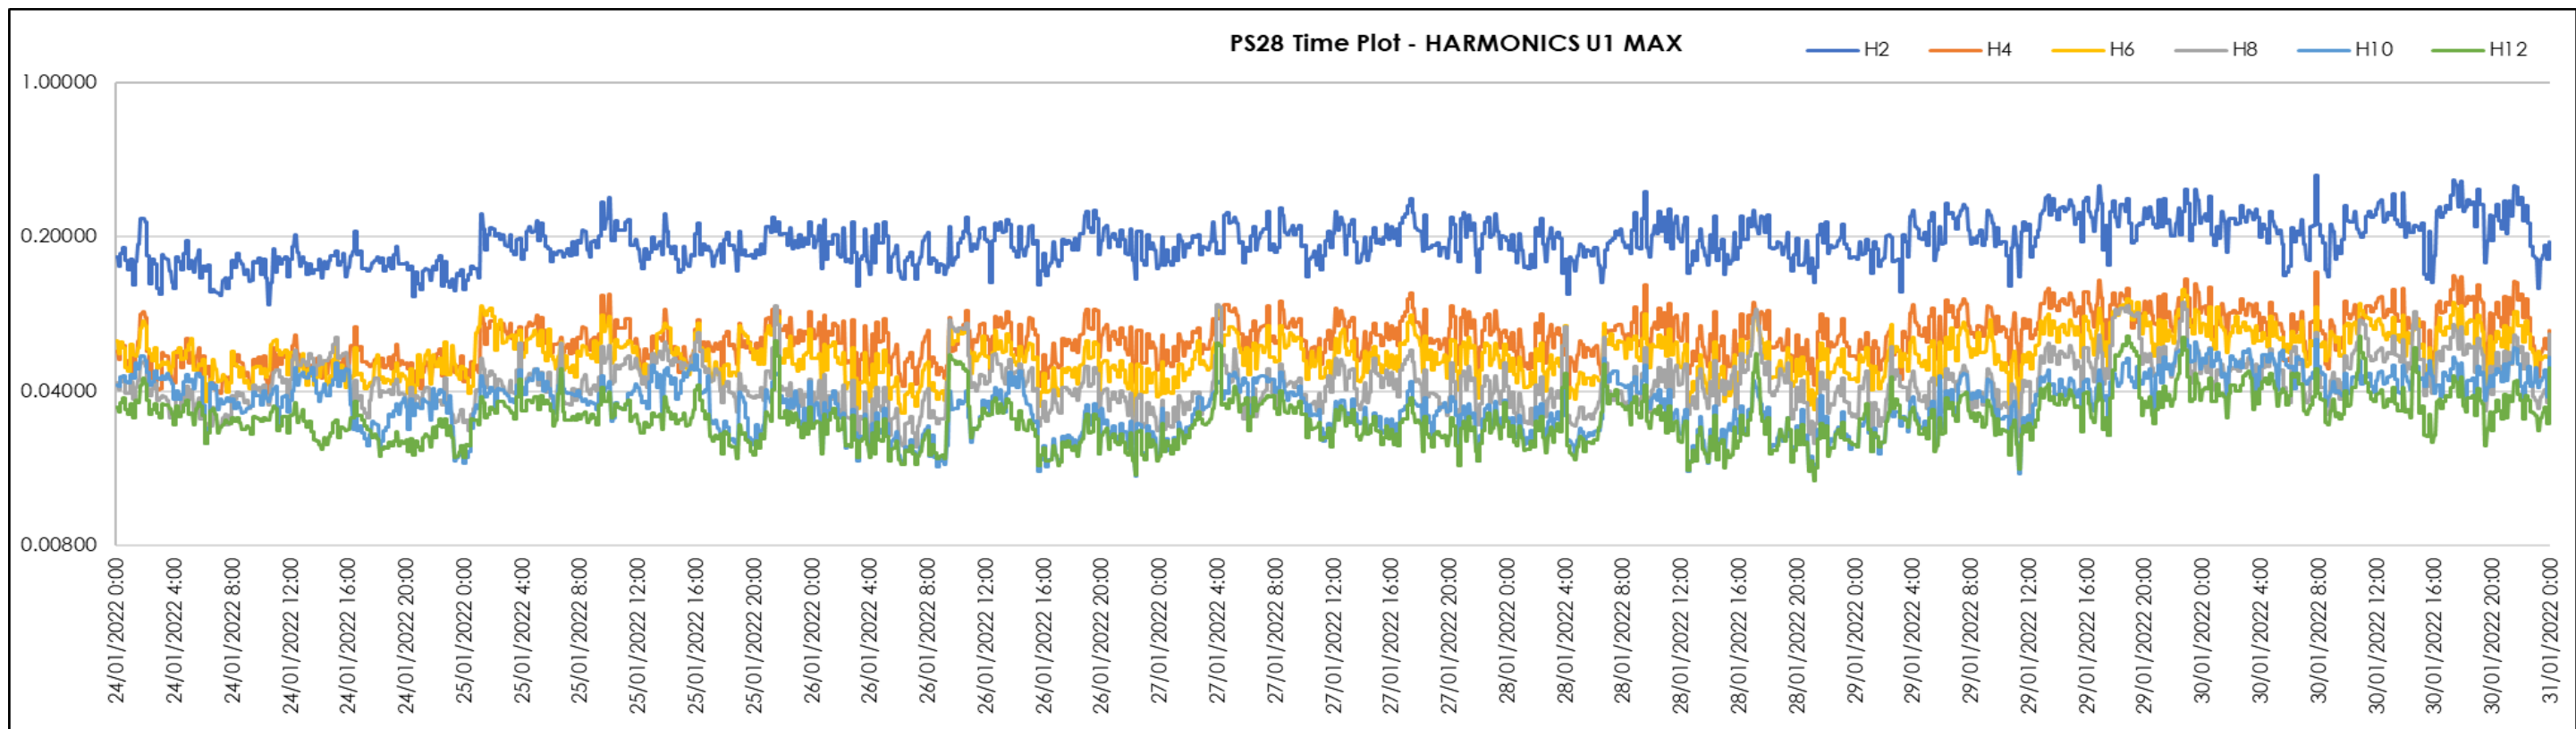
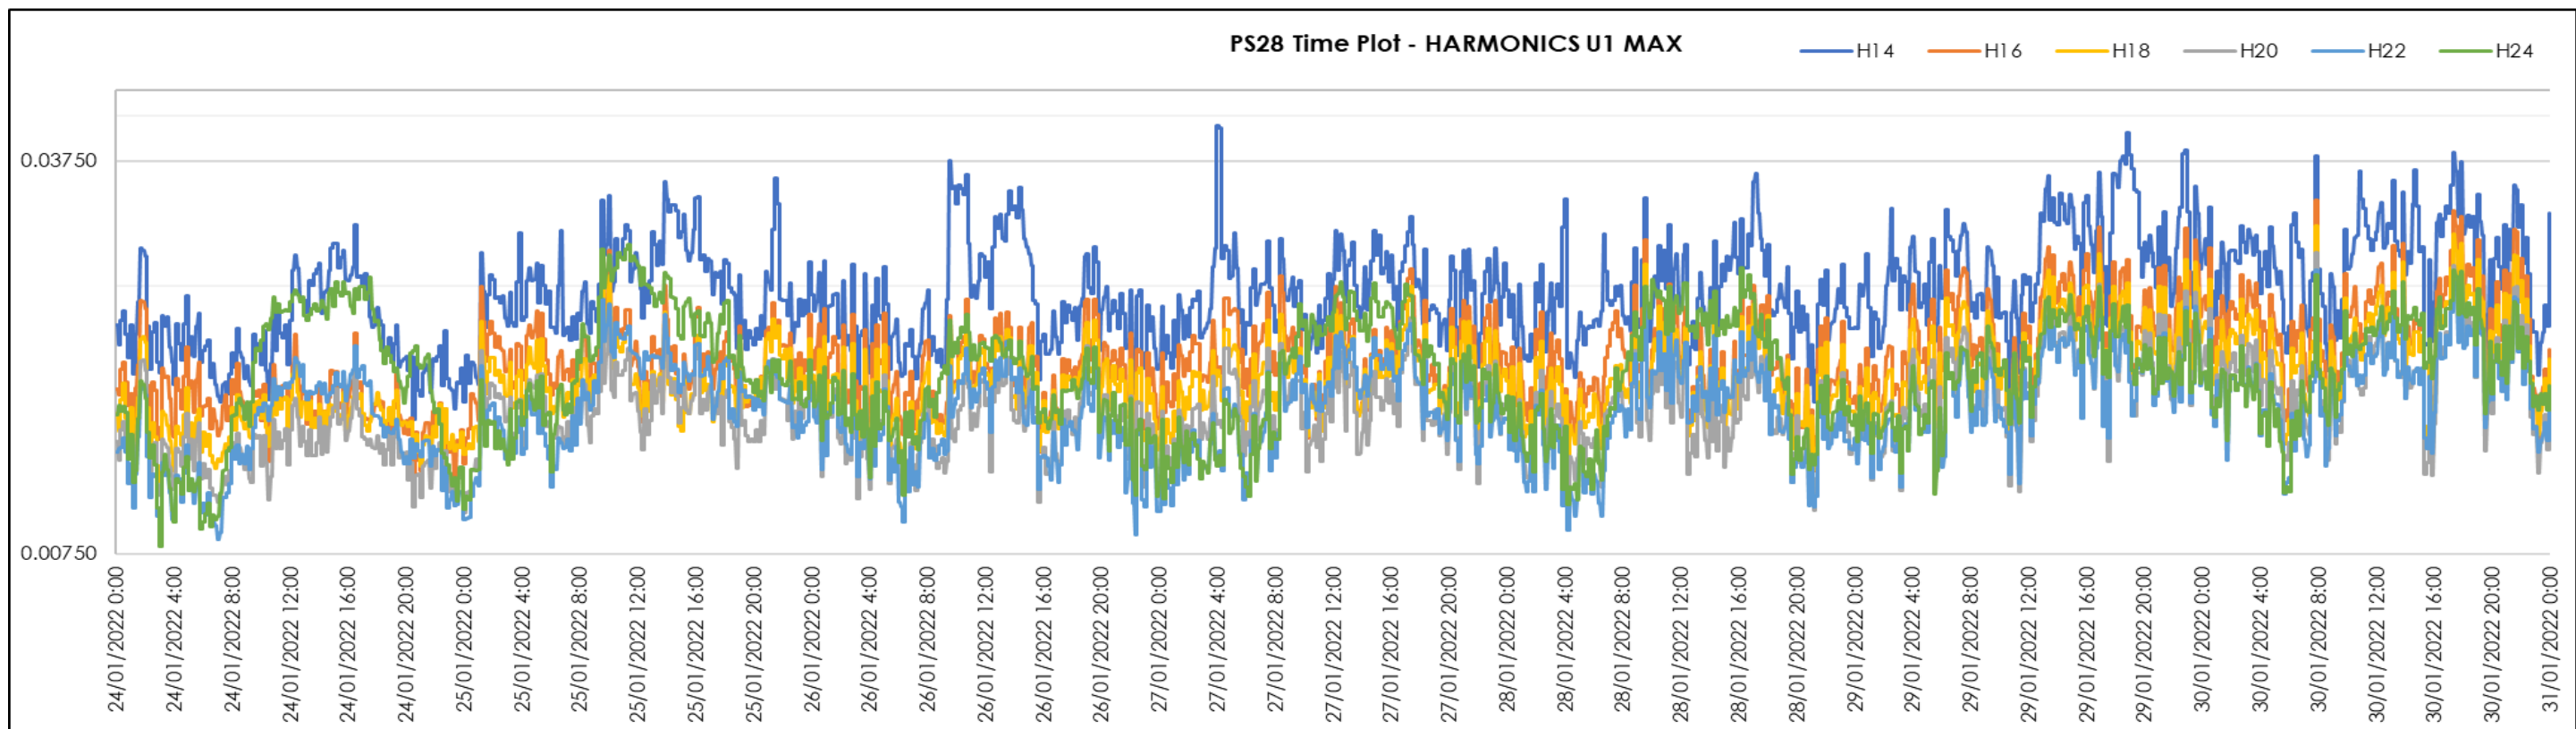
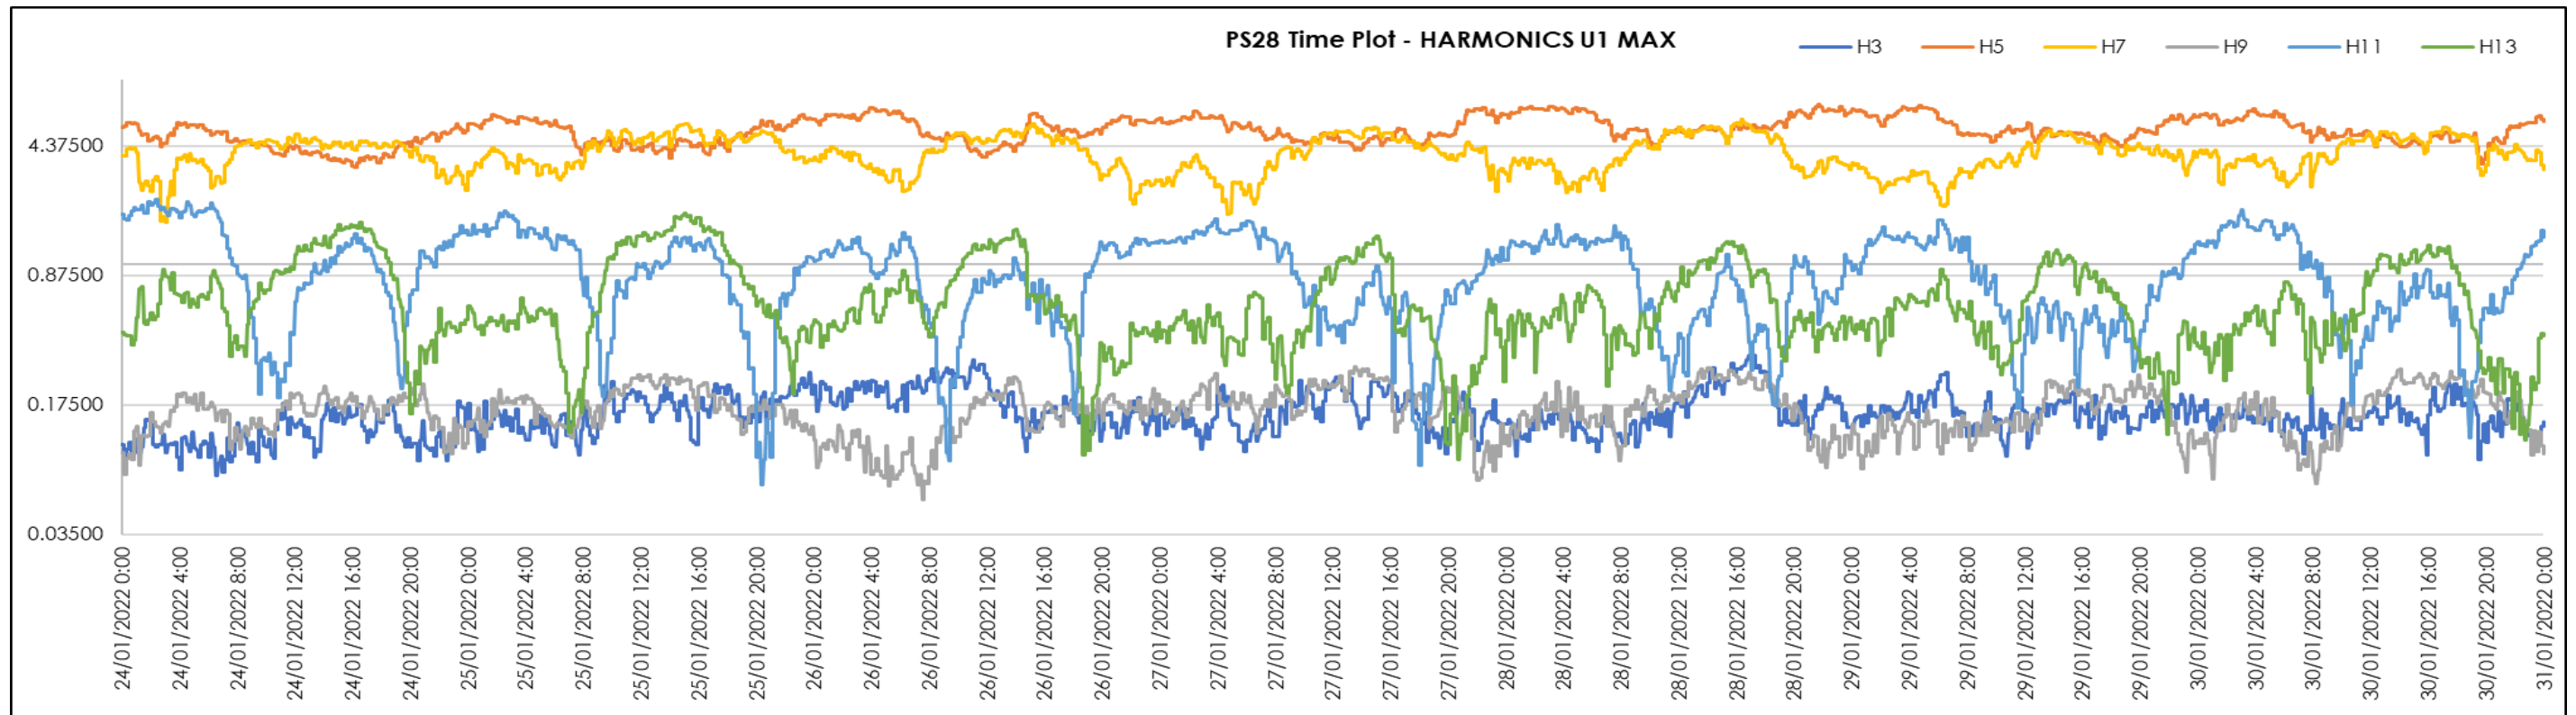
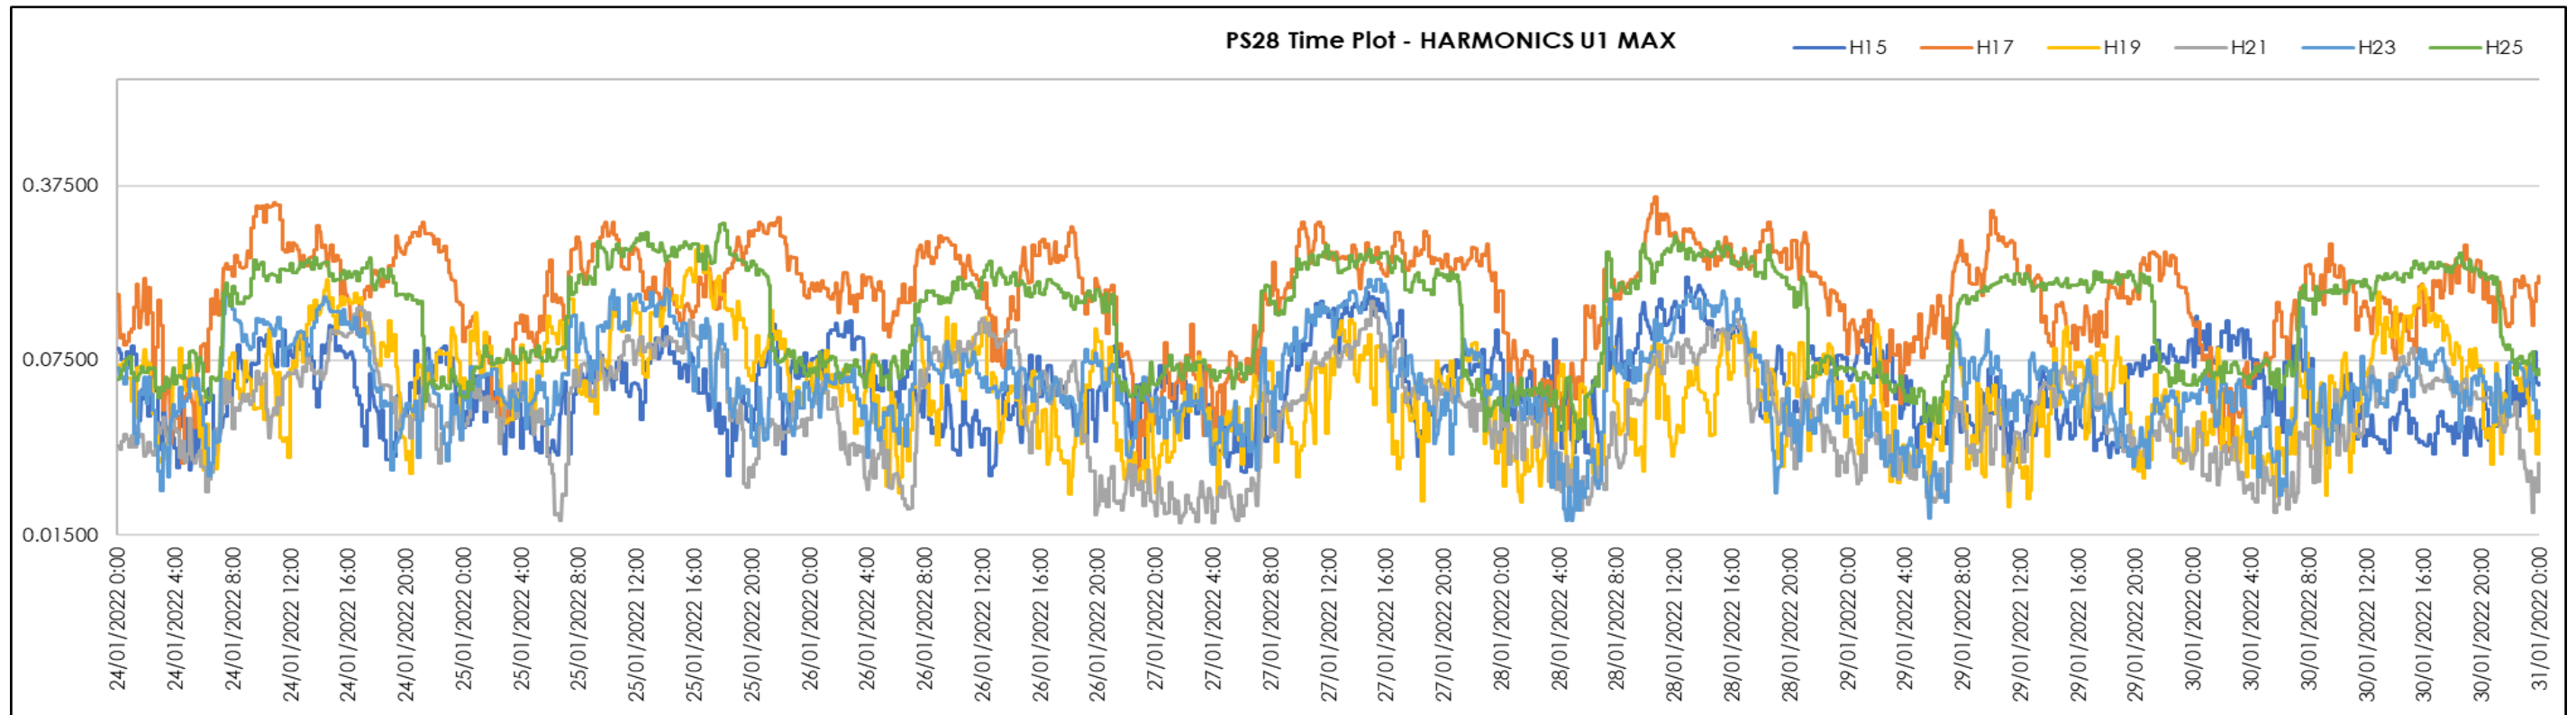
Figure 11 | TC1 Start Harmonics

The logged harmonic data for the start and end of the TC1 feeder is shown from Figure 11 to Figure 12 in Appendix A.2. No non-compliant harmonics were recorded for the recording period.
