APD
ENGINEERING

BHP NEWMAN TOWNSHIP ELECTRICITY SUPPLY
ANNUAL COMPLIANCE REPORT
2021/2022

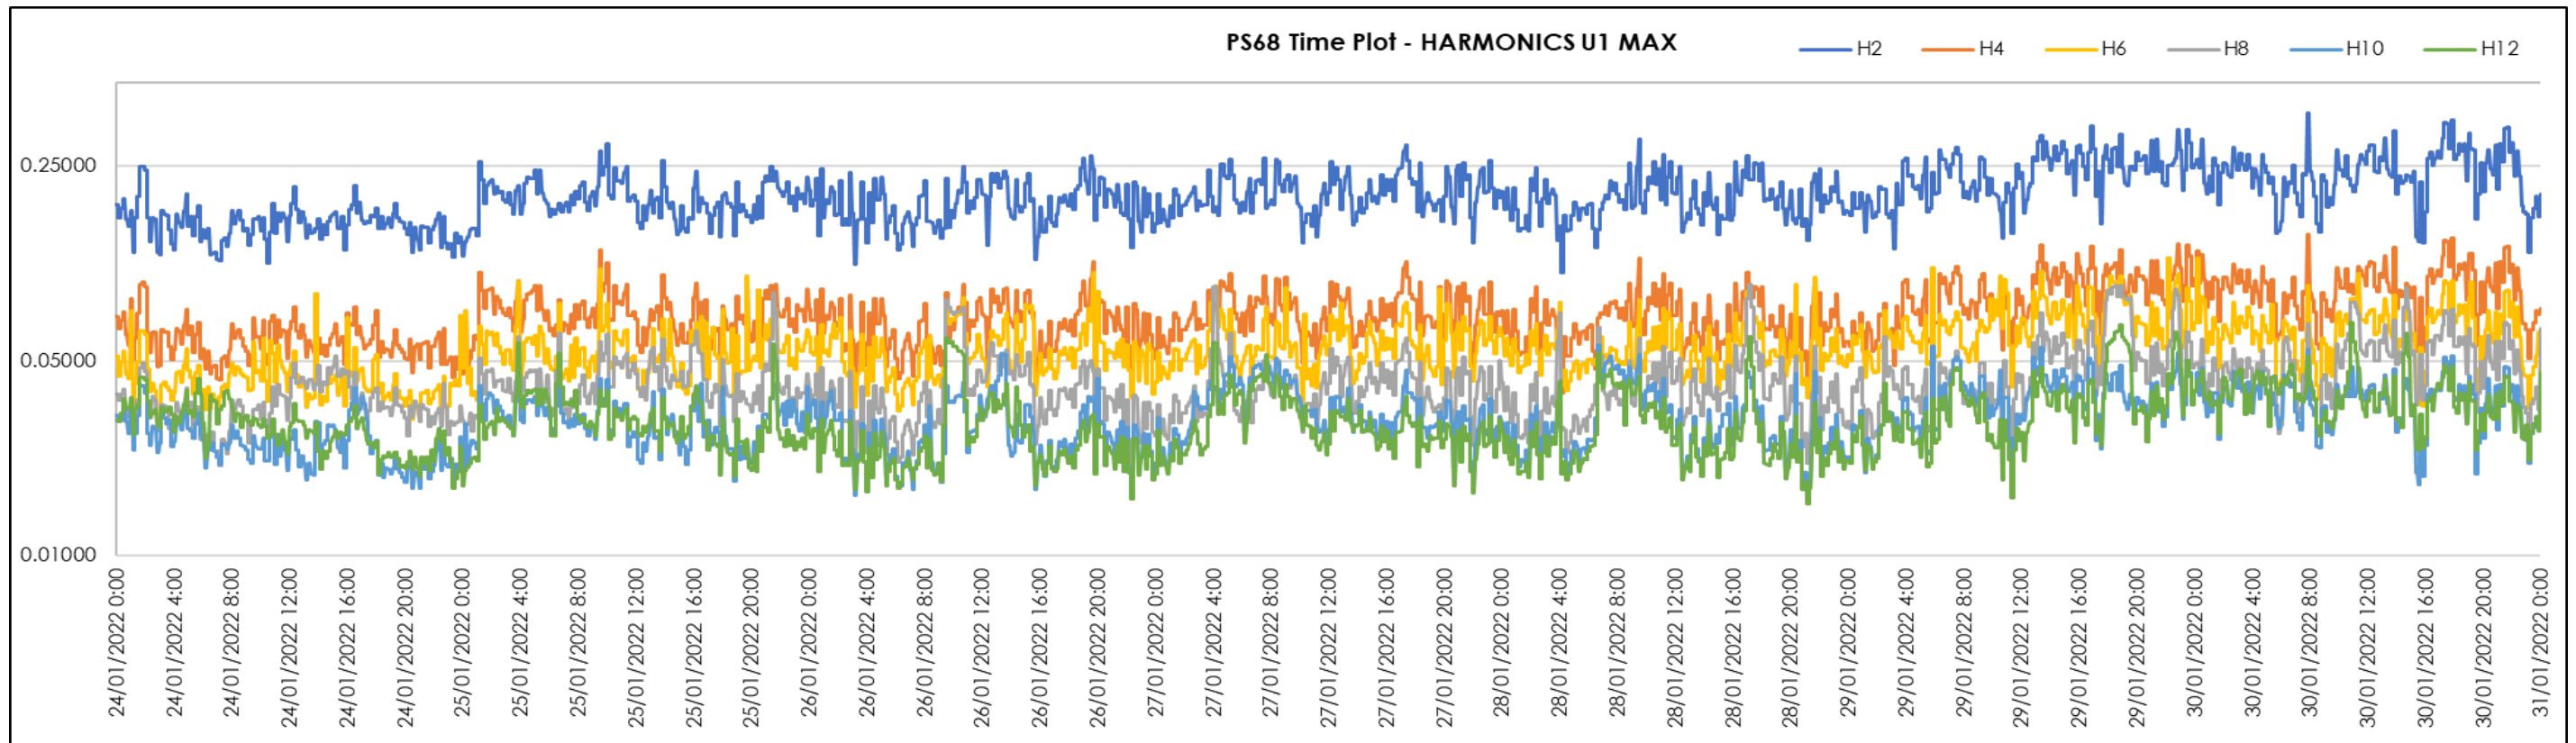
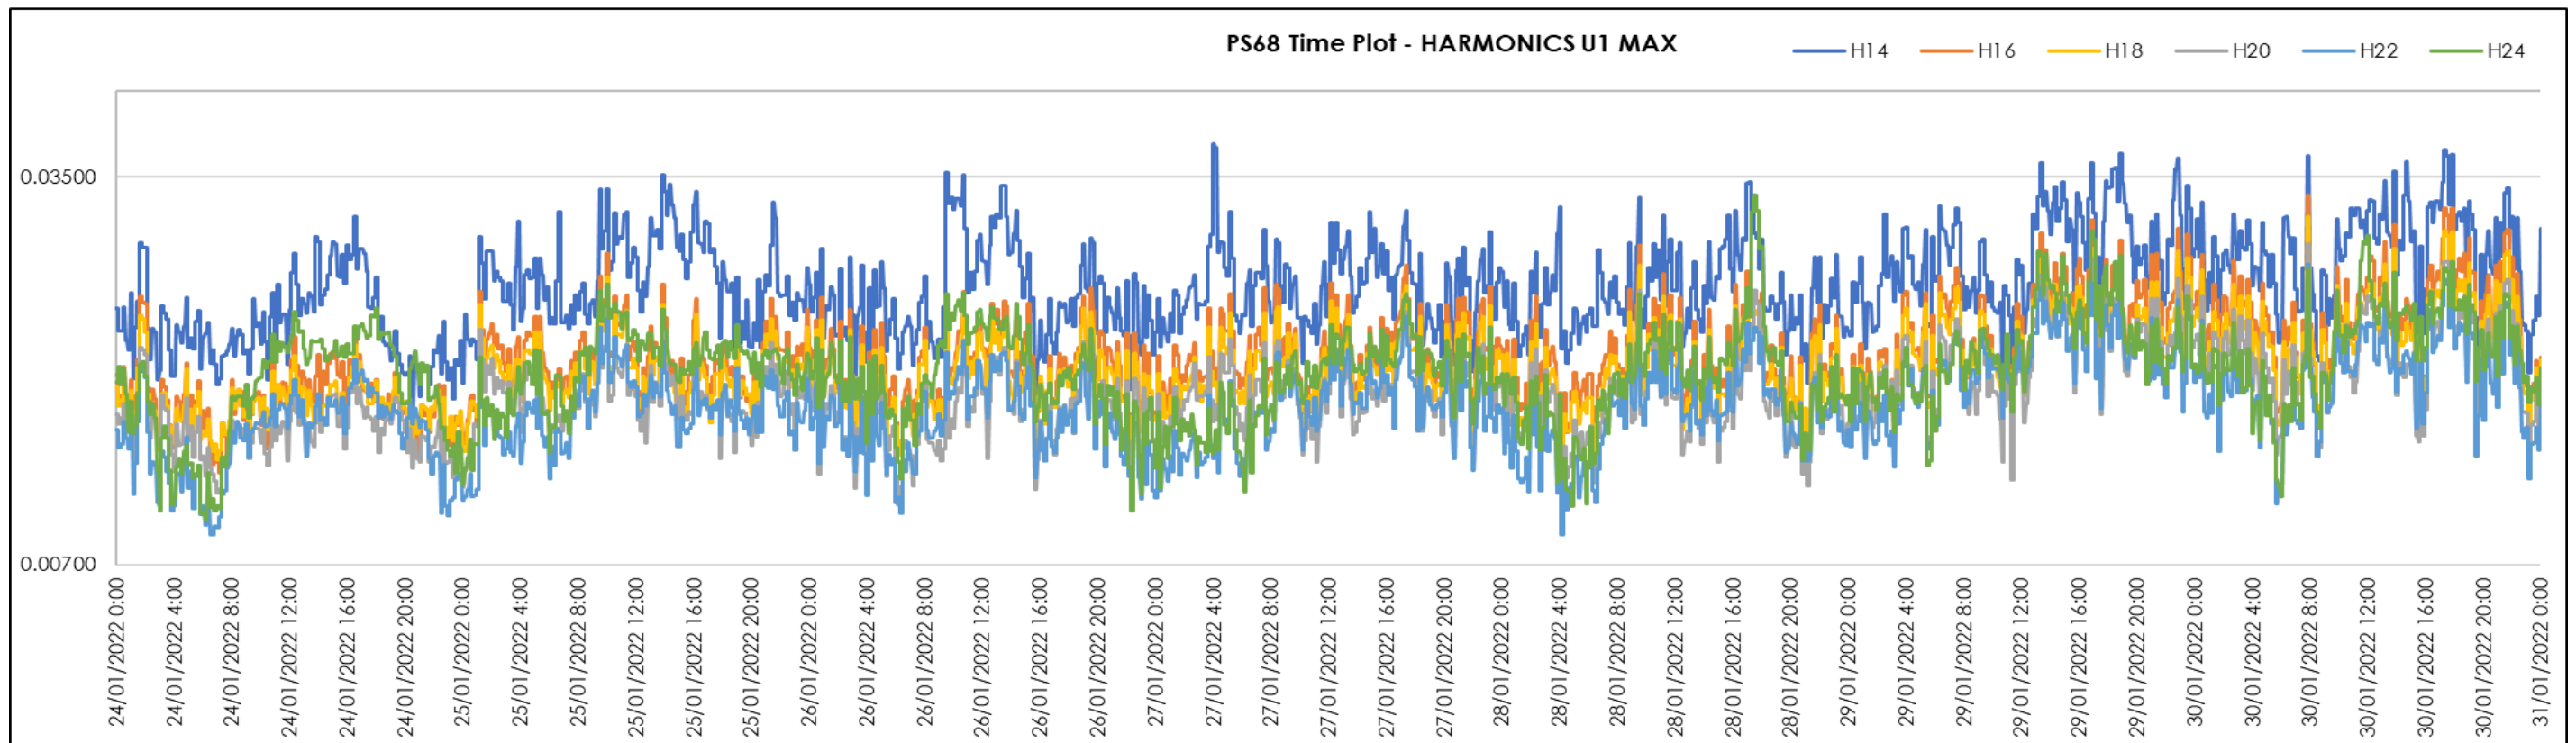
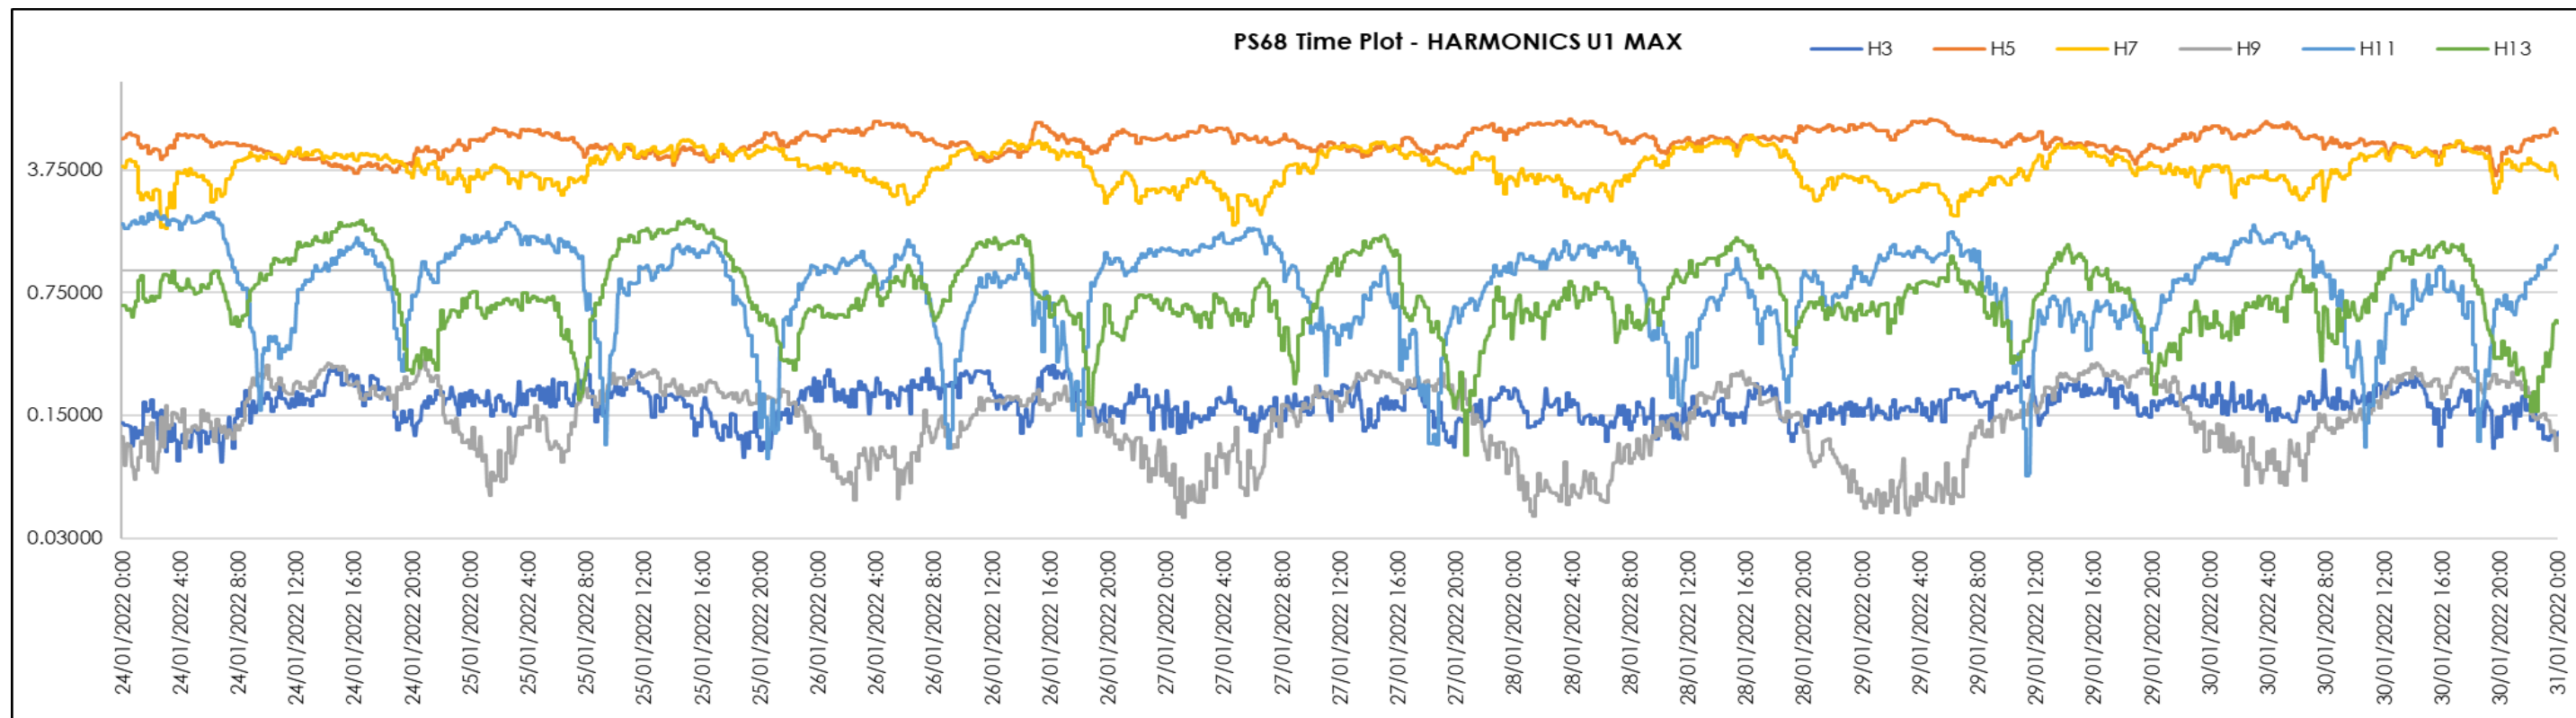
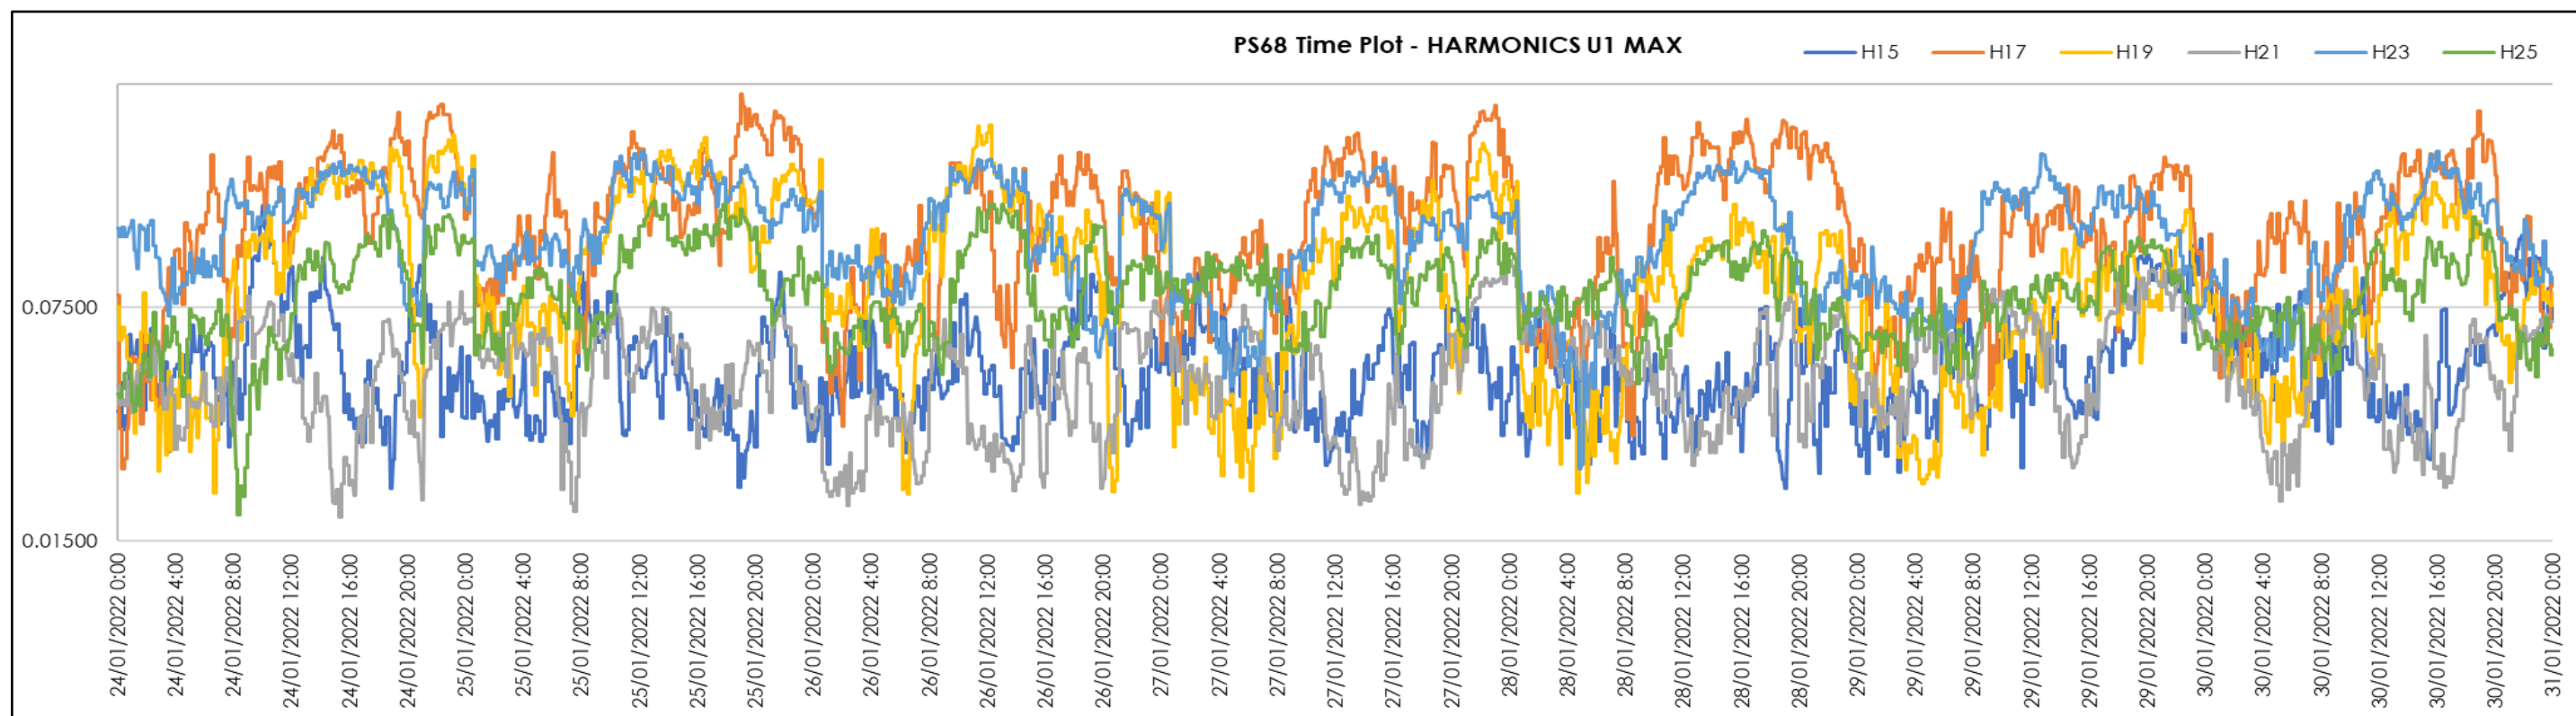
Figure 12 | TC1 End Harmonics

The logged harmonic data for the start and end of the TC1 feeder is shown from Figure 11 to Figure 12 in Appendix A.2. No non-compliant harmonics were recorded for the recording period.

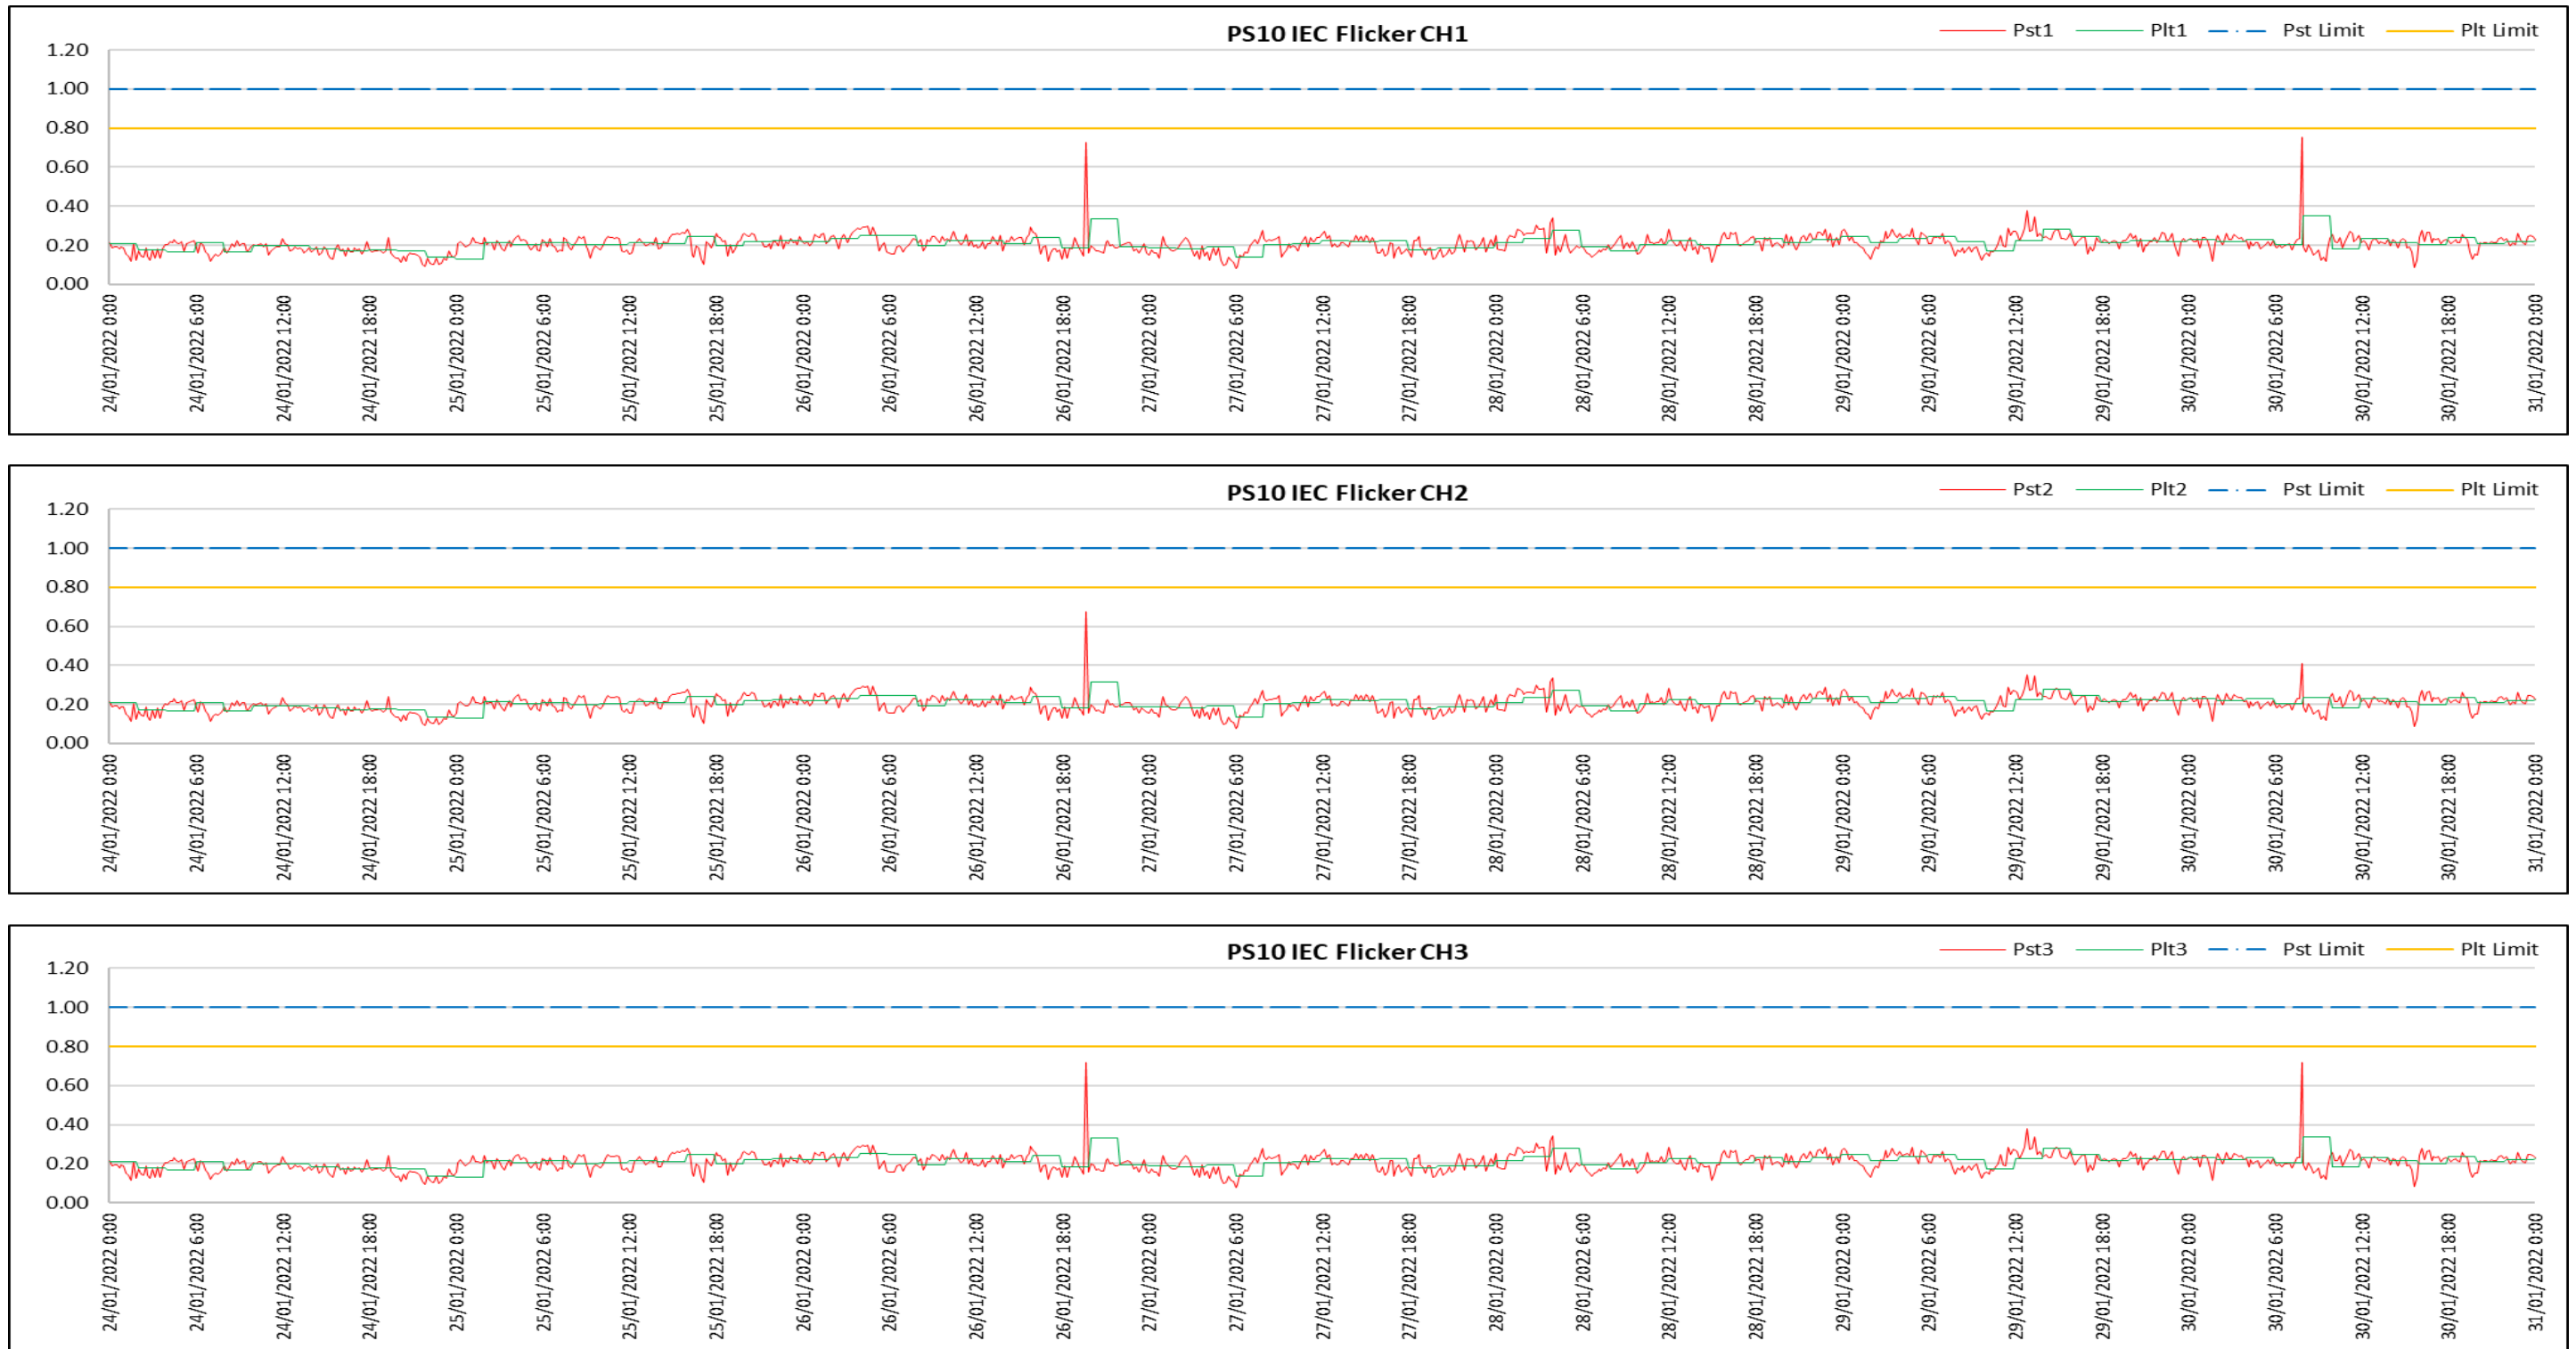
Figure 13 | TC2 Start Flicker measurements

The logged flicker data for the start and end of the TC2 feeder is shown from Figure 13 to Figure 14 in Appendix A.2. There were no recorded flicker limit events causing the flicker level to breach the Code's limits (i.e., full compliance with the Code requirements).

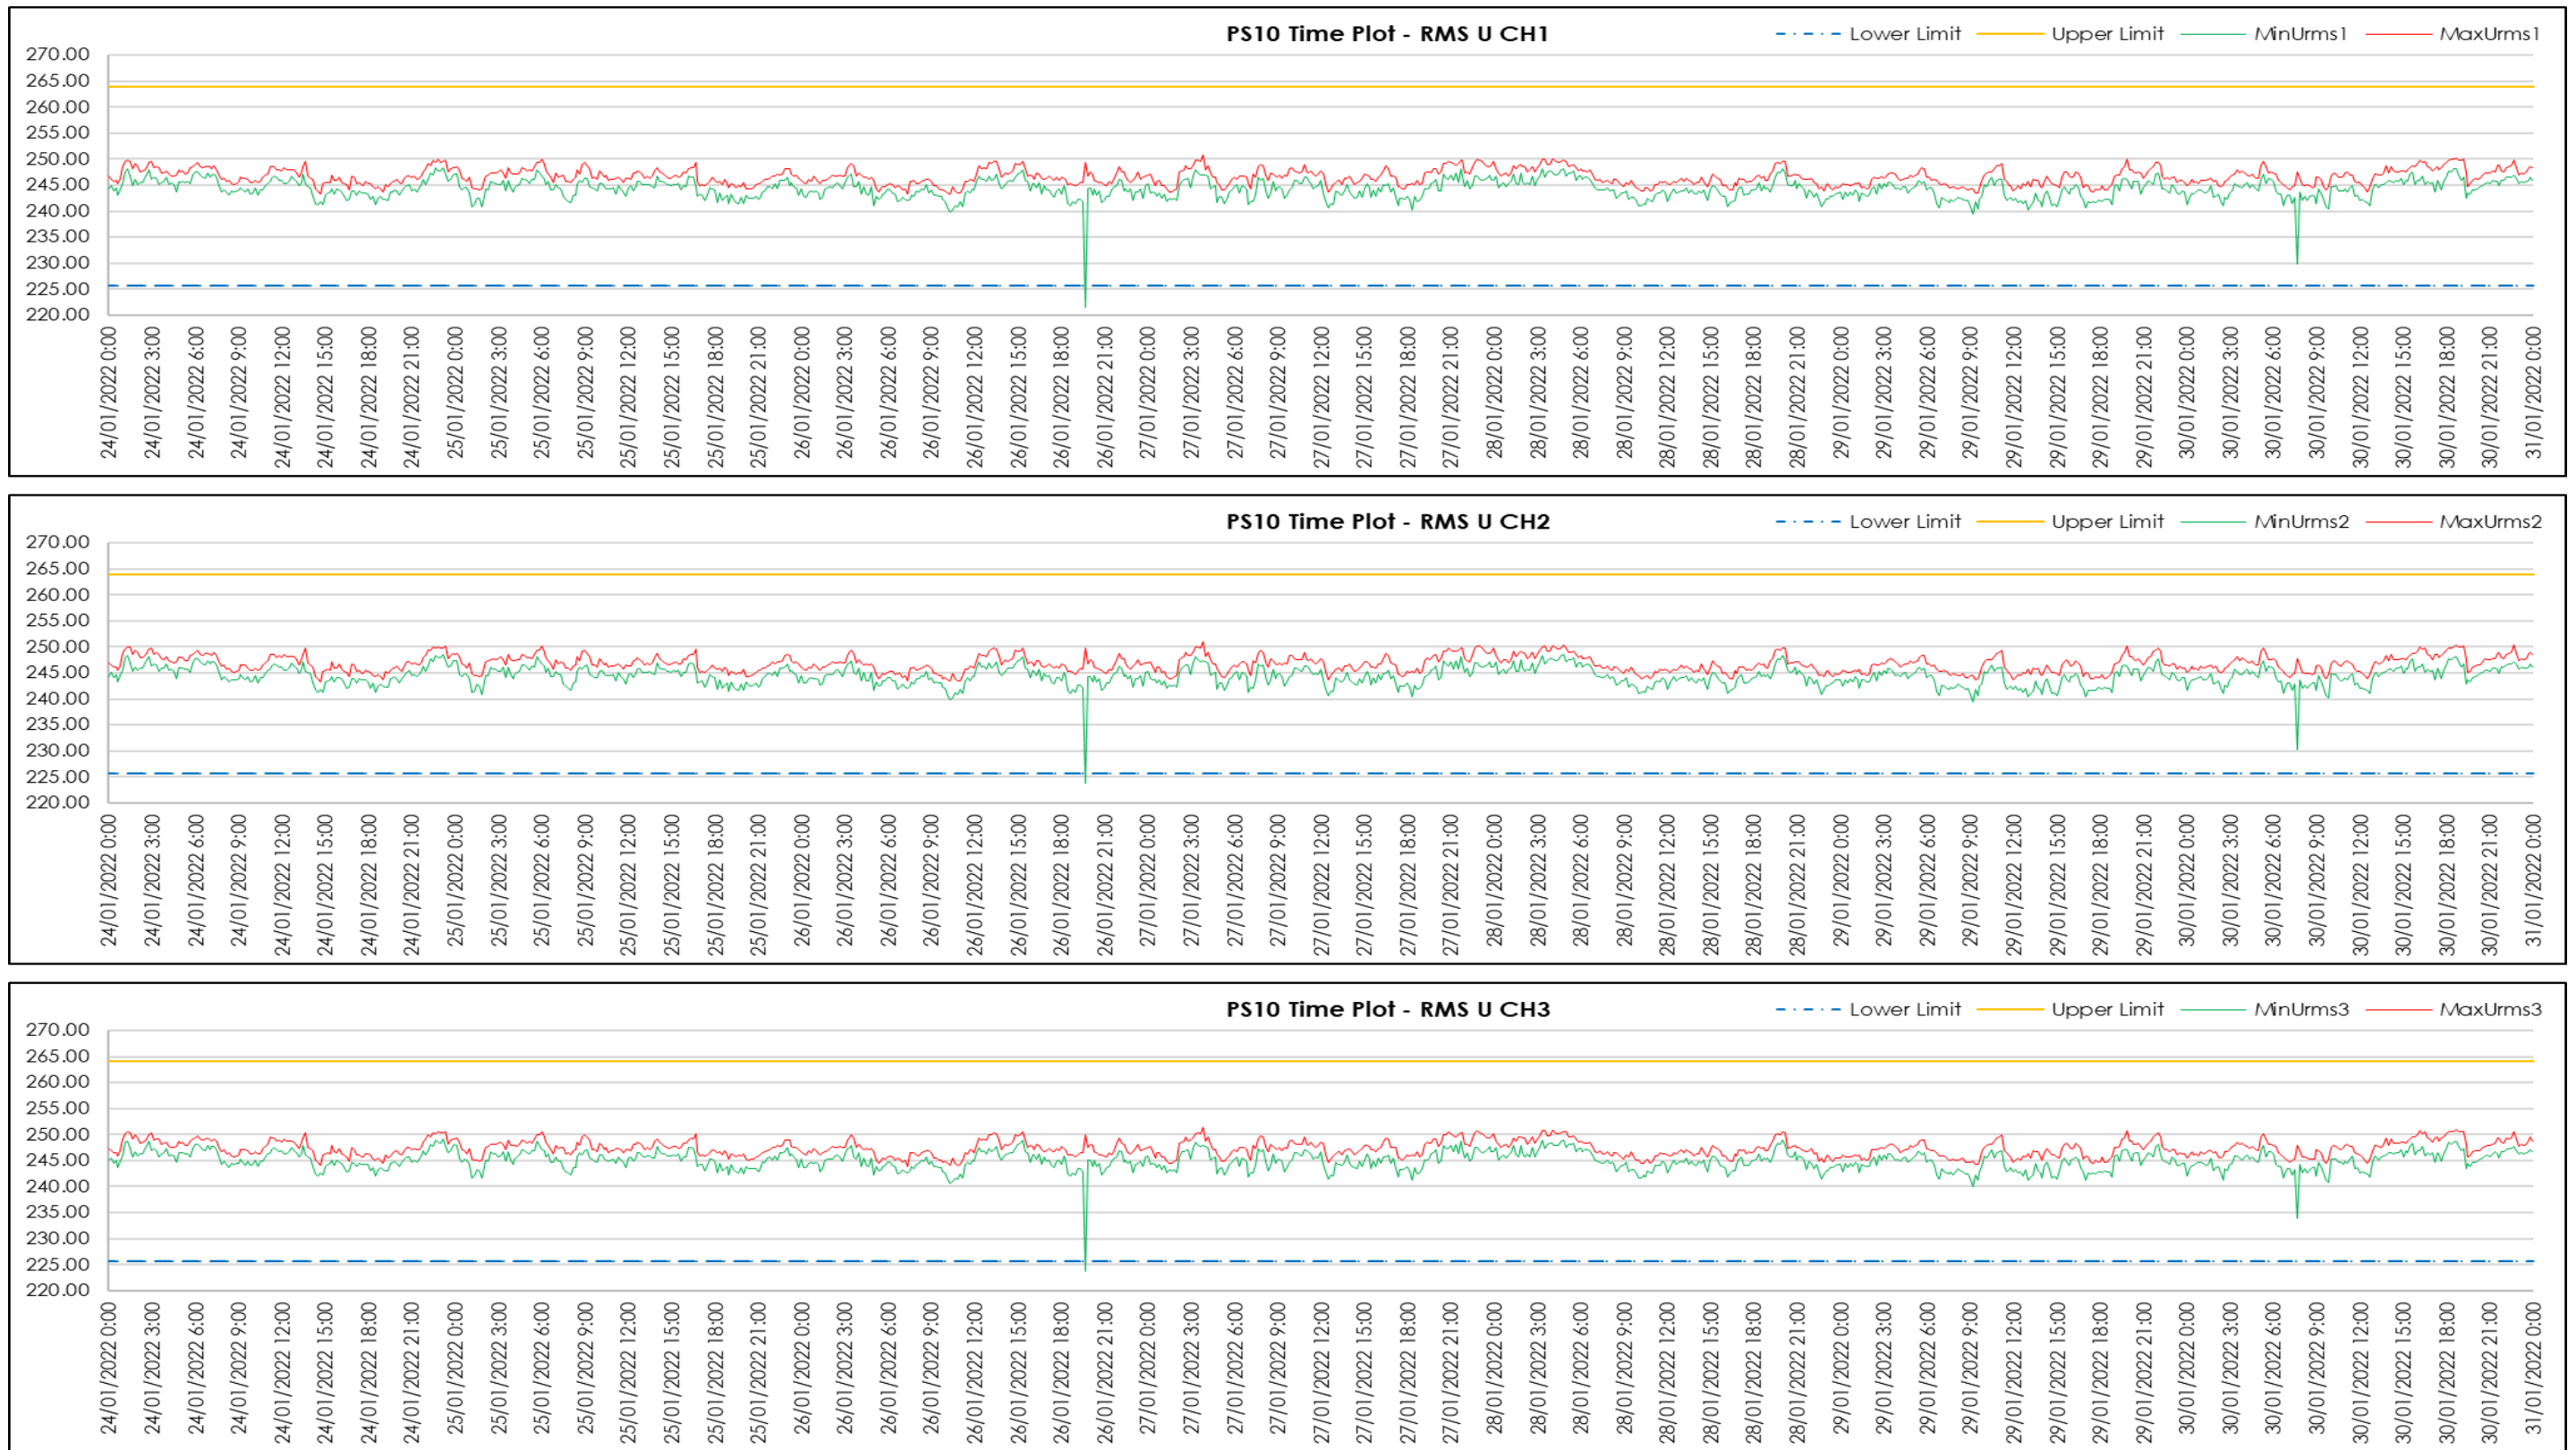
Figure 15 | TC2 Start Voltage measurements

The logged voltage level data for the start and end of the TC2 feeder is shown from Figure 15 to Figure 16 in Appendix A.2. Table 5 below shows the recorded breach events during the logging period.

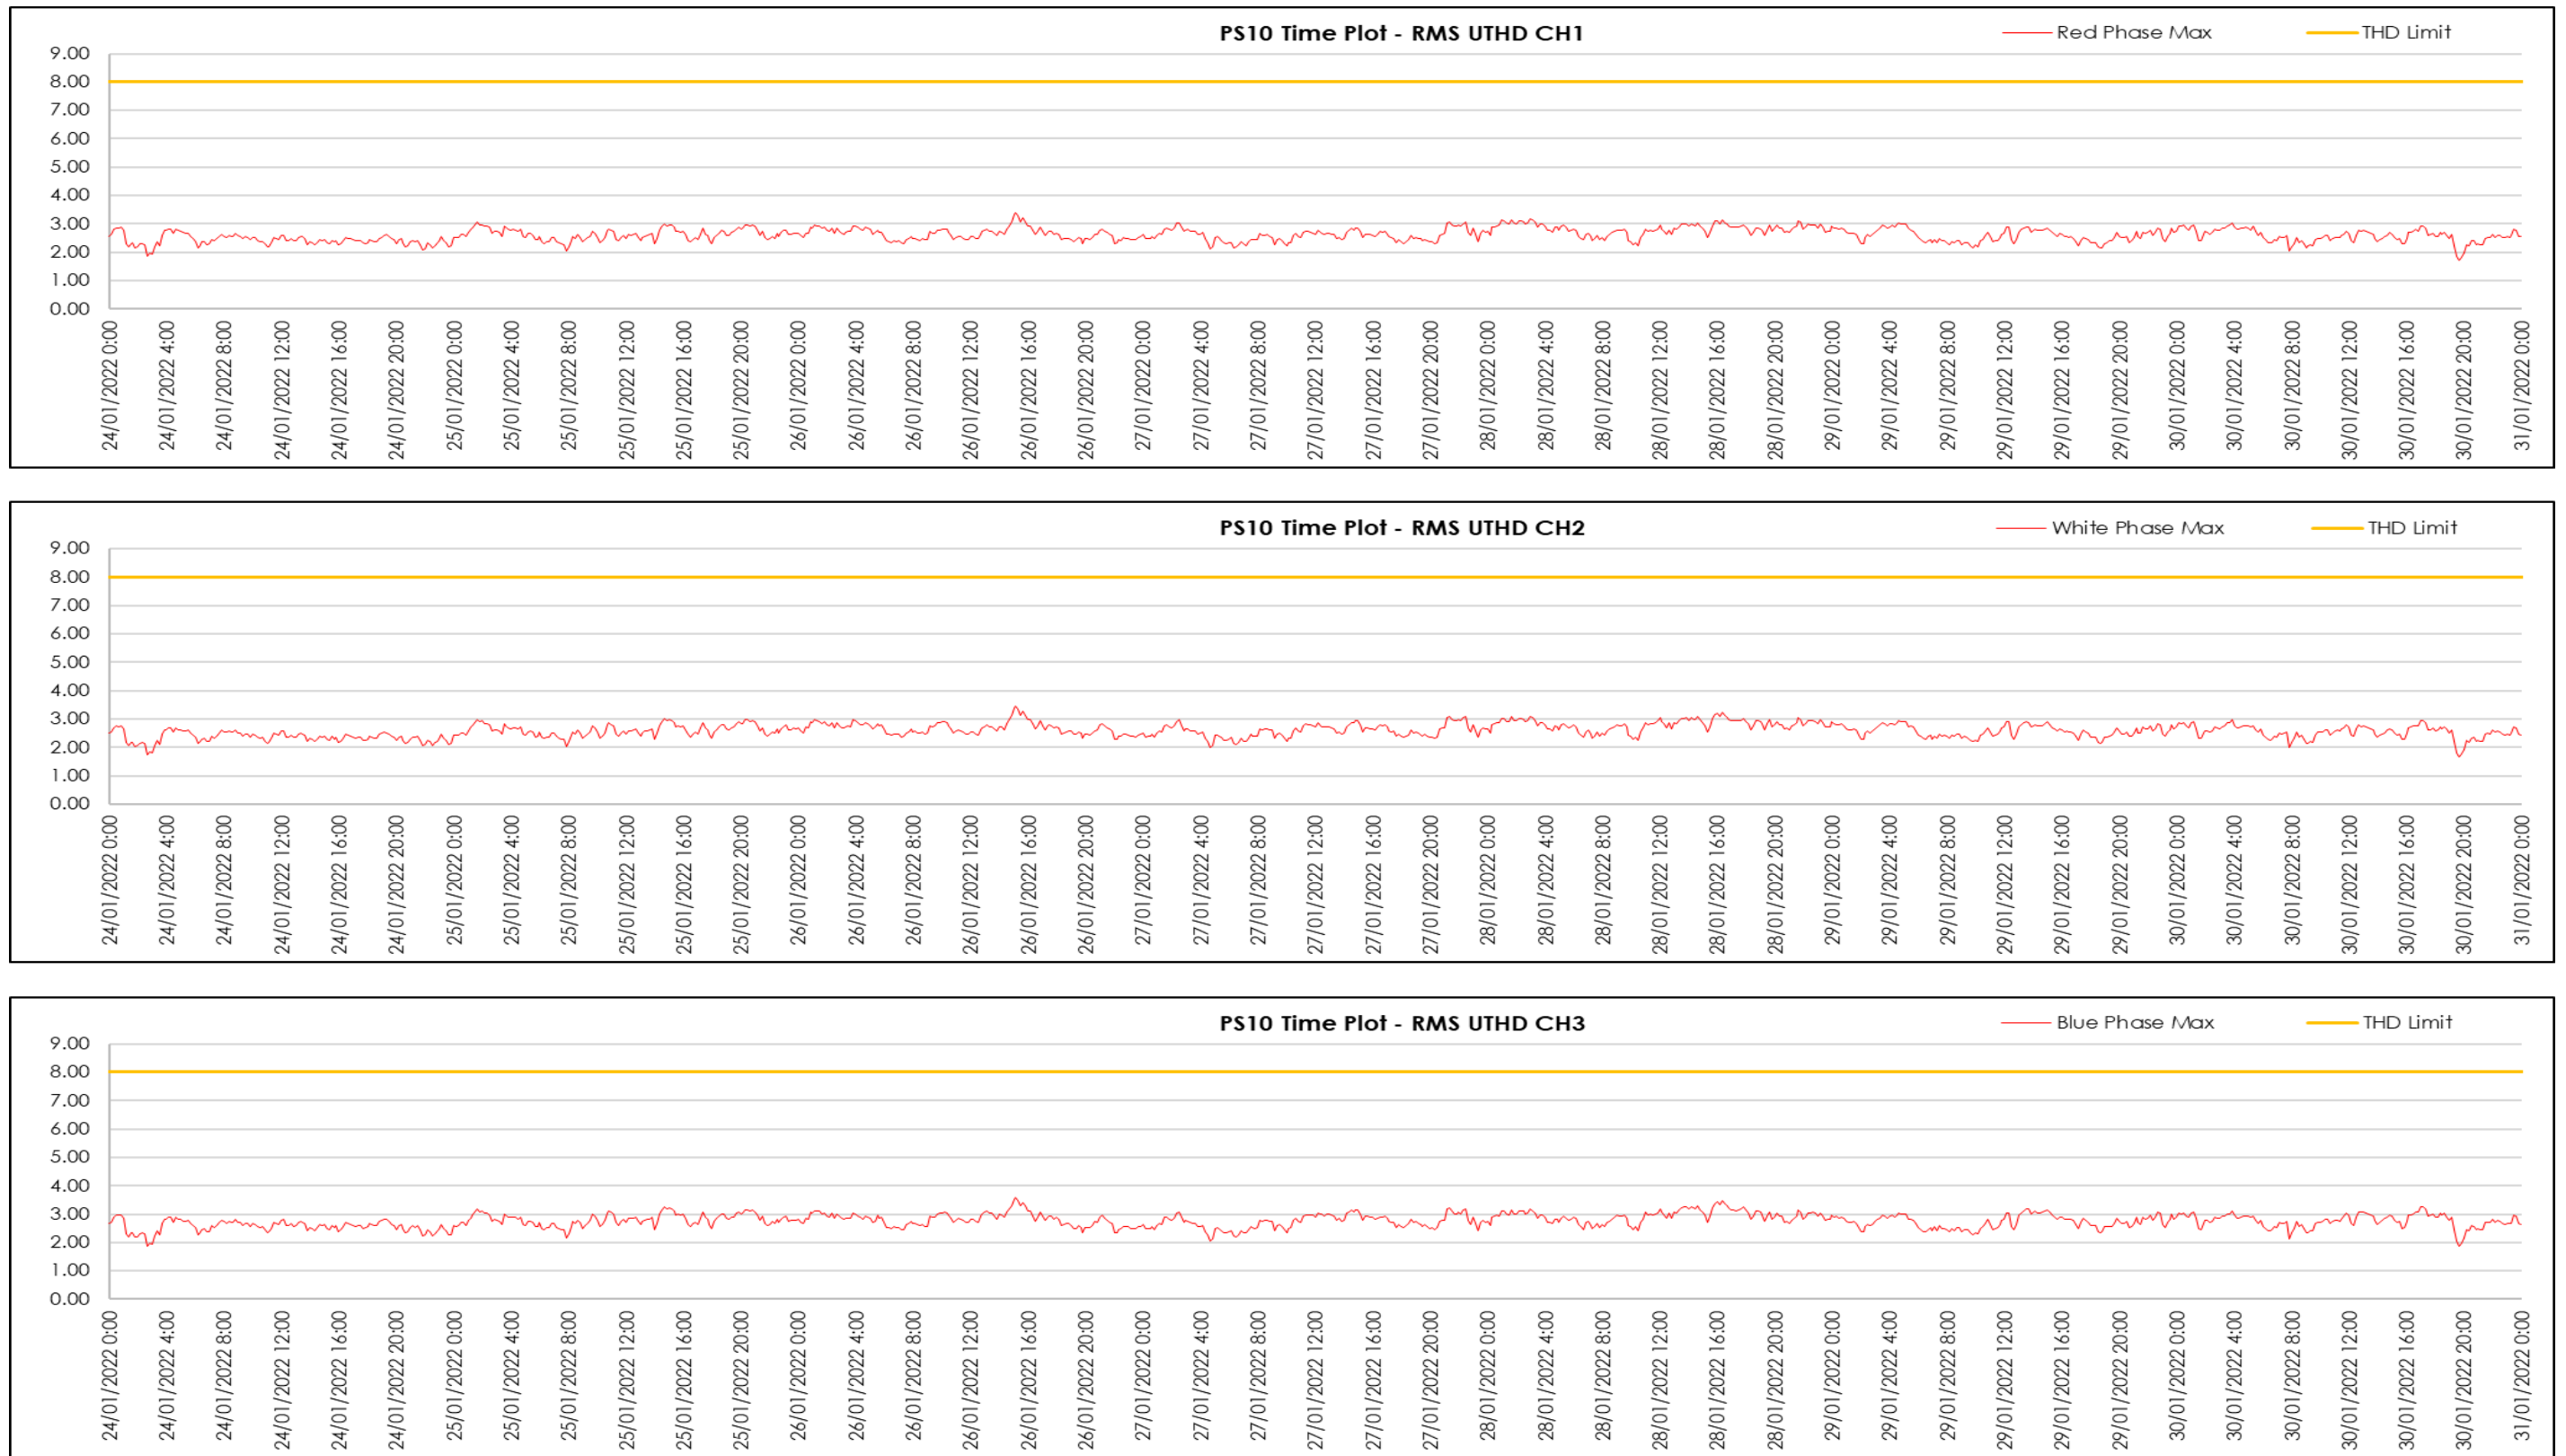
Figure 19 | TC2 Start U-THD measurements

The logged voltage THD level data for the start and end of the TC2 feeder is shown from Figure 19 to Figure 20 in Appendix A.2. There were no recorded voltage THD limit events causing the voltage THD level to breach the Code's limits (i.e., full compliance with the Code requirements).
