APD
ENGINEERING

BHP NEWMAN TOWNSHIP ELECTRICITY SUPPLY
ANNUAL COMPLIANCE REPORT
2021/2022

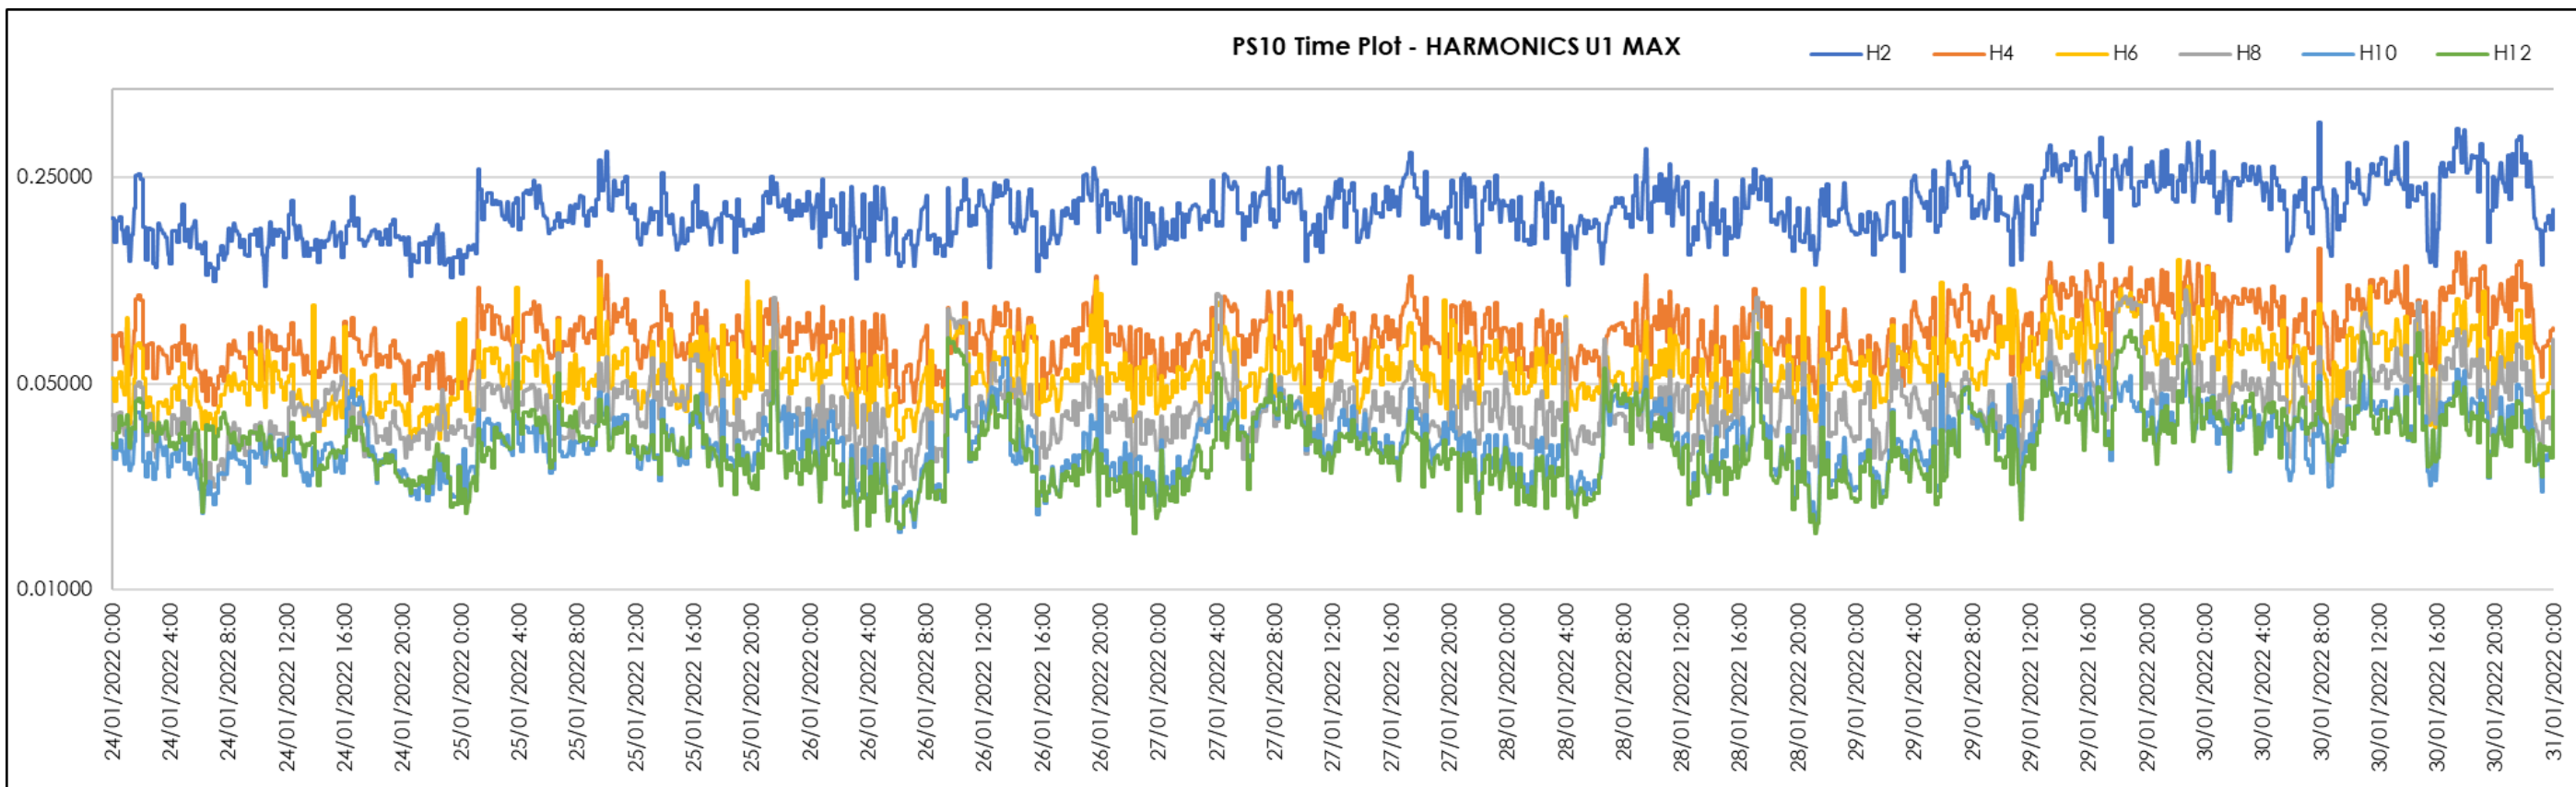
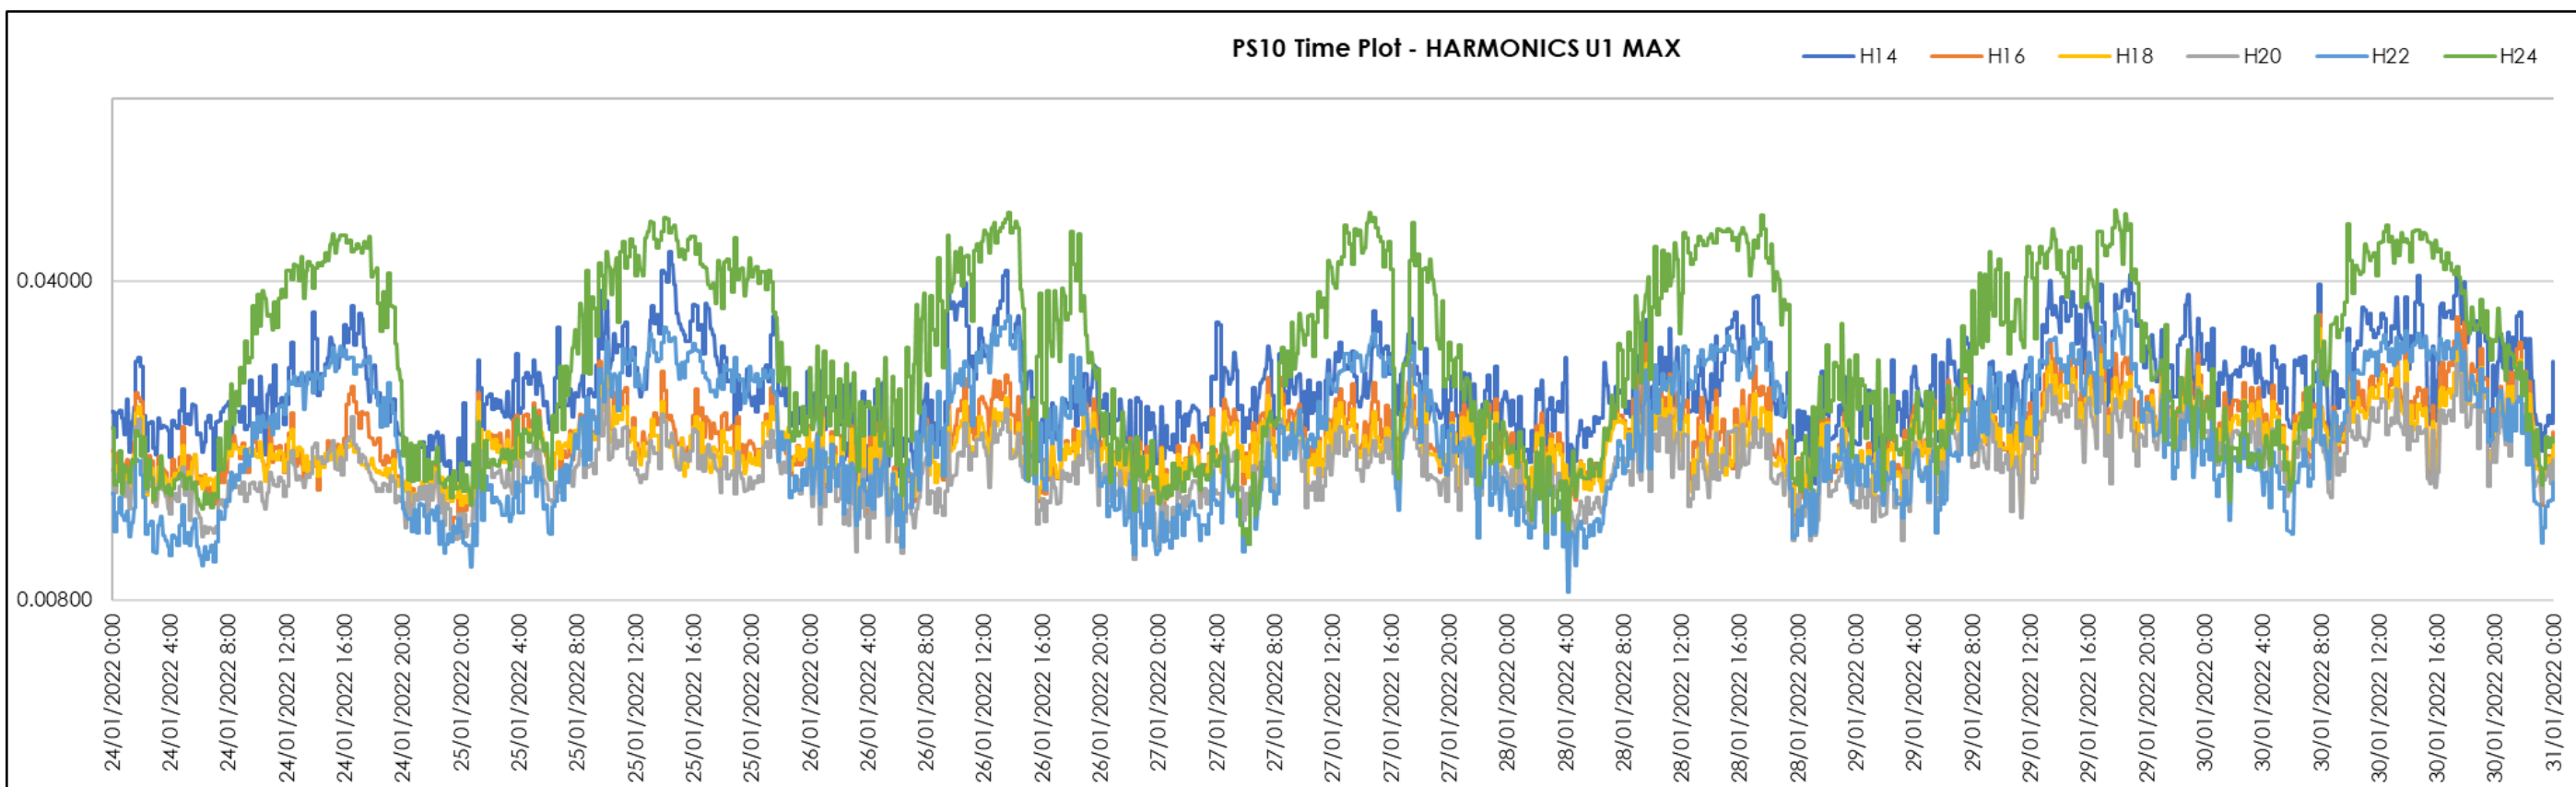
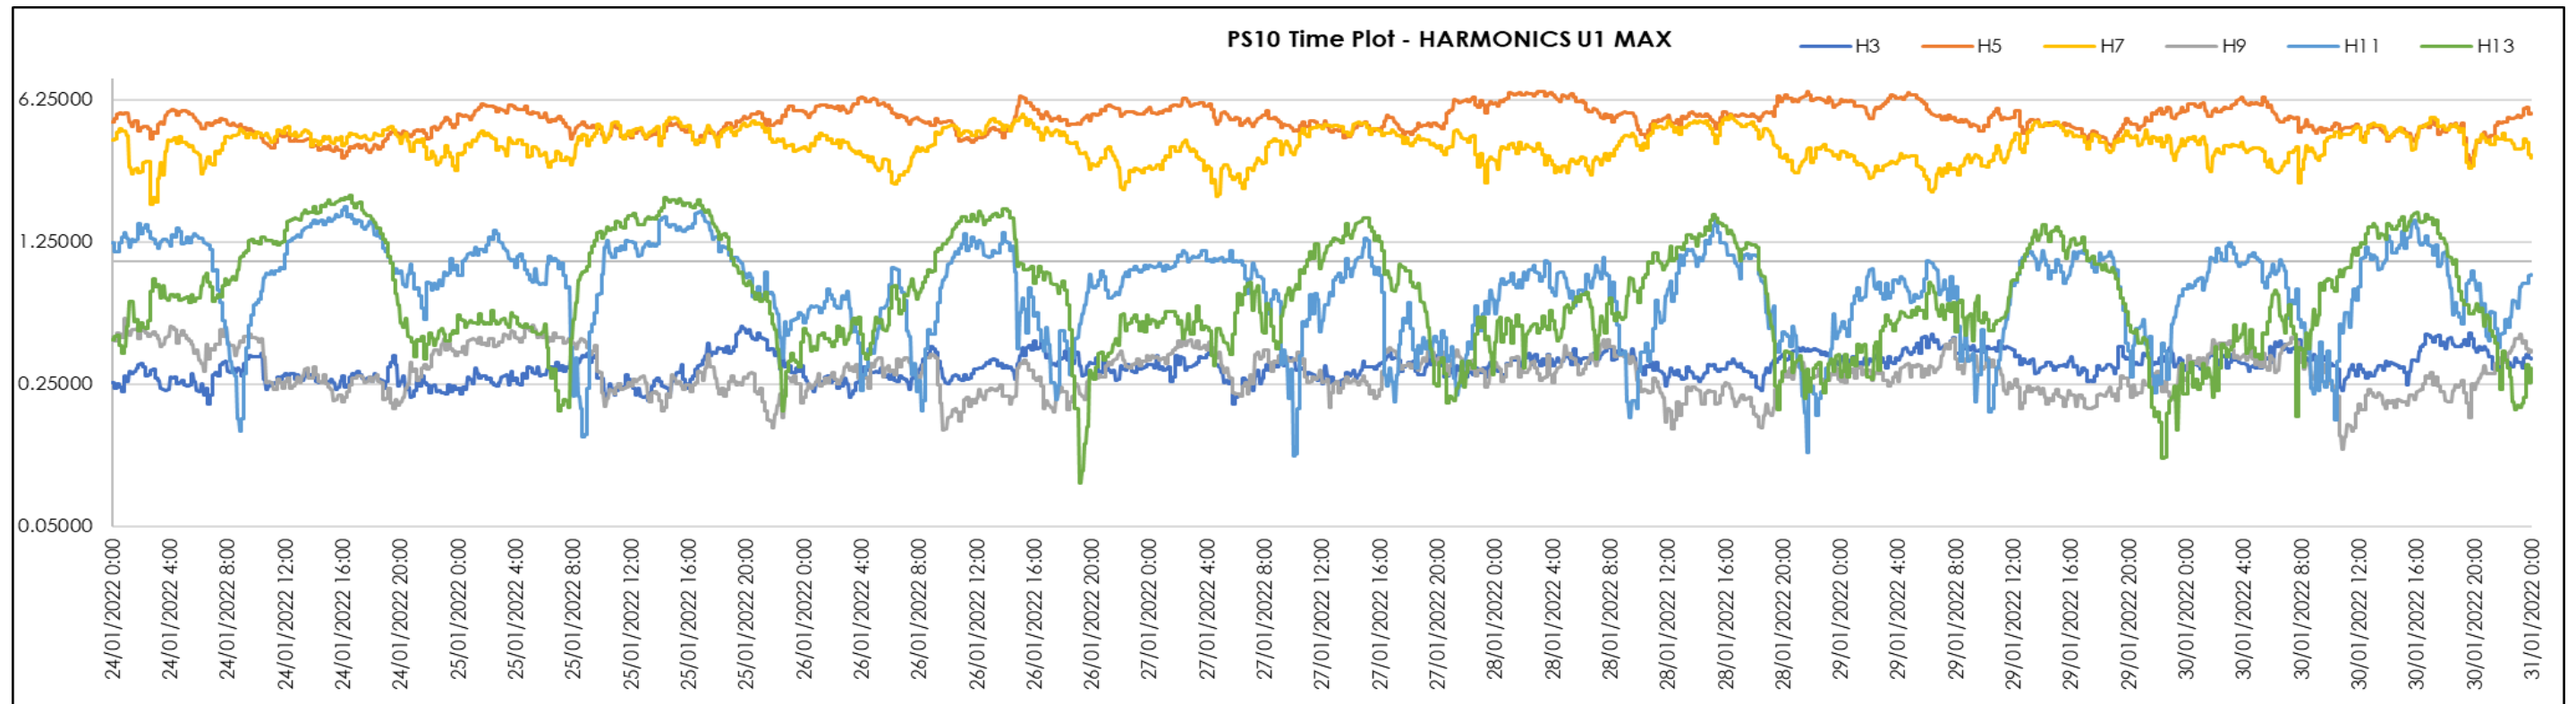
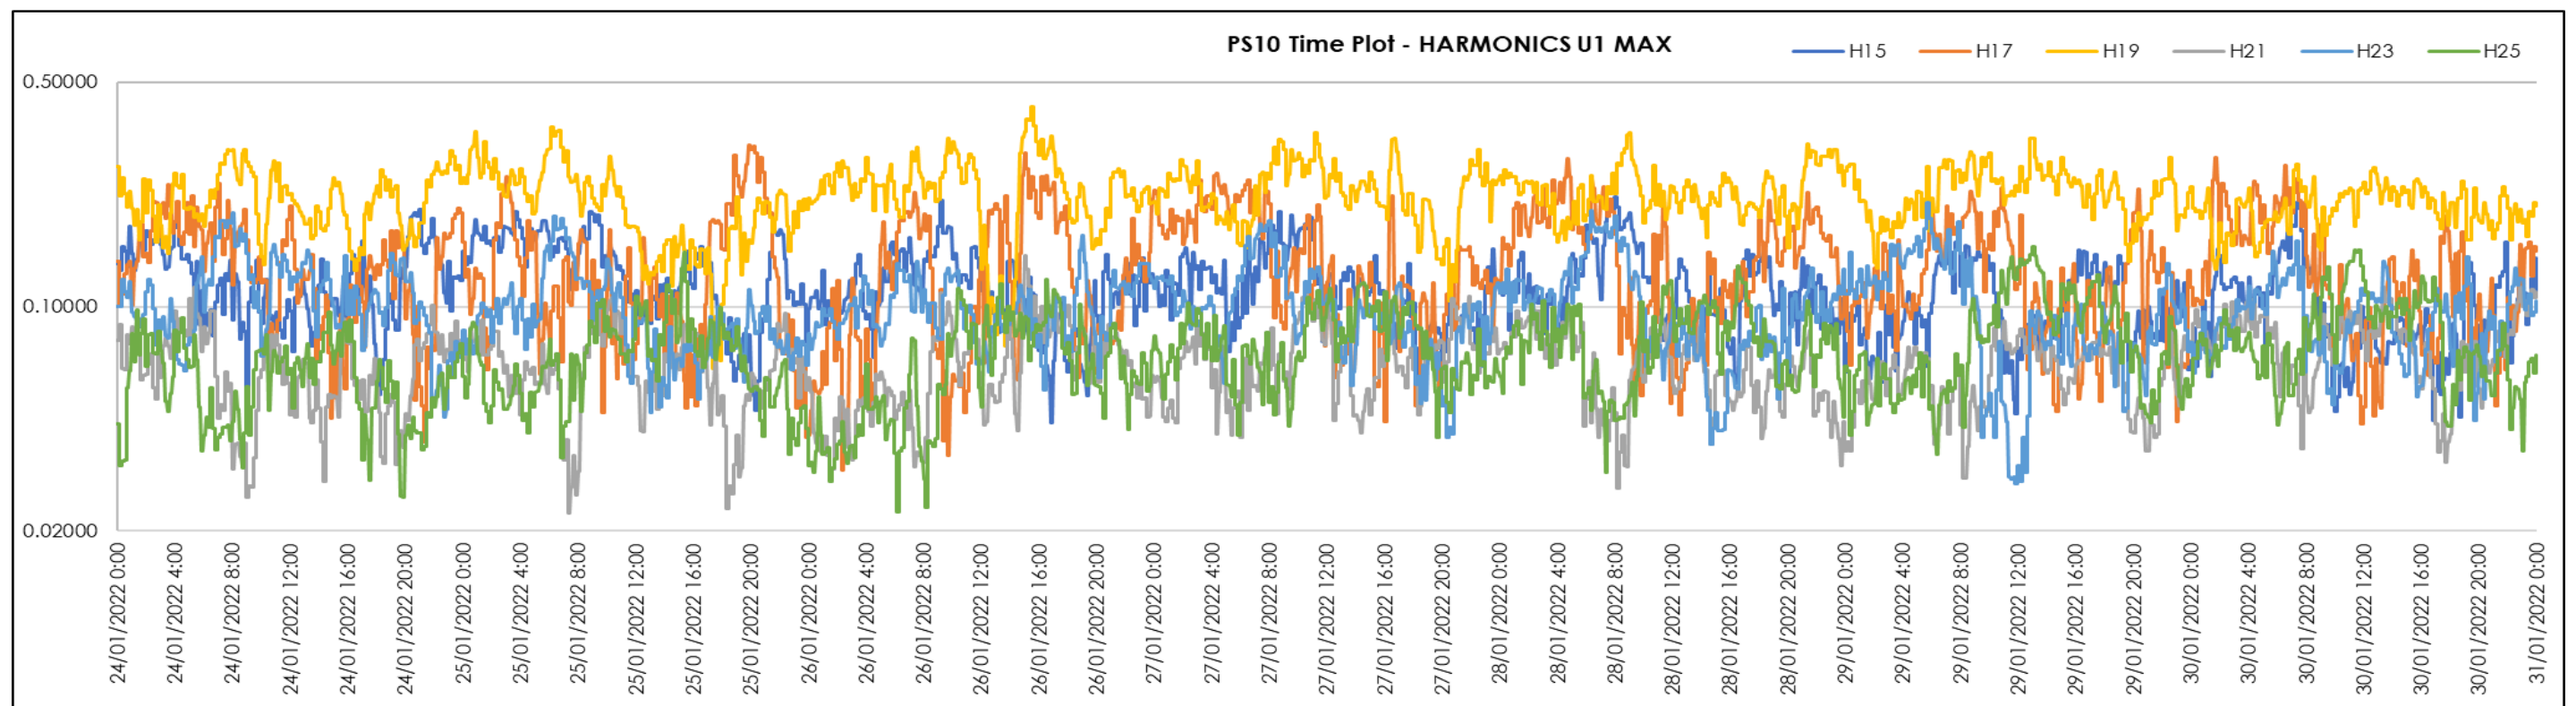
Figure 21 | TC2 Start Harmonics

The logged harmonic data for the start and end of the TC2 feeder is shown from Figure 21 to Figure 22 in Appendix A.2. No non-compliant harmonics were recorded for the recording period.

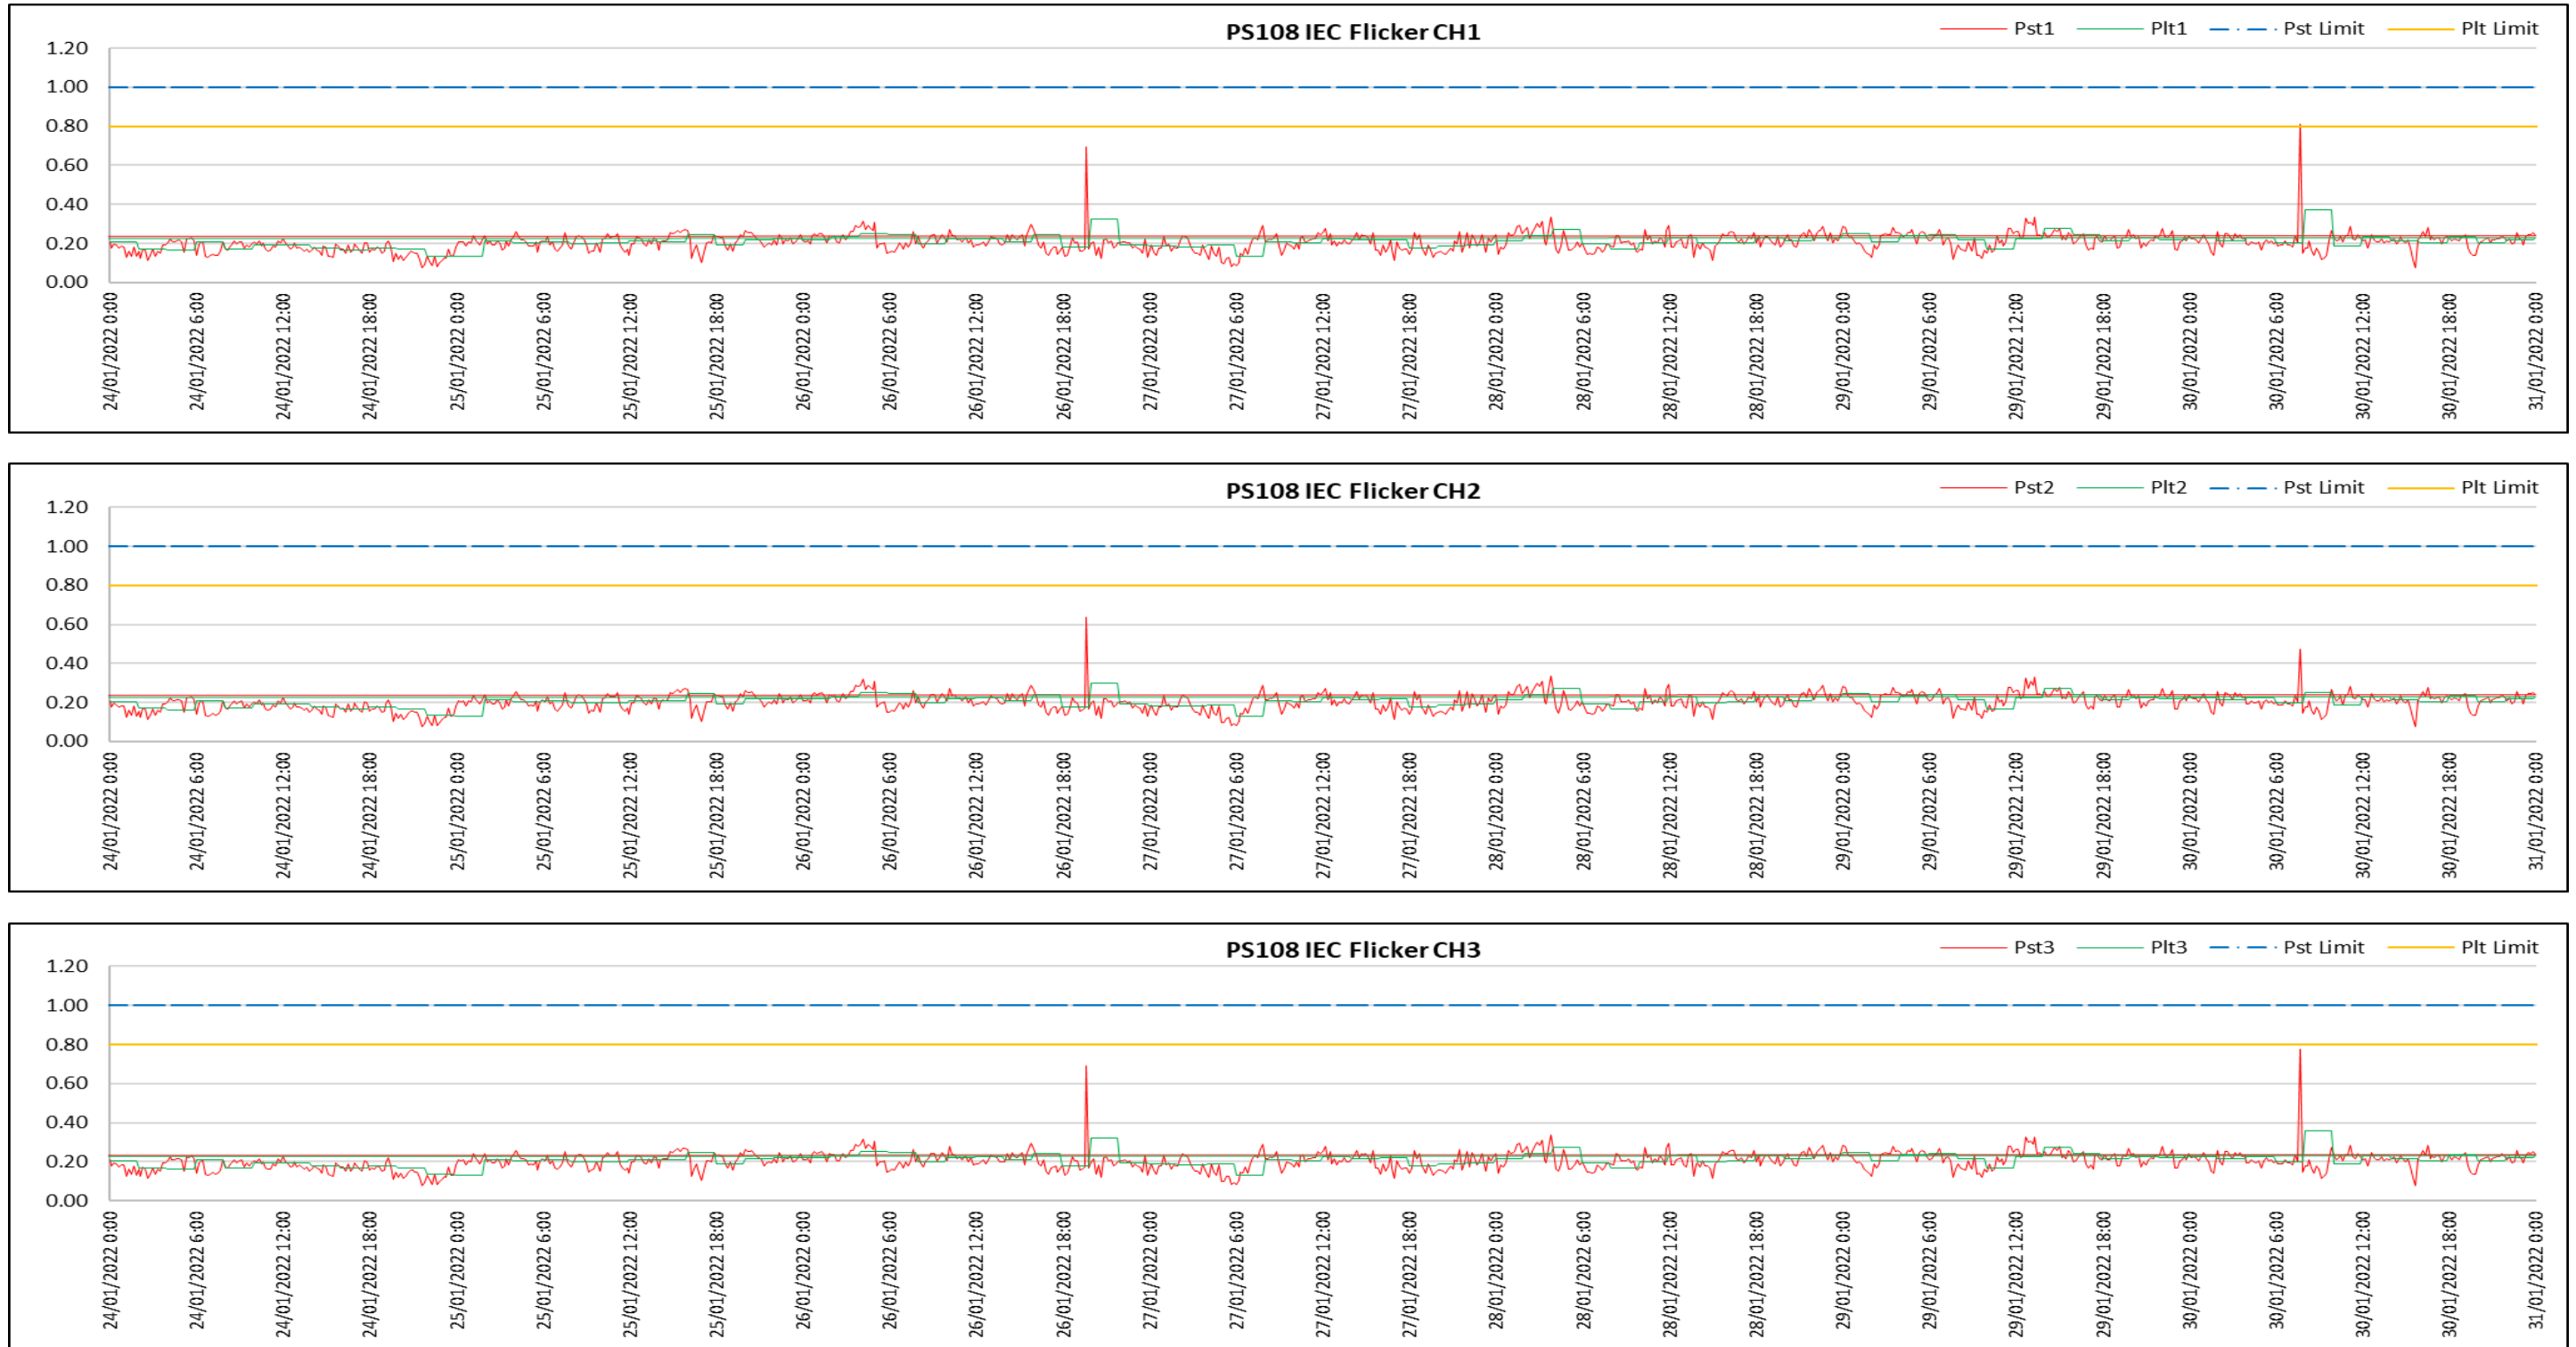
Figure 23 | TC3 Start Flicker measurements

The logged flicker data for the start and end of the TC3 feeder is shown from Figure 23 to Figure 24 in Appendix A.3. There were no recorded flicker limit events causing the flicker level to breach the Code's limits (i.e., full compliance with the Code requirements).

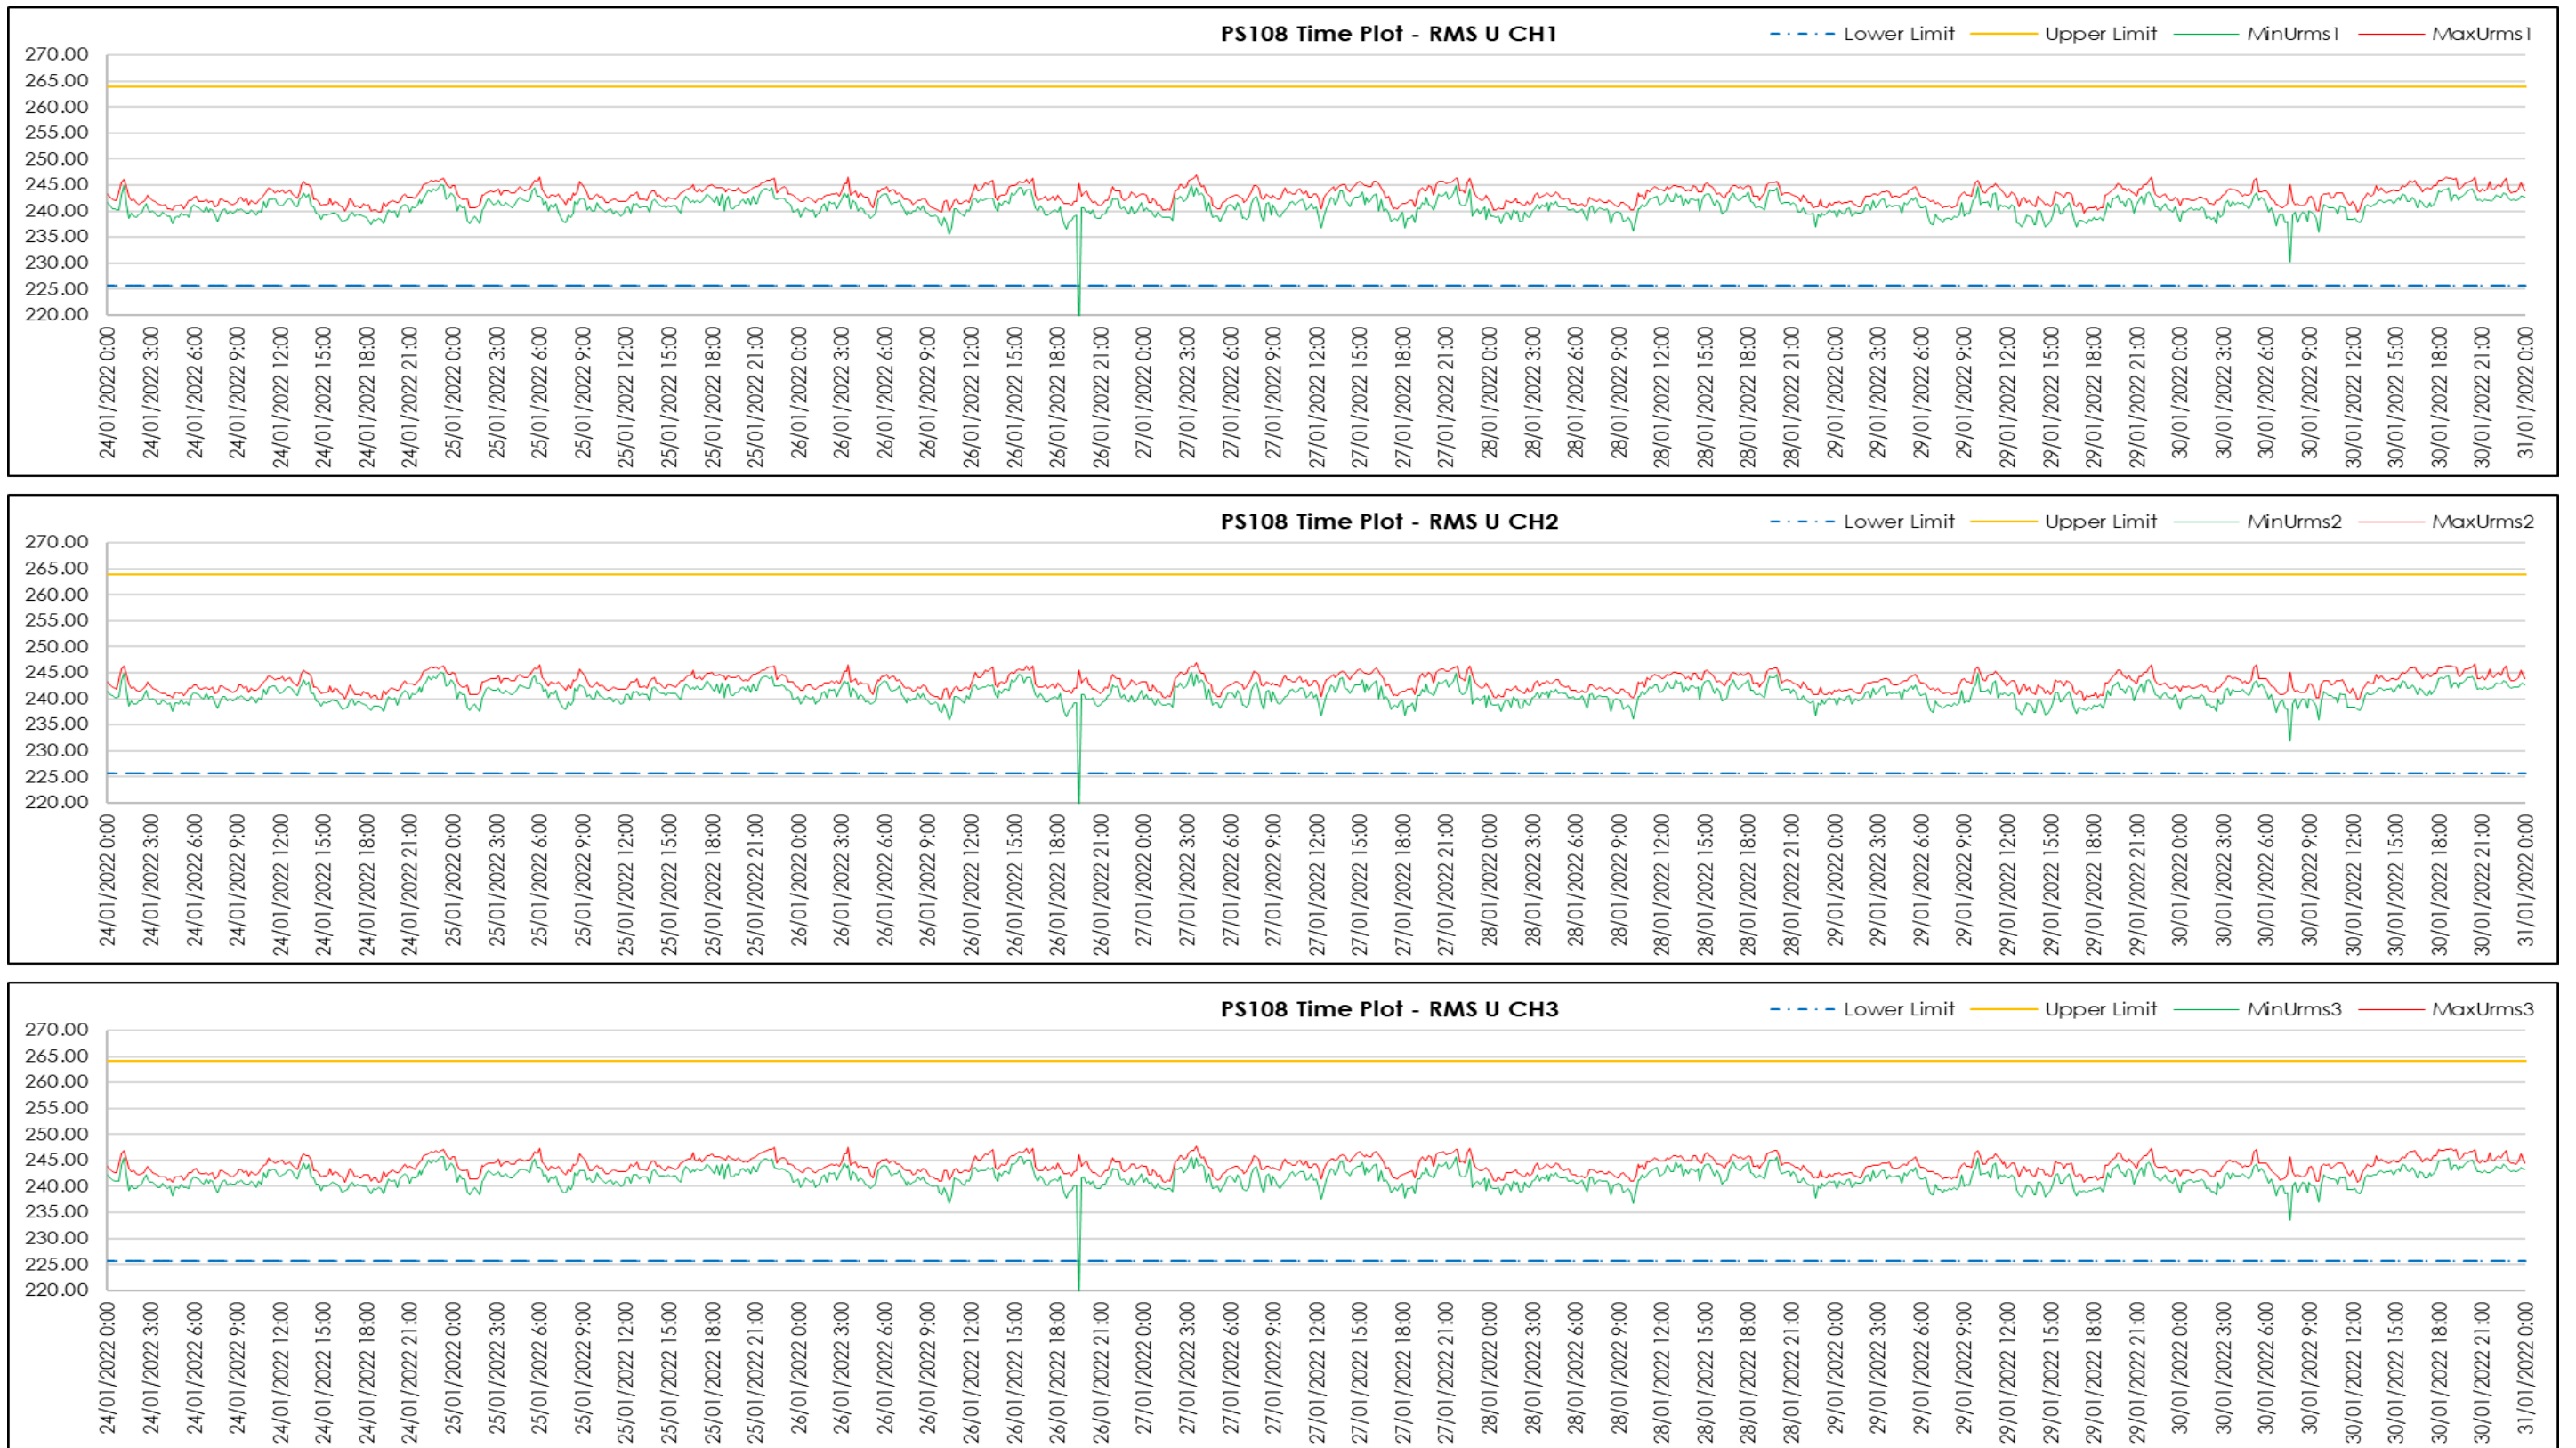
Figure 25 | TC3 Start Voltage measurements

The logged voltage level data for the start and end of the TC3 feeder is shown from Figure 25 to Figure 26 in Appendix A.3. Table 6 below shows the recorded breach events during the logging period.

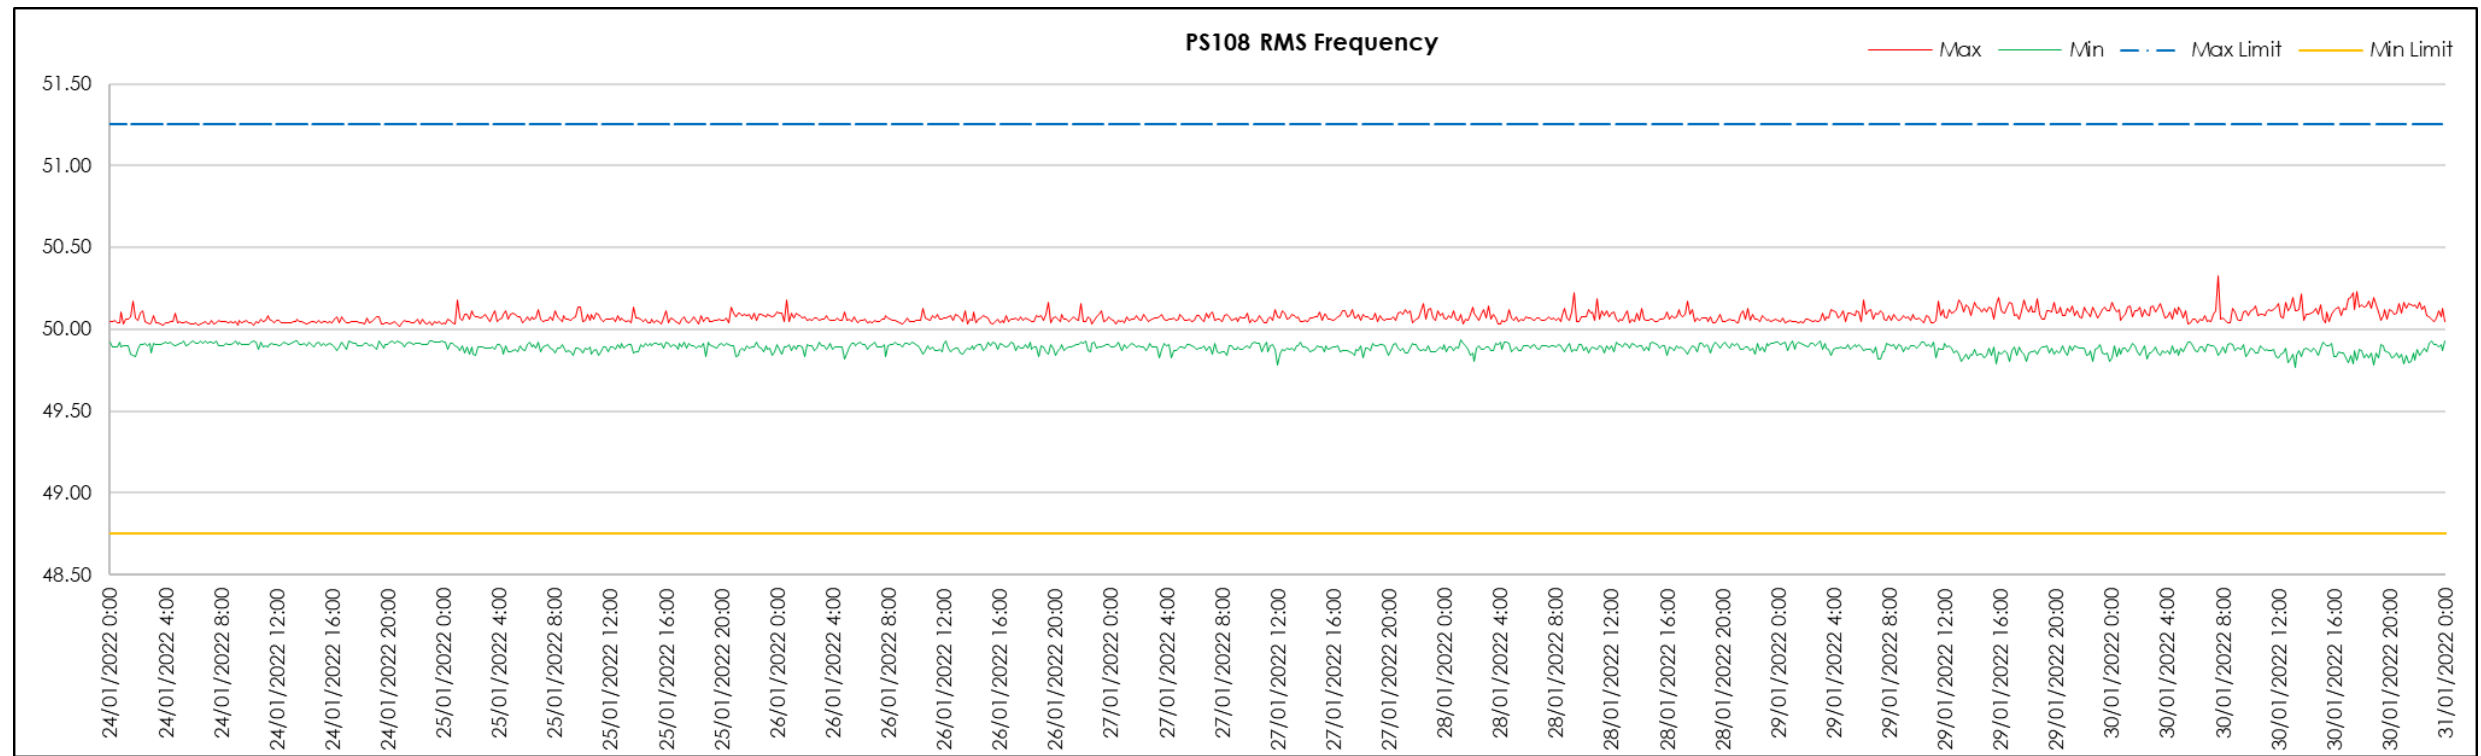
Figure 27 | TC3 Start Frequency measurements

Figure 27 to Figure 28 in Appendix A.3. *There were no recorded frequency limit events causing the frequency level to breach the Code's limits (i.e., full compliance with the Code requirements).*

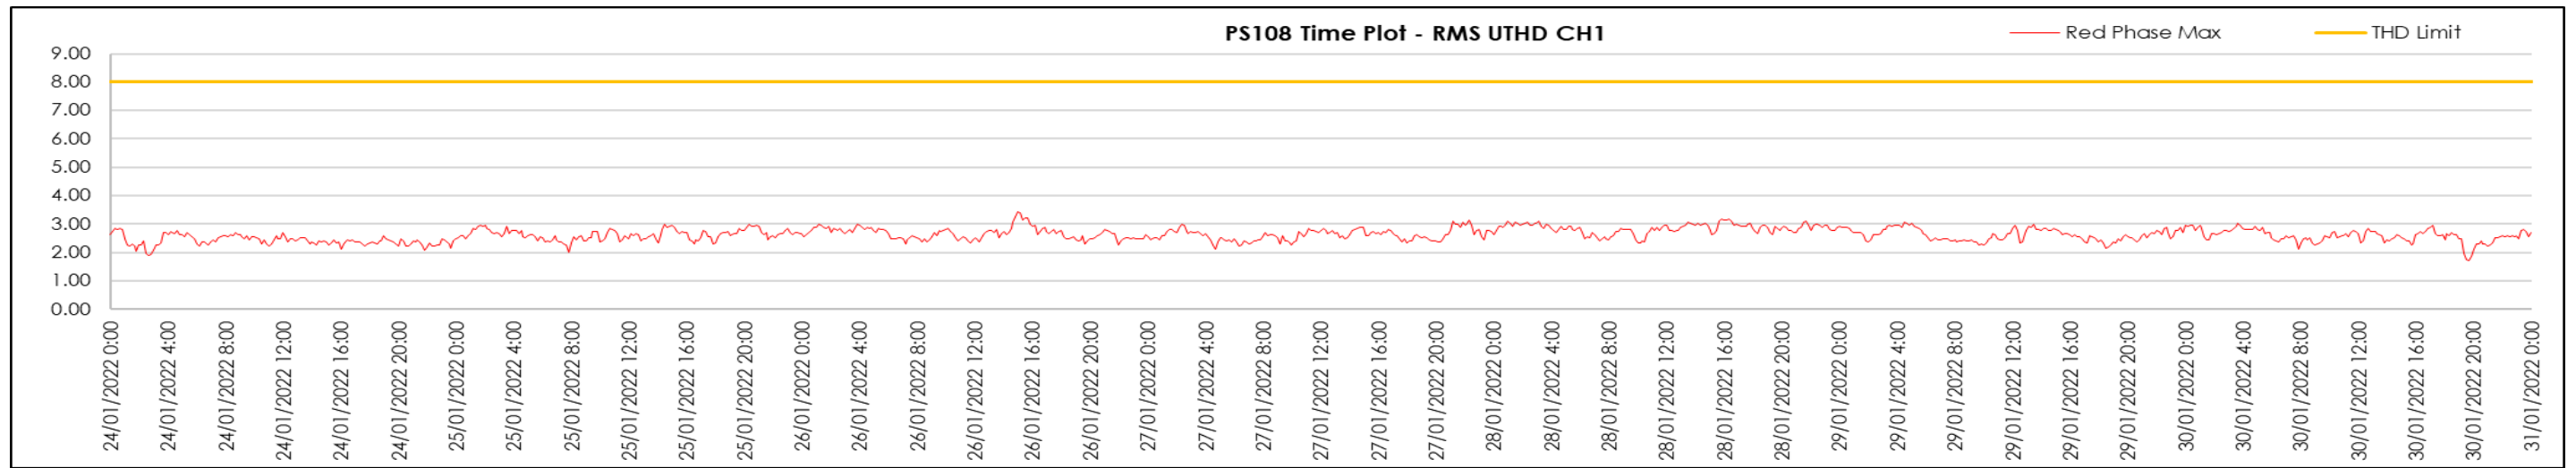
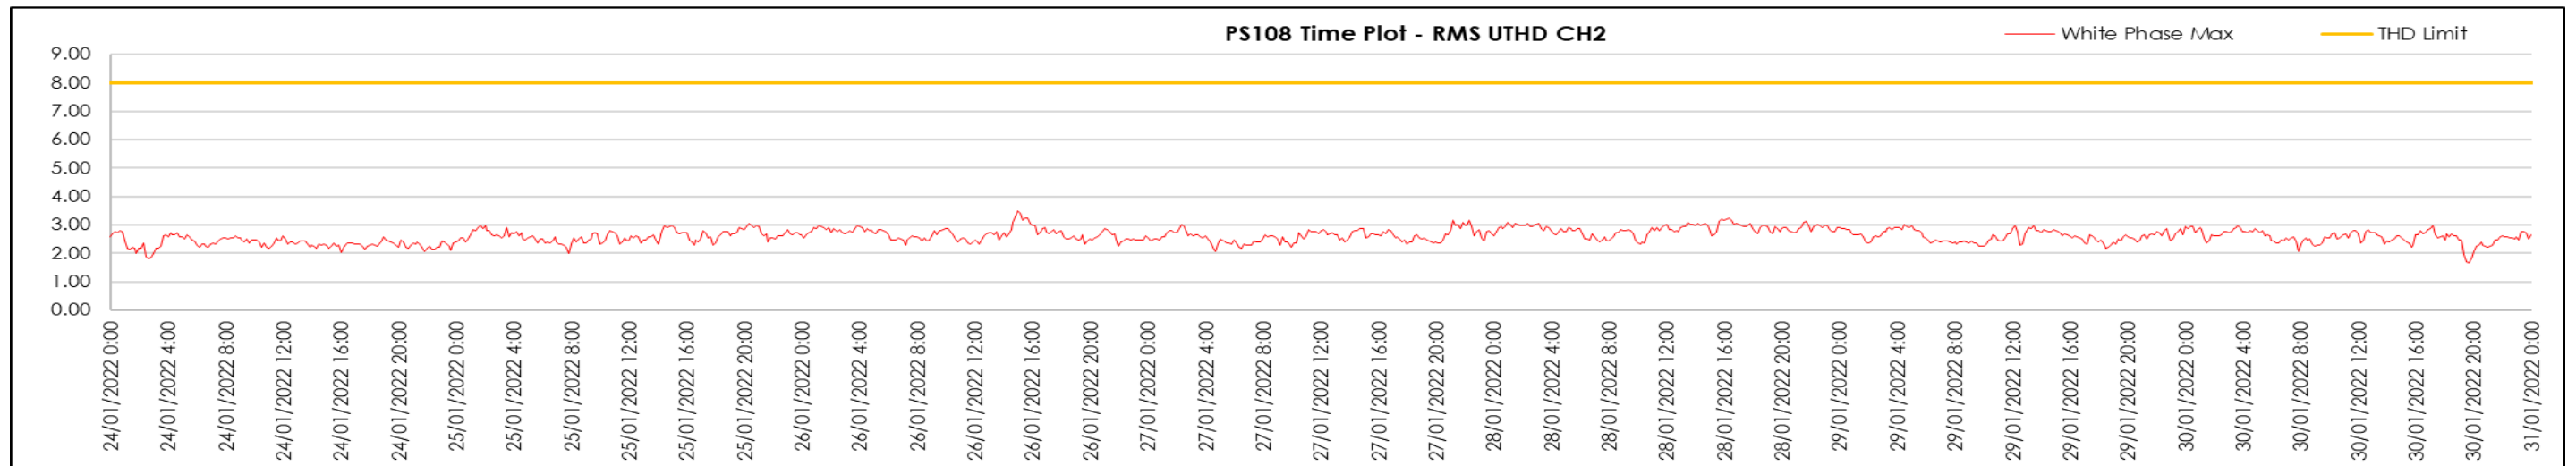
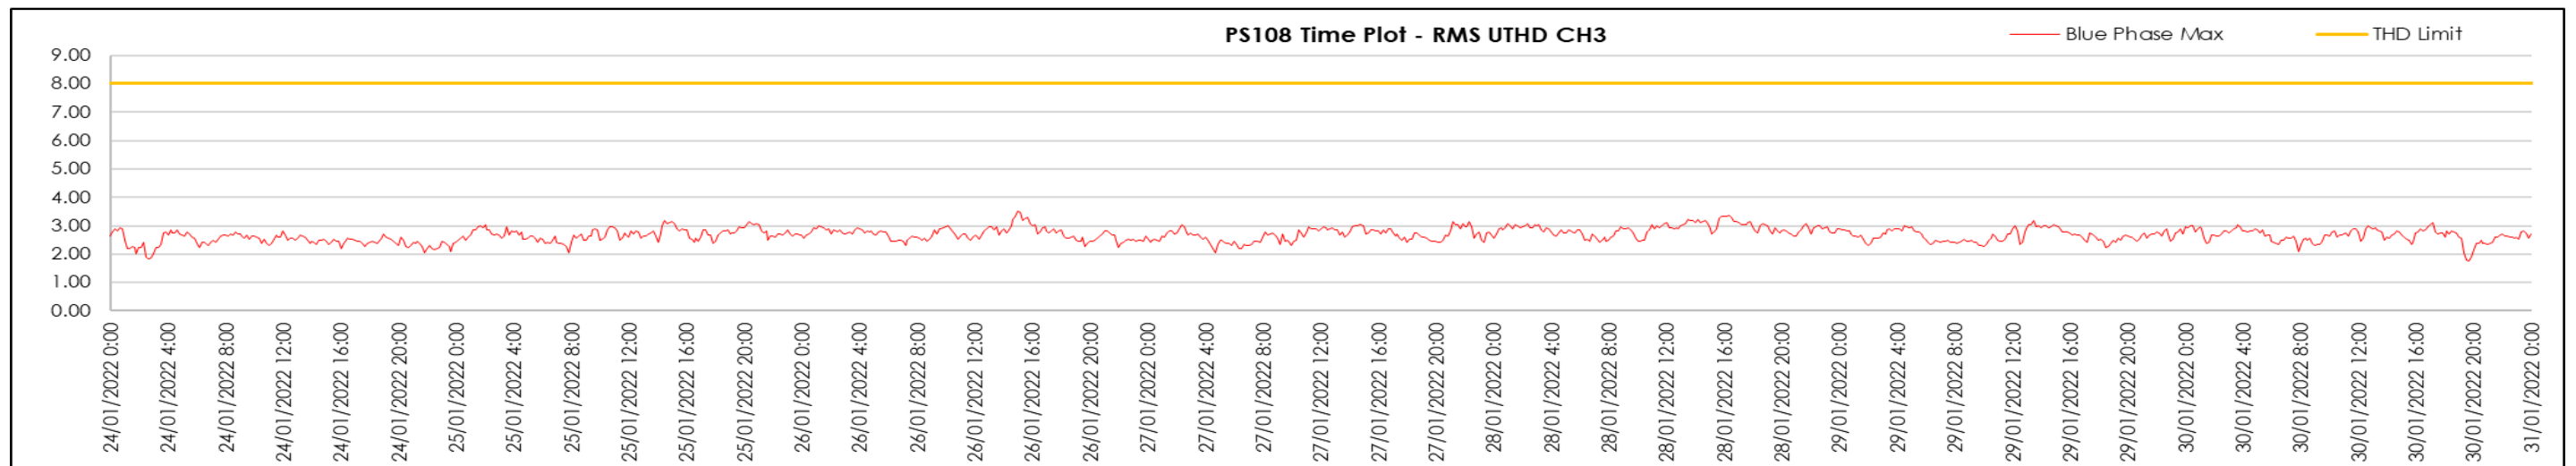
Figure 29 | TC3 Start U-THD measurements

The logged voltage THD level data for the start and end of the TC3 feeder is shown from Figure 29 to Figure 30 in Appendix A.3. There were no recorded voltage THD limit events causing the voltage THD level to breach the Code's limits (i.e., full compliance with the Code requirements).
