APD
ENGINEERING

BHP NEWMAN TOWNSHIP ELECTRICITY SUPPLY
ANNUAL COMPLIANCE REPORT
2021/2022

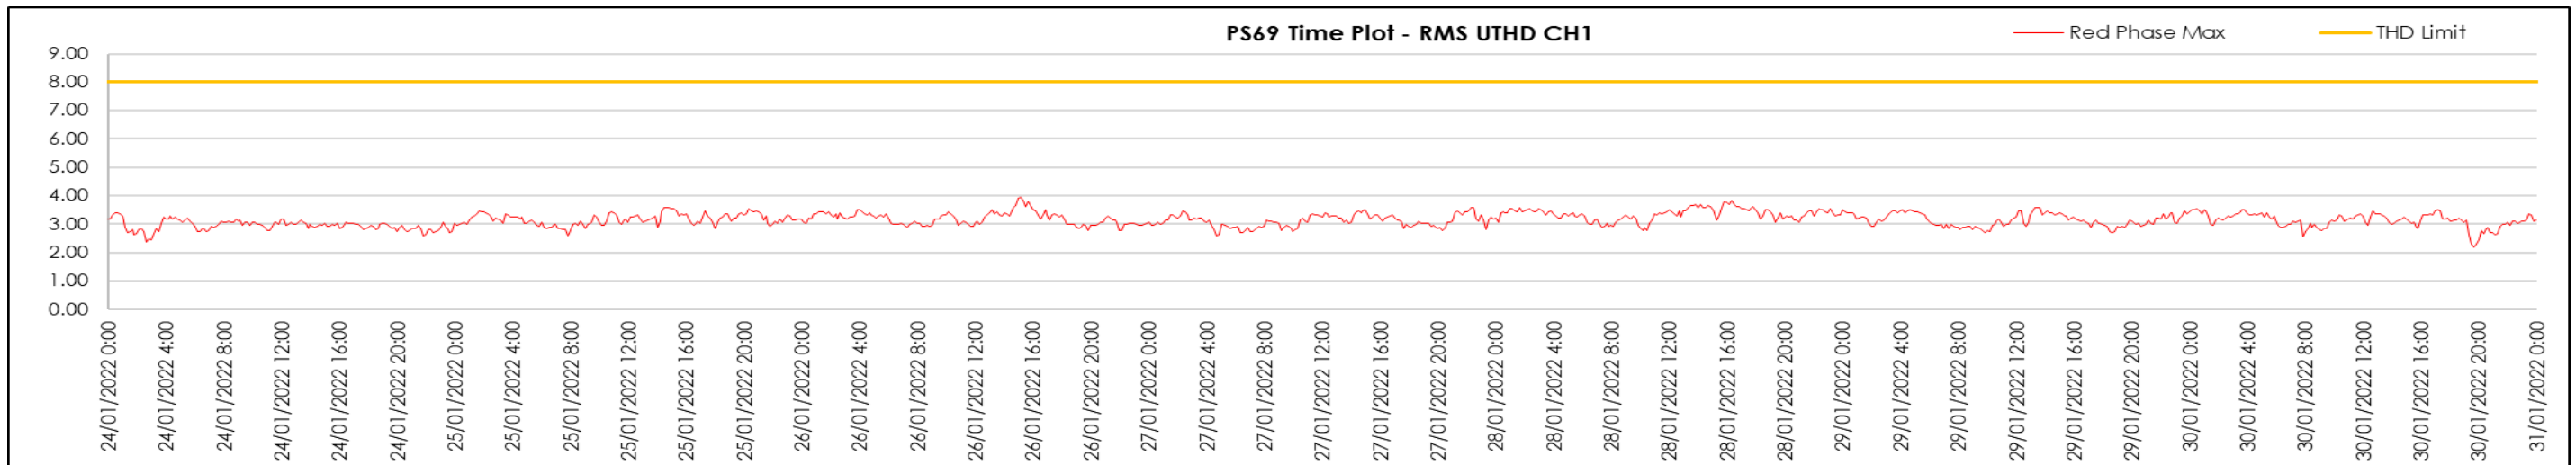
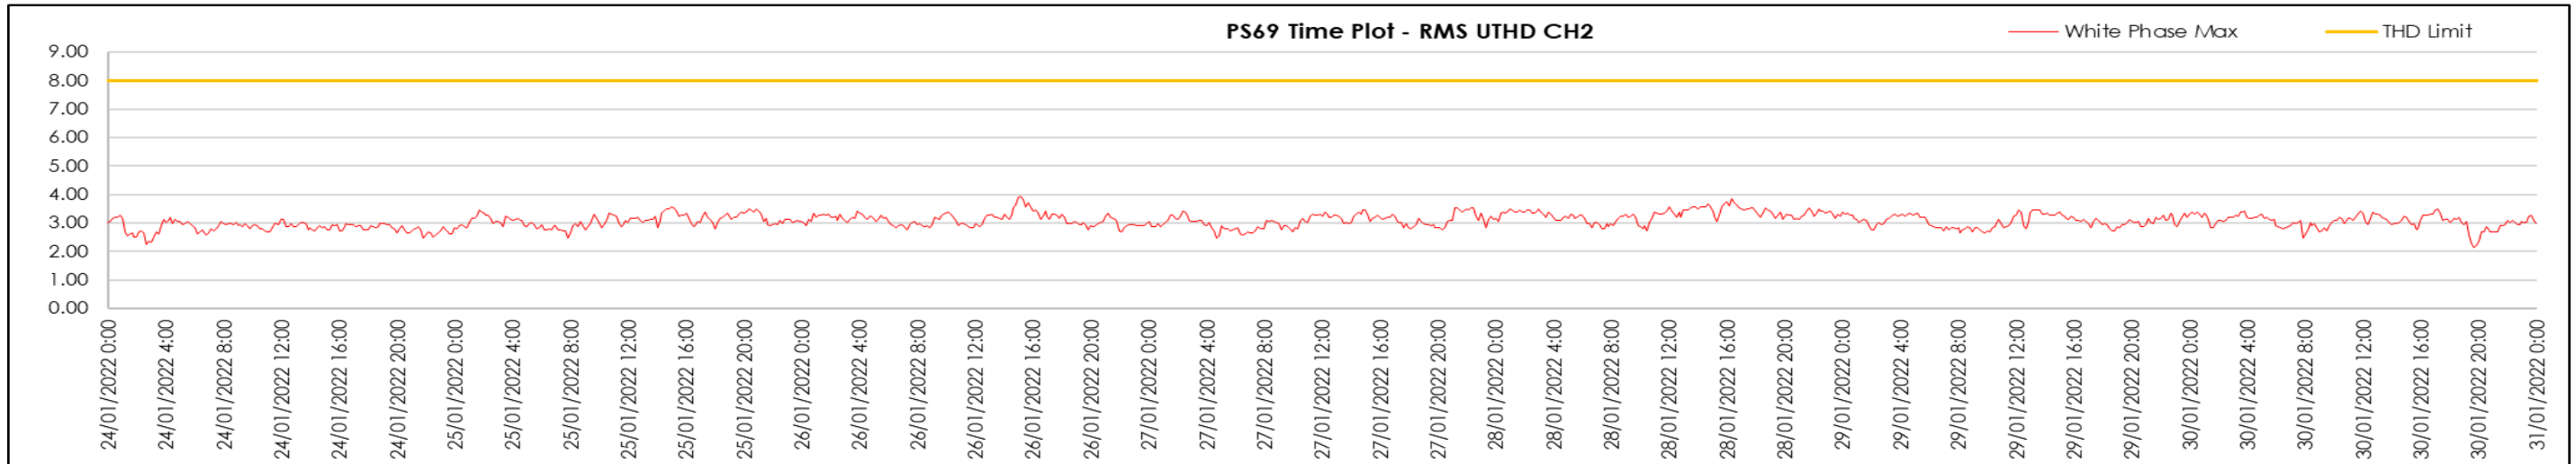
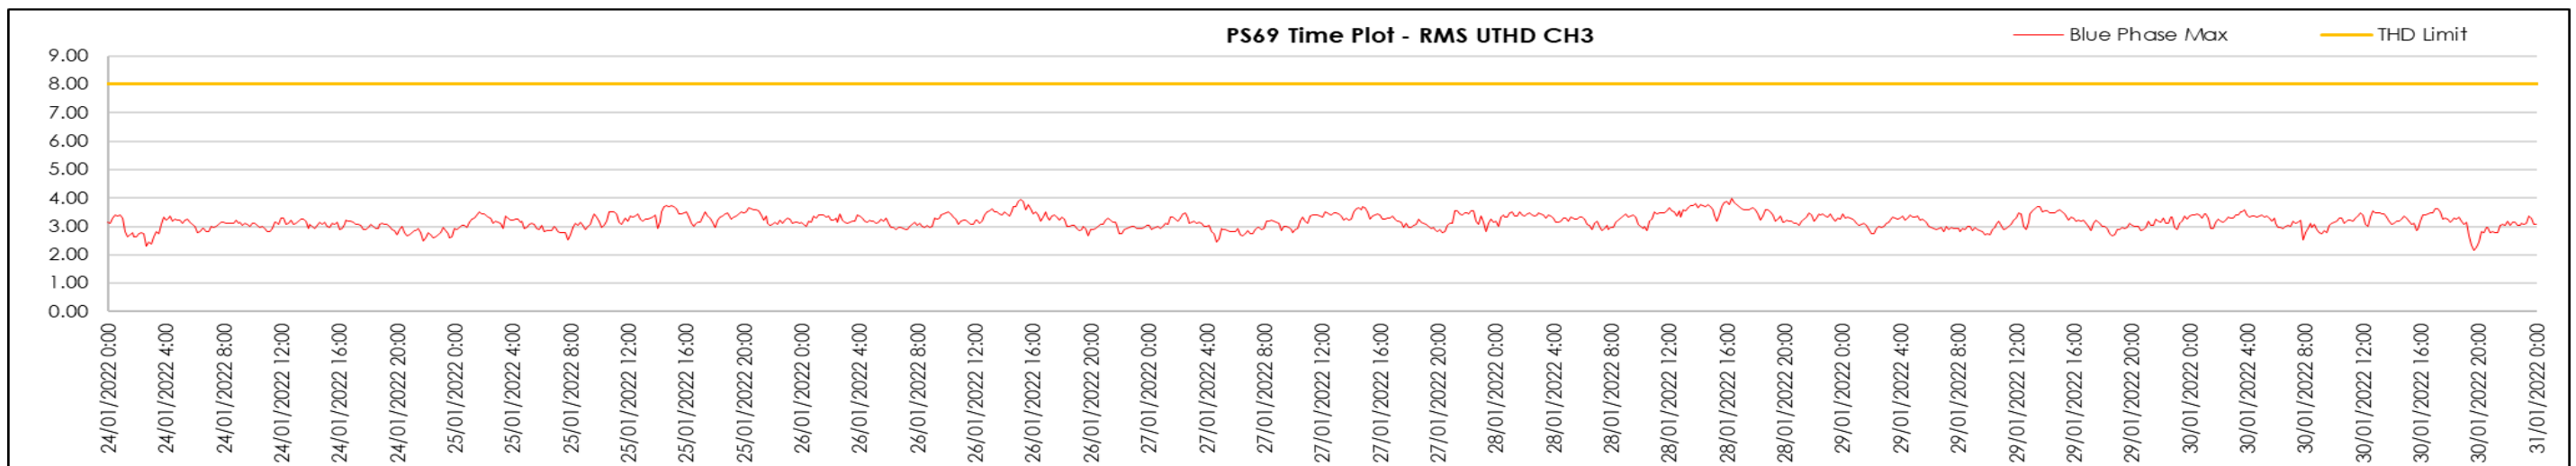
Figure 30 | TC3 End U-THD measurements

The logged voltage THD level data for the start and end of the TC3 feeder is shown from Figure 29 to Figure 30 in Appendix A.3. There were no recorded voltage THD limit events causing the voltage THD level to breach the Code's limits (i.e., full compliance with the Code requirements).

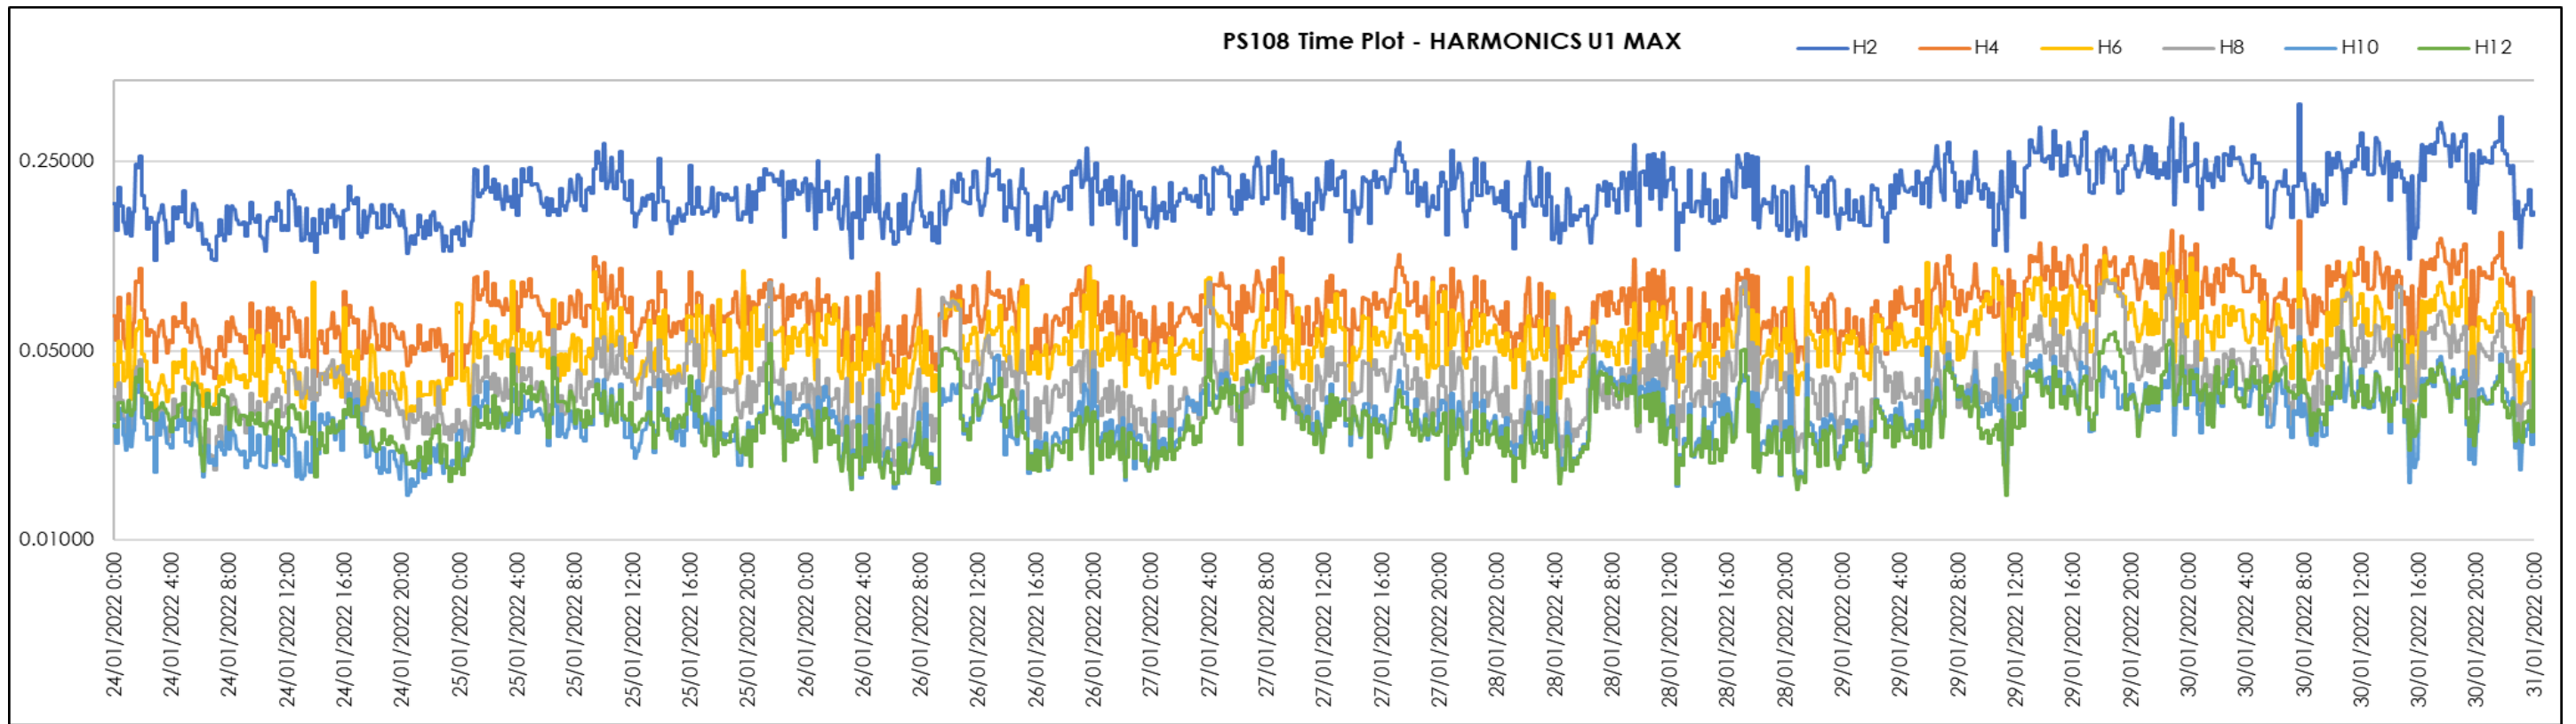
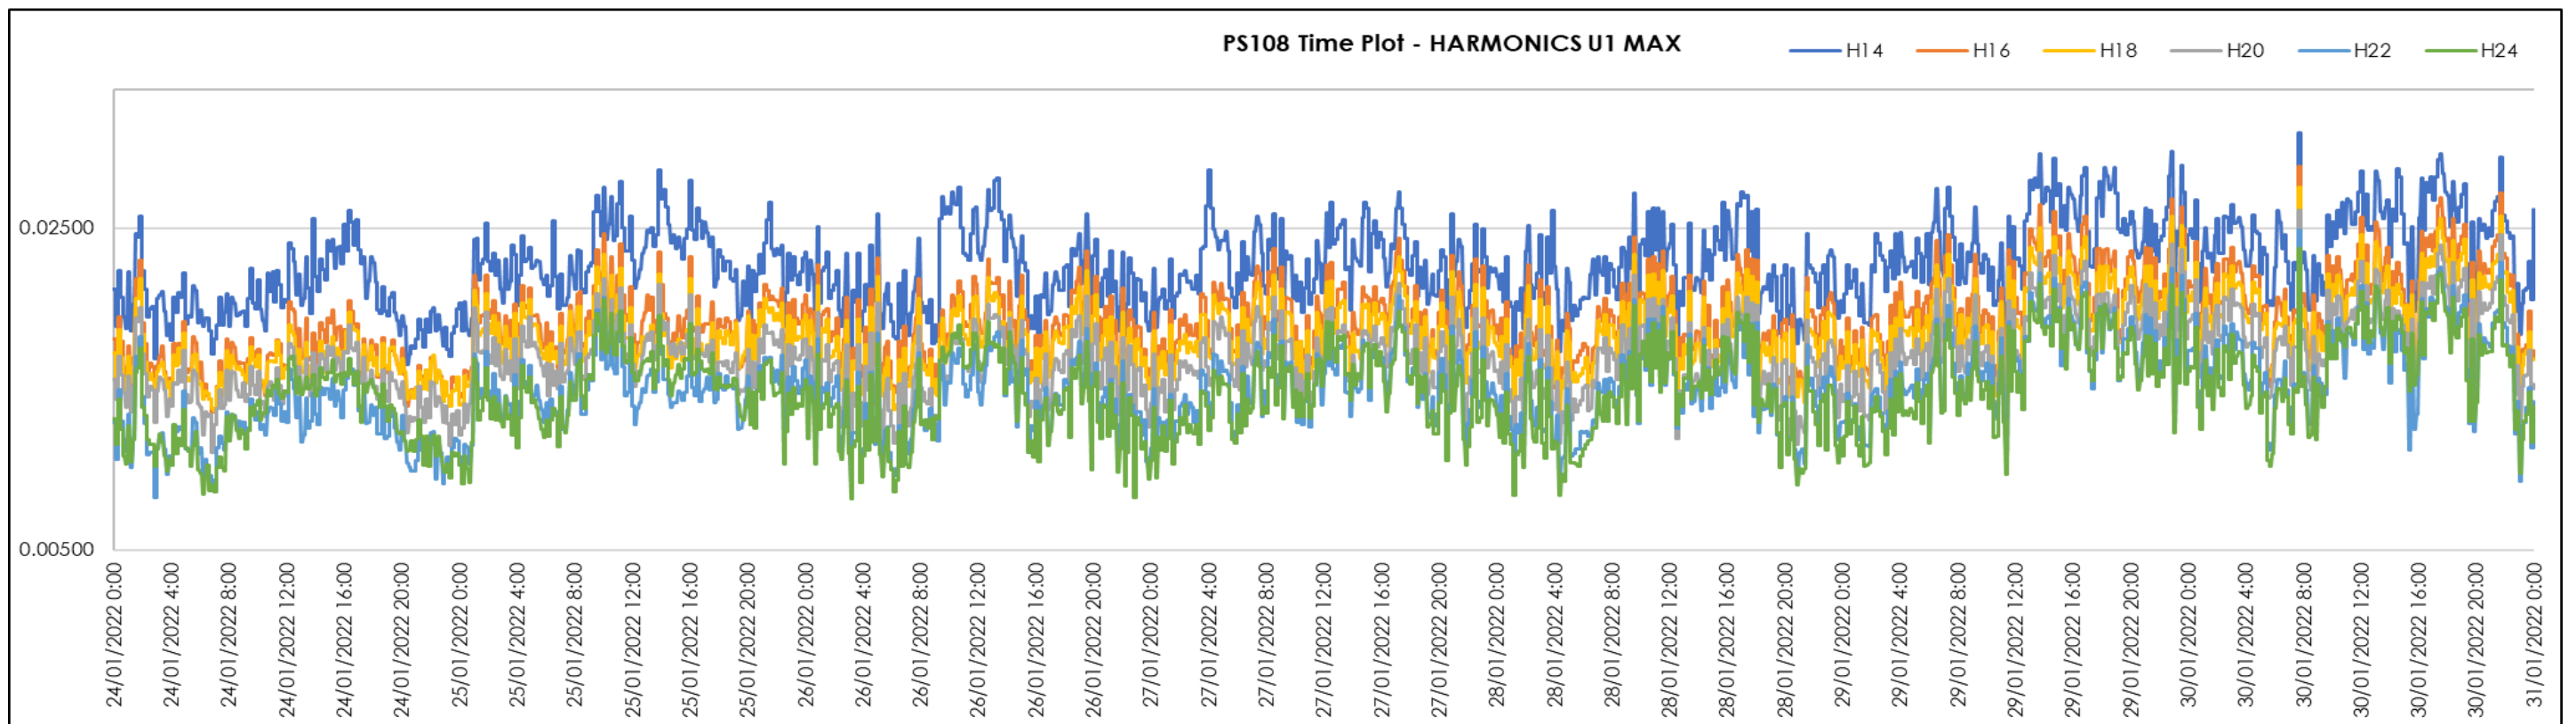
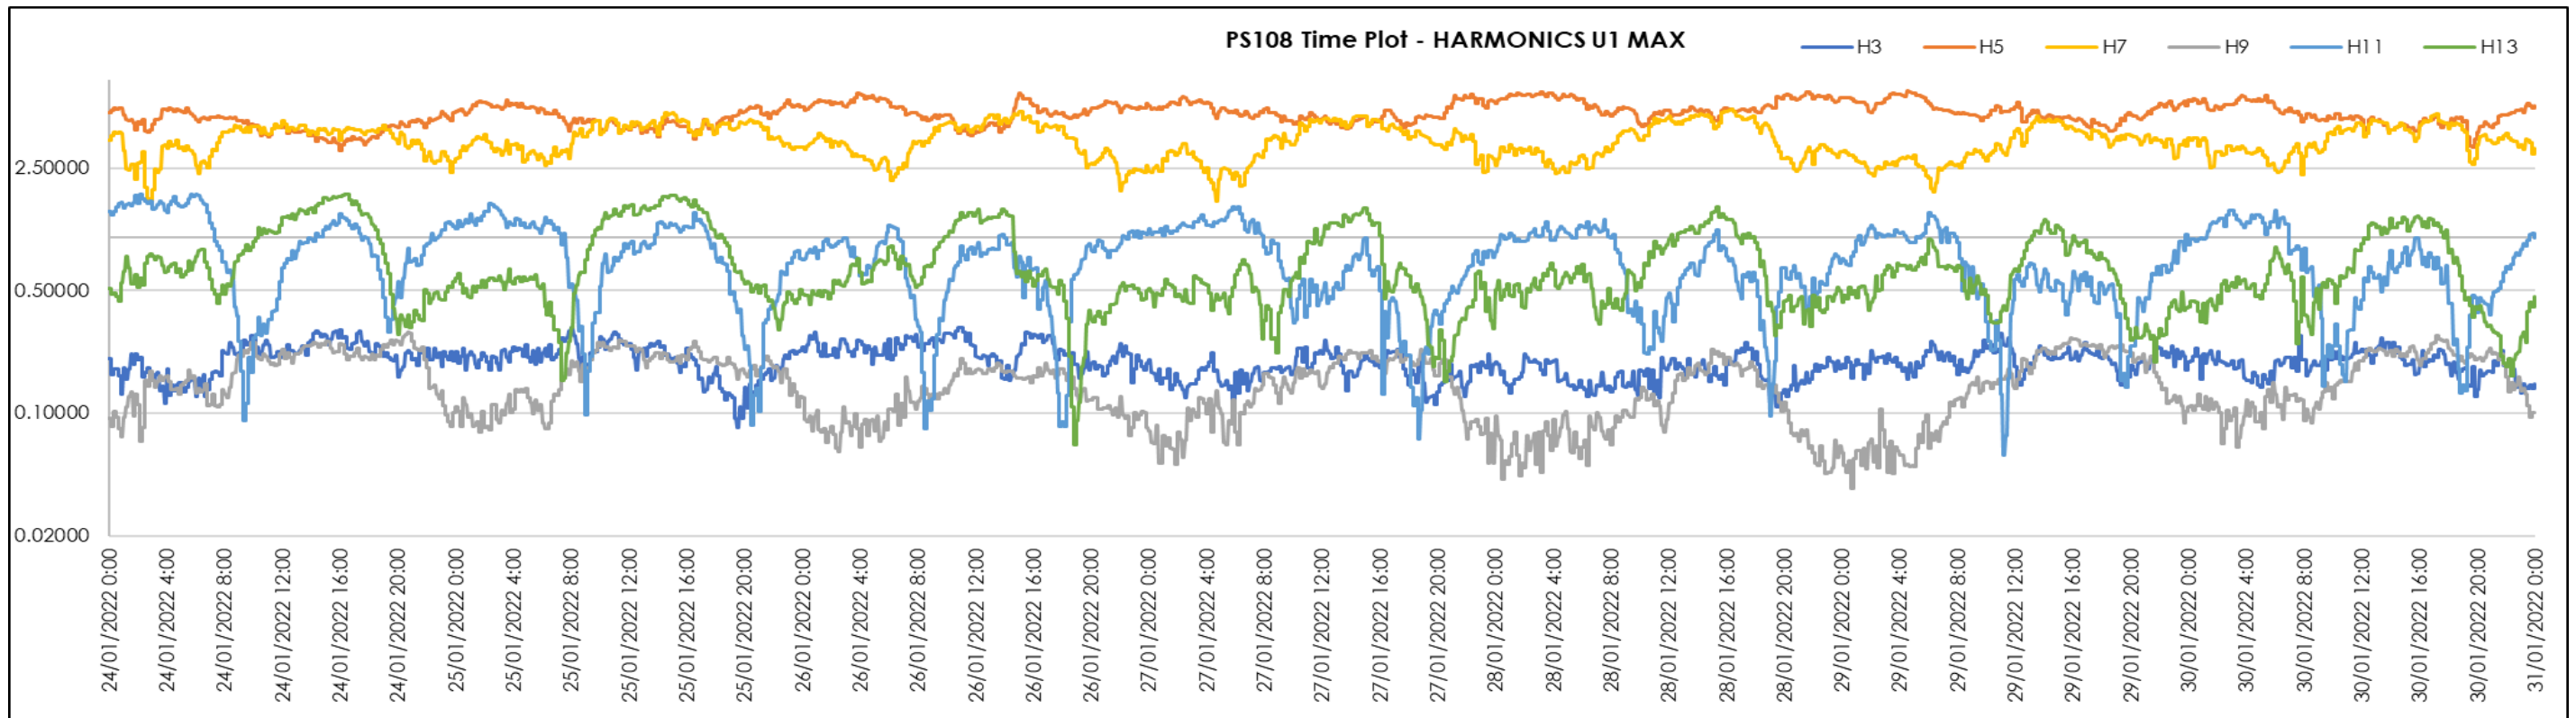
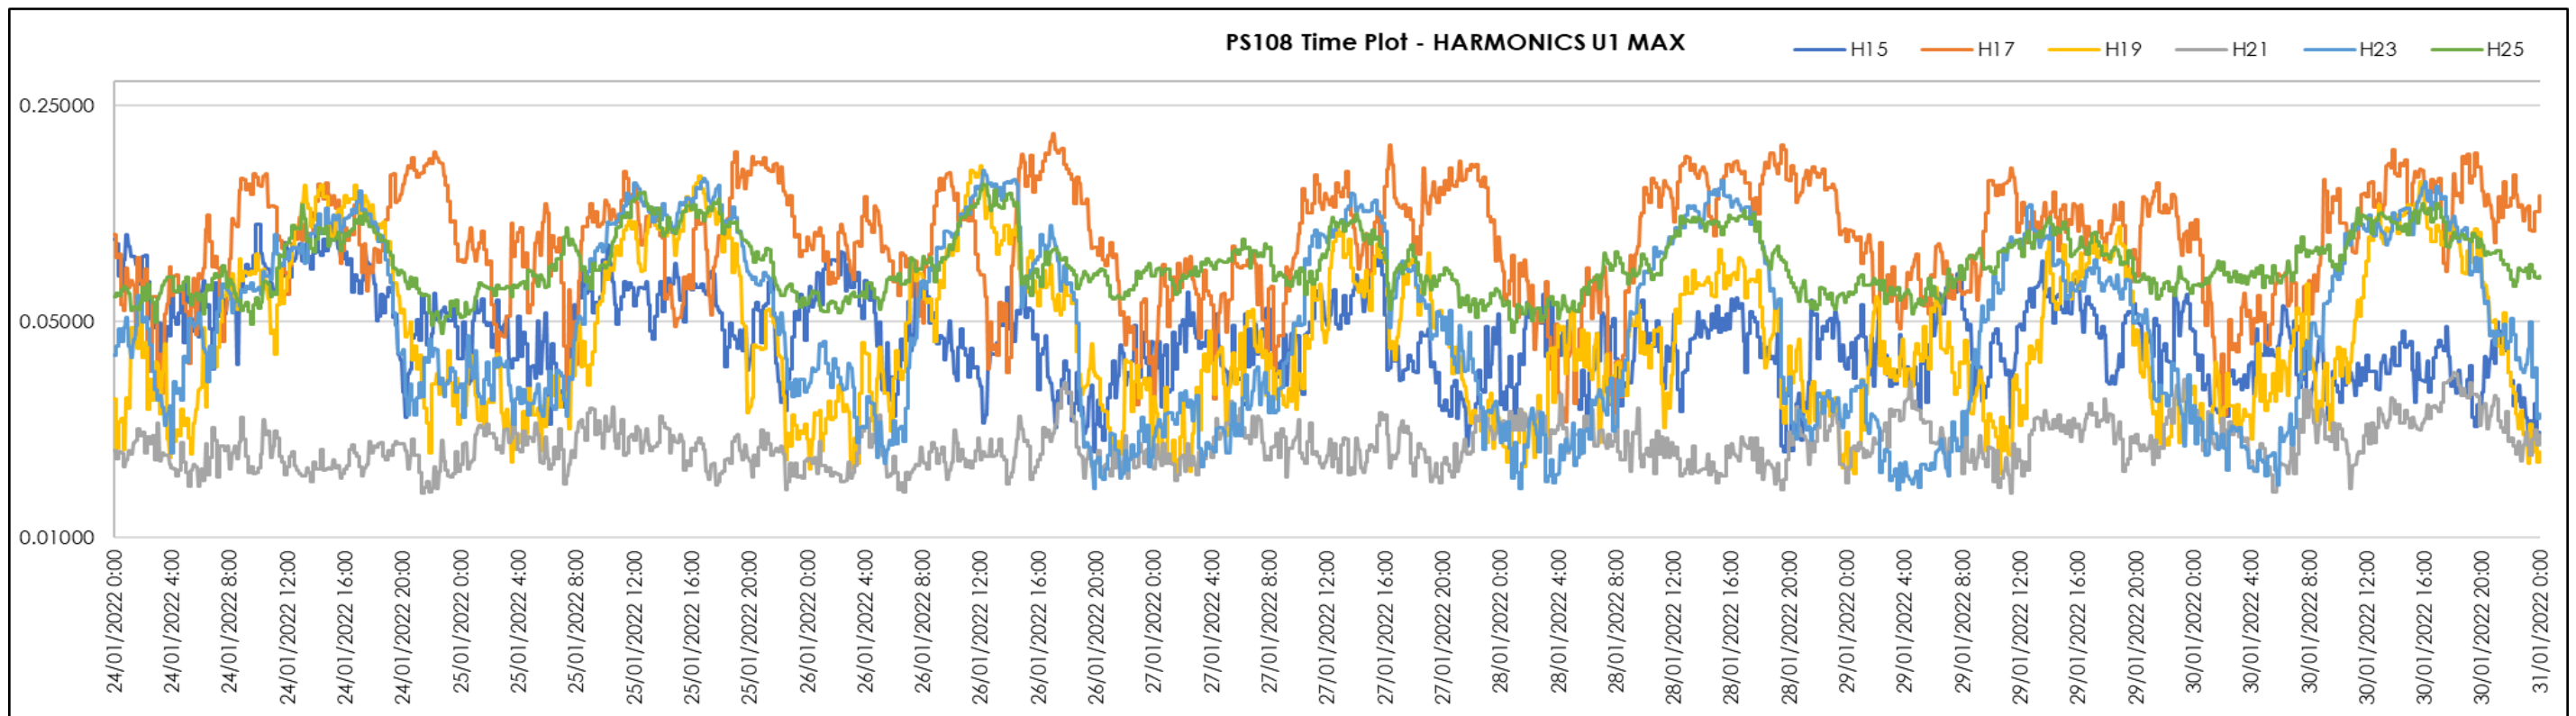
Figure 31 | TC3 Start Harmonics

The logged harmonic data for the start and end of the TC3 feeder is shown from Figure 31 to Figure 32 in Appendix A.3. No non-compliant harmonics were recorded for the recording period.

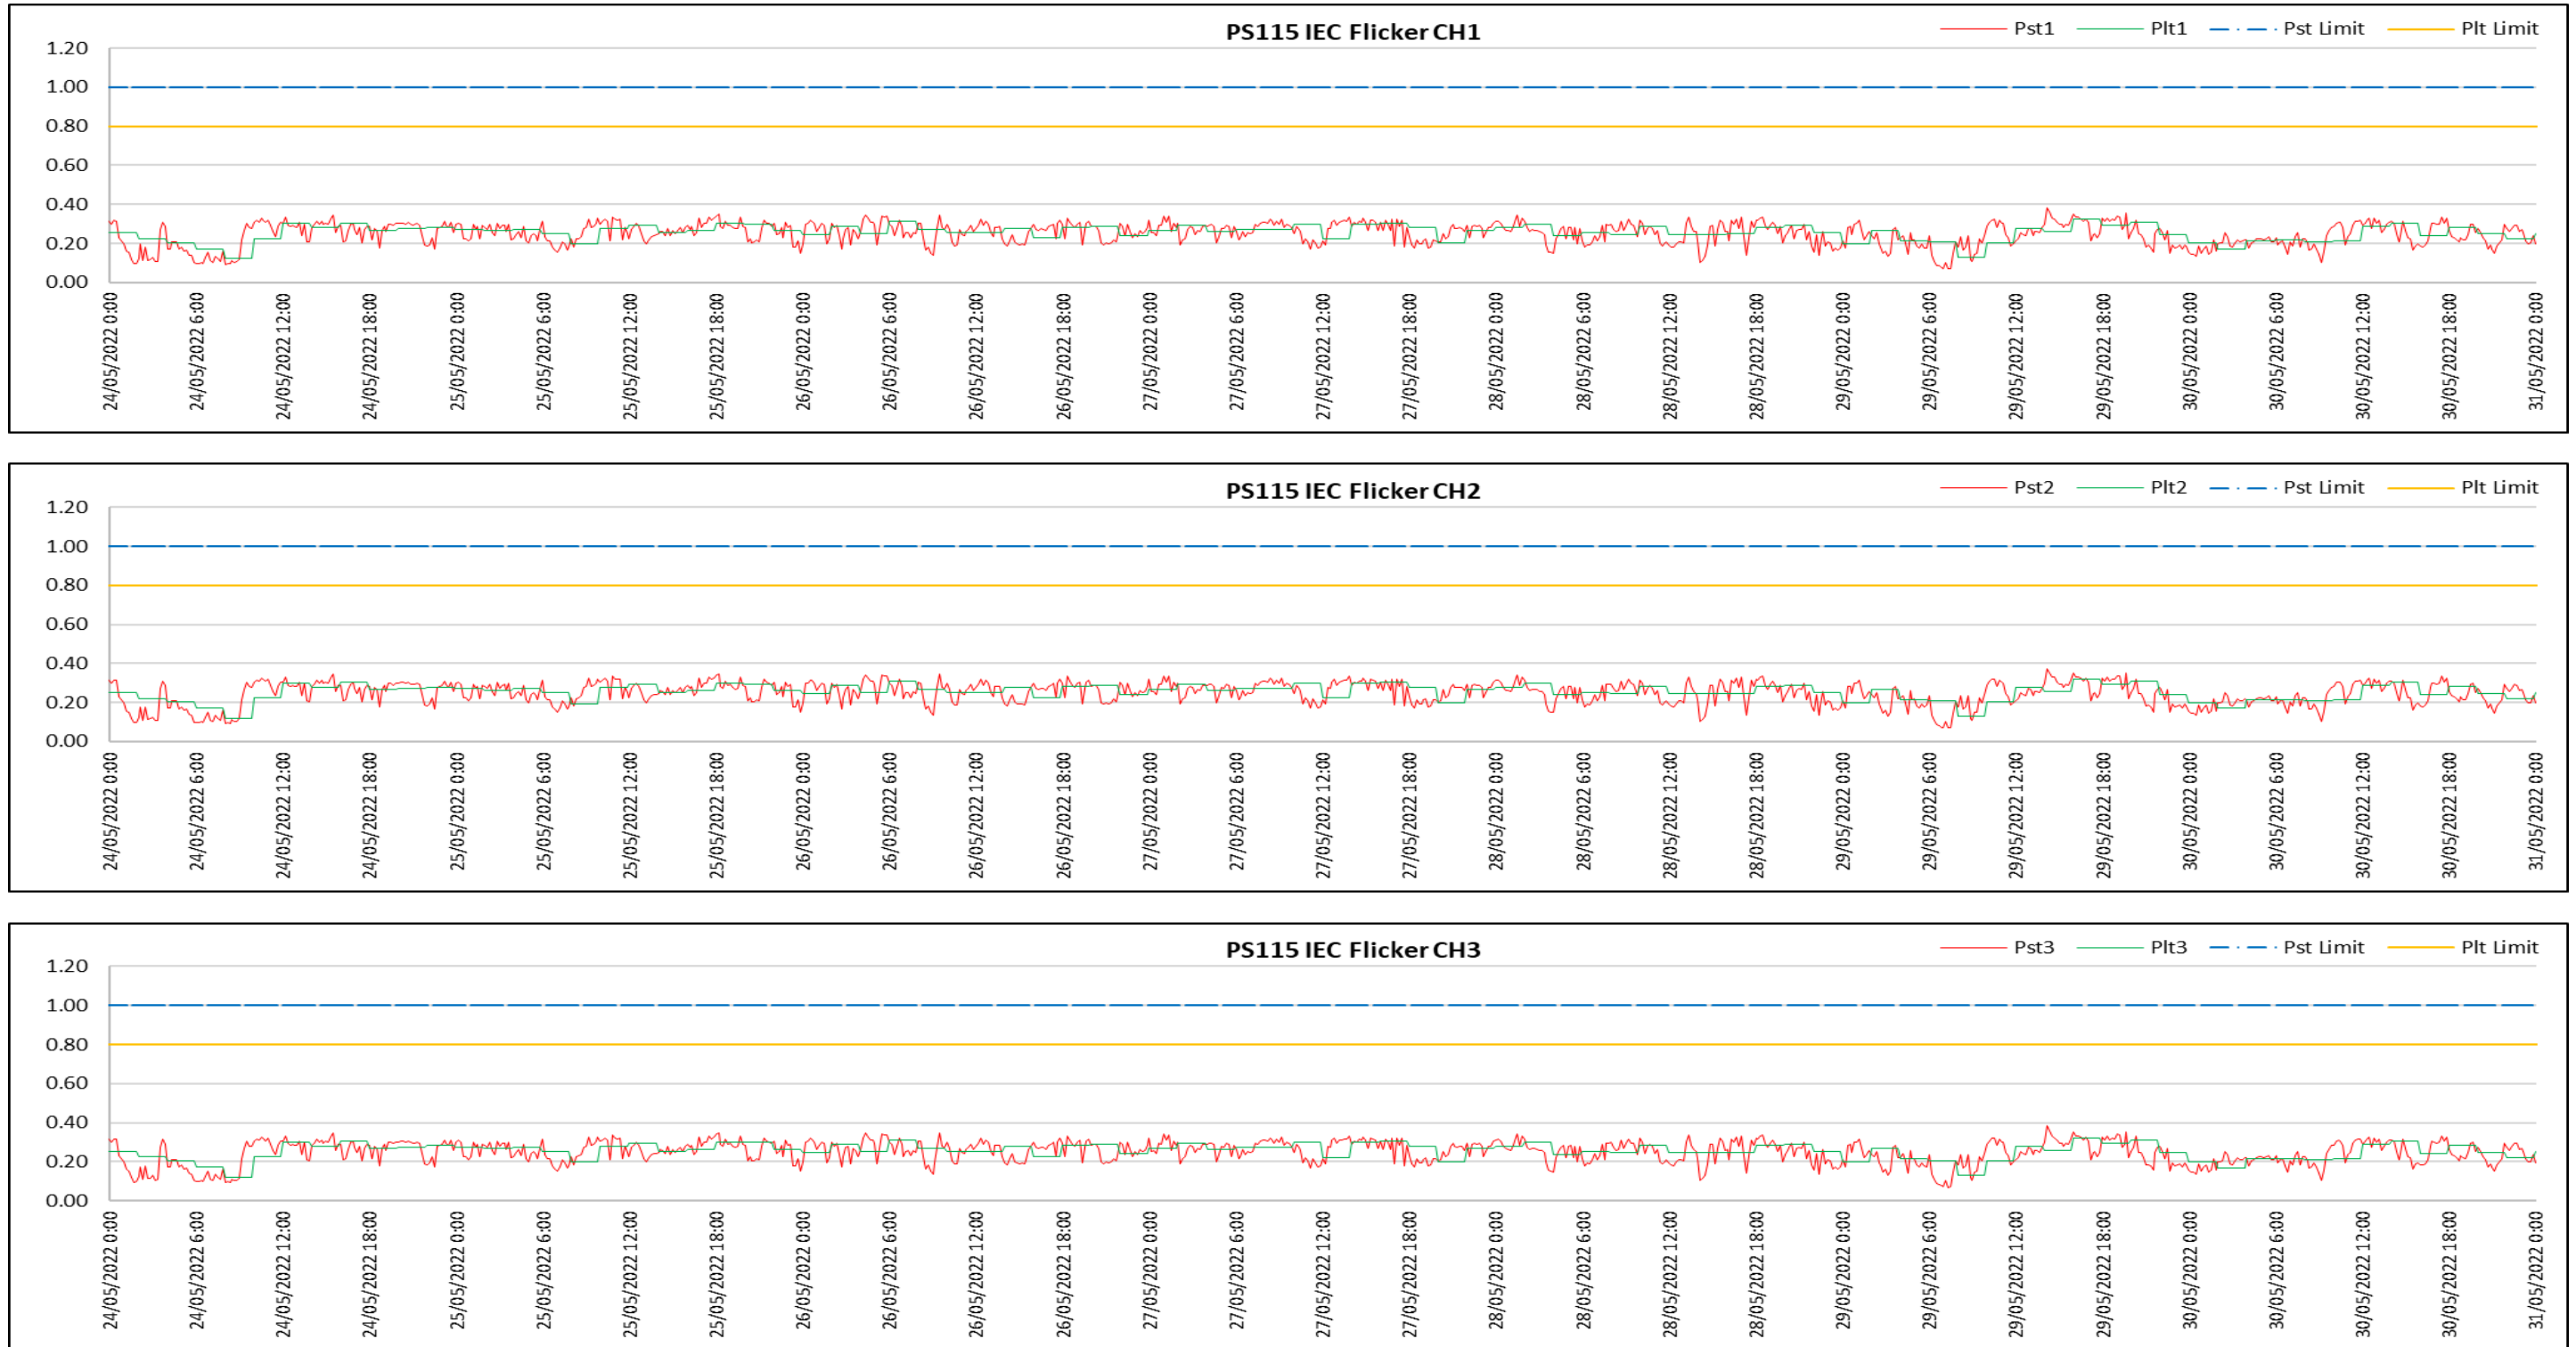
Figure 33 | TC4 Start Flicker measurements

The logged flicker data for the start and end of the TC4 feeder is shown from Figure 33 to Figure 34 in Appendix A.4. There were no recorded flicker limit events causing the flicker level to breach the Code's limits (i.e., full compliance with the Code requirements).

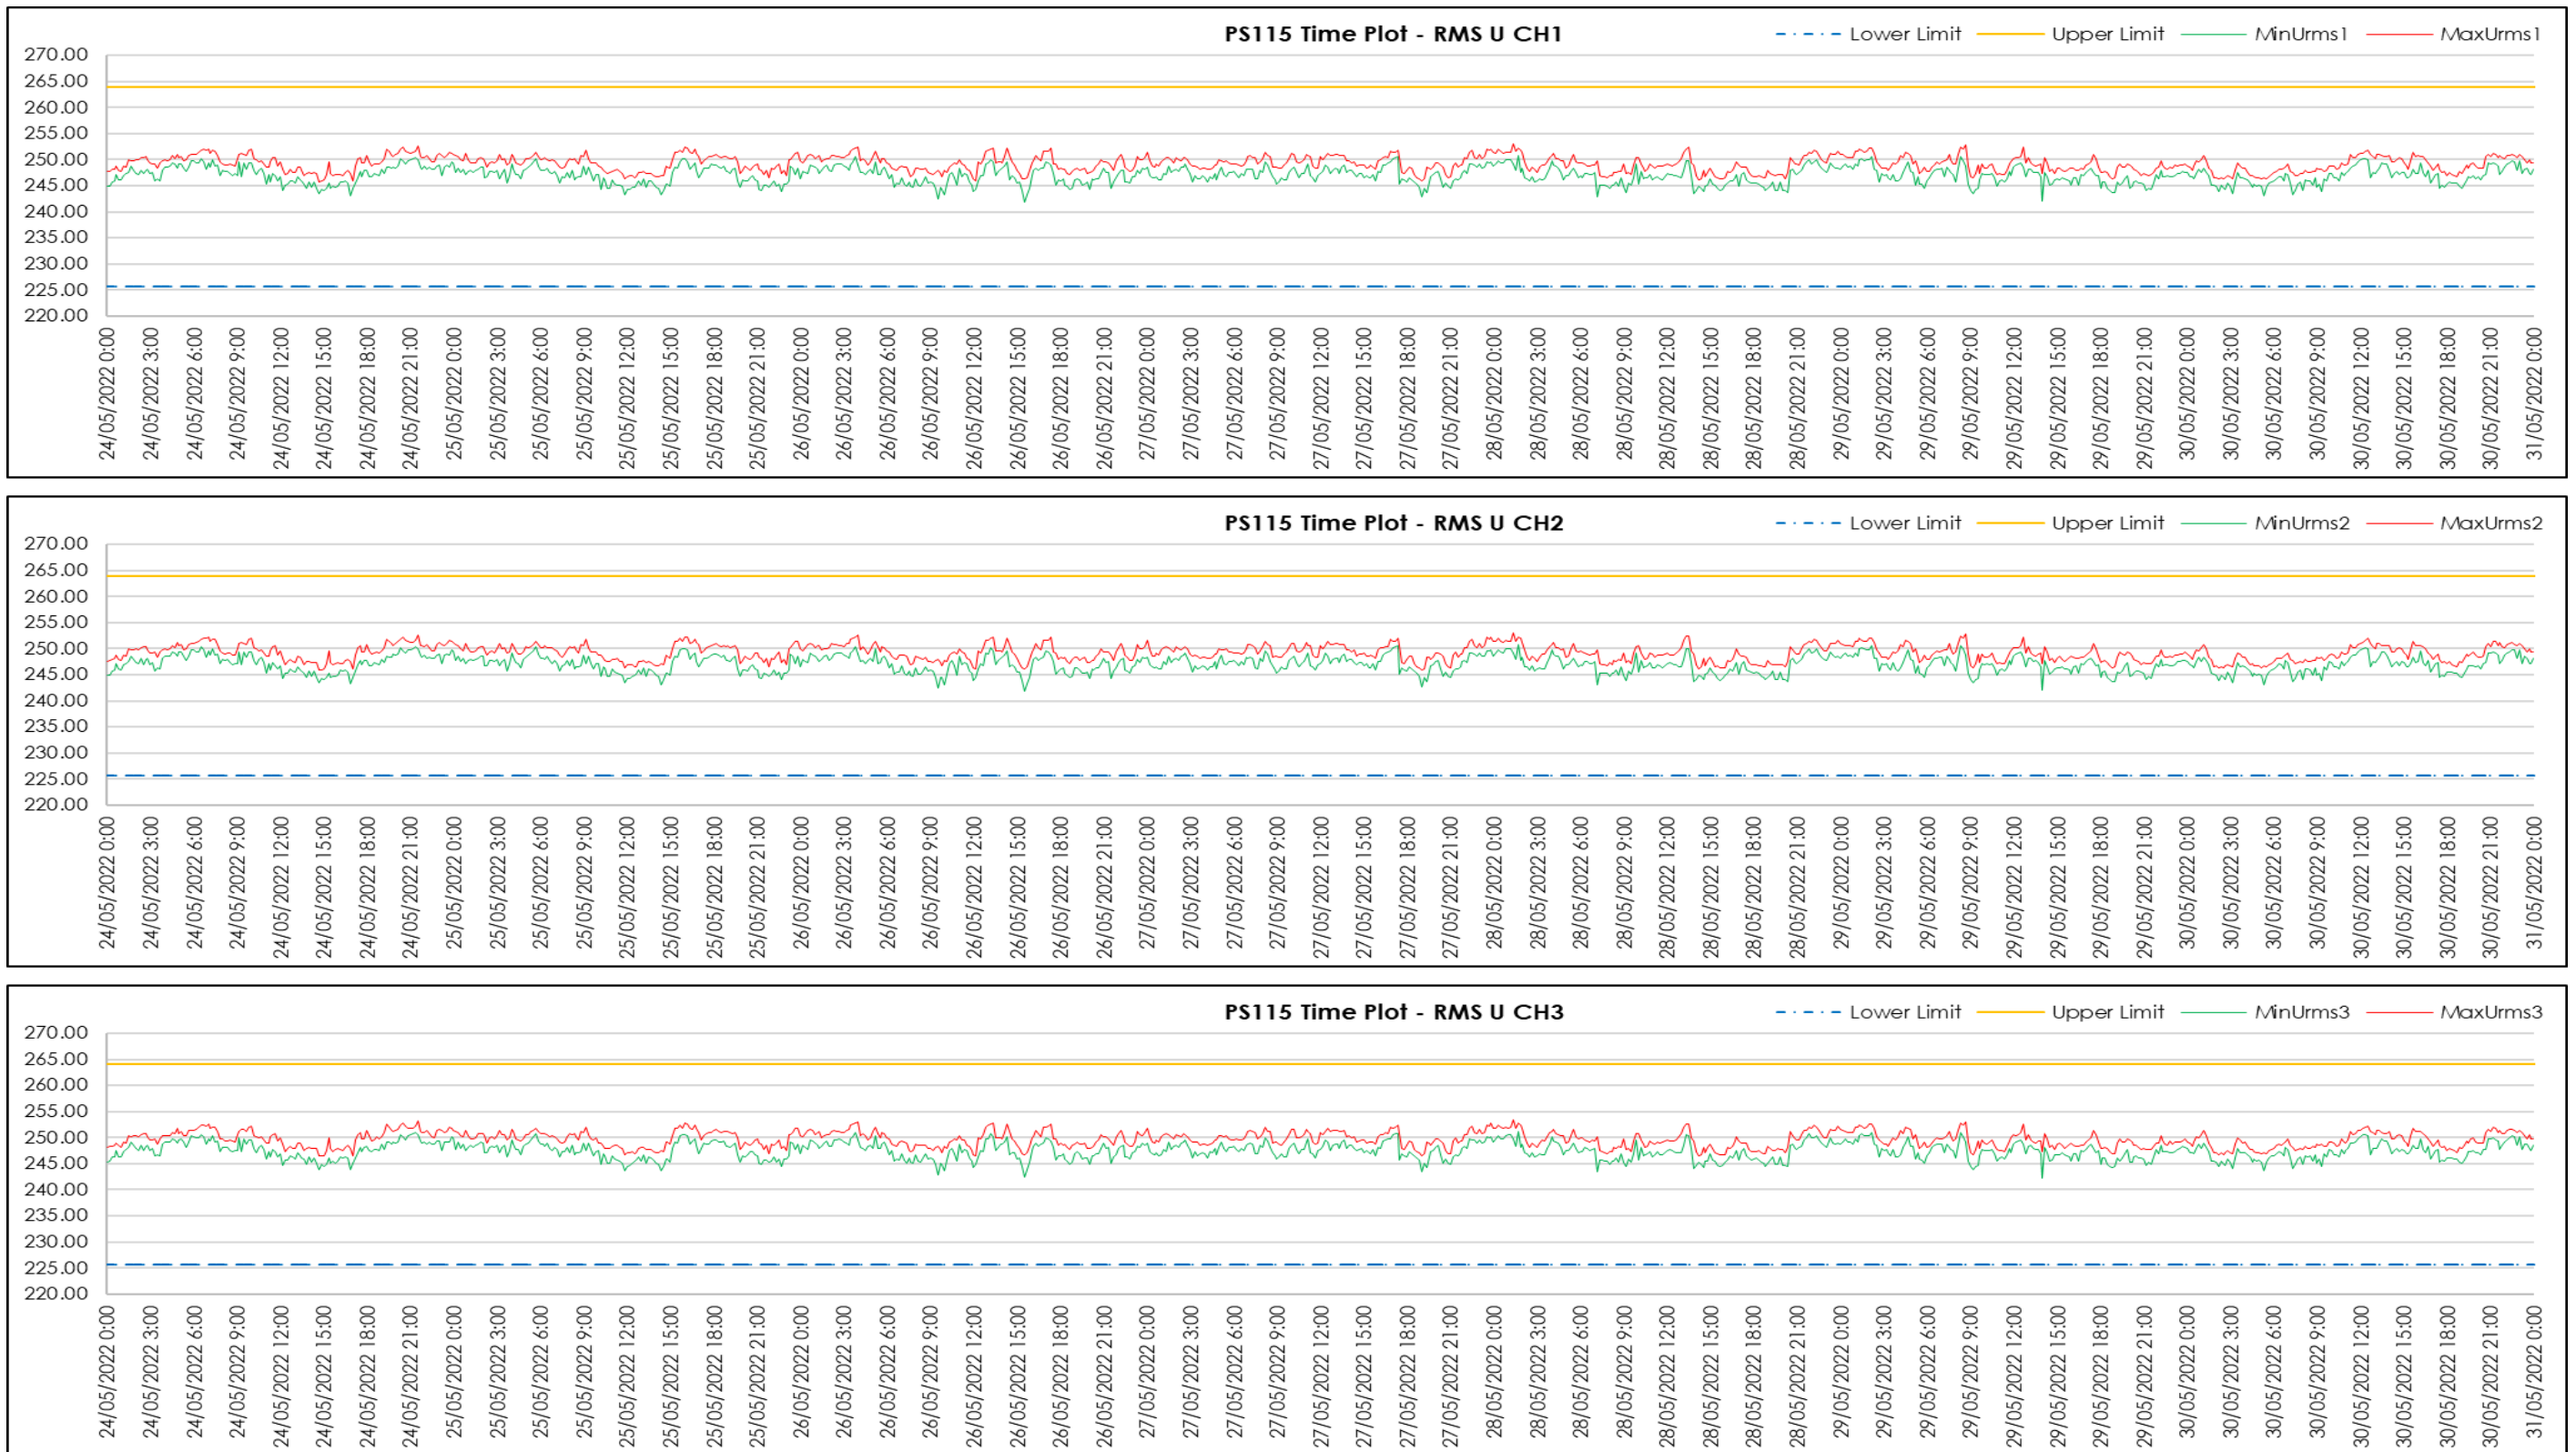
Figure 35 | TC4 Start Voltage measurements

The logged voltage level data for the start and end of the TC4 feeder is shown from Figure 35 to Figure 36 in Appendix A.4. **Table 7** below lists the recorded breach events during the logging period.

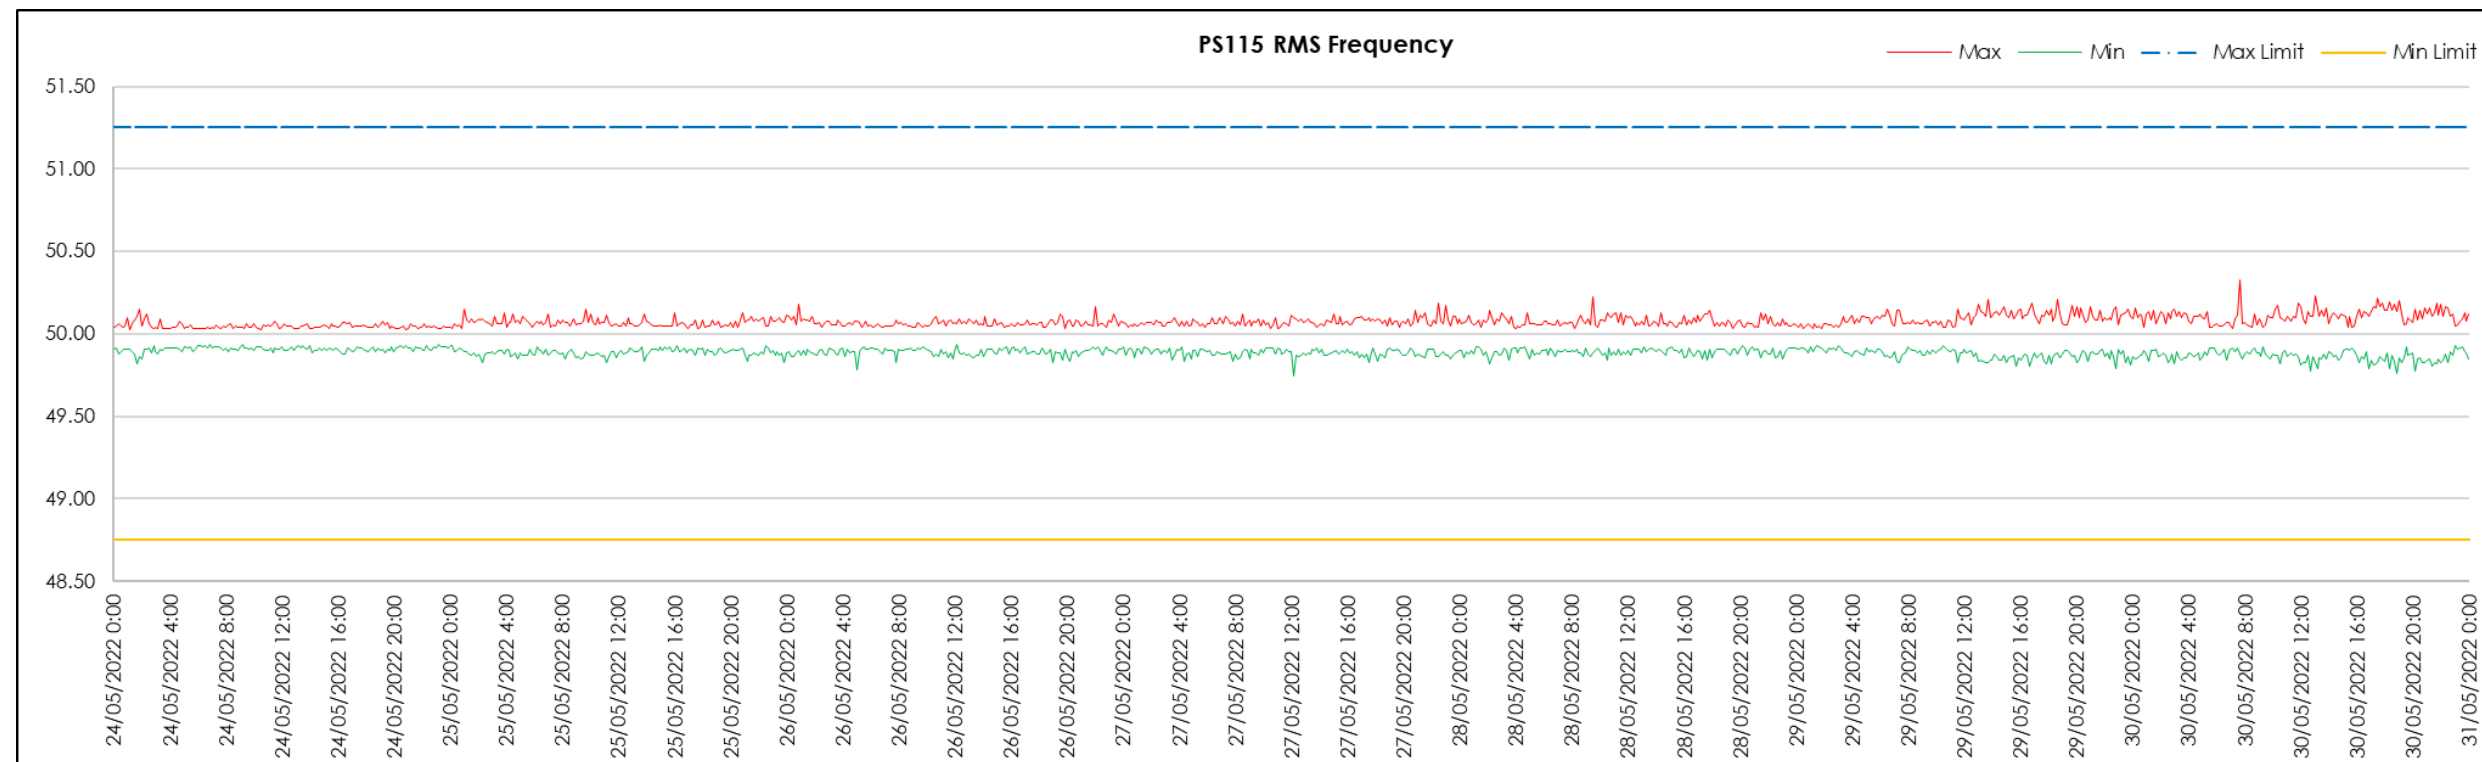
Figure 37 | TC4 Start Frequency measurements

The logged frequency data for the start and end of the TC4 feeder is shown from Figure 37 to Figure 38 in Appendix A.4. There were no recorded frequency limit events causing the frequency level to breach the Code's limits (i.e., full compliance with the Code requirements).
