APD
ENGINEERING

BHP NEWMAN TOWNSHIP ELECTRICITY SUPPLY
ANNUAL COMPLIANCE REPORT
2021/2022

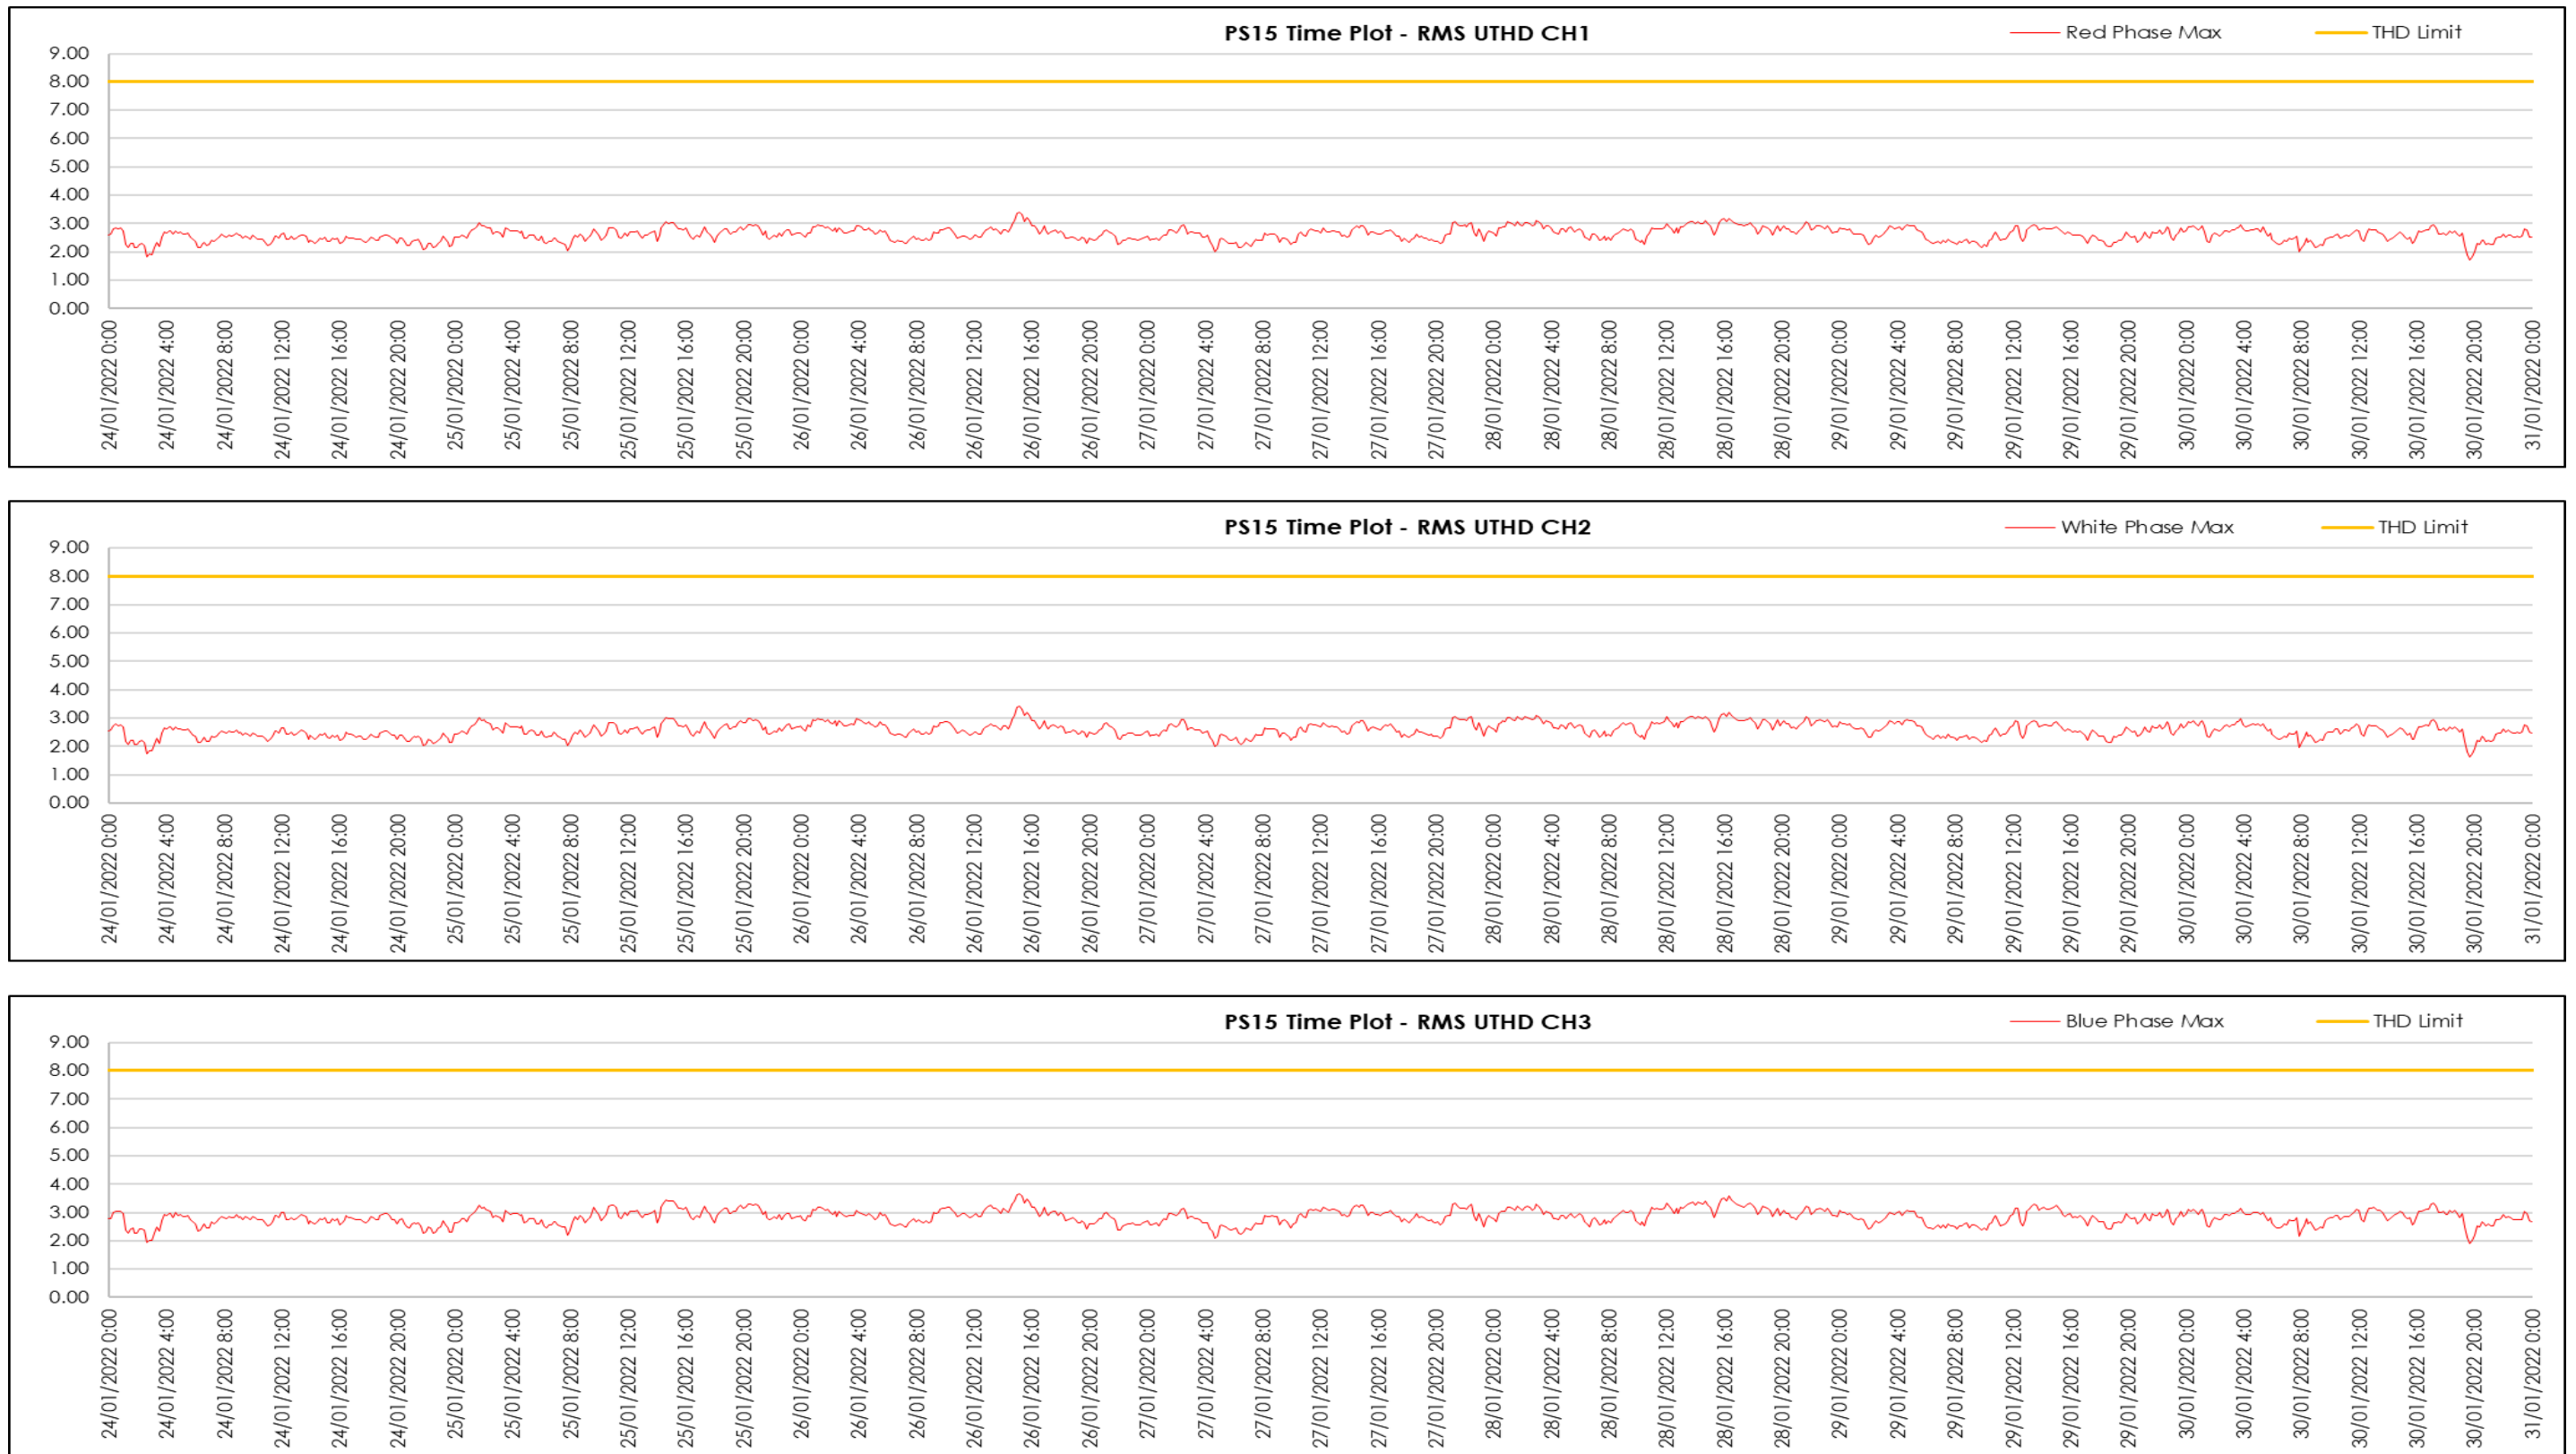
Figure 39 | TC4 Start U-THD measurements

The logged voltage THD level data for the start and end of the TC4 feeder is shown from Figure 39 to Figure 40 in Appendix A.4. There were no recorded voltage THD limit events causing the voltage THD level to breach the Code's limits (i.e., full compliance with the Code requirements).

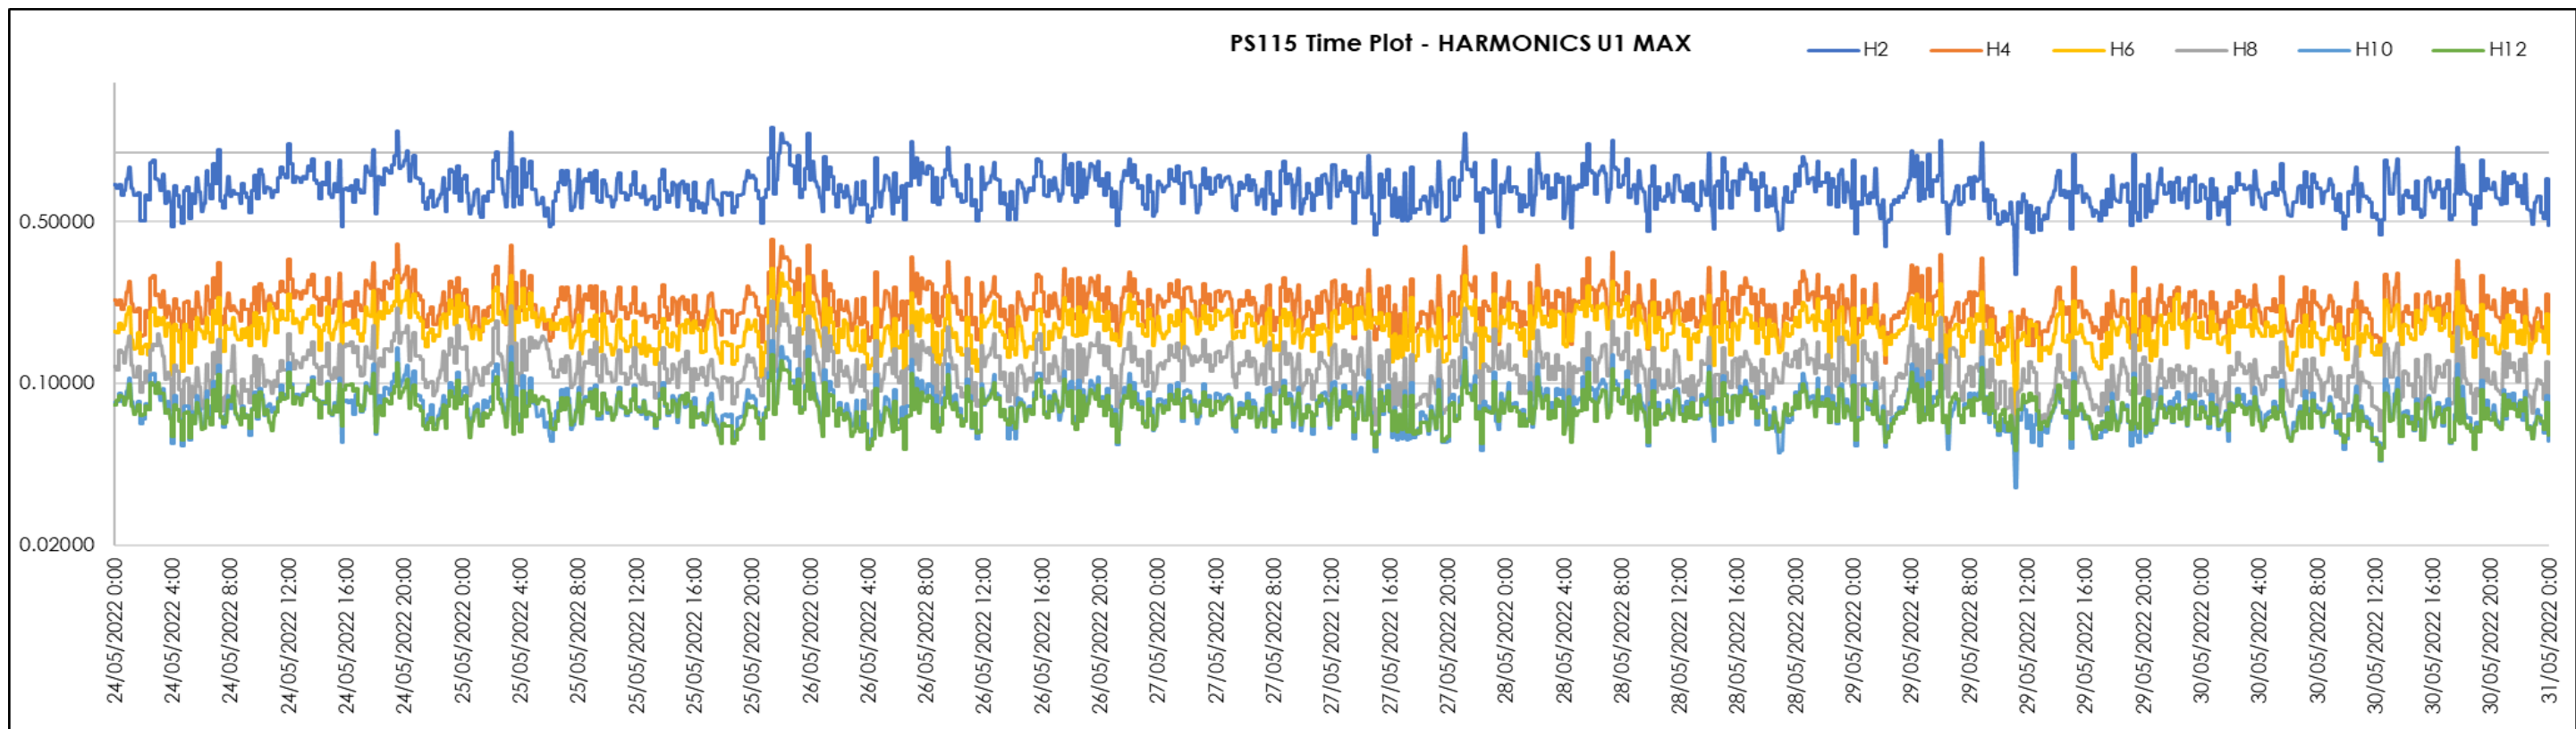
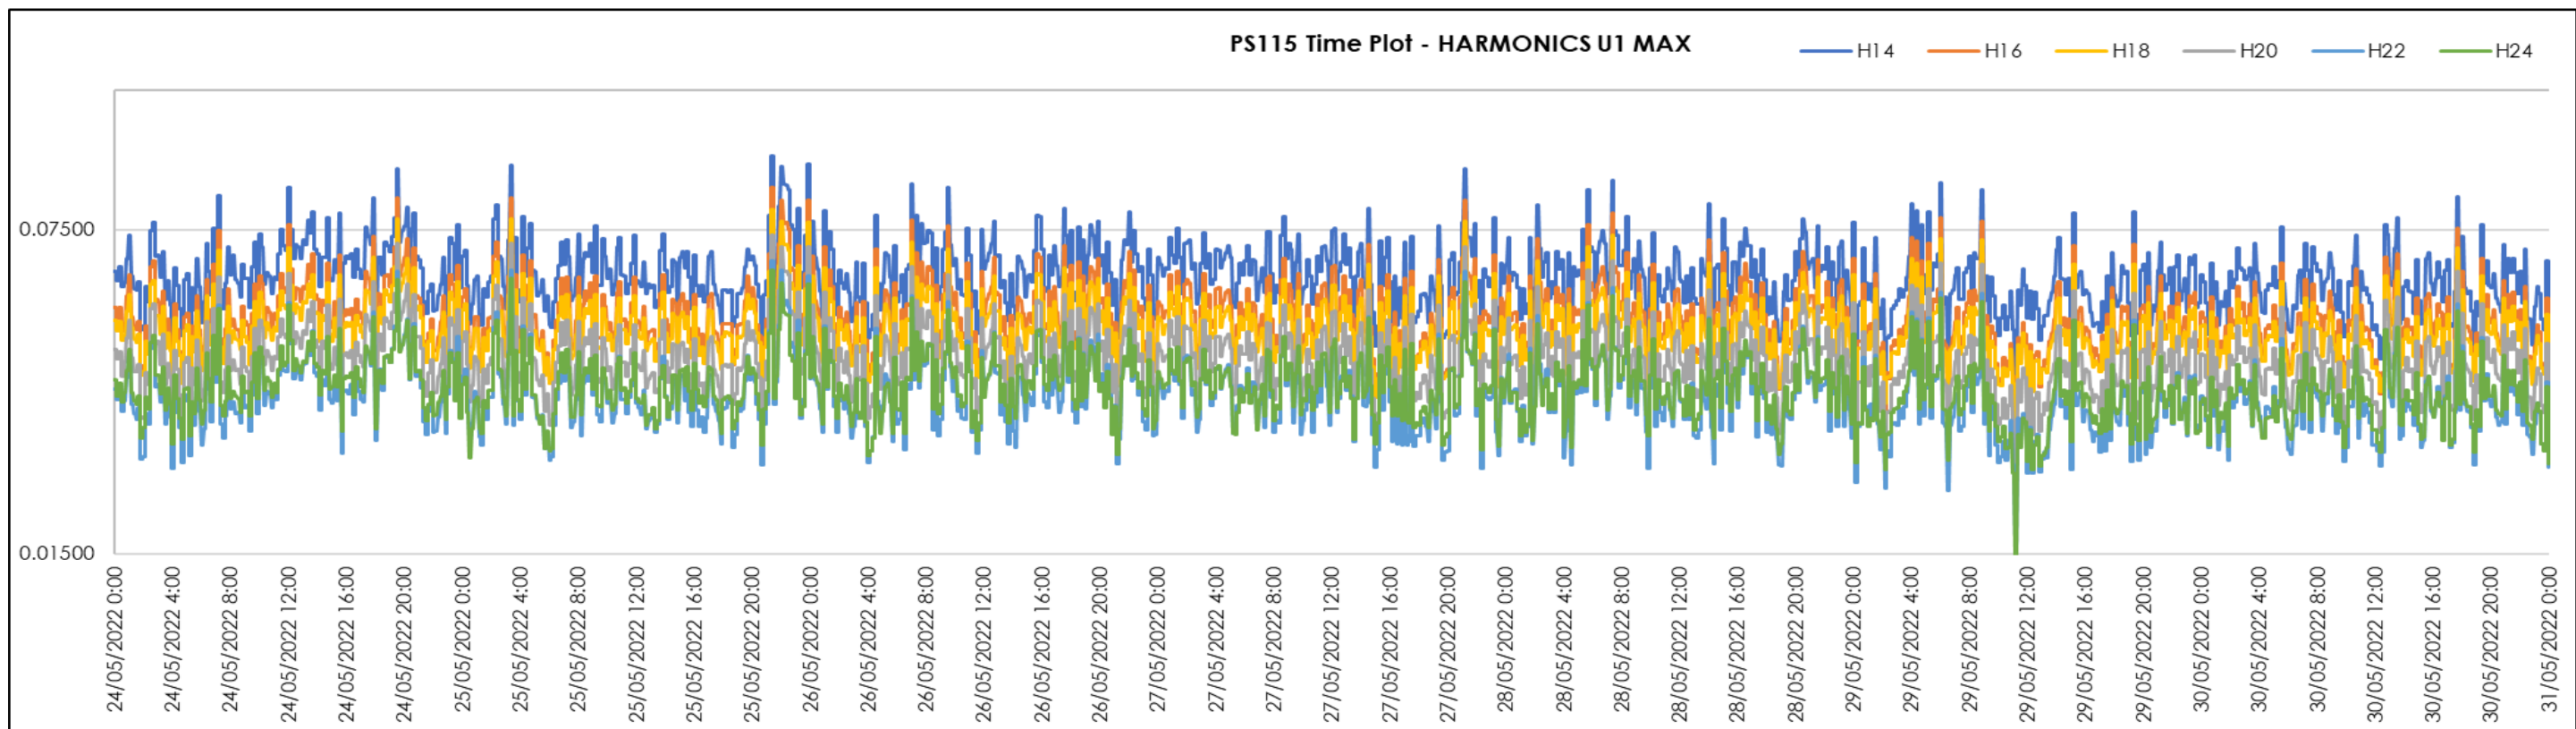
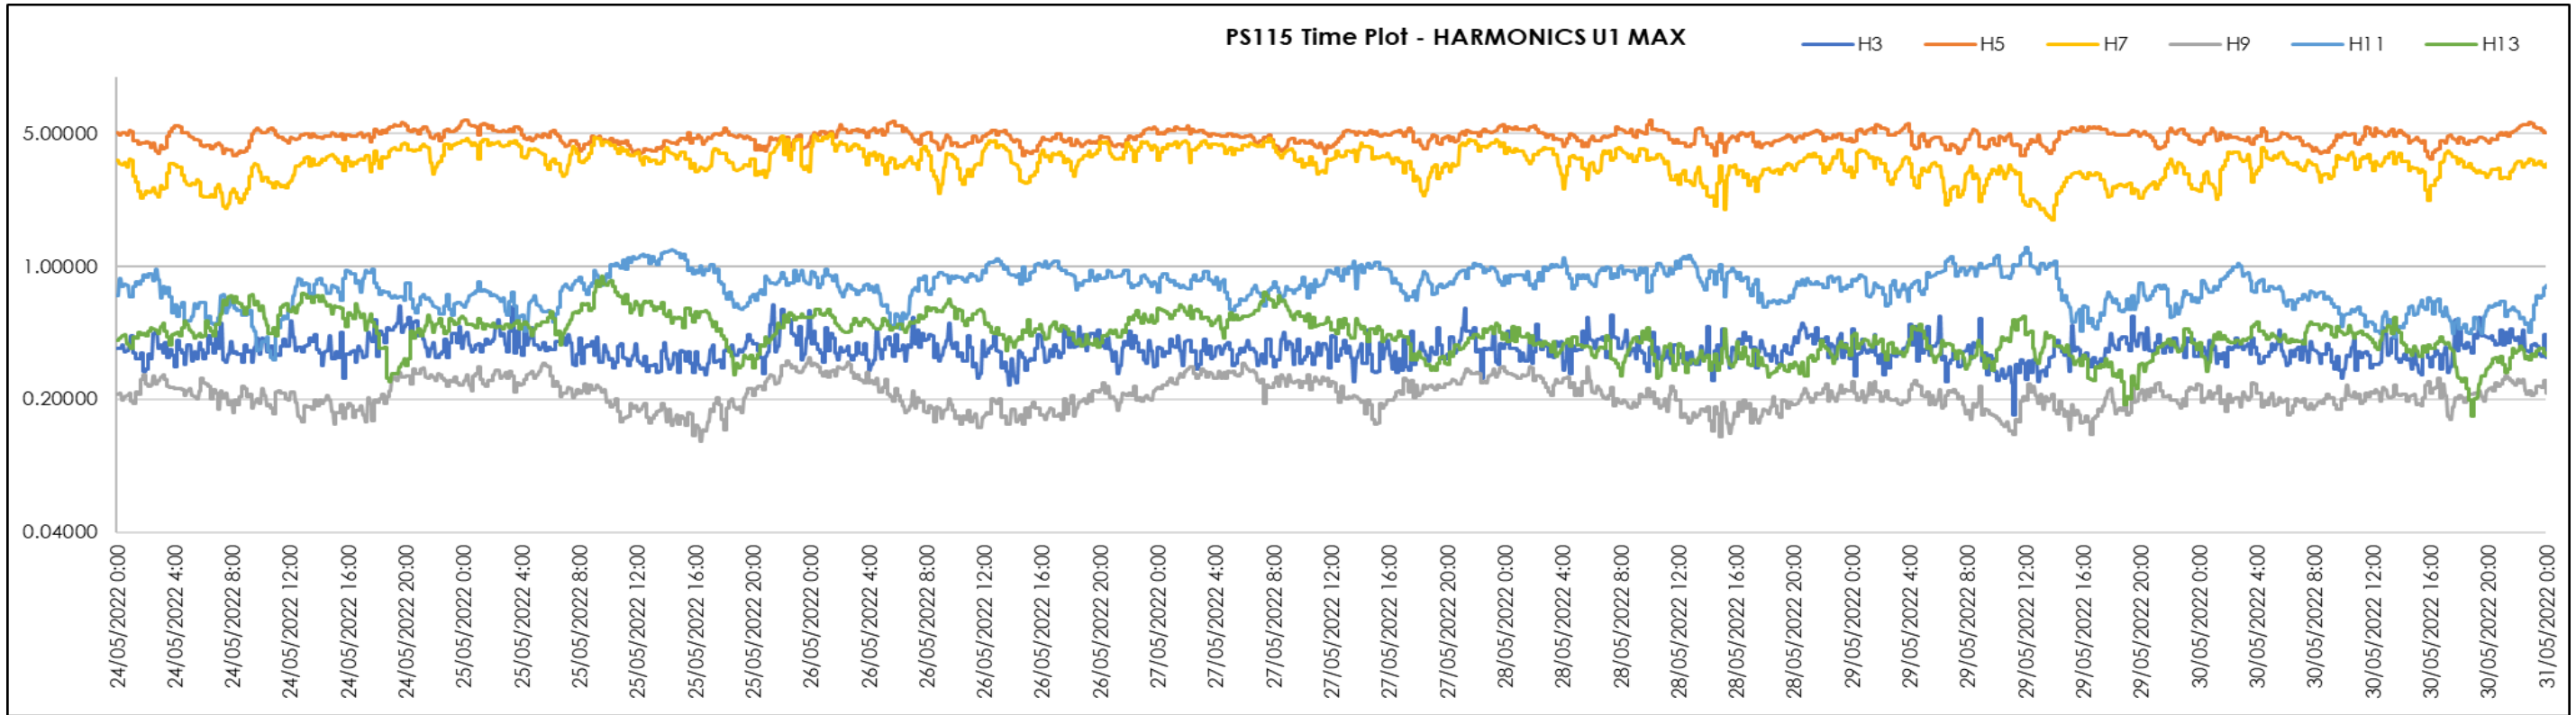
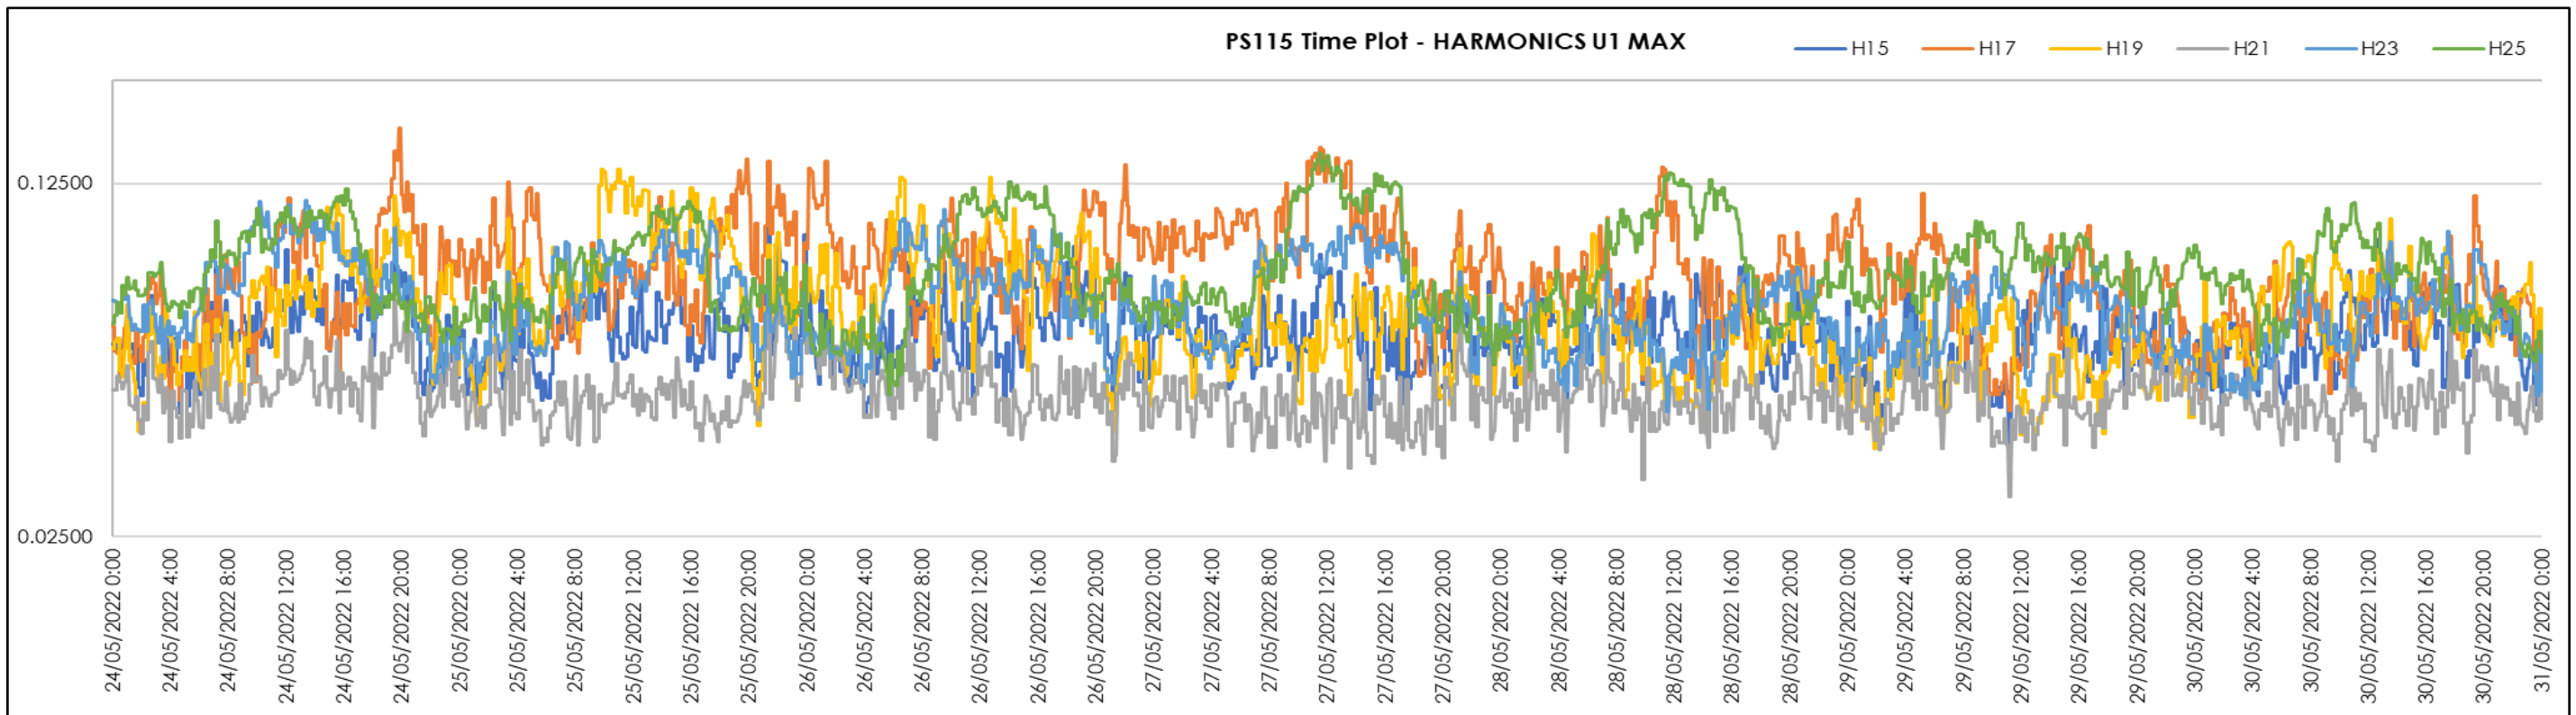
Figure 41 | TC4 Start Harmonics

The logged harmonic data for the start and end of the TC4 feeder is shown from Figure 41 to Figure 42 in Appendix A.4. No non-compliant harmonics were recorded for the recording period.

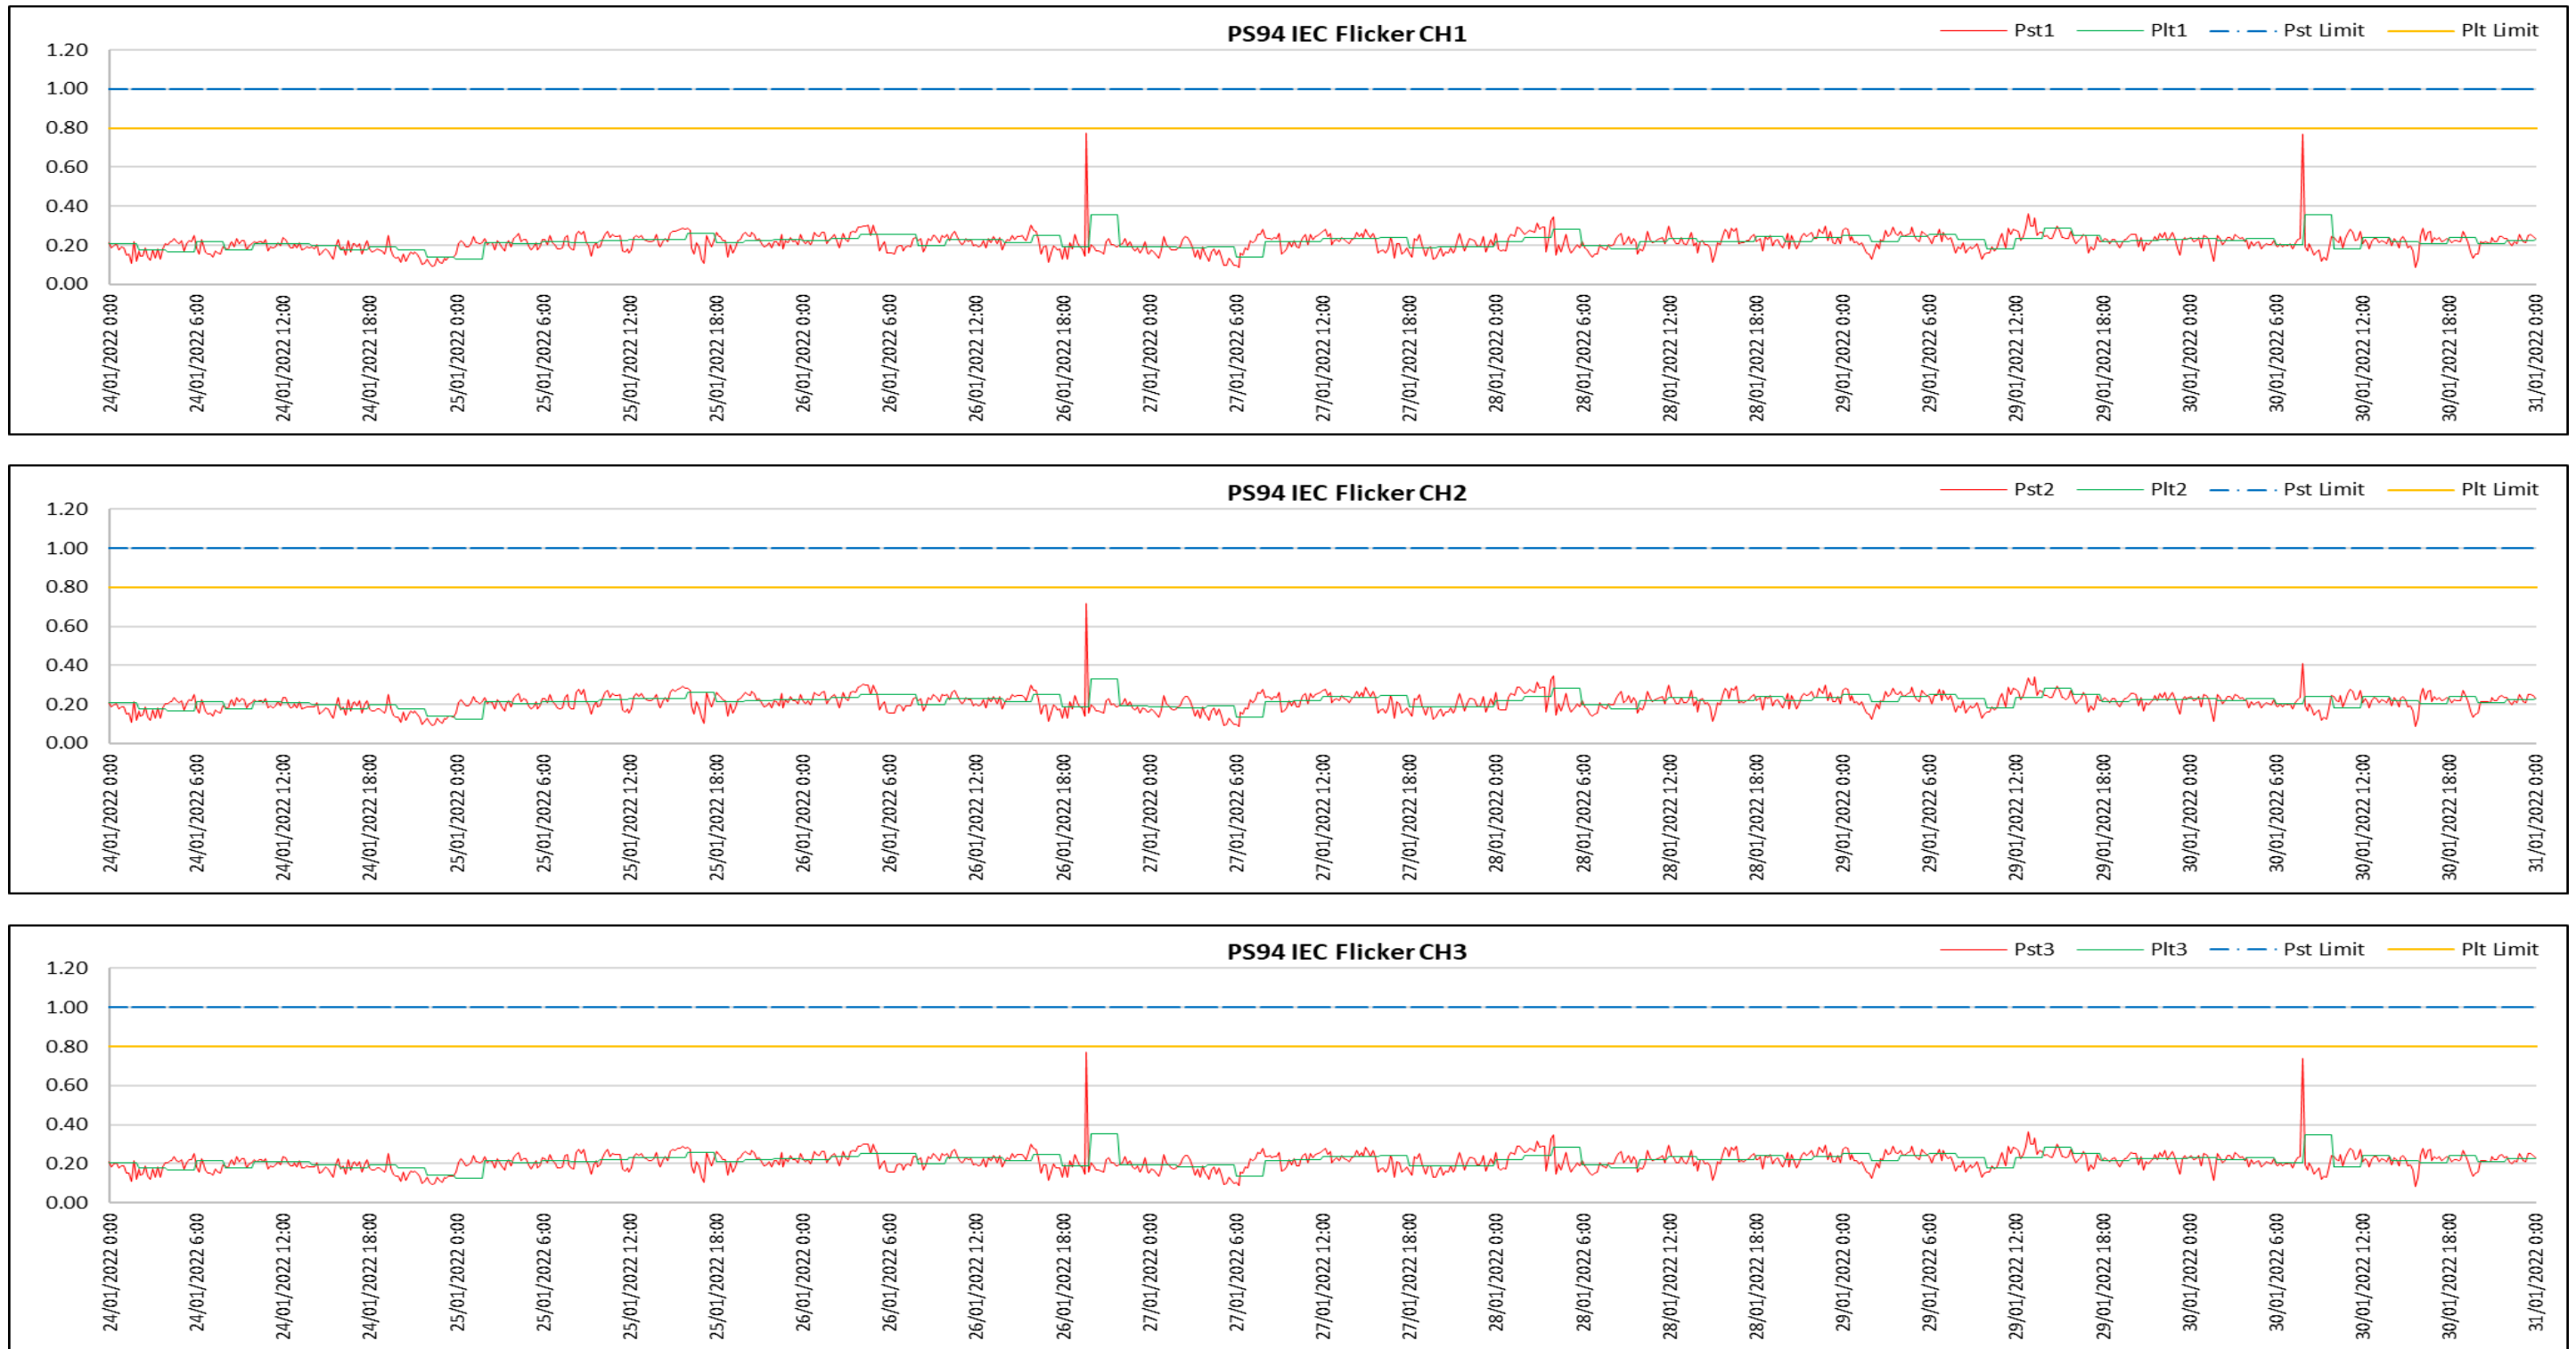
Figure 43 | STS1 Start Flicker measurements

The logged flicker data for the start and end of the STS1 feeder is shown from Figure 43 to Figure 44 in Appendix A.5. There were no recorded flicker limit events causing the flicker level to breach the Code's limits (i.e., full compliance with the Code requirements).

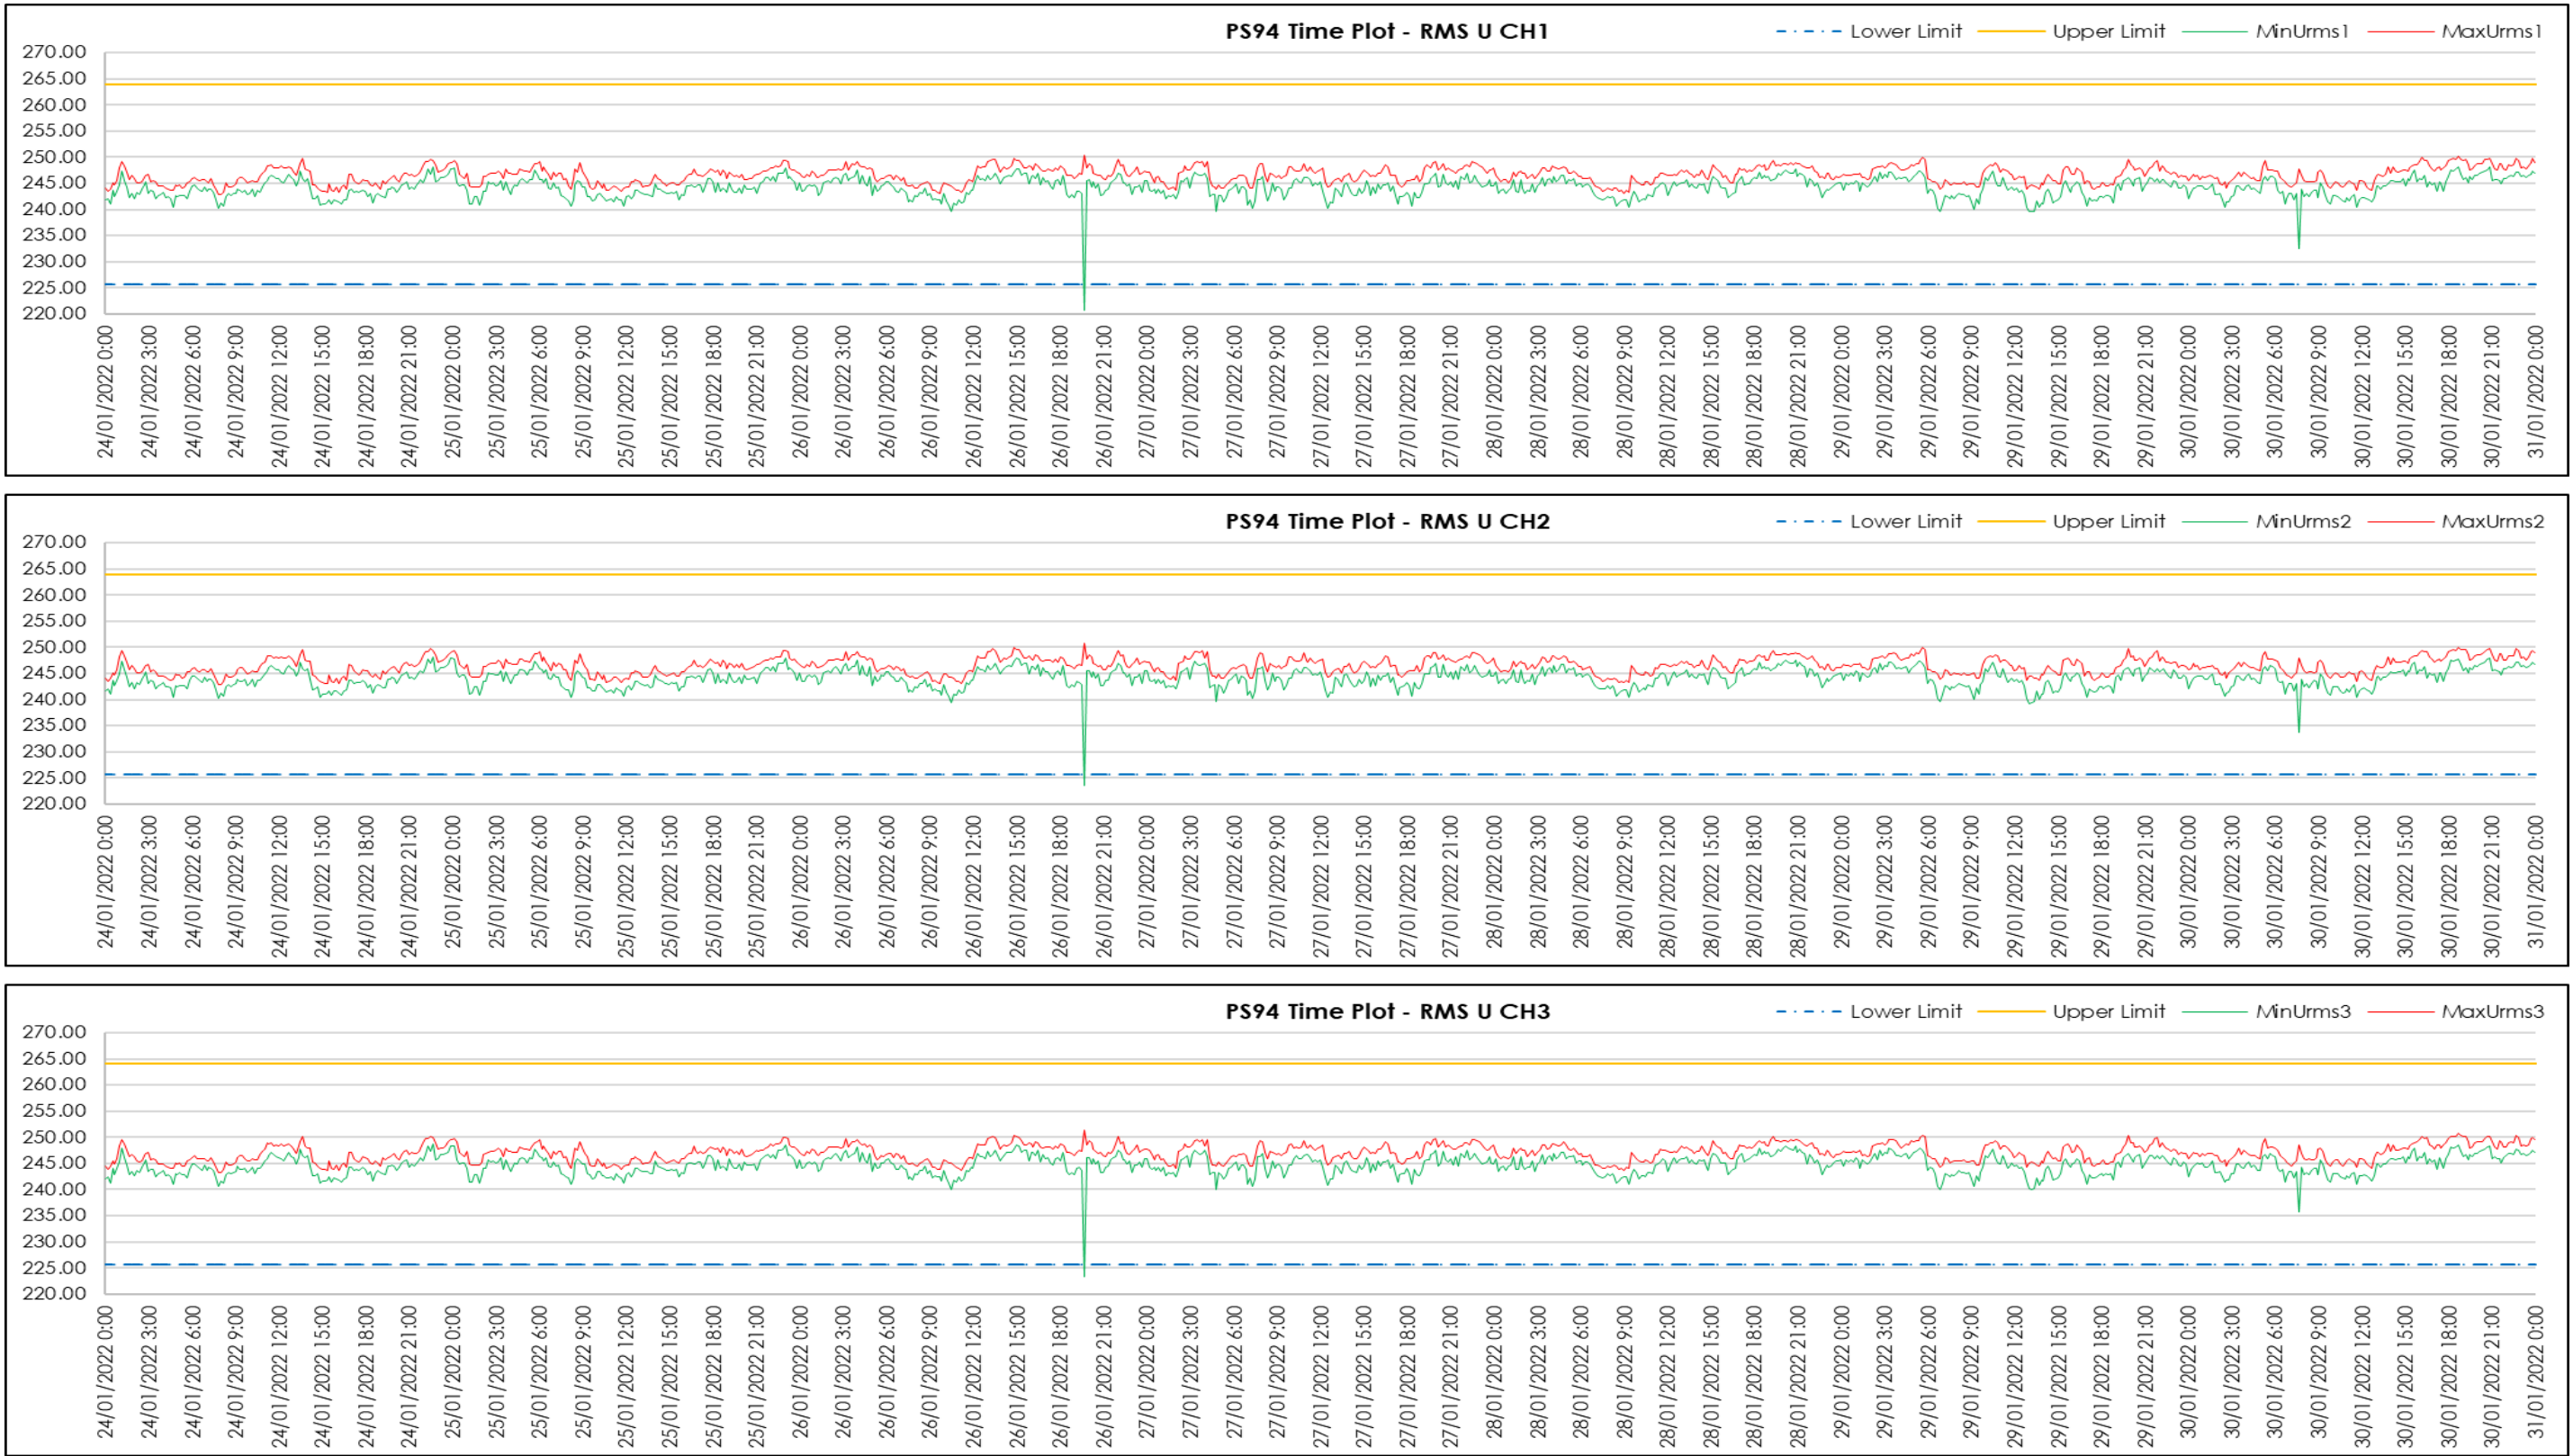
Figure 45 | STS1 Start Voltage measurements

The logged voltage level data for the start and end of the STS1 feeder is shown from Figure 45 to Figure 46 in Appendix A.5. **Table 8** below shows the recorded breach events during the logging period.

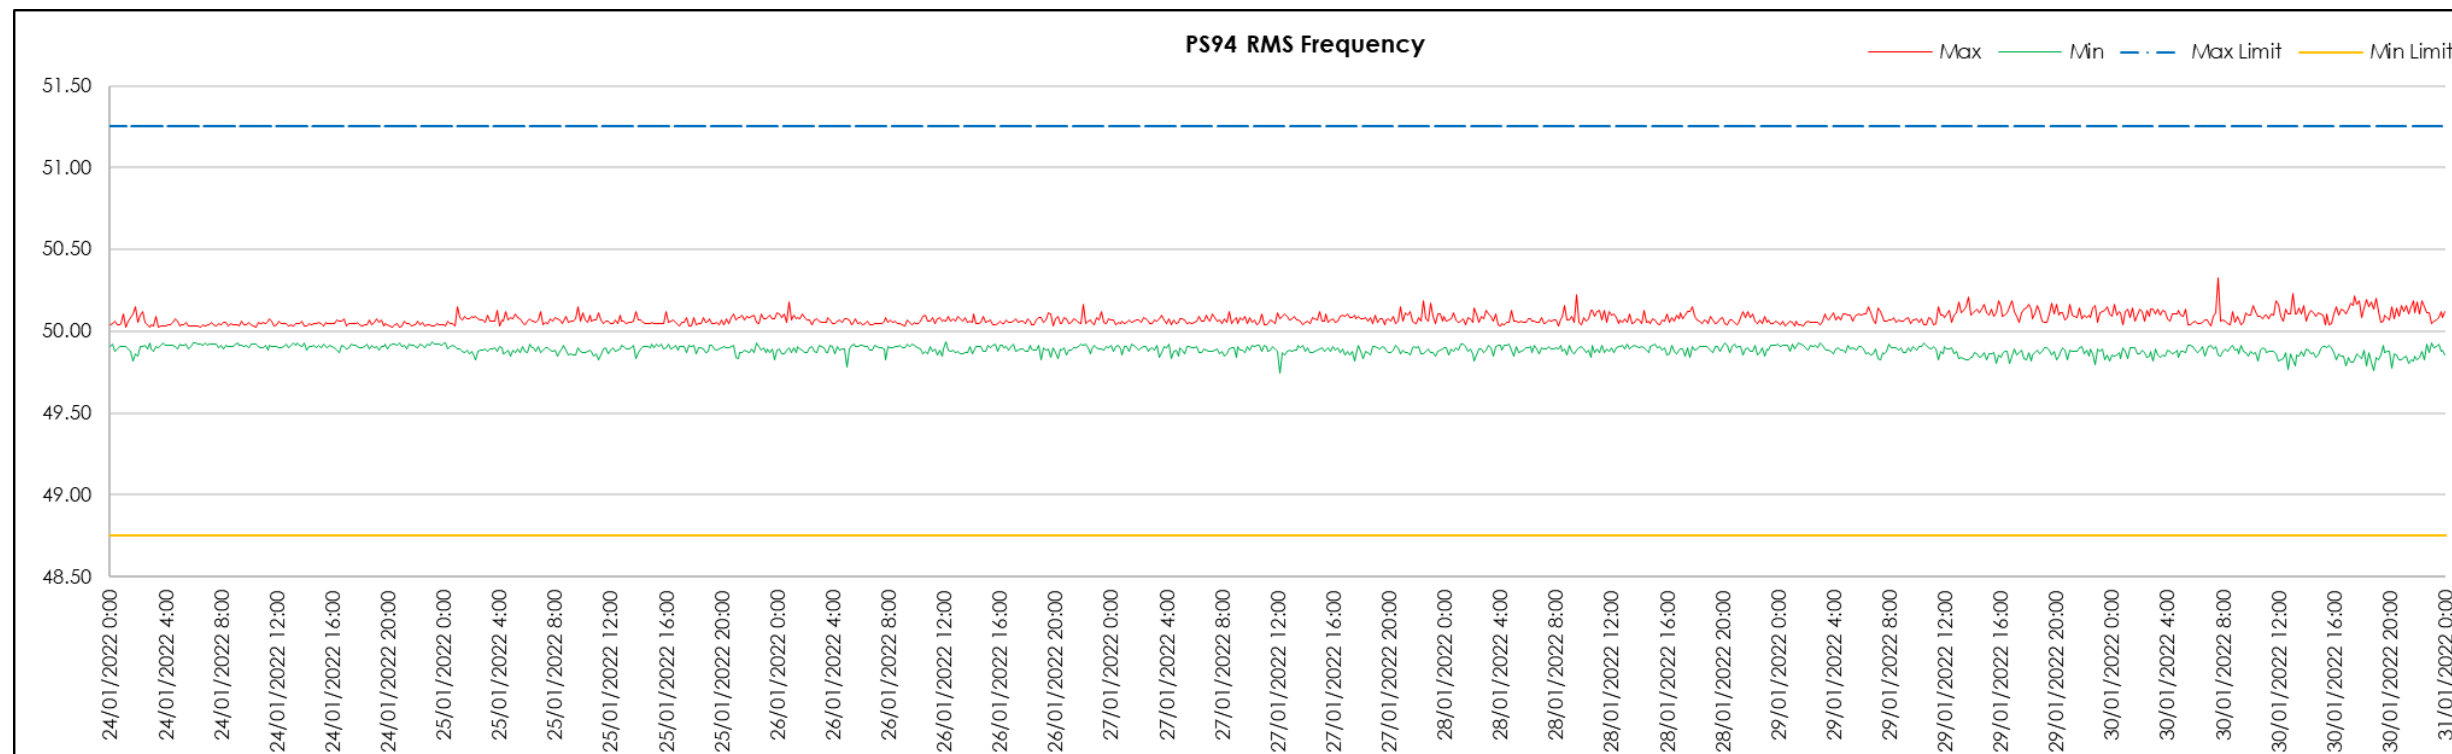
Figure 47 | STS1 Start Frequency measurements

The logged frequency data for the start and end of the STS1 feeder is shown from Figure 47 to Figure 48 in Appendix A.5. There were no recorded frequency limit events causing the frequency level to breach the Code's limits (i.e., full compliance with the Code requirements).
