APD
ENGINEERING

BHP NEWMAN TOWNSHIP ELECTRICITY SUPPLY
ANNUAL COMPLIANCE REPORT
2021/2022

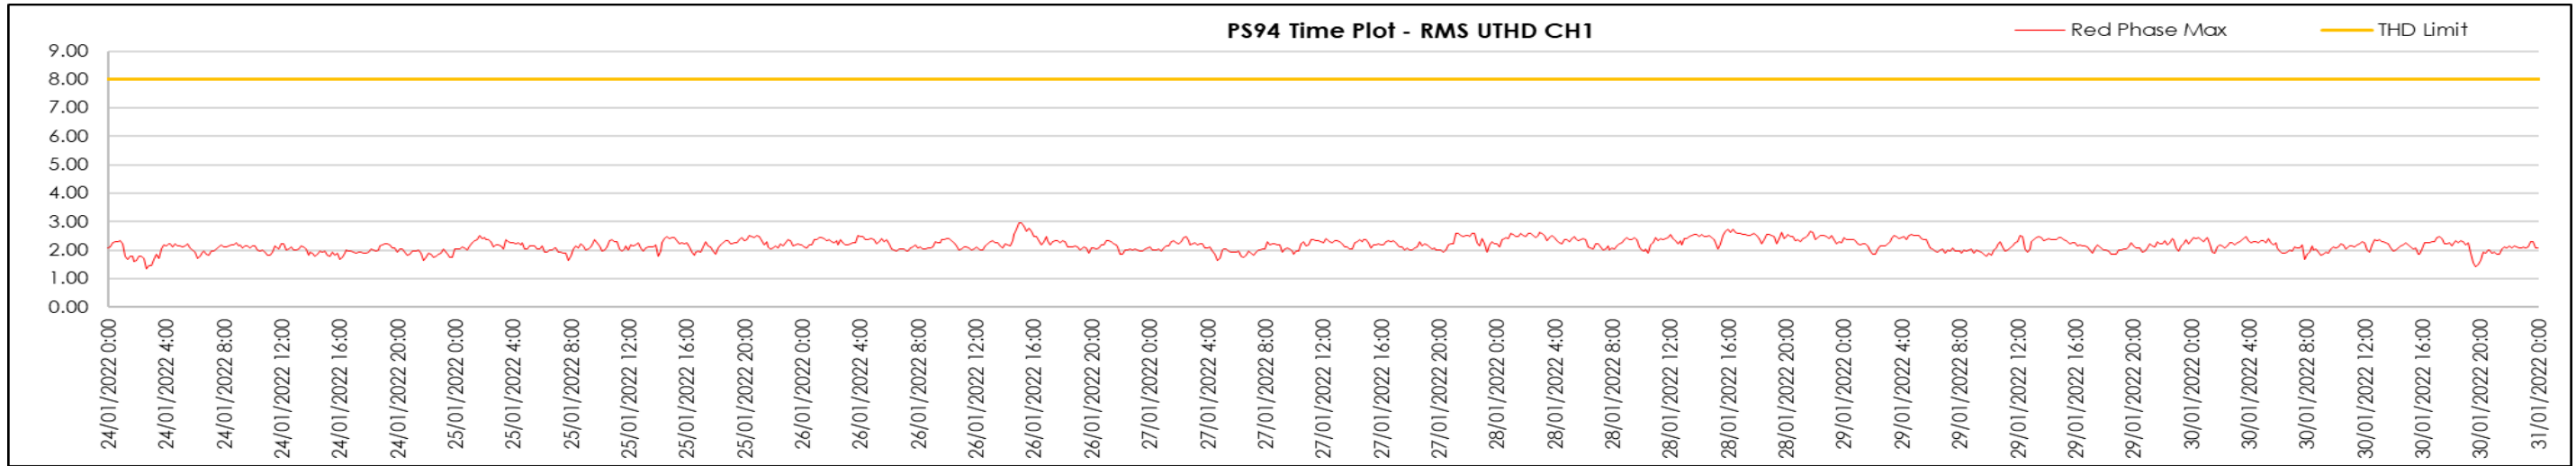
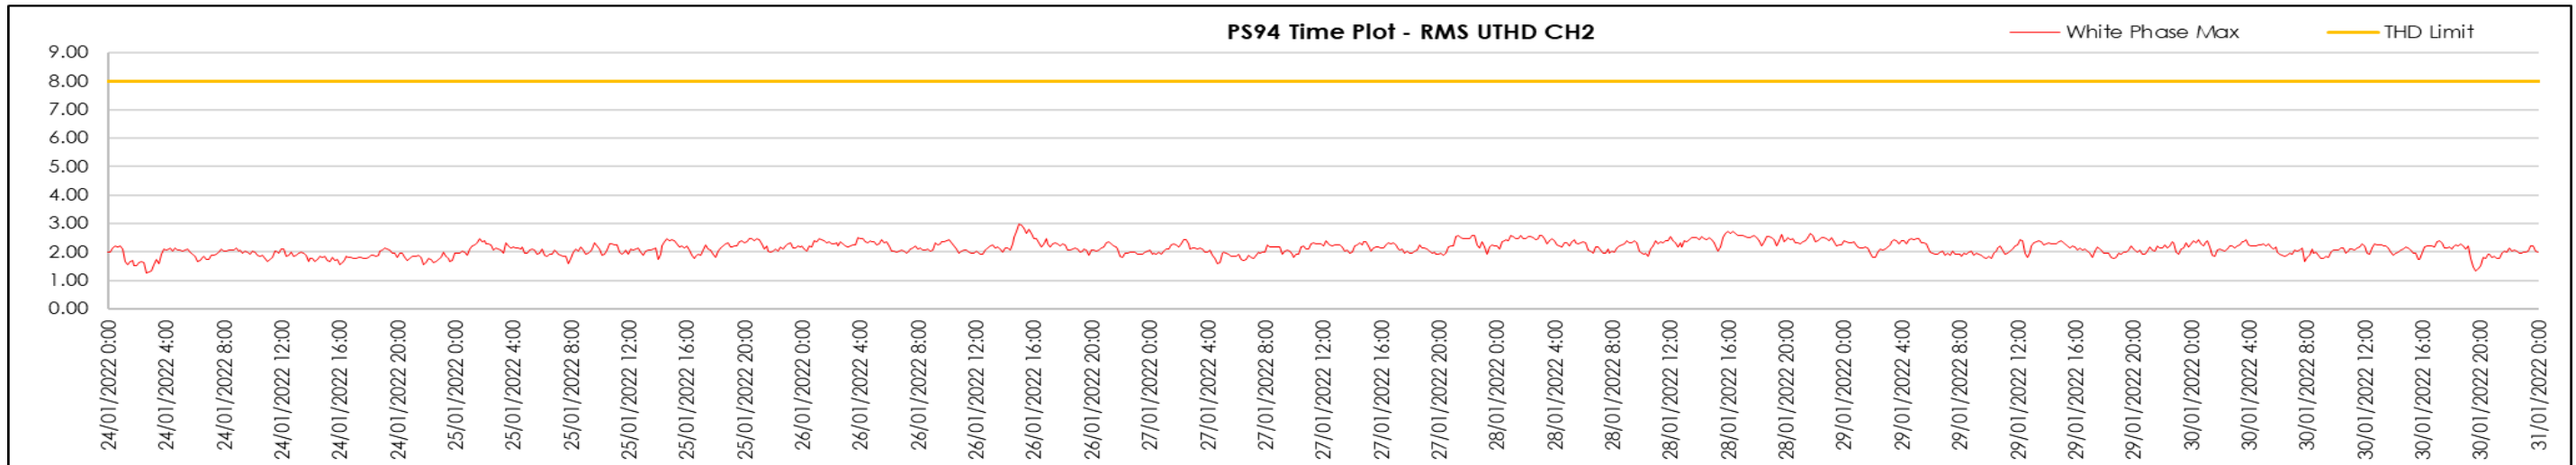
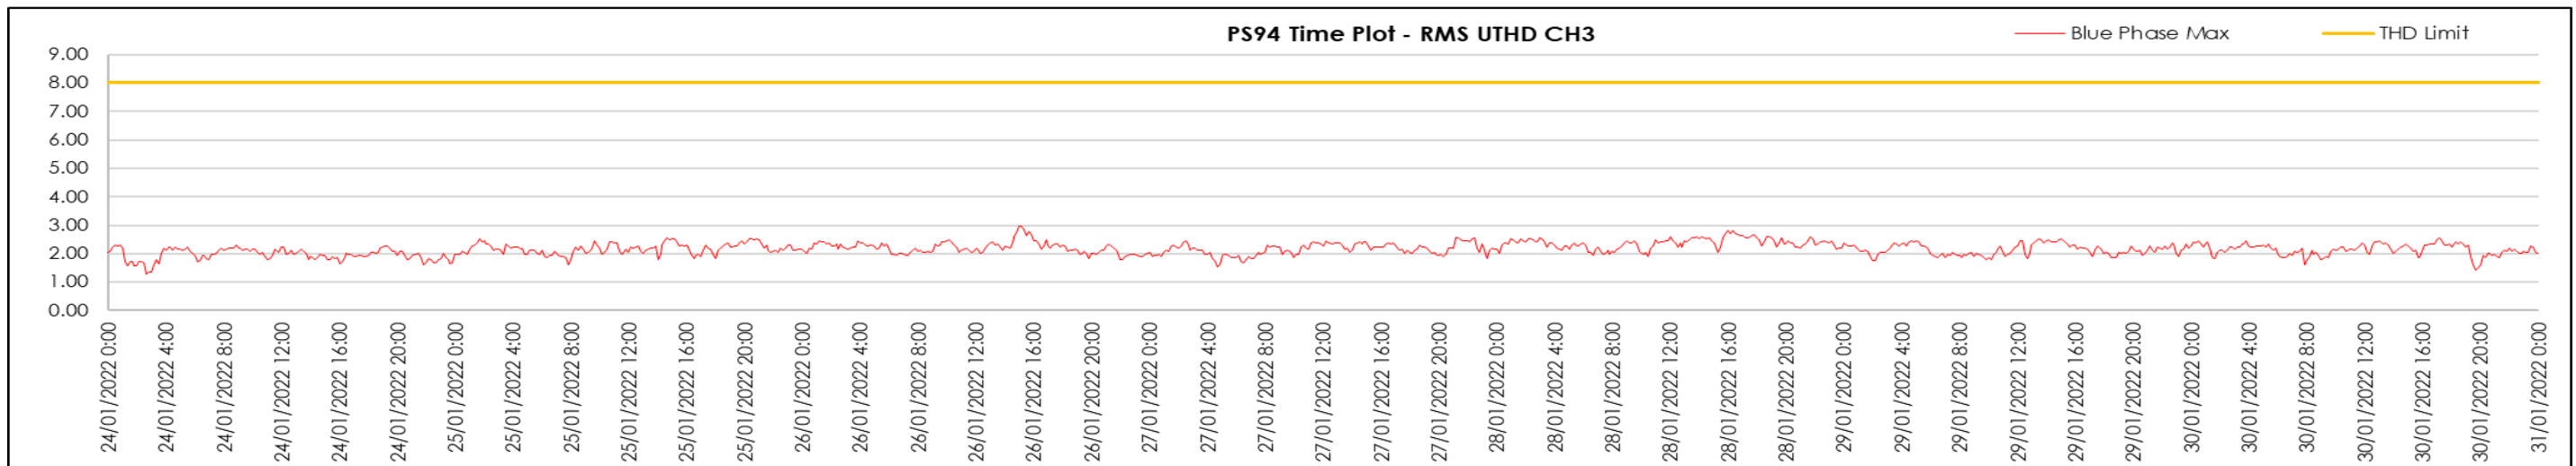
Figure 49 | STS1 Start U-THD measurements

The logged voltage THD level data for the start and end of the STS1 feeder is shown from Figure 49 to Figure 50 in Appendix A.5. There were no recorded voltage THD limit events causing the voltage THD level to breach the Code's limits (i.e., full compliance with the Code requirements).

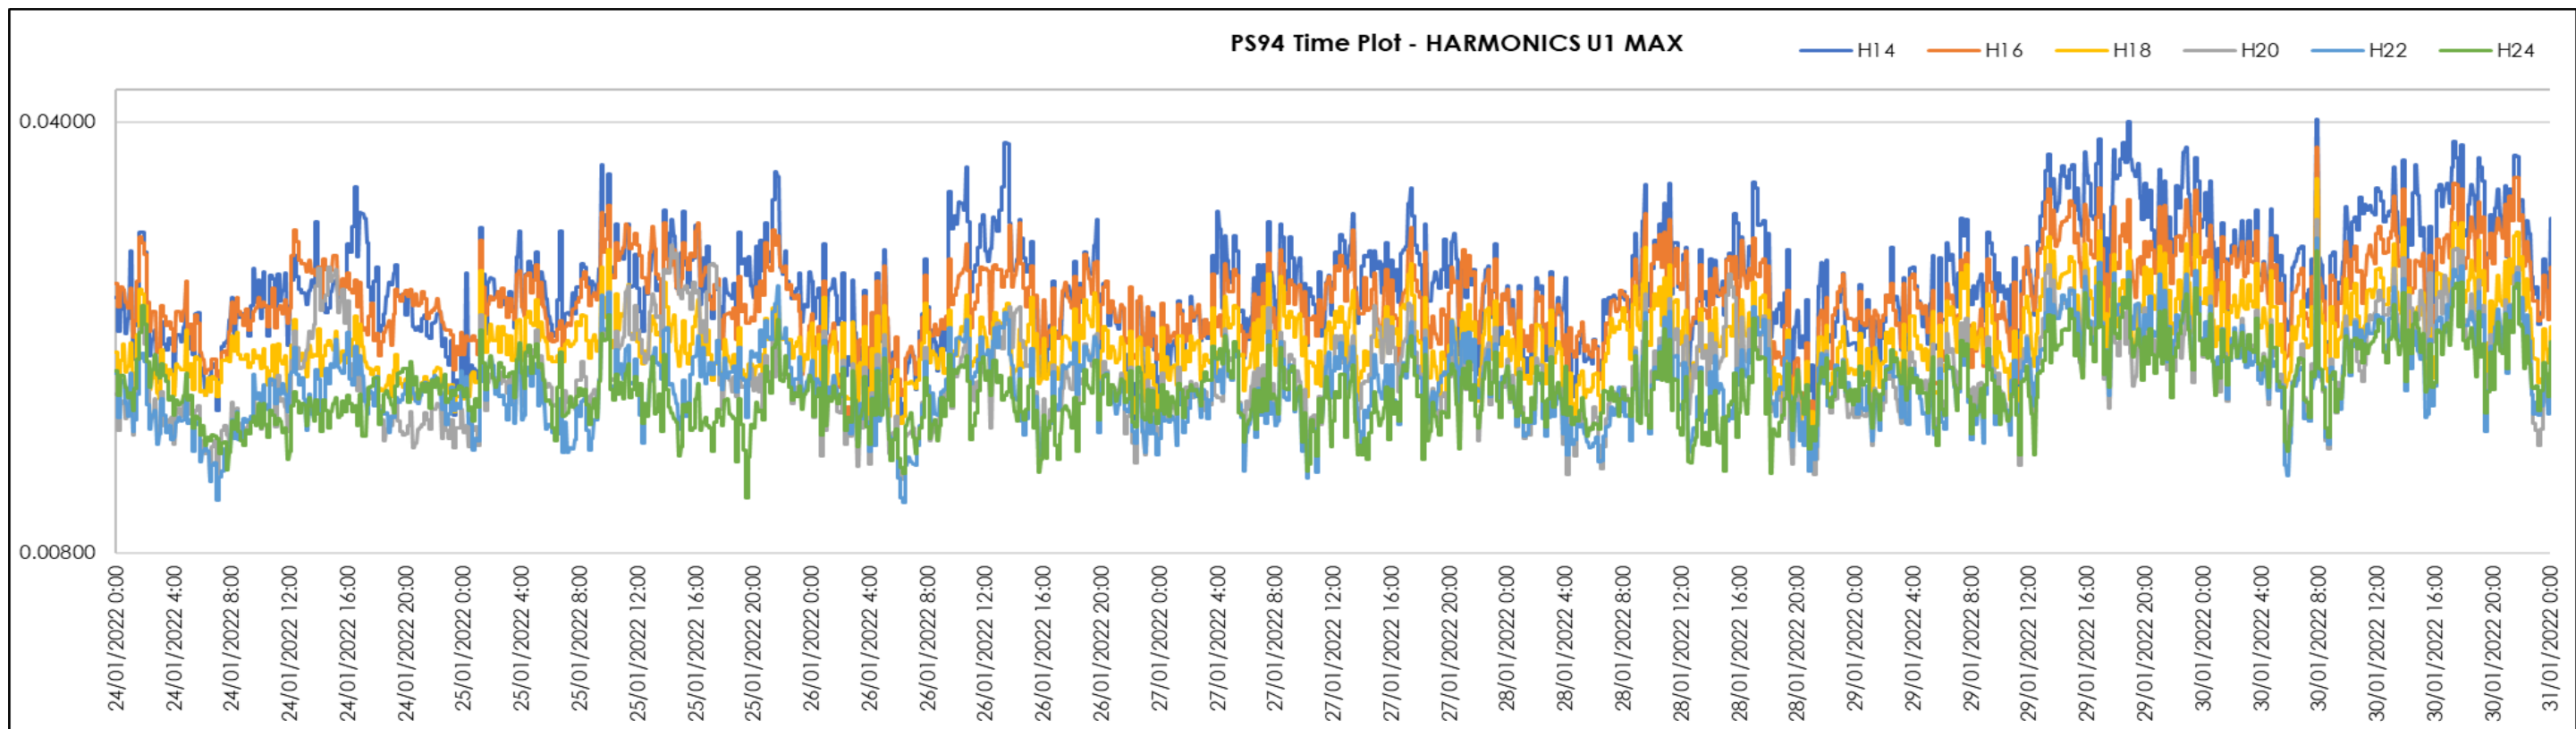
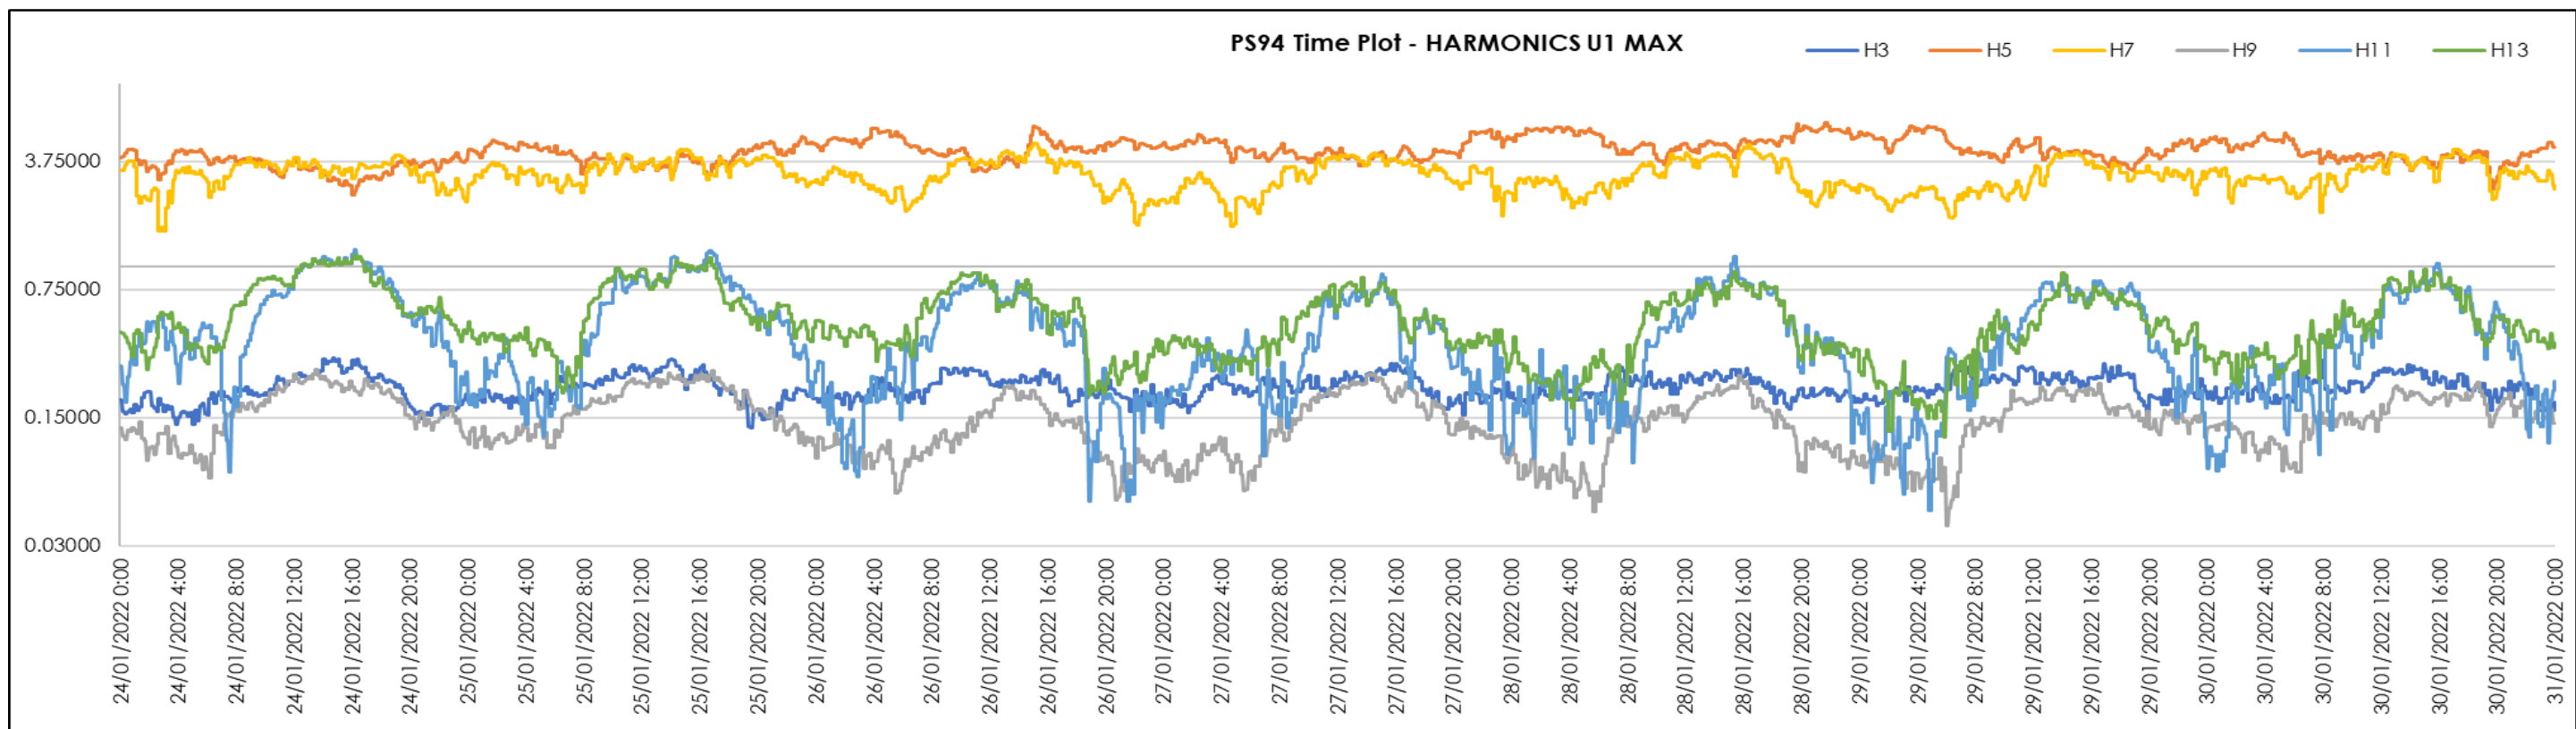
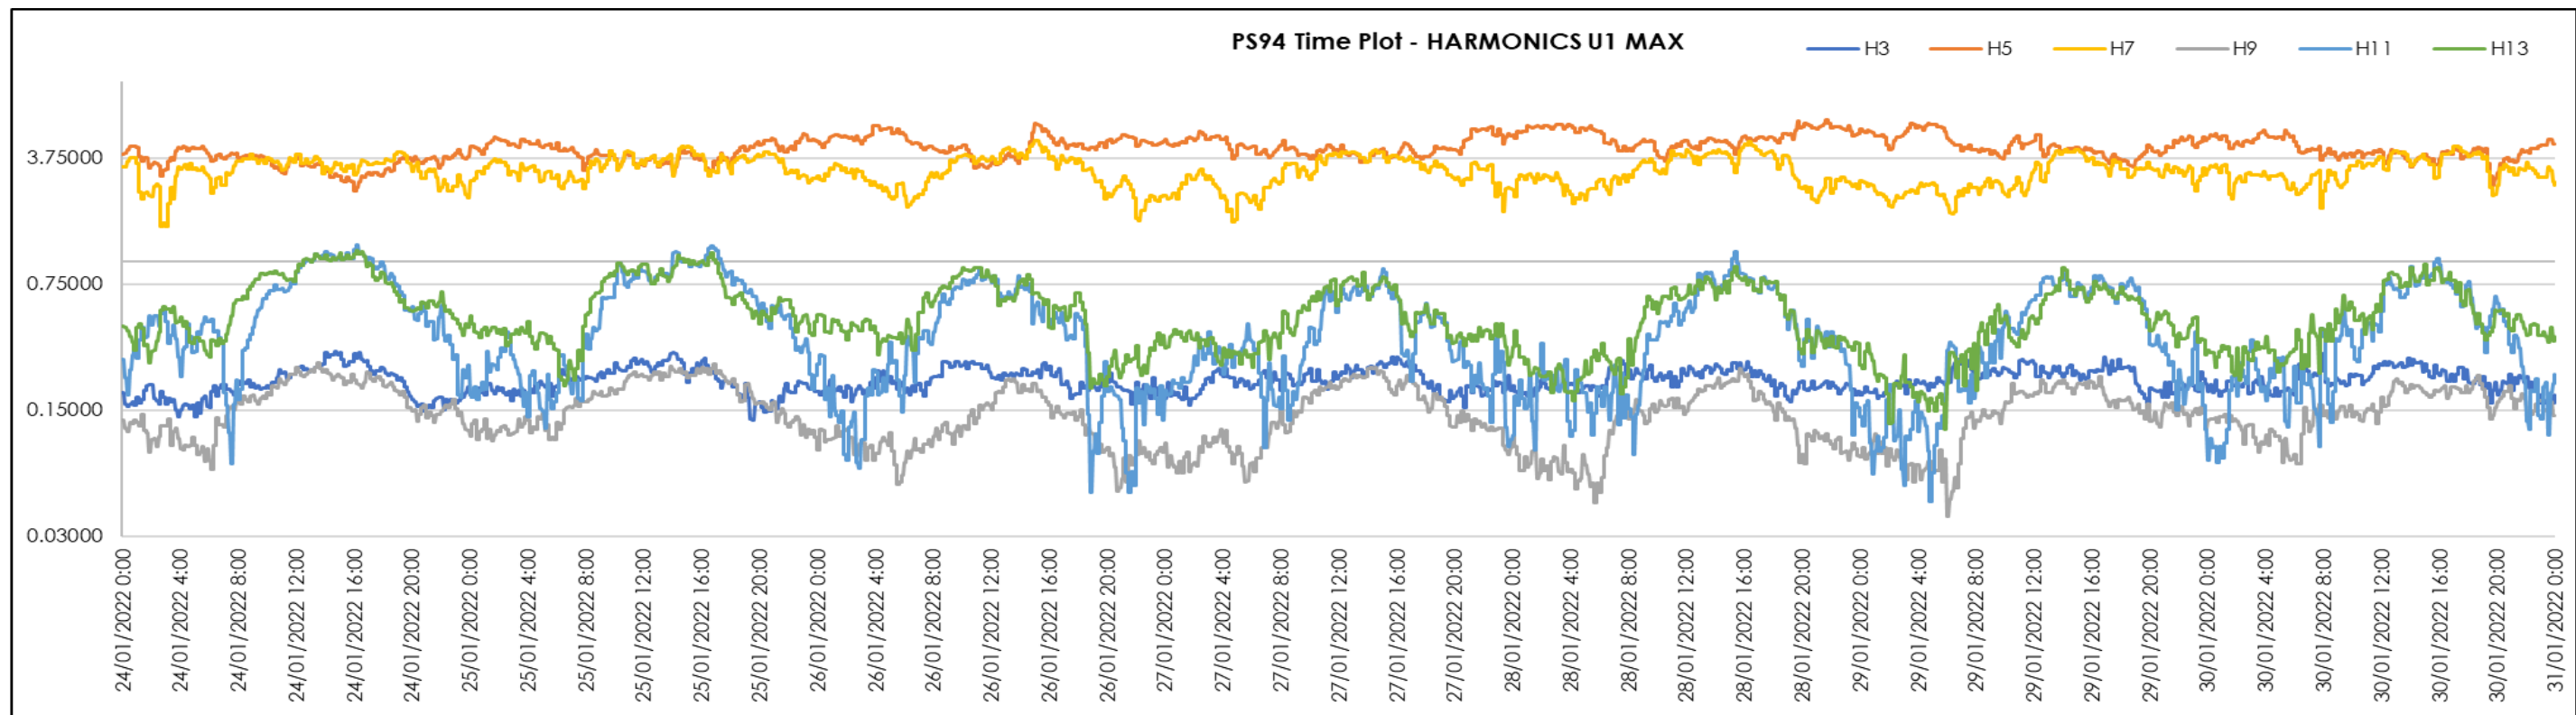
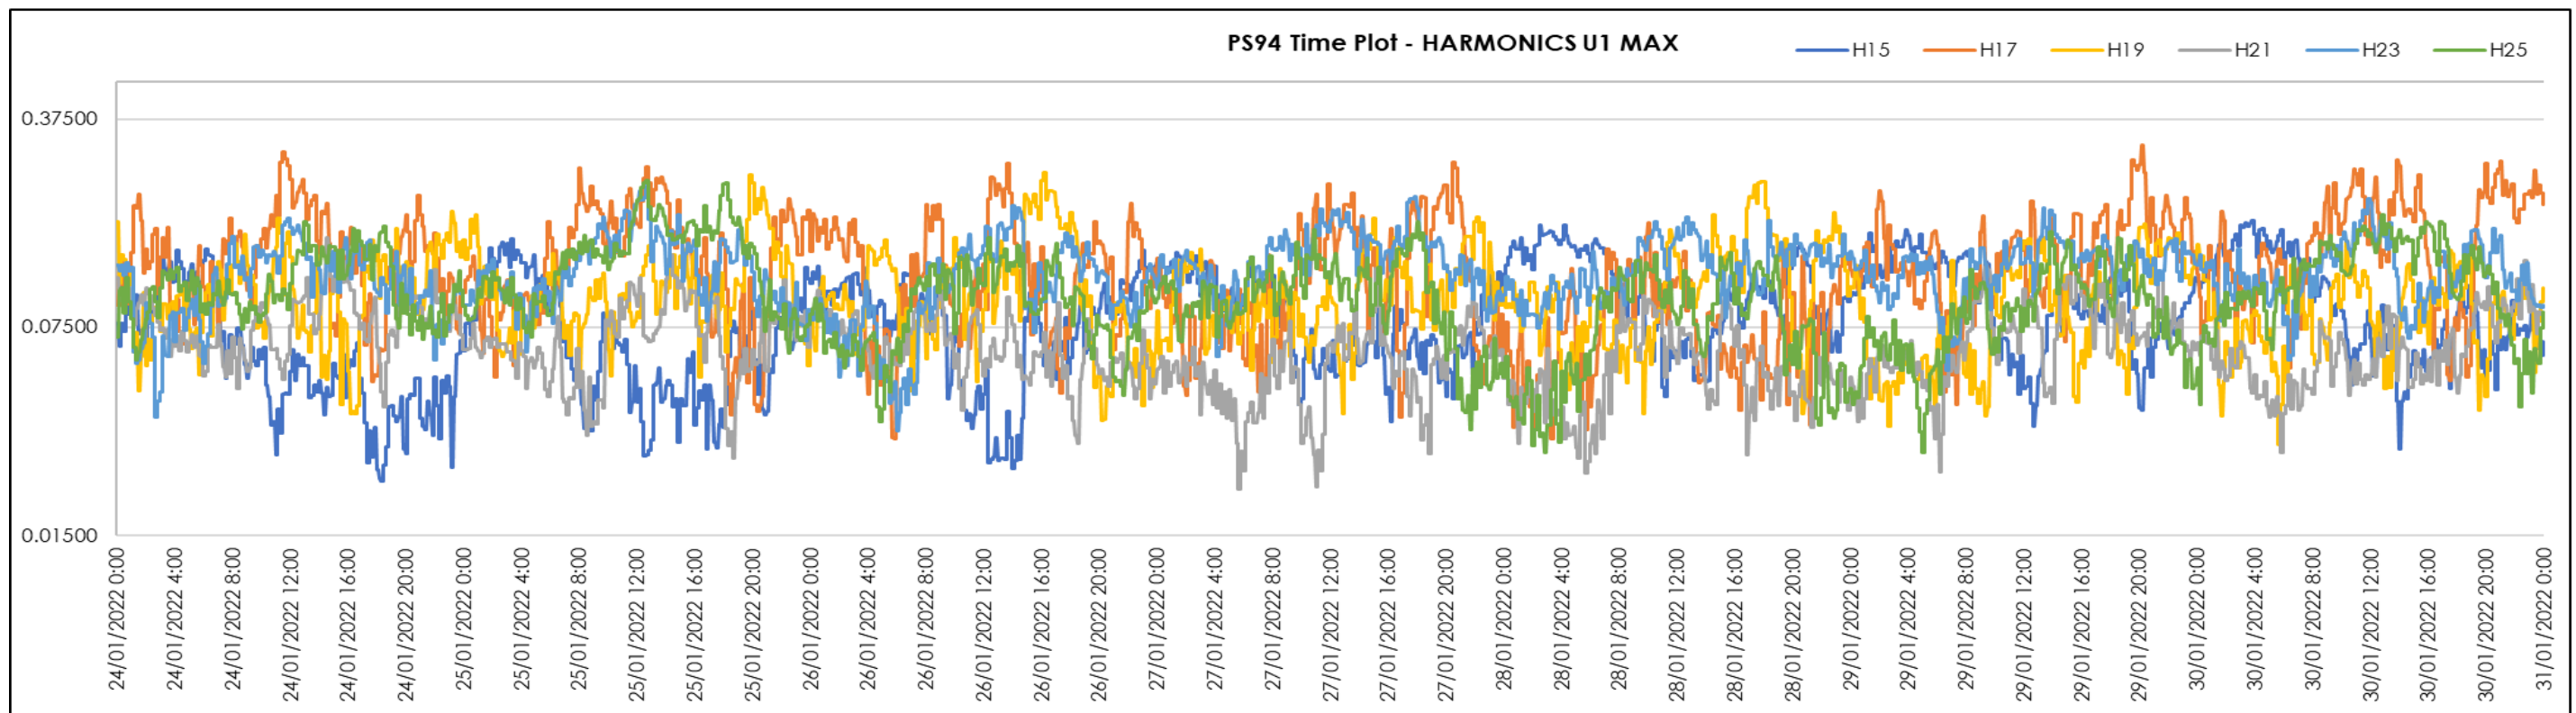
Figure 51 | STS1 Start Harmonics

The logged harmonic data for the start and end of the STS1 feeder is shown from Figure 51 to Figure 52 in Appendix A.5. No non-compliant harmonics were recorded for the recording period.

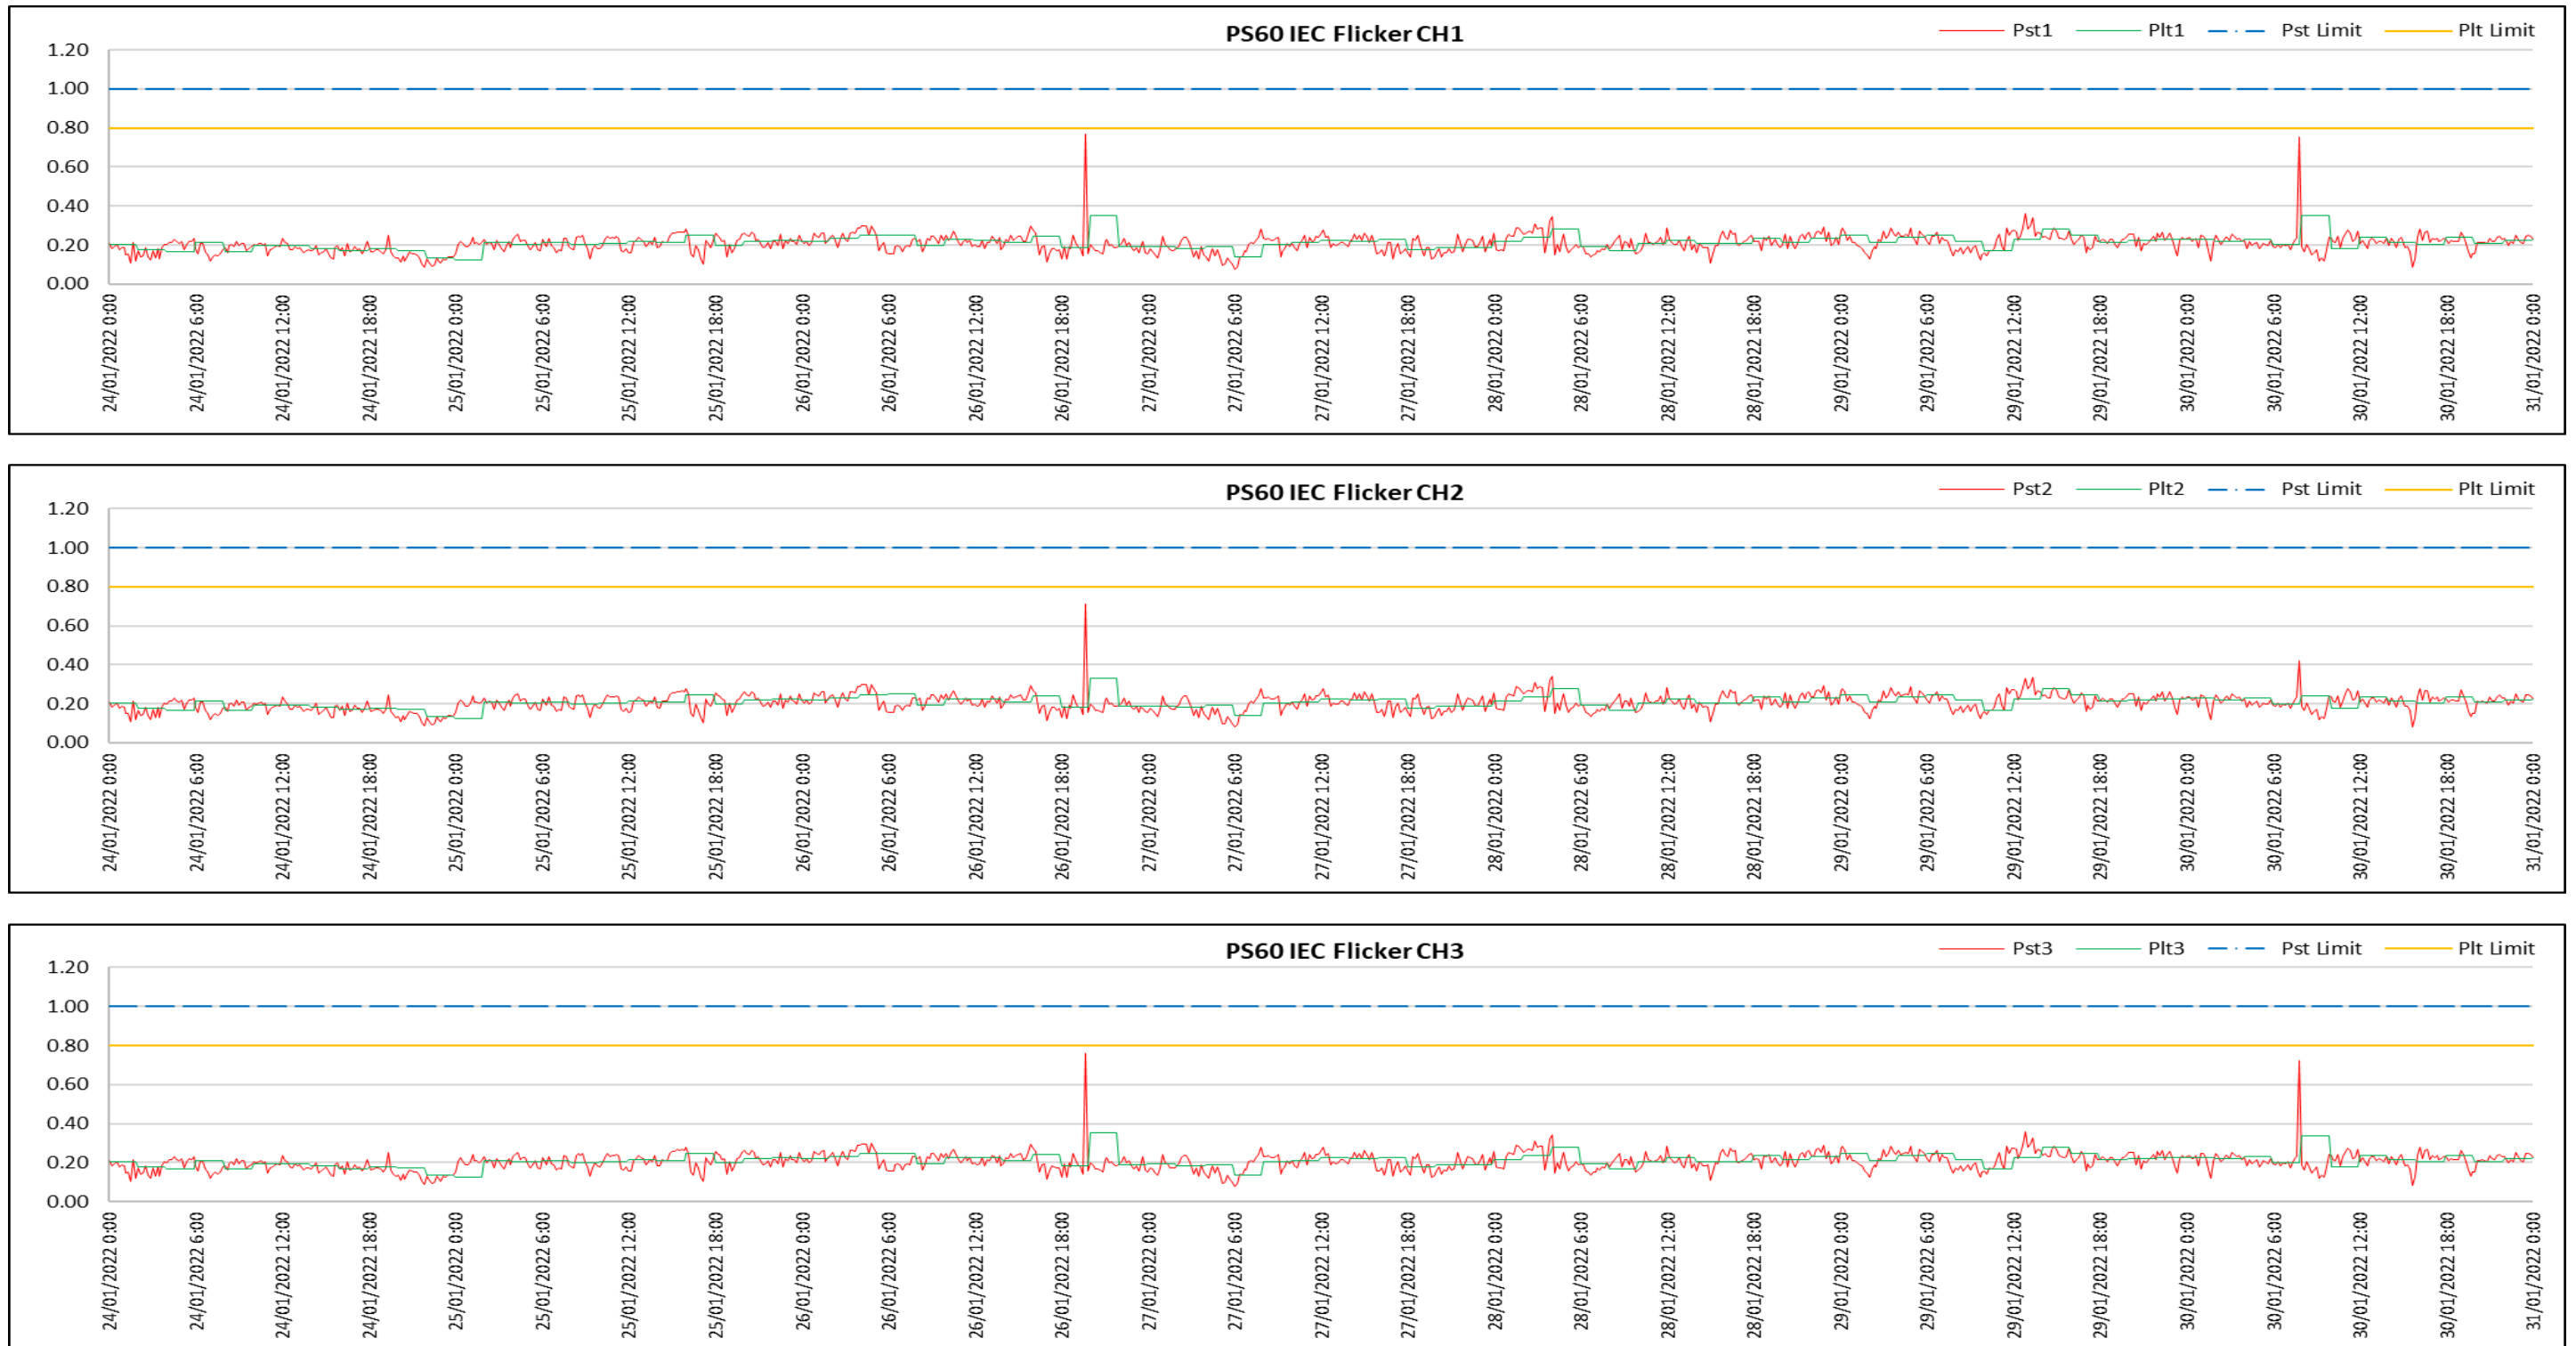
Figure 53 | STS2 Start Flicker measurements

The logged flicker data for the start and end of the STS2 feeder is shown from Figure 53 to Figure 54 in Appendix A.6. There were no recorded flicker limit events causing the flicker level to breach the Code's limits (i.e., full compliance with the Code requirements).

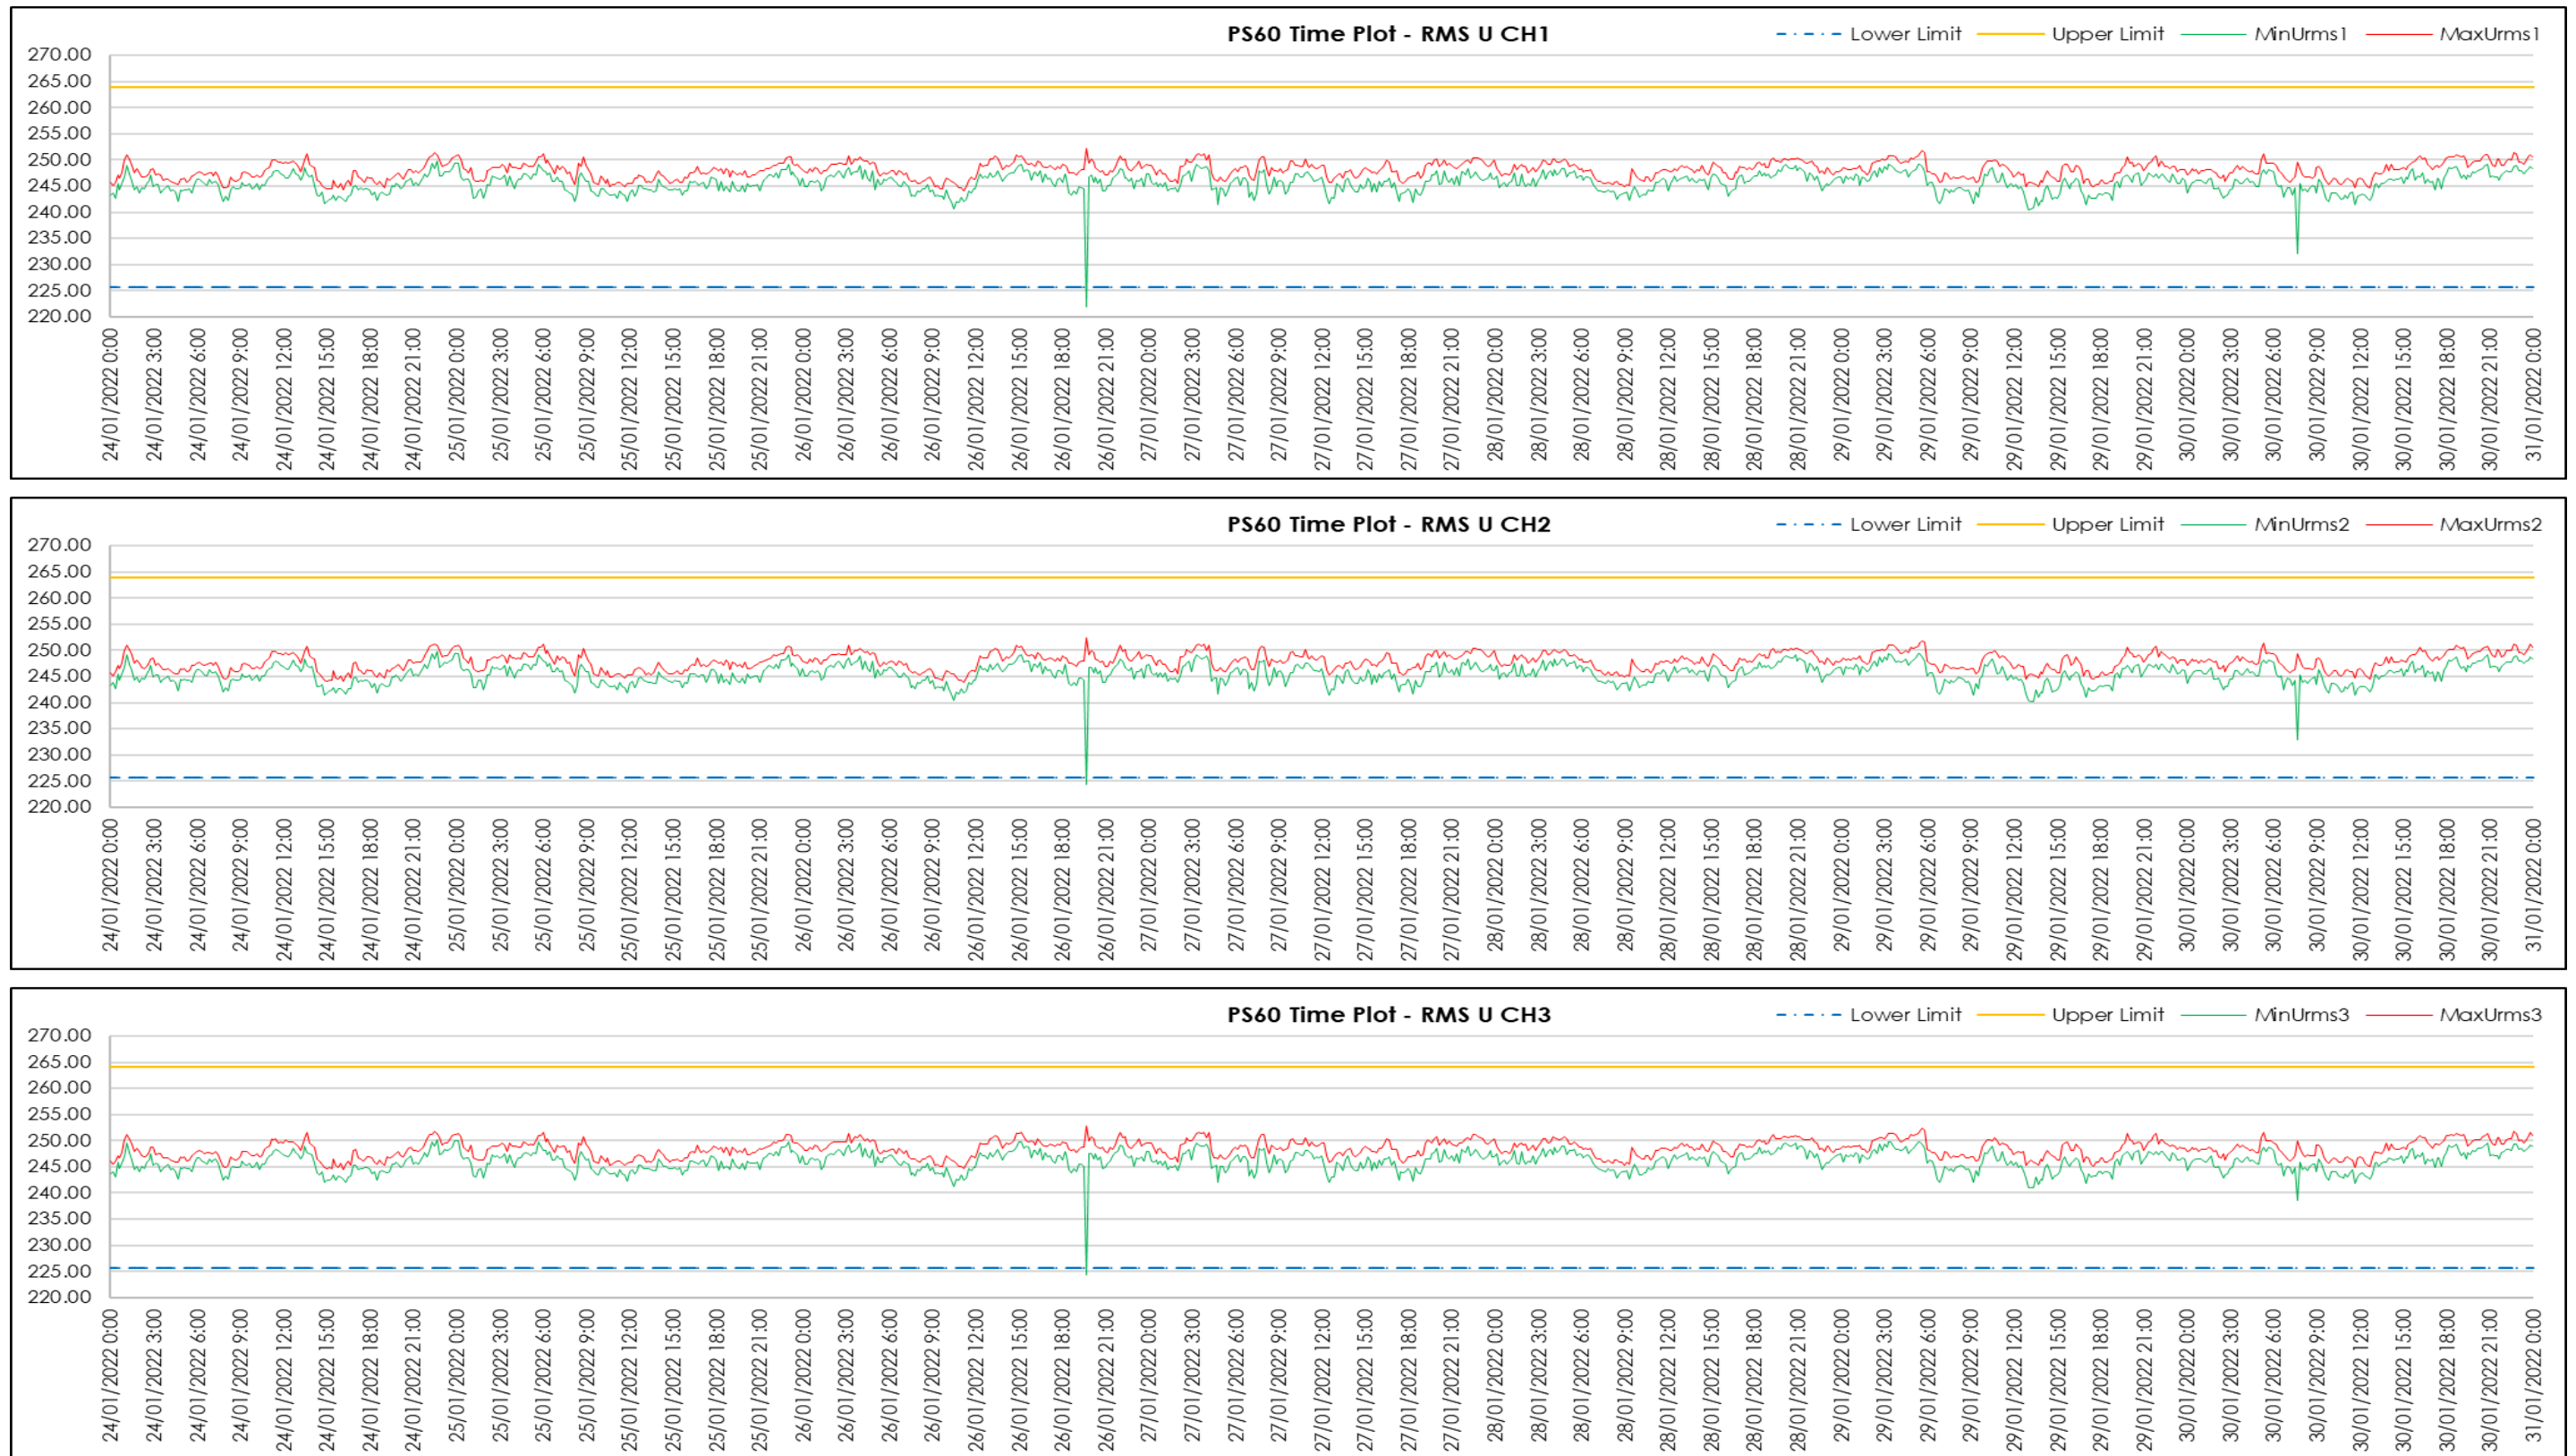
Figure 55 | STS2 Start Voltage measurements

The logged voltage level data for the start and end of the STS2 feeder is shown in Figure 55 to Figure 56 in Appendix A.6. Table 7 below lists the recorded breach events during the Logging Period:

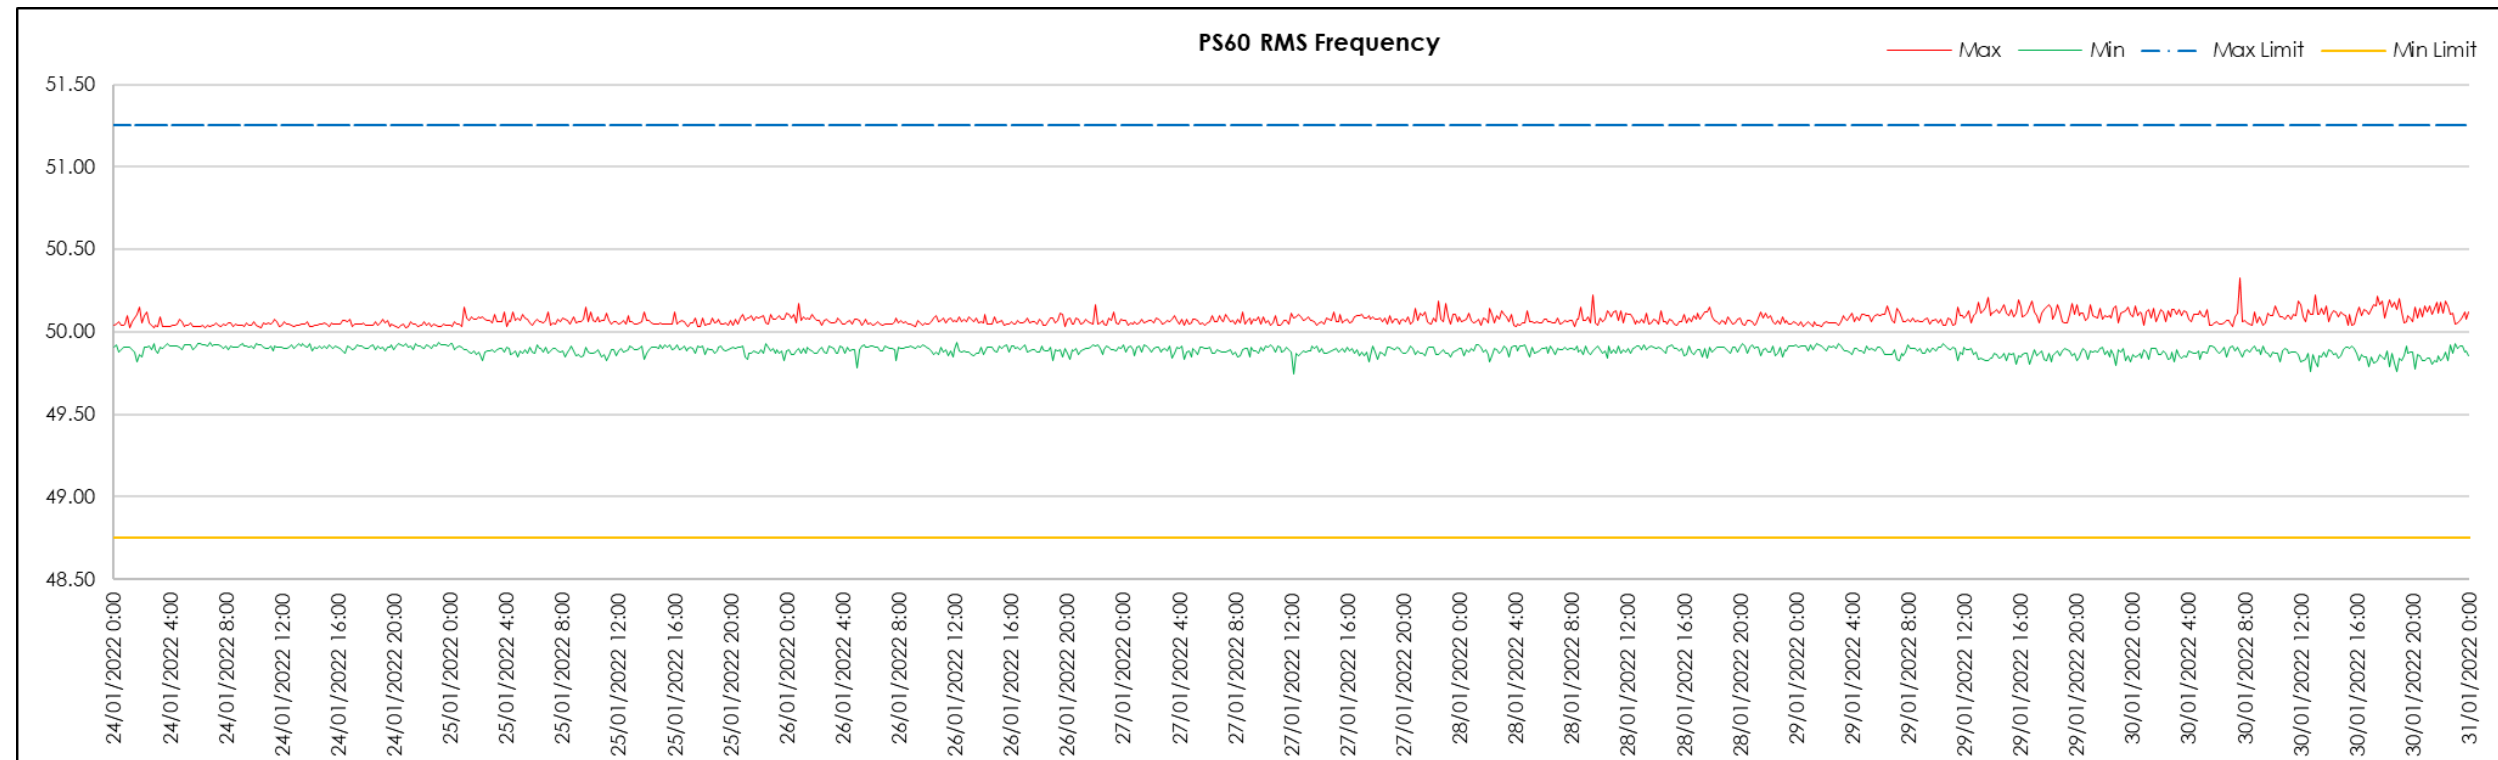
Figure 57 | STS2 Start Frequency measurements

Figure 57 to Figure 58 in Appendix A.6. There were no recorded frequency limit events causing the frequency level to breach the code's limit. (i.e., full compliance with the Code requirements).
