APD
ENGINEERING

BHP NEWMAN TOWNSHIP ELECTRICITY SUPPLY
ANNUAL COMPLIANCE REPORT
2021/2022

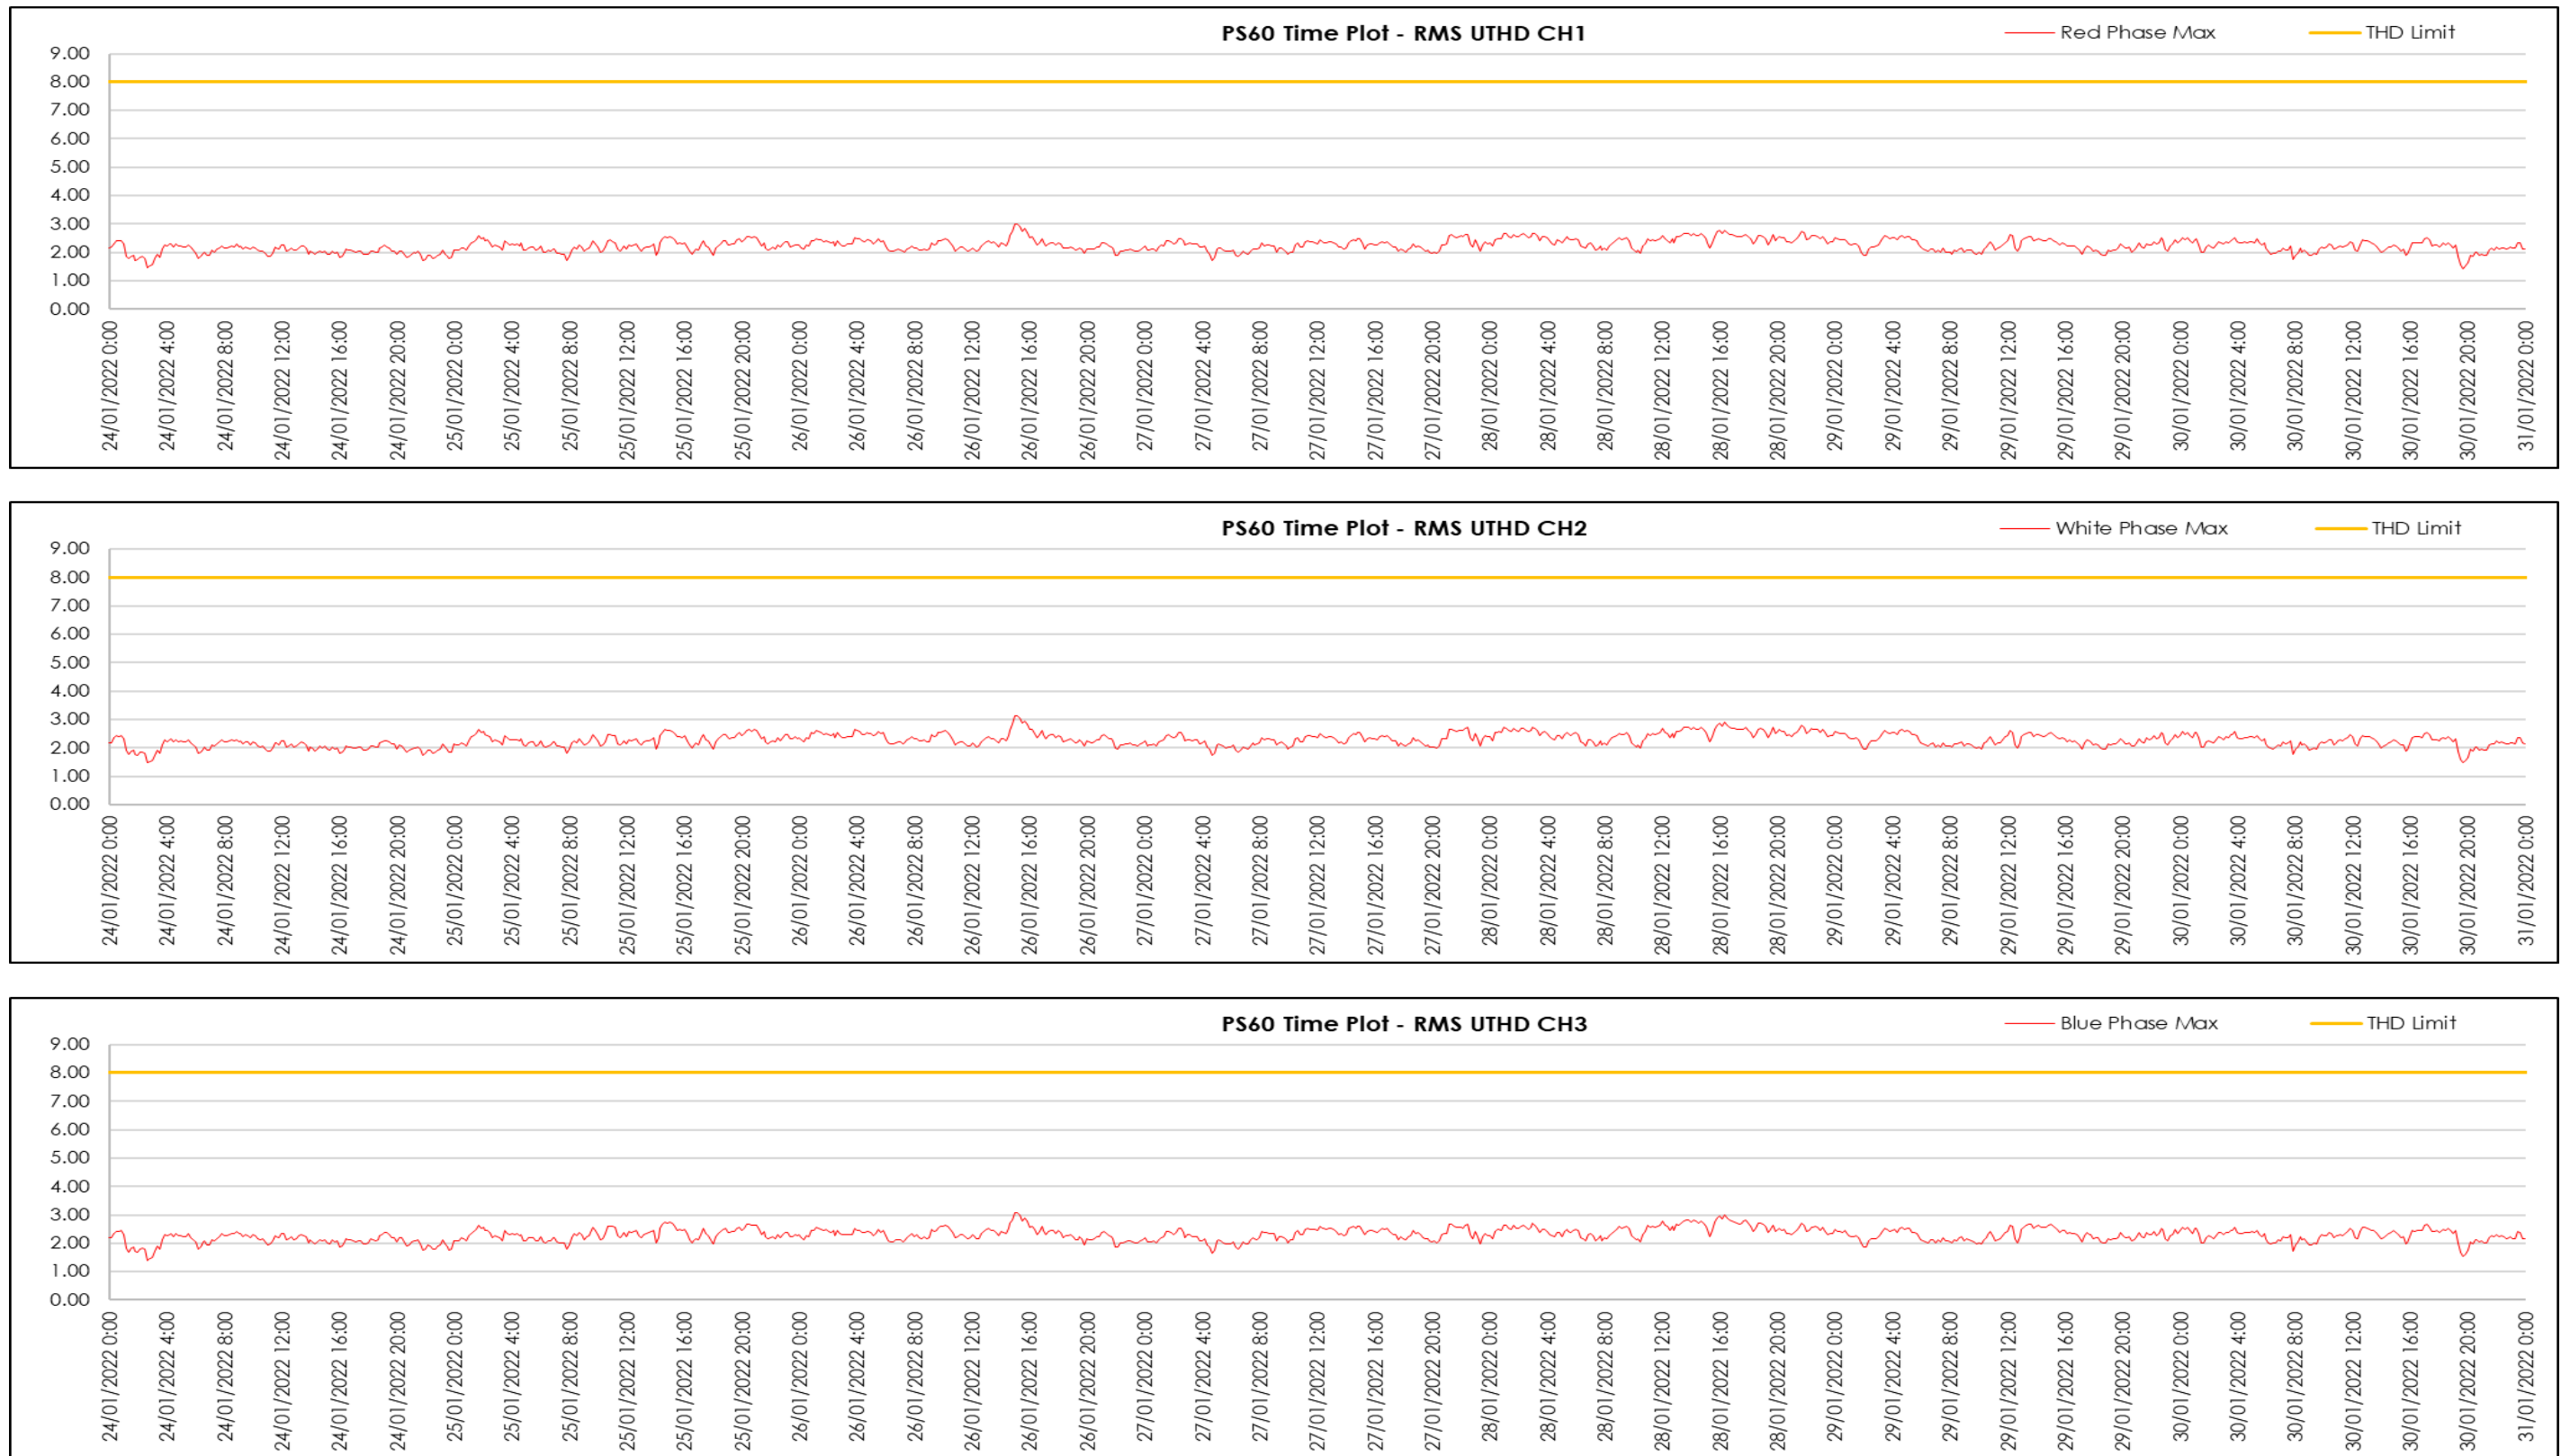
Figure 59 | STS2 Start U-THD measurements

The logged voltage THD level data for the start and end of the STS2 feeder is shown from Figure 59 to Figure 60 in Appendix A.6. There were no recorded voltage THD limit events causing the voltage THD level to breach the Code's limits (i.e., full compliance with the Code requirements).

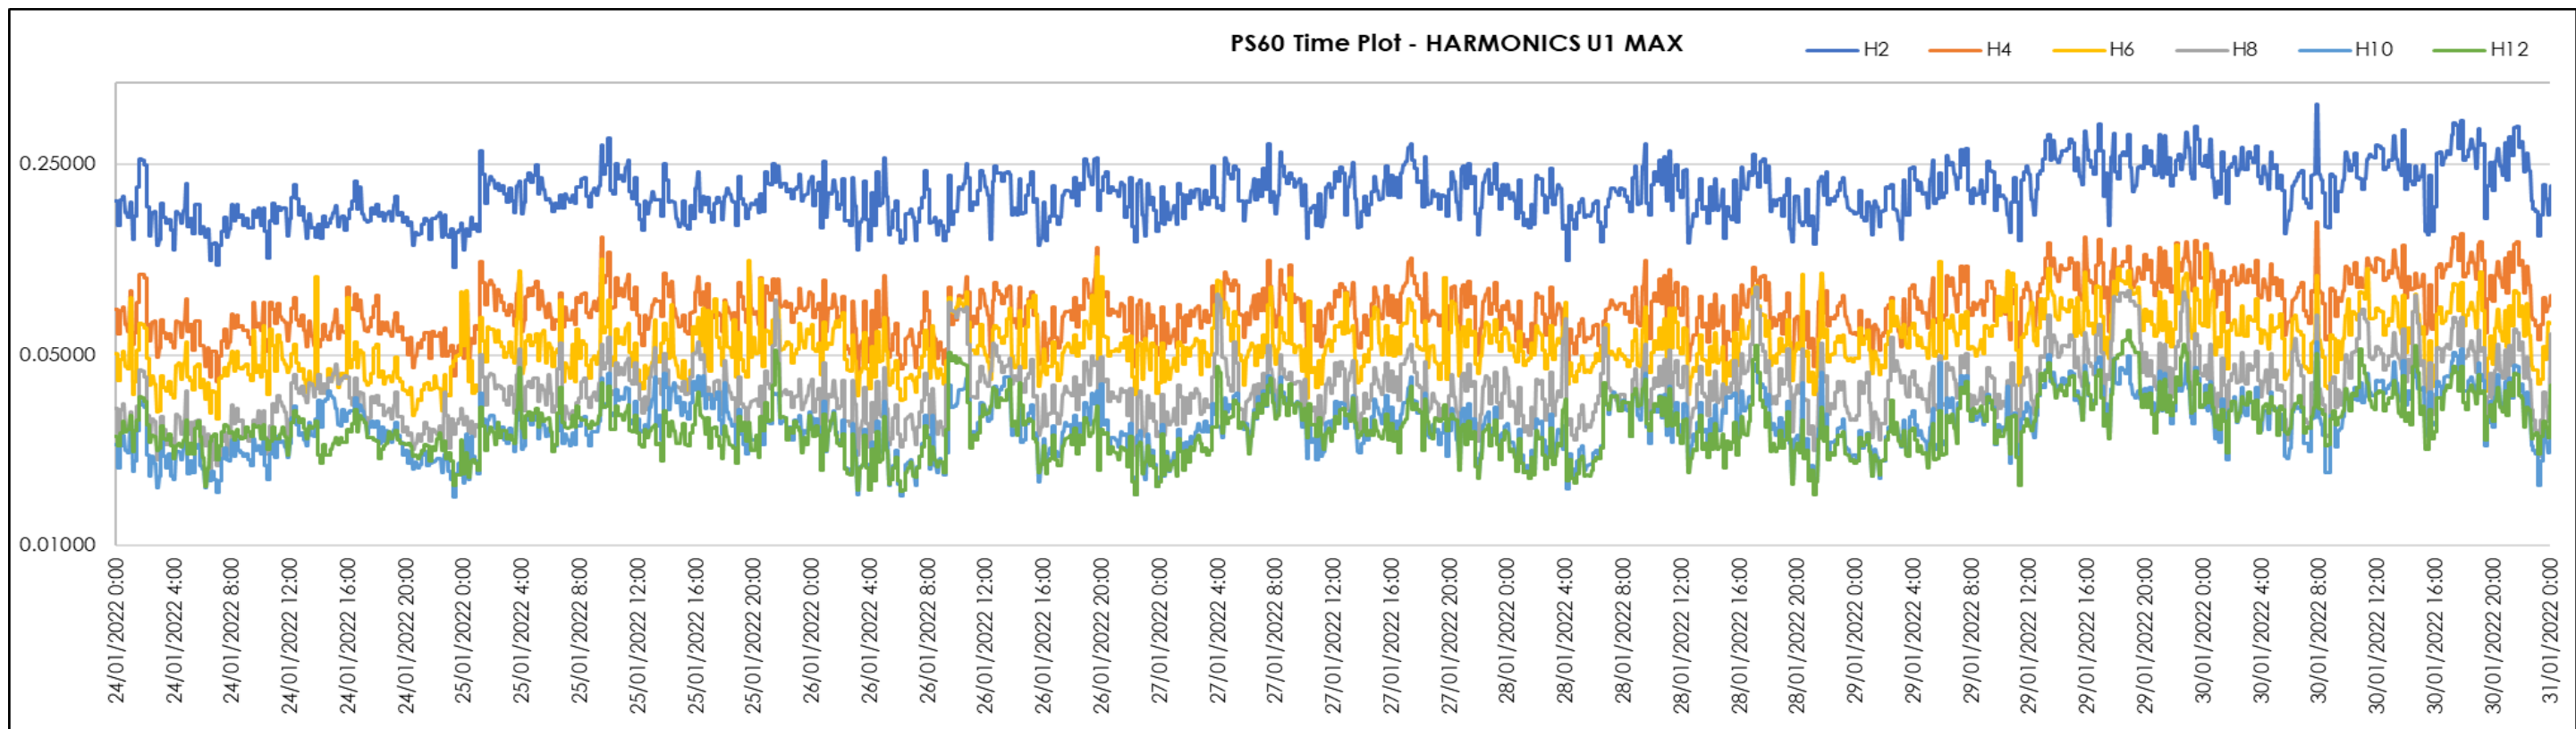
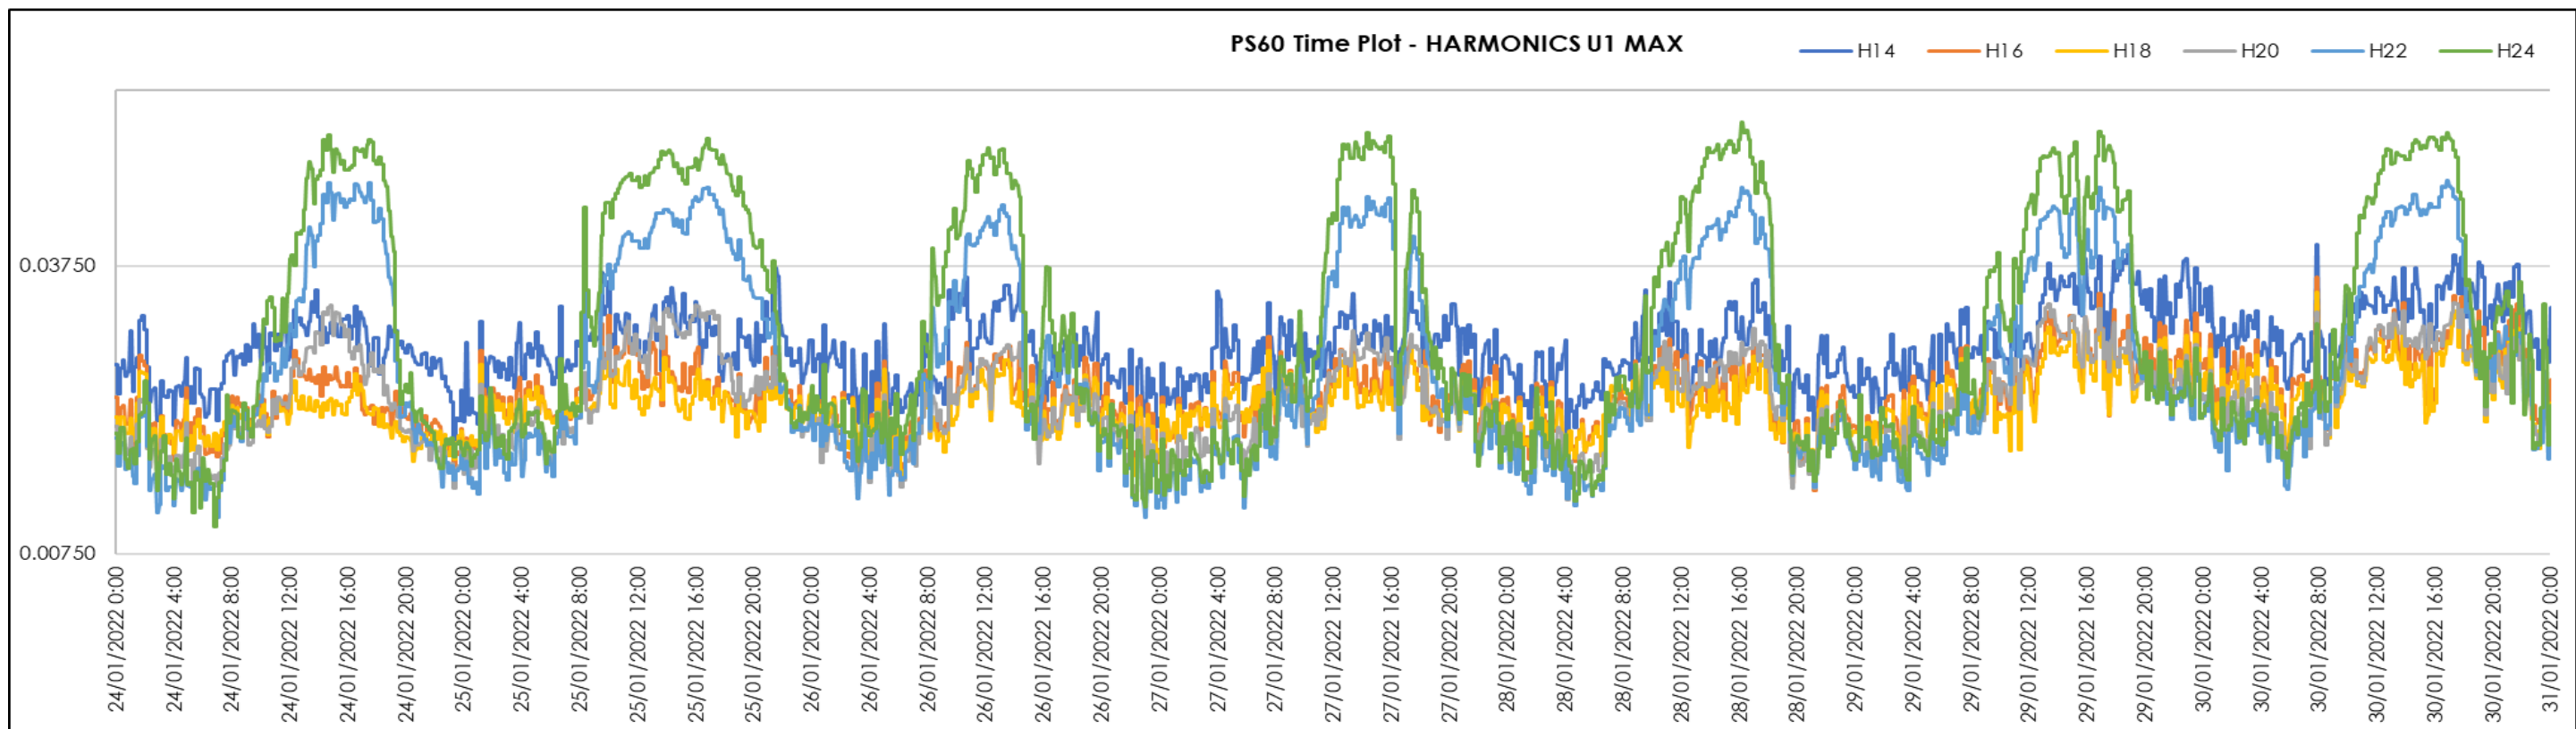
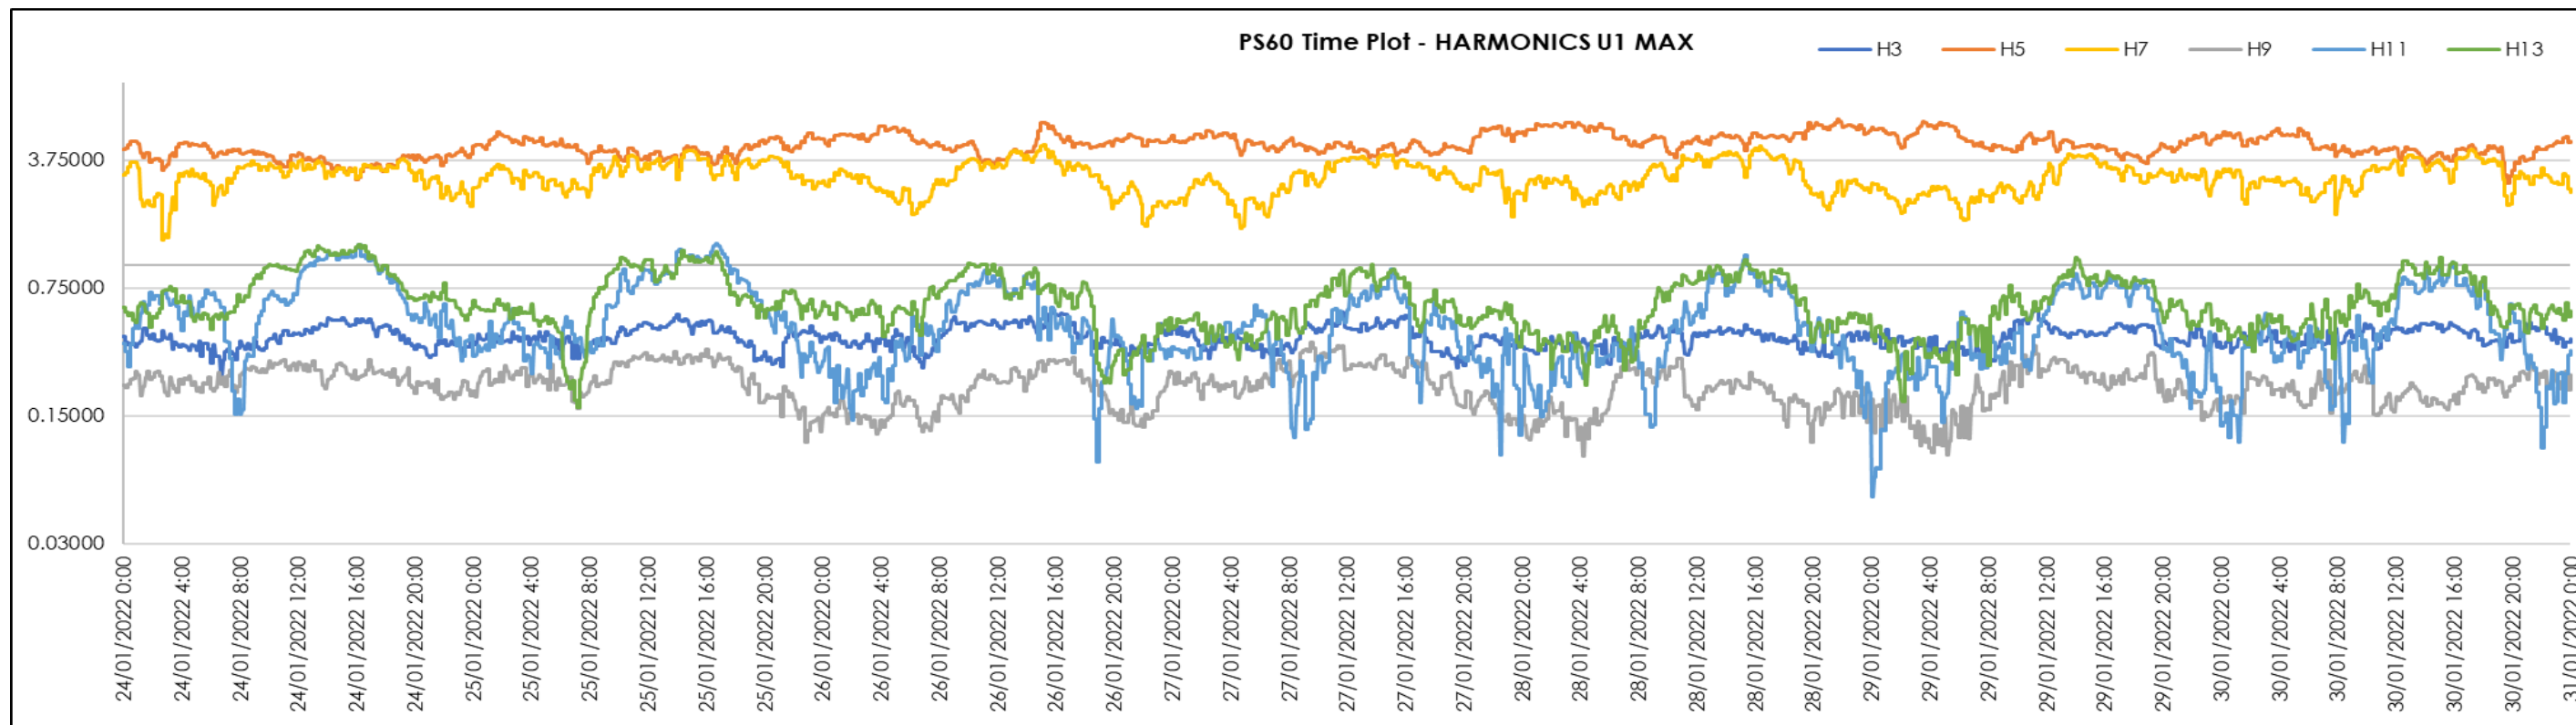
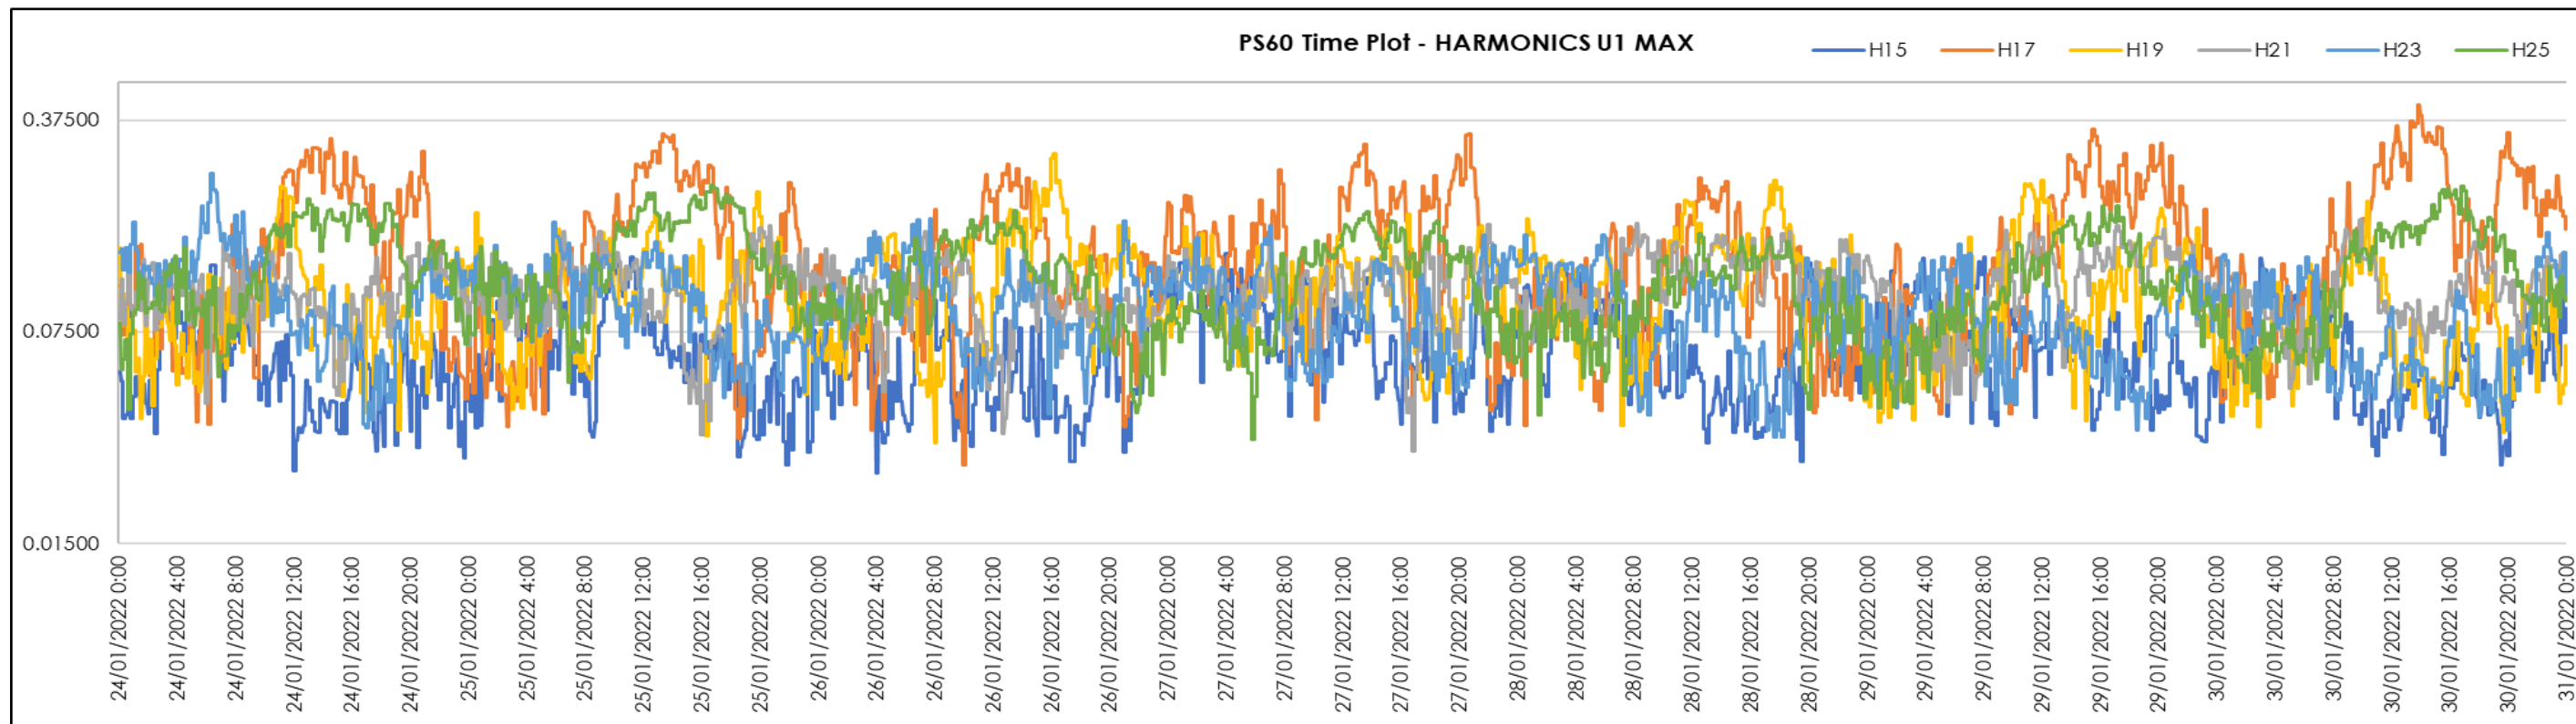
Figure 61 | STS2 Start Harmonics

The logged harmonic data for the start and end of the STS2 feeder is shown from Figure 61 to Figure 62 in Appendix A.6. No non-compliant harmonics were recorded for the recording period.

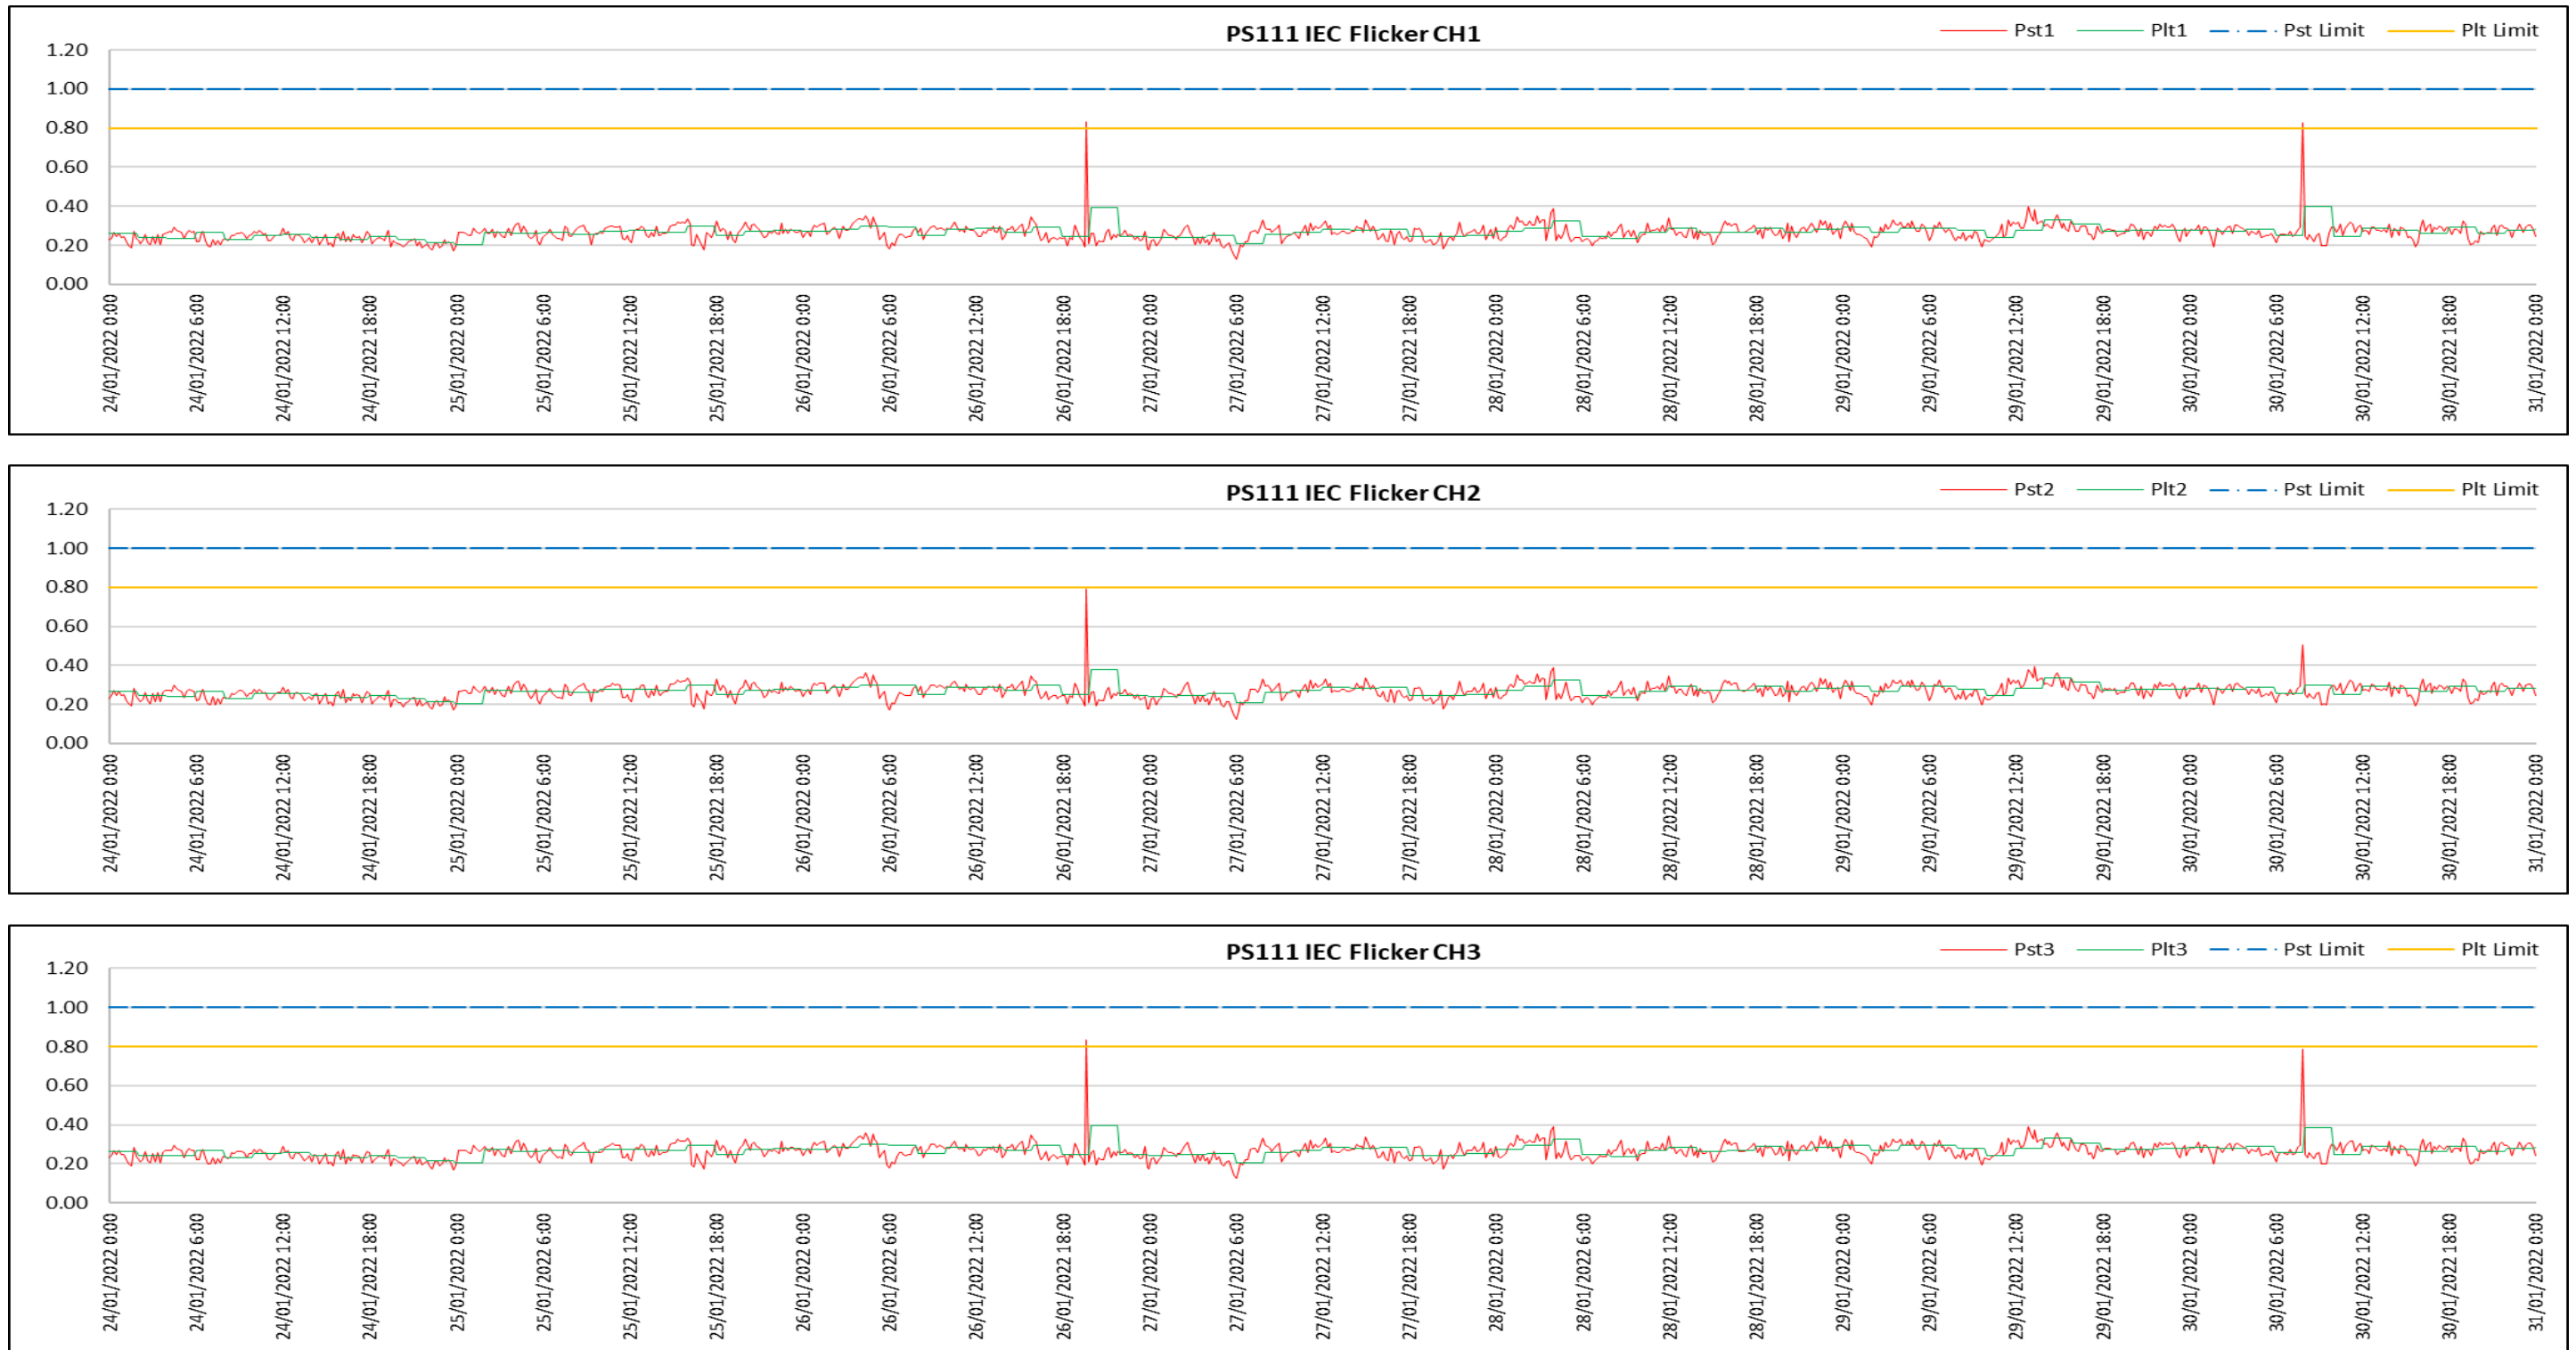
Figure 63 | STS4 Start Flicker measurements

The logged flicker data for the start and end of the STS4 feeder is shown from Figure 63 to Figure 64 in Appendix A.7. There were no recorded flicker limit events causing the flicker level to breach the Code's limits (i.e., full compliance with the Code requirements).

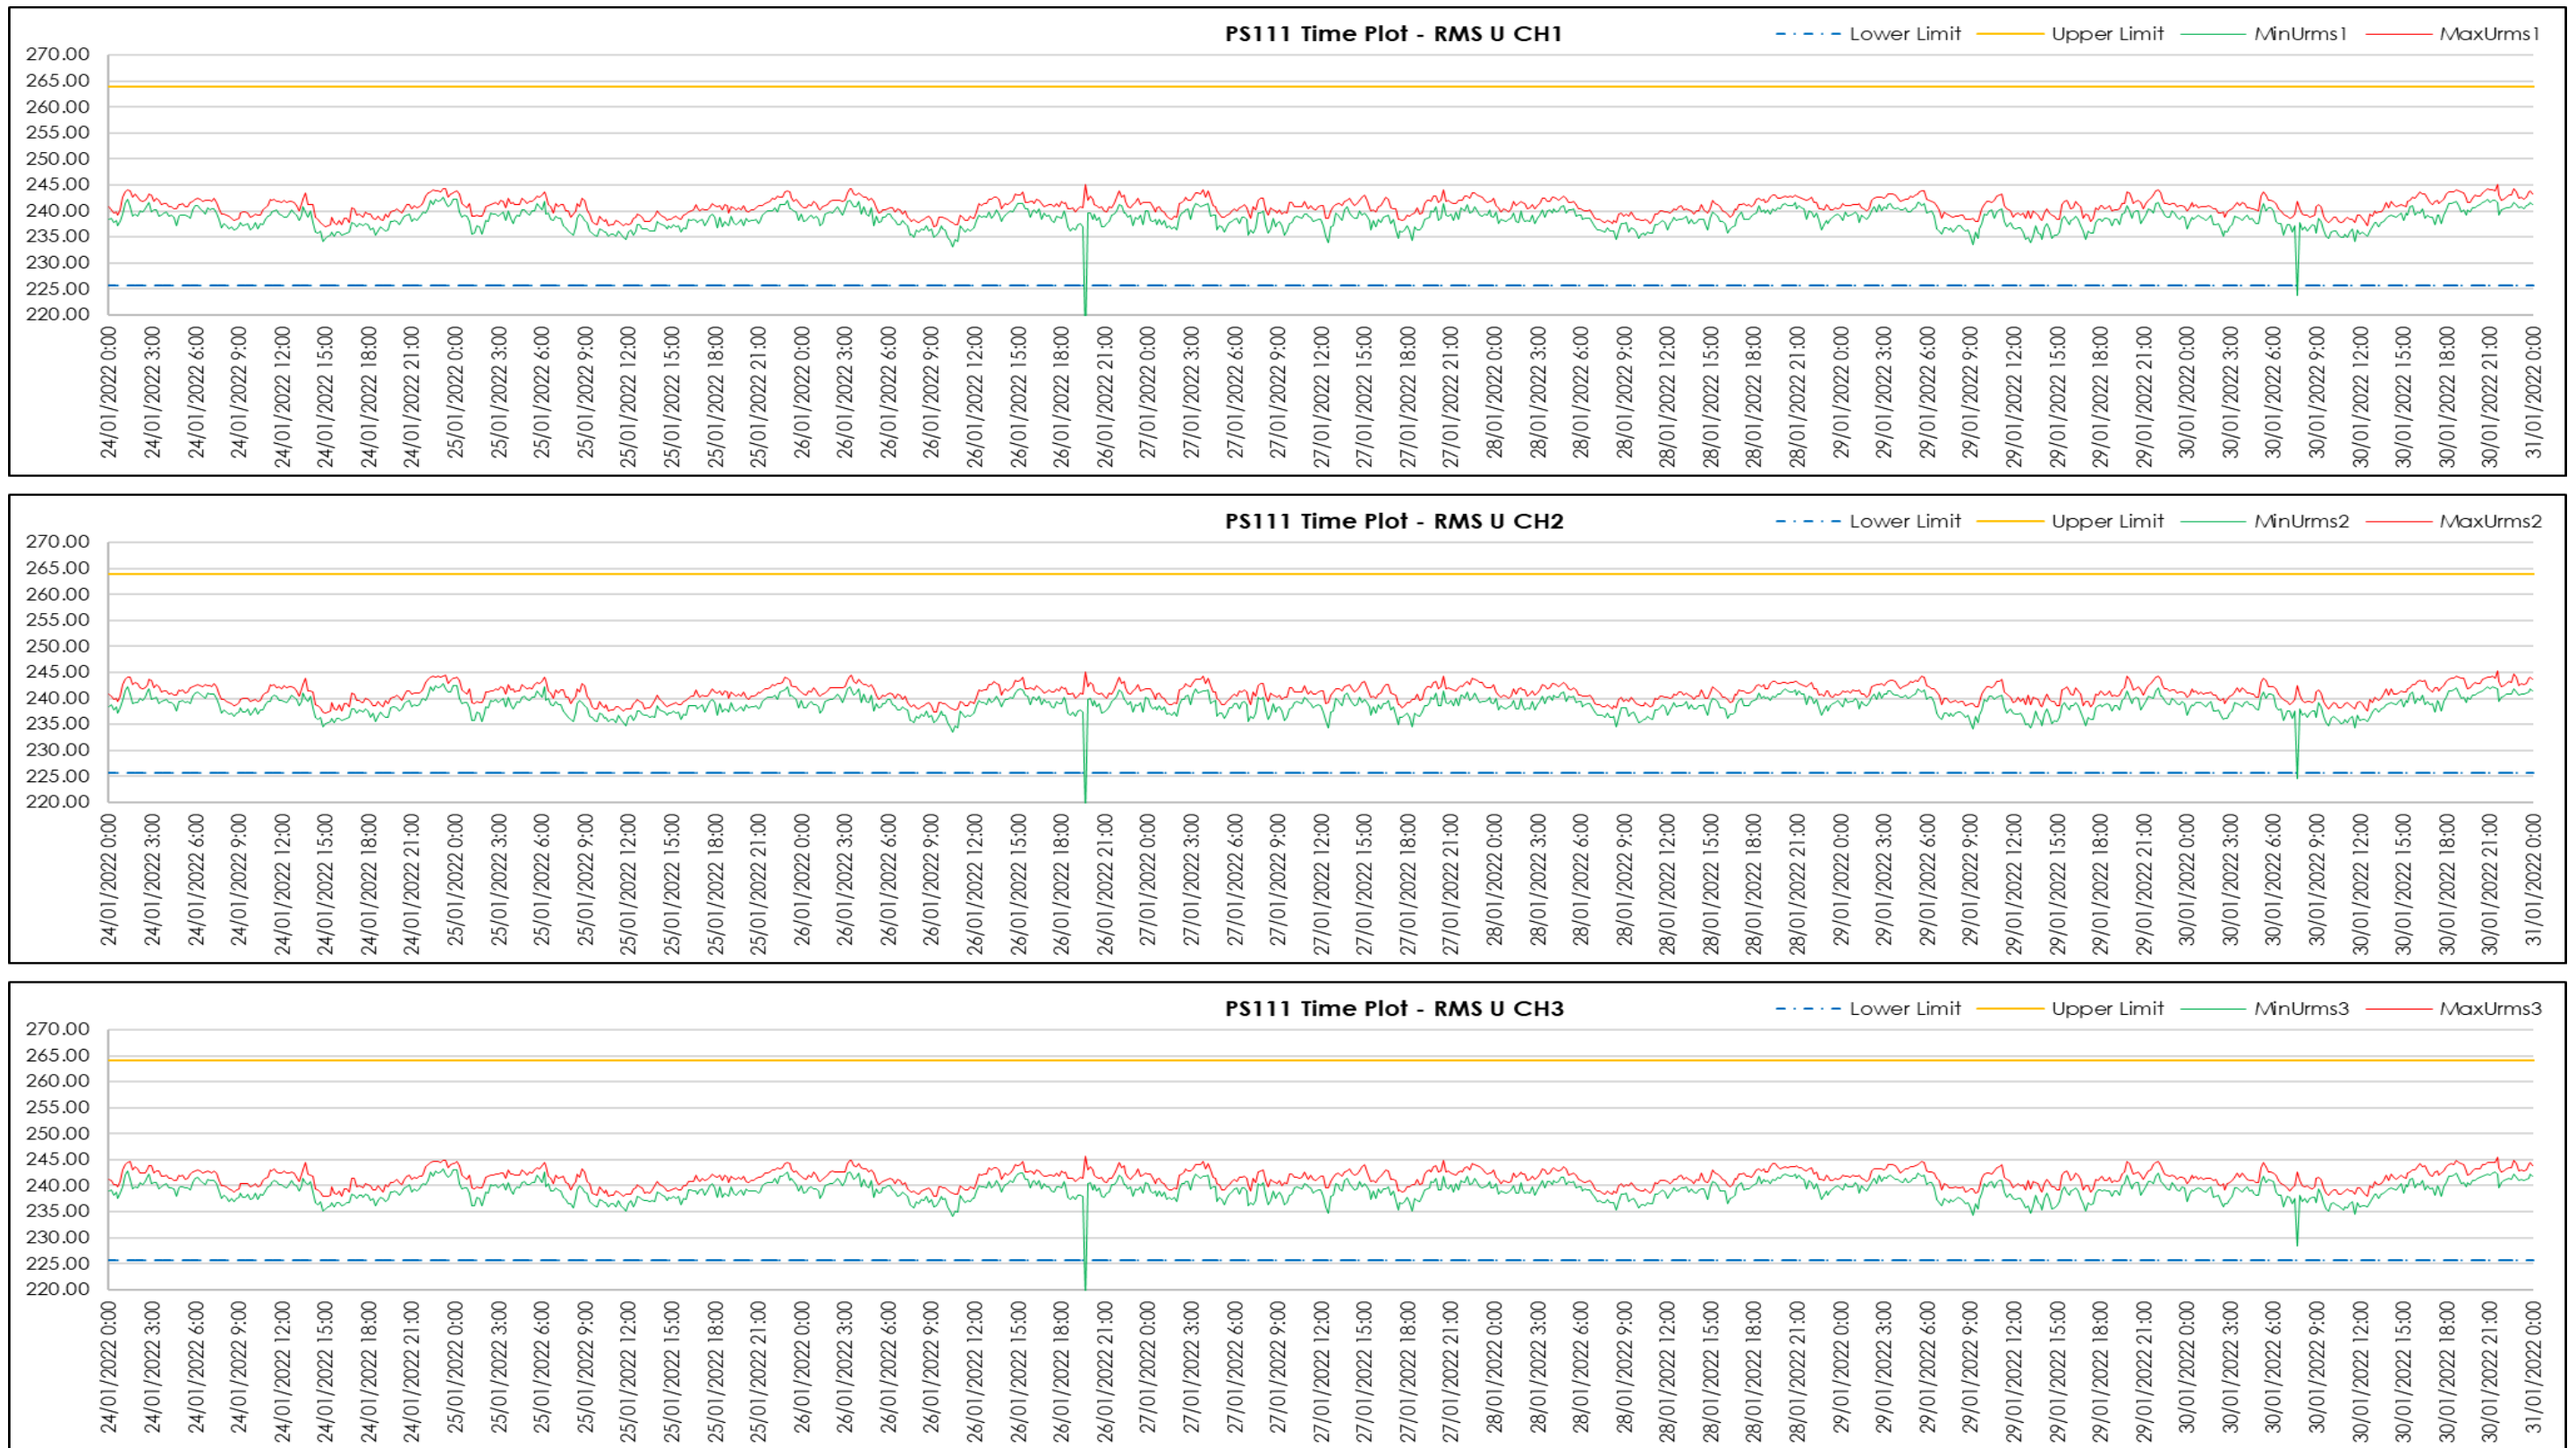
Figure 65 | STS4 Start Voltage measurements

The logged voltage level data for the start and end of the STS4 feeder is shown from Figure 65 to Figure 66 in Appendix A.7. Table 10 below shows the recorded breach events during the logging period.

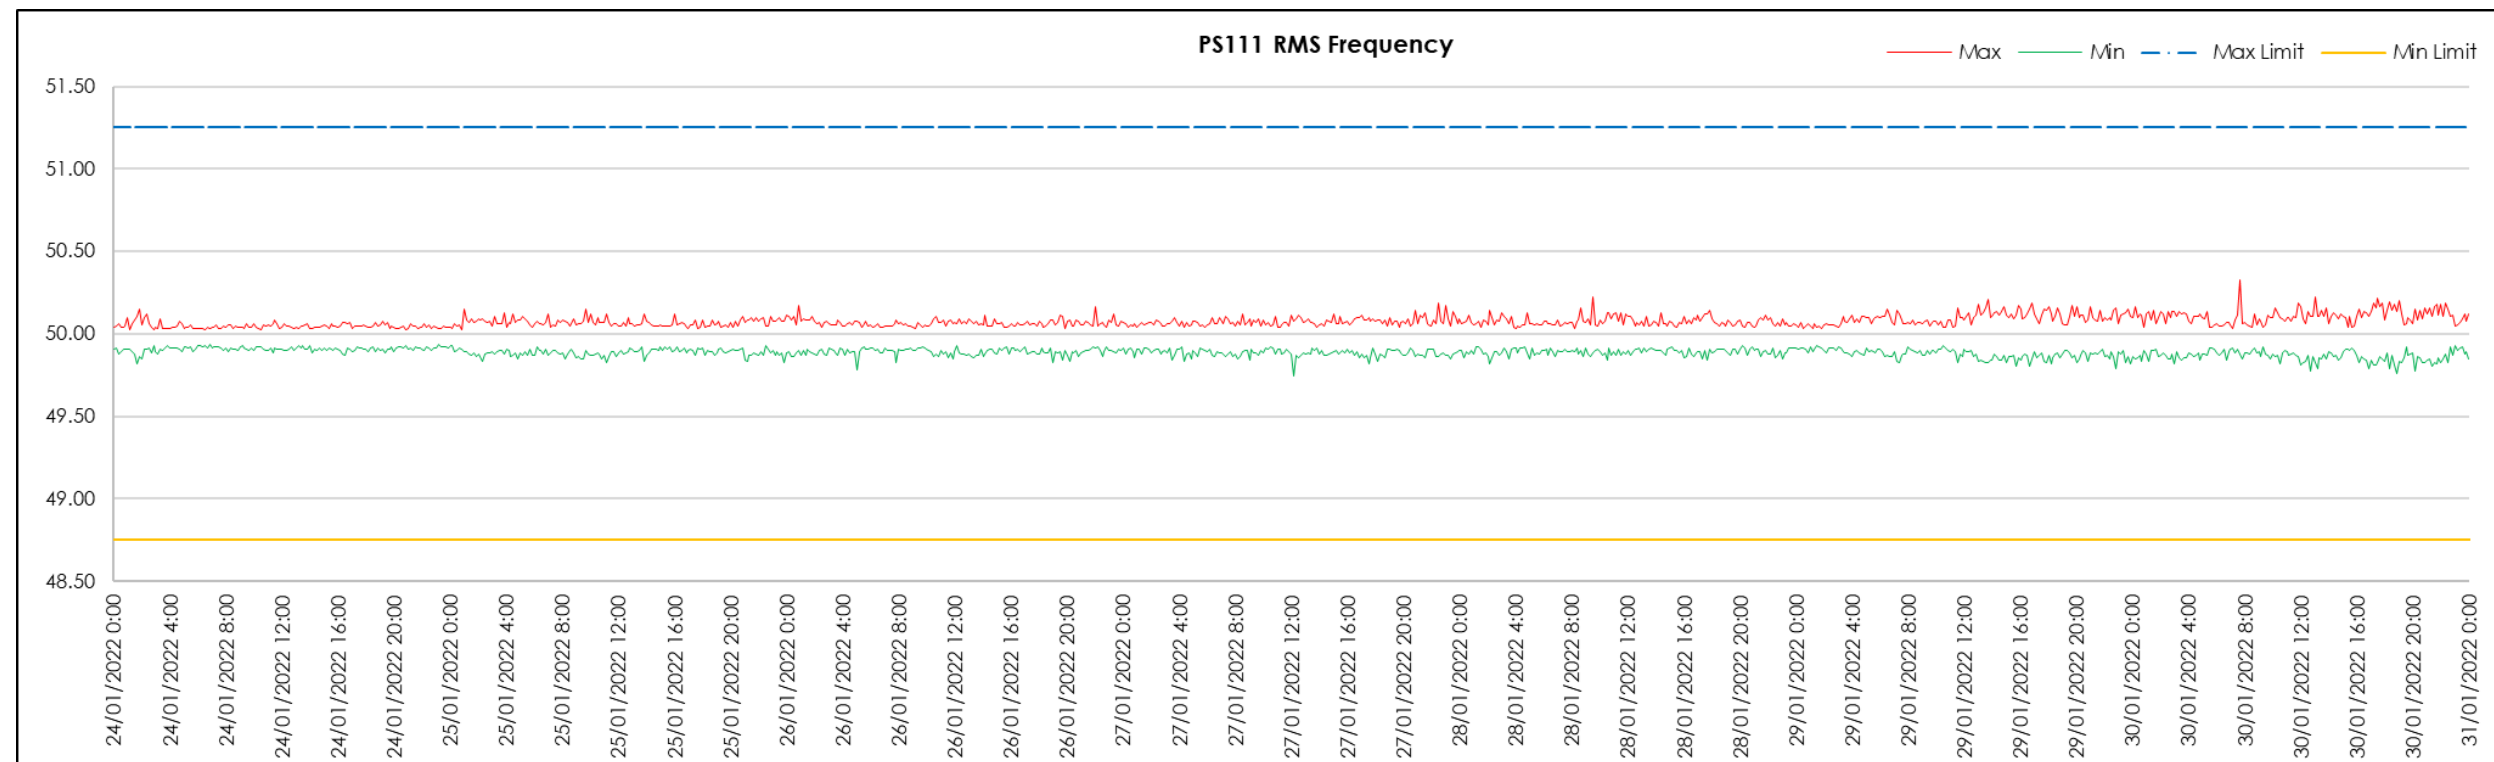
Figure 67 | STS4 Start Frequency measurements

The logged frequency data for the start and end of the STS4 feeder is shown from Figure 67 to Figure 68 in Appendix A.7. There were no recorded frequency limit events causing the frequency level to breach the Code's limits (i.e., full compliance with the Code requirements).
