APD
ENGINEERING

BHP NEWMAN TOWNSHIP ELECTRICITY SUPPLY
ANNUAL COMPLIANCE REPORT
2021/2022

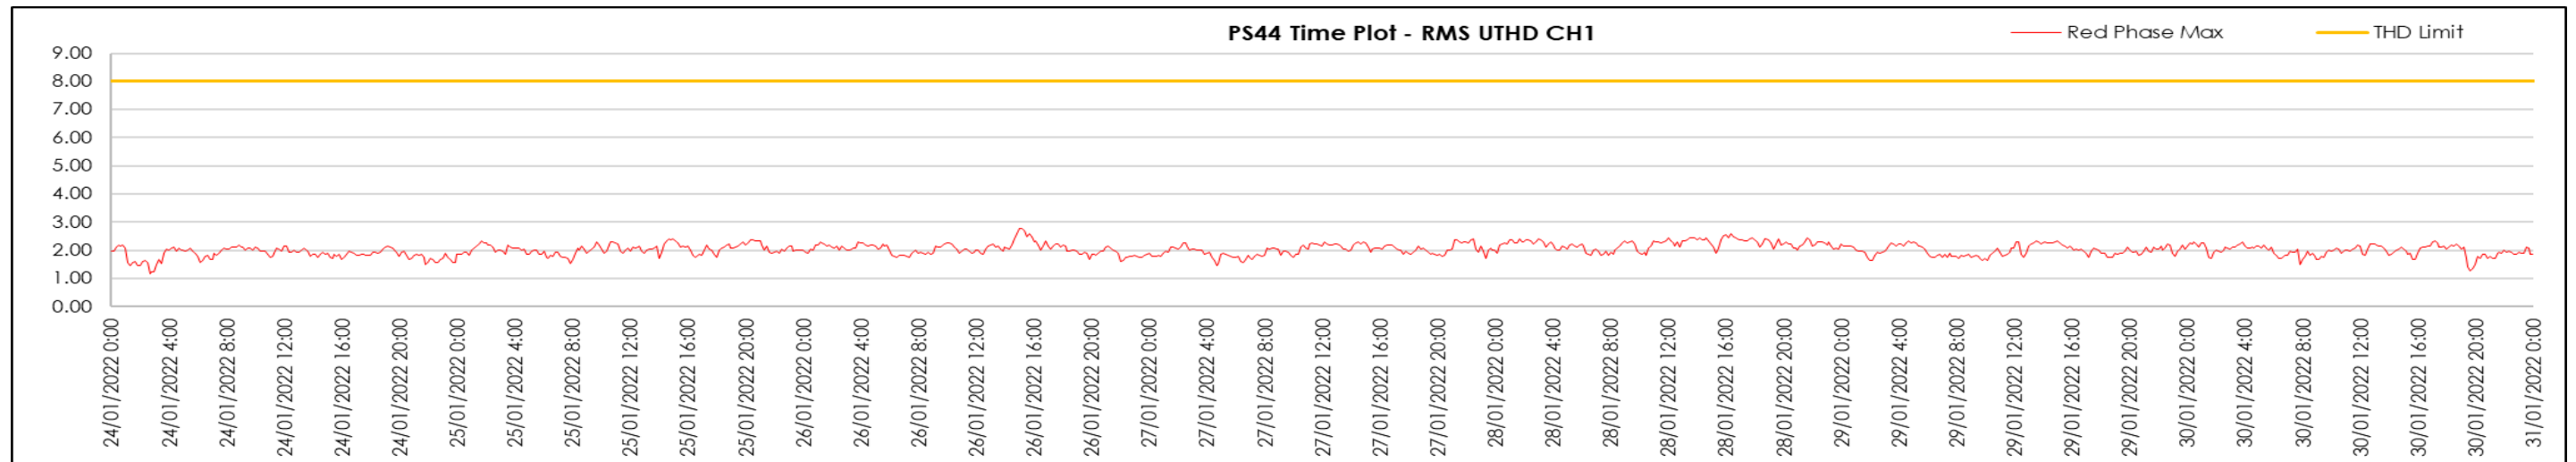
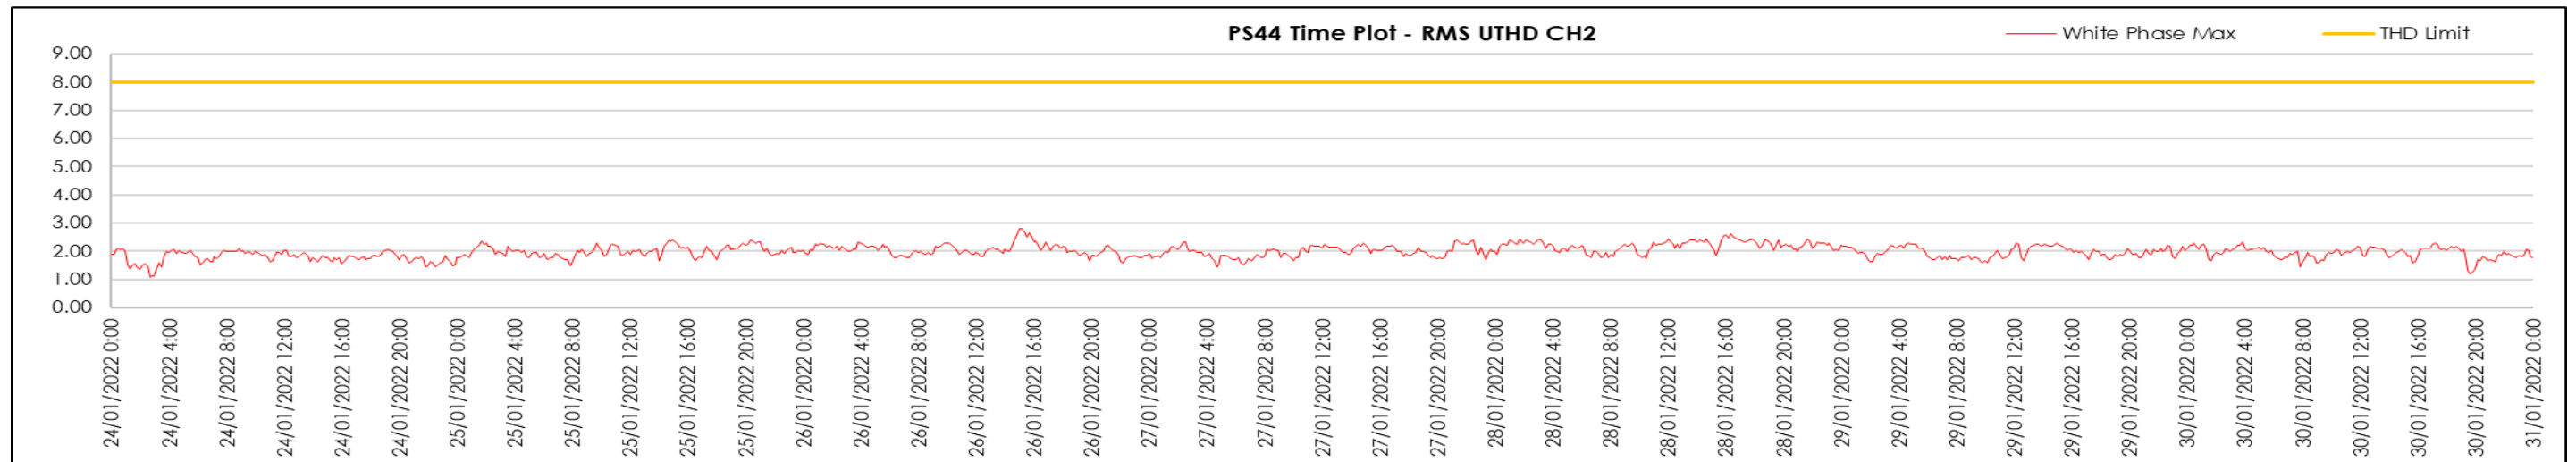
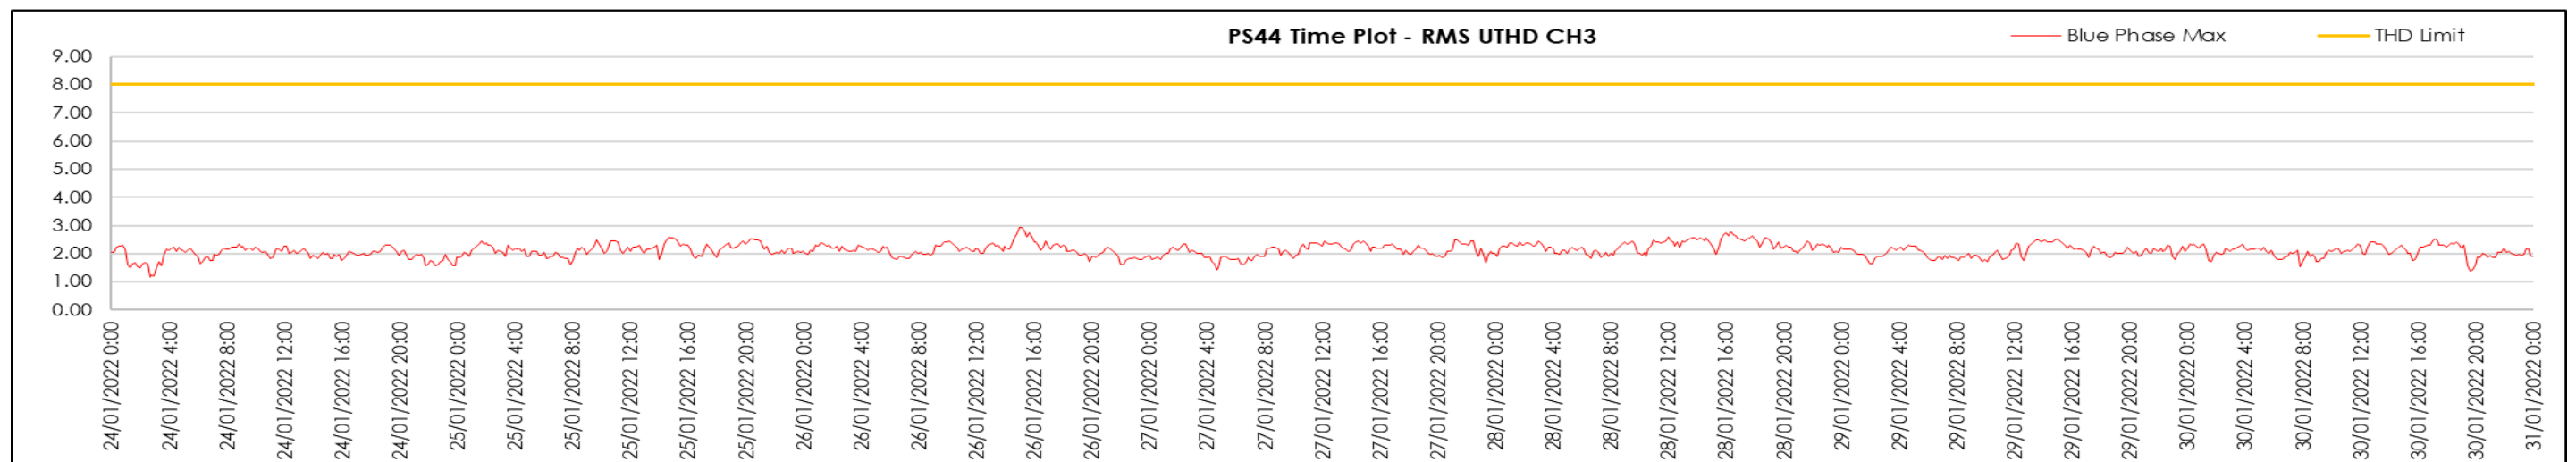
Figure 69 | STS4 Start U-THD measurements

The logged voltage THD level data for the start and end of the STS4 feeder is shown from Figure 69 to Figure 70 in Appendix A.7. There were no recorded voltage THD limit events causing the voltage THD level to breach the Code's limits (i.e., full compliance with the Code requirements).

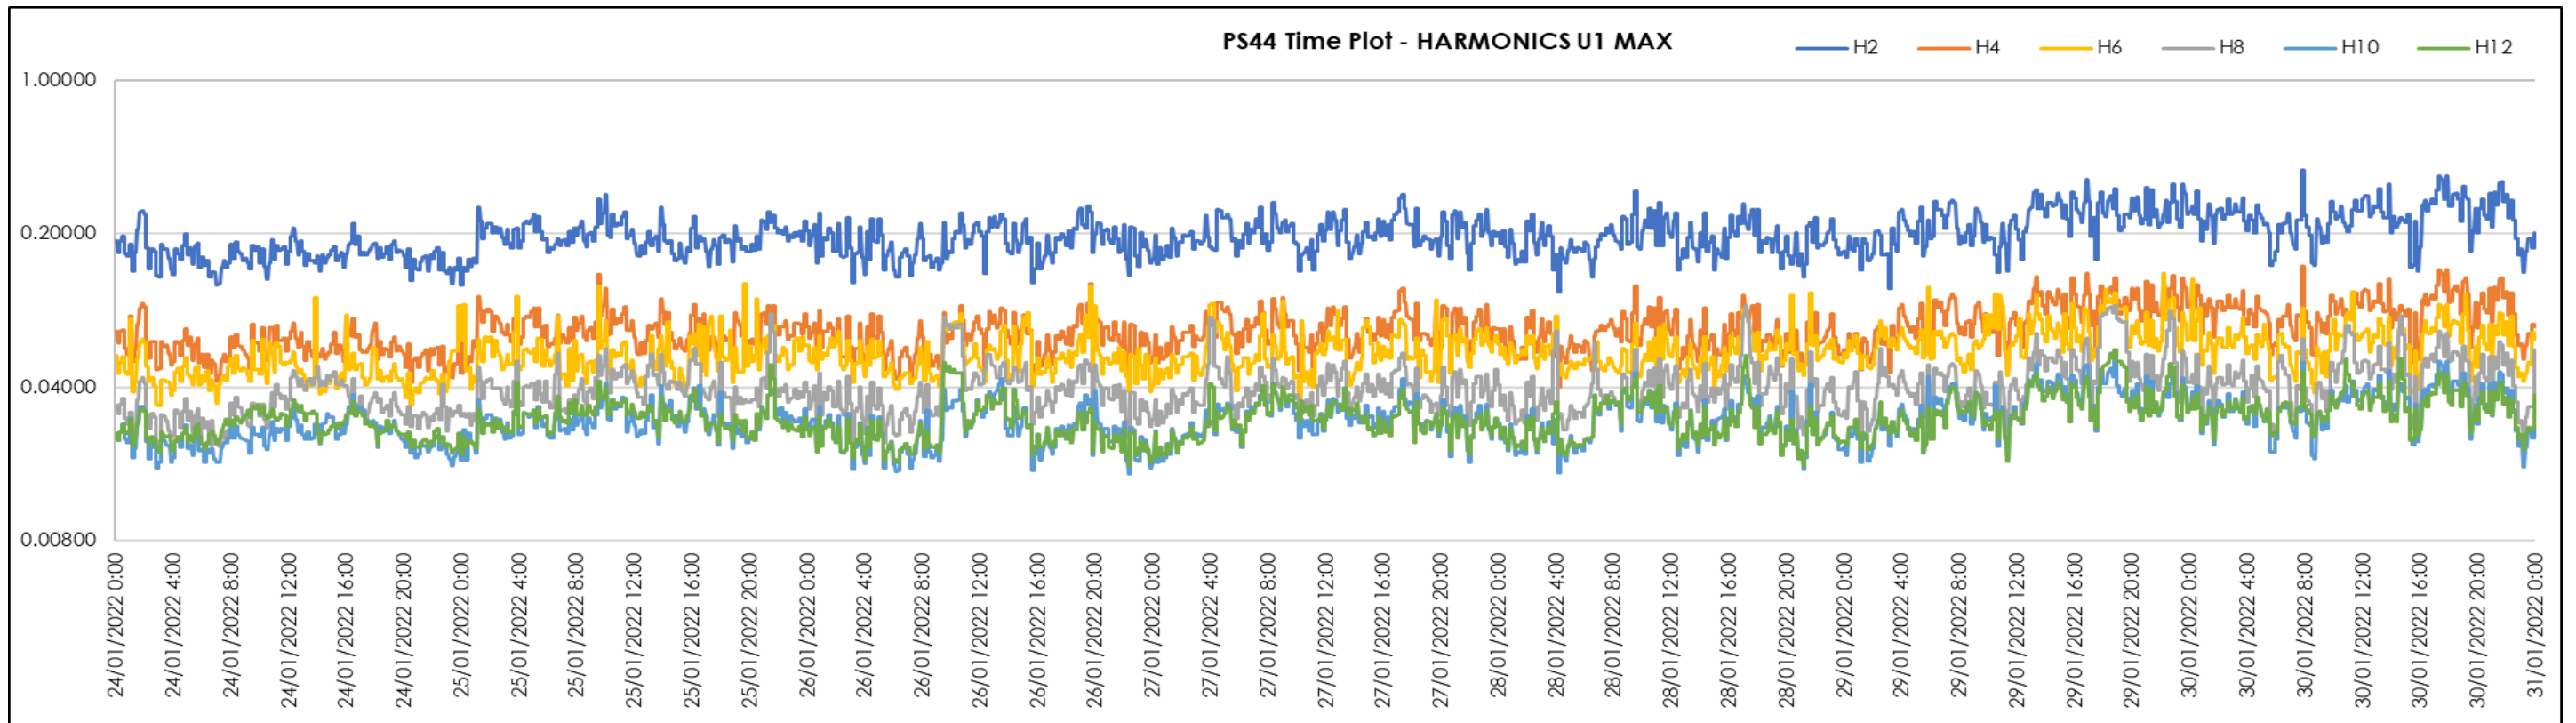
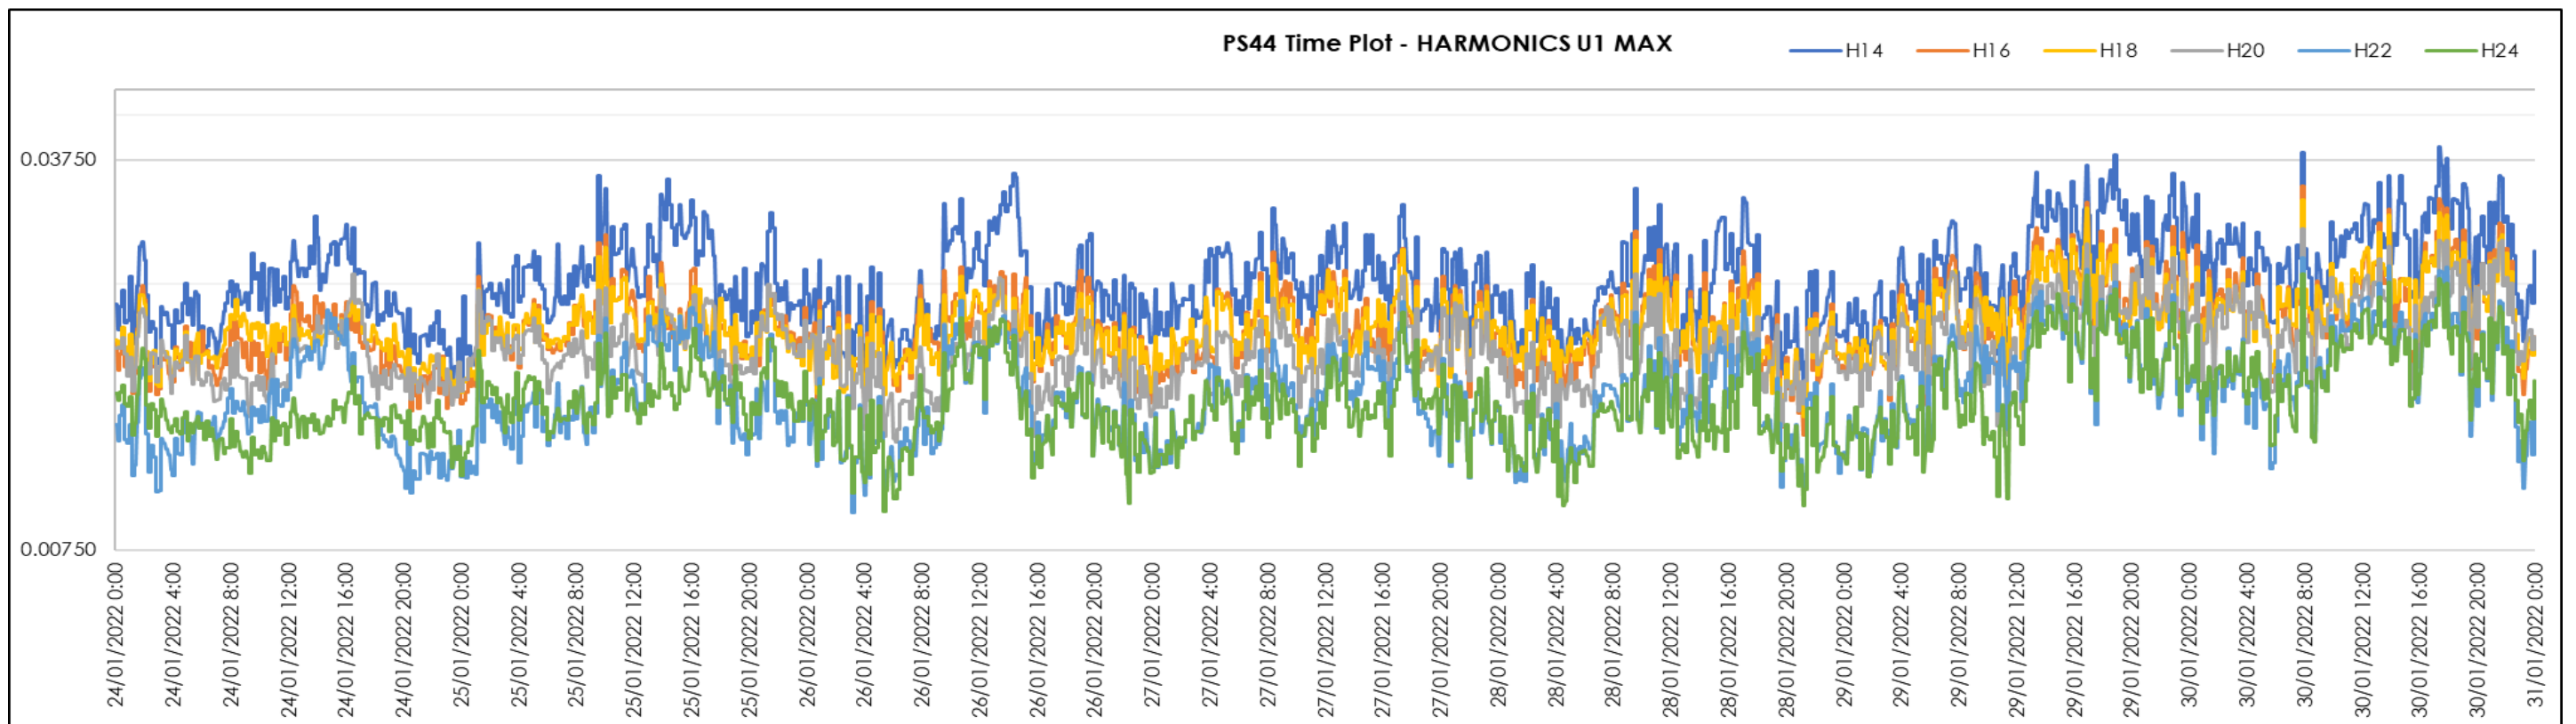
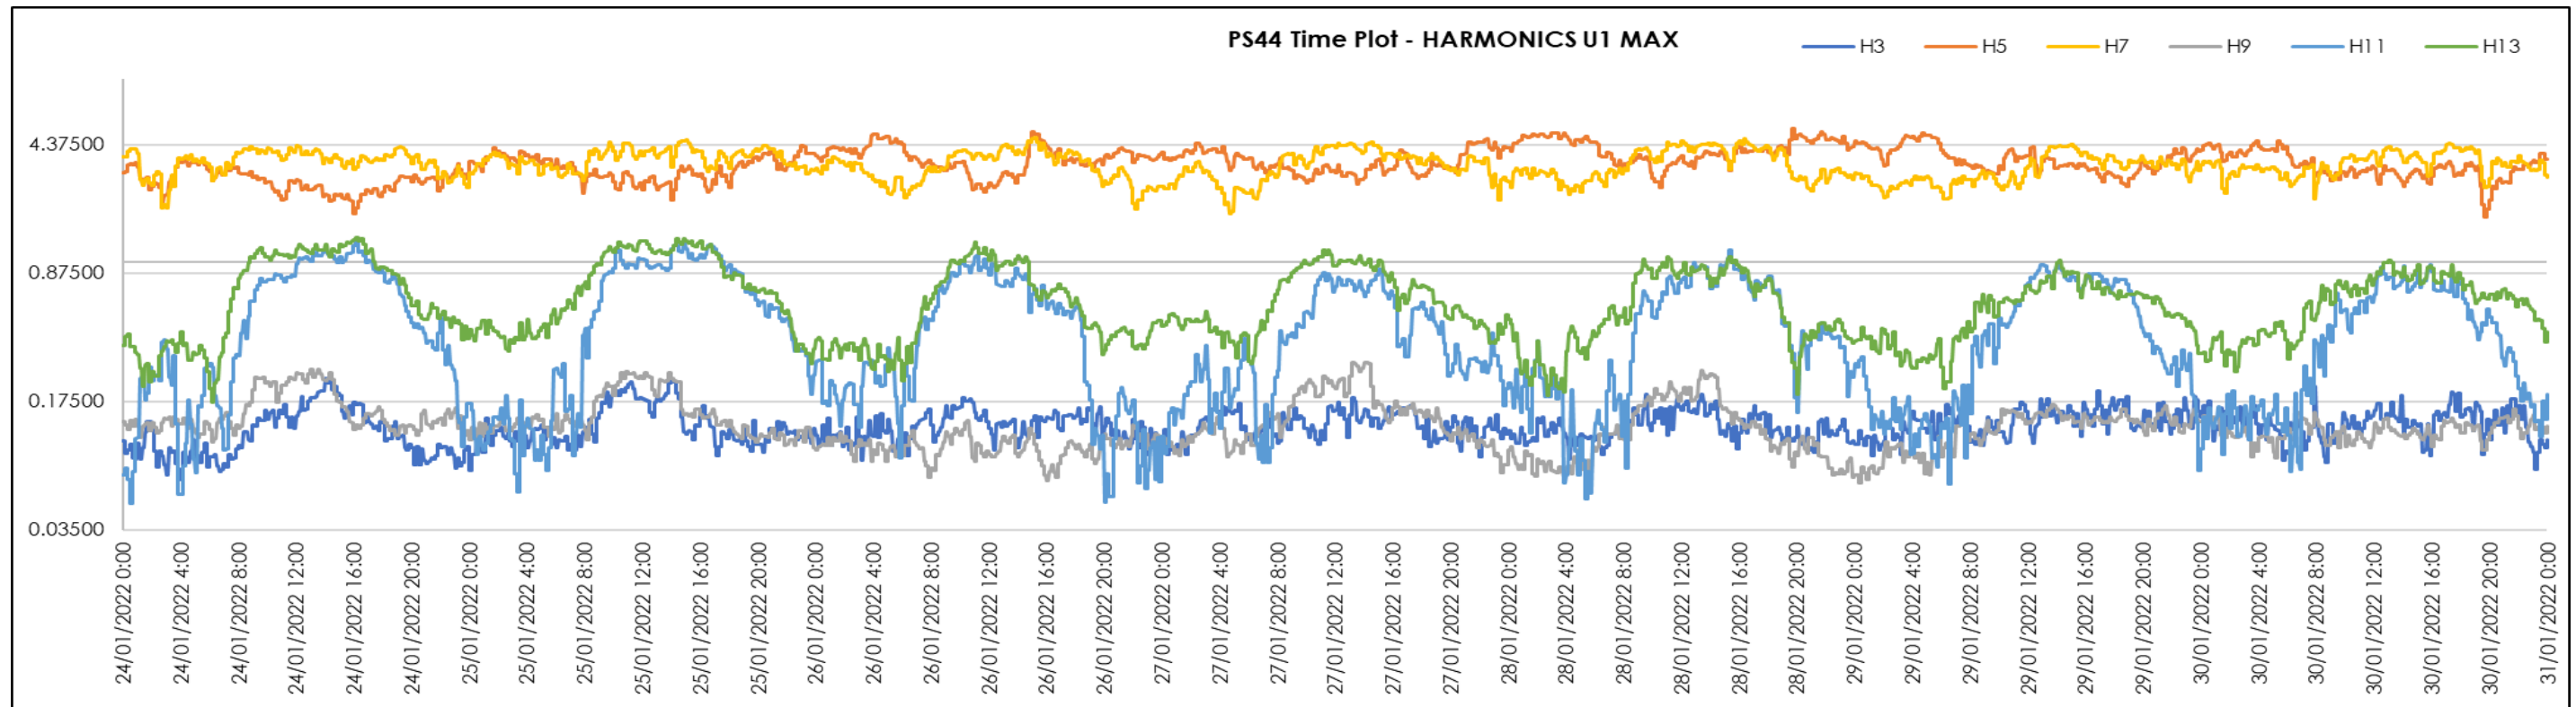
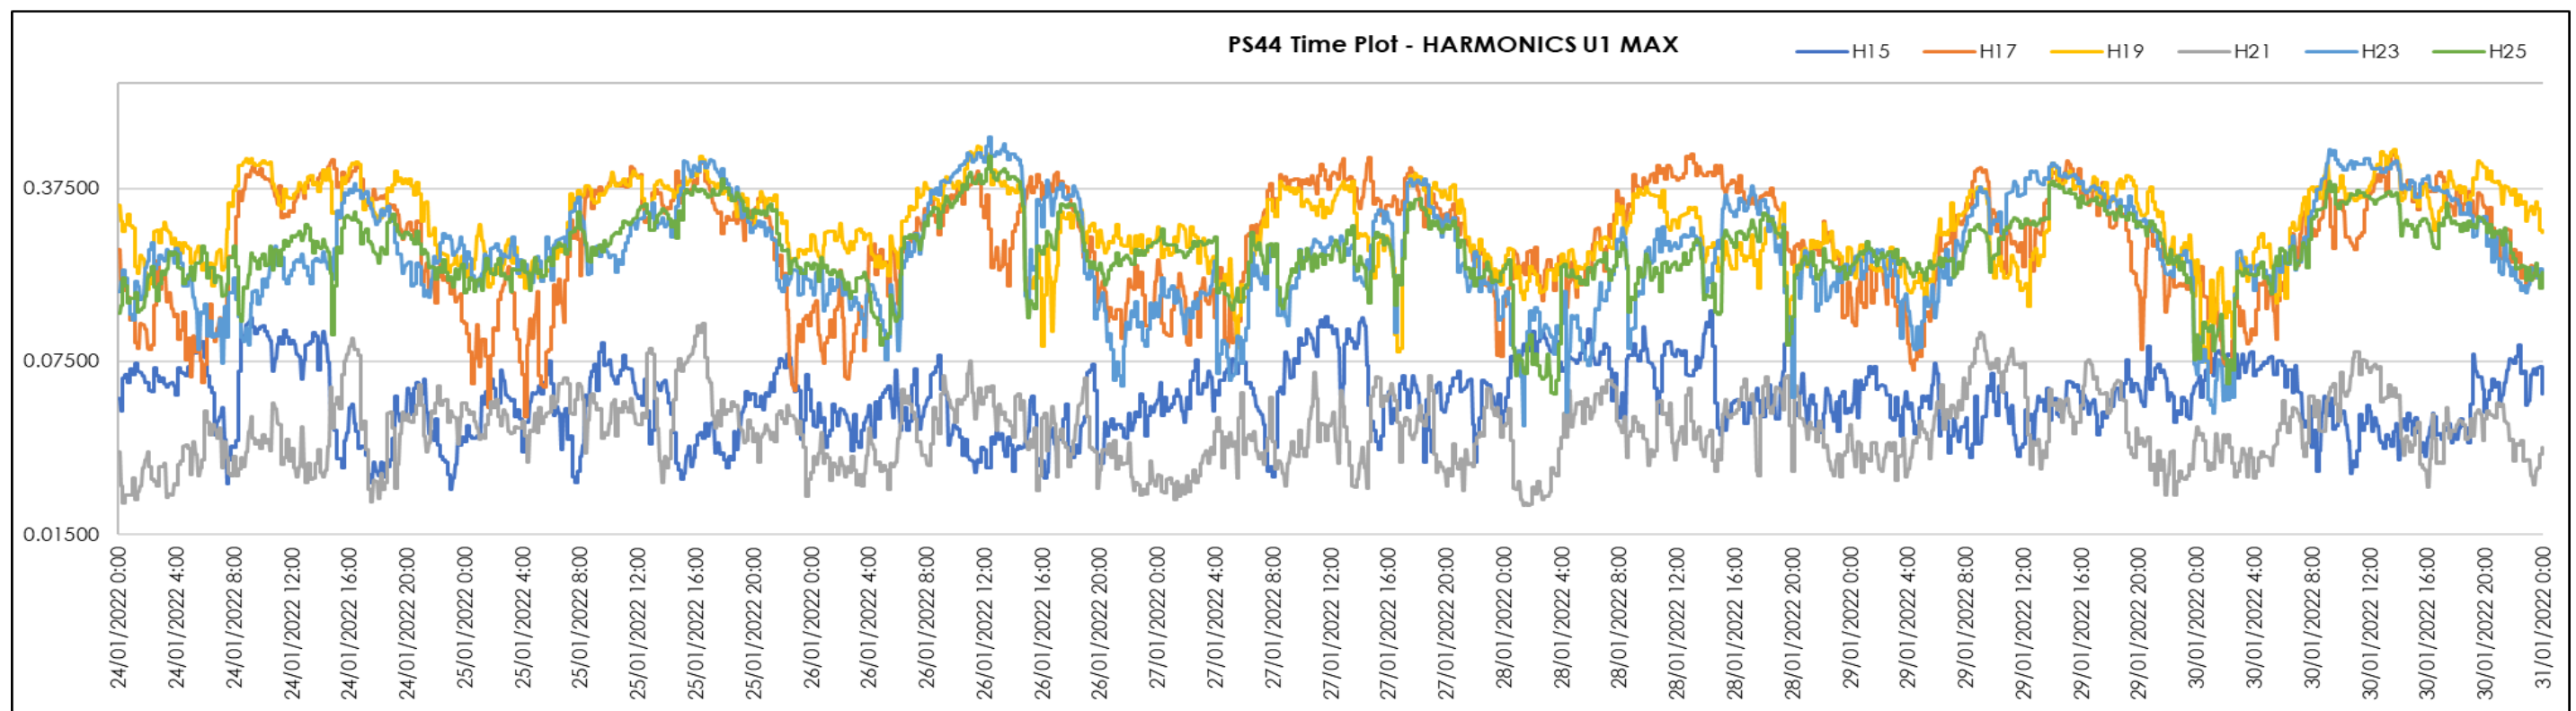
Figure 71 | STS4 Start Harmonics

The logged harmonic data for the start and end of the STS4 feeder is shown from Figure 71 to Figure 72 in Appendix A.7. A summary of non-compliant harmonics and the scale of non-compliances is shown in Figure 2.

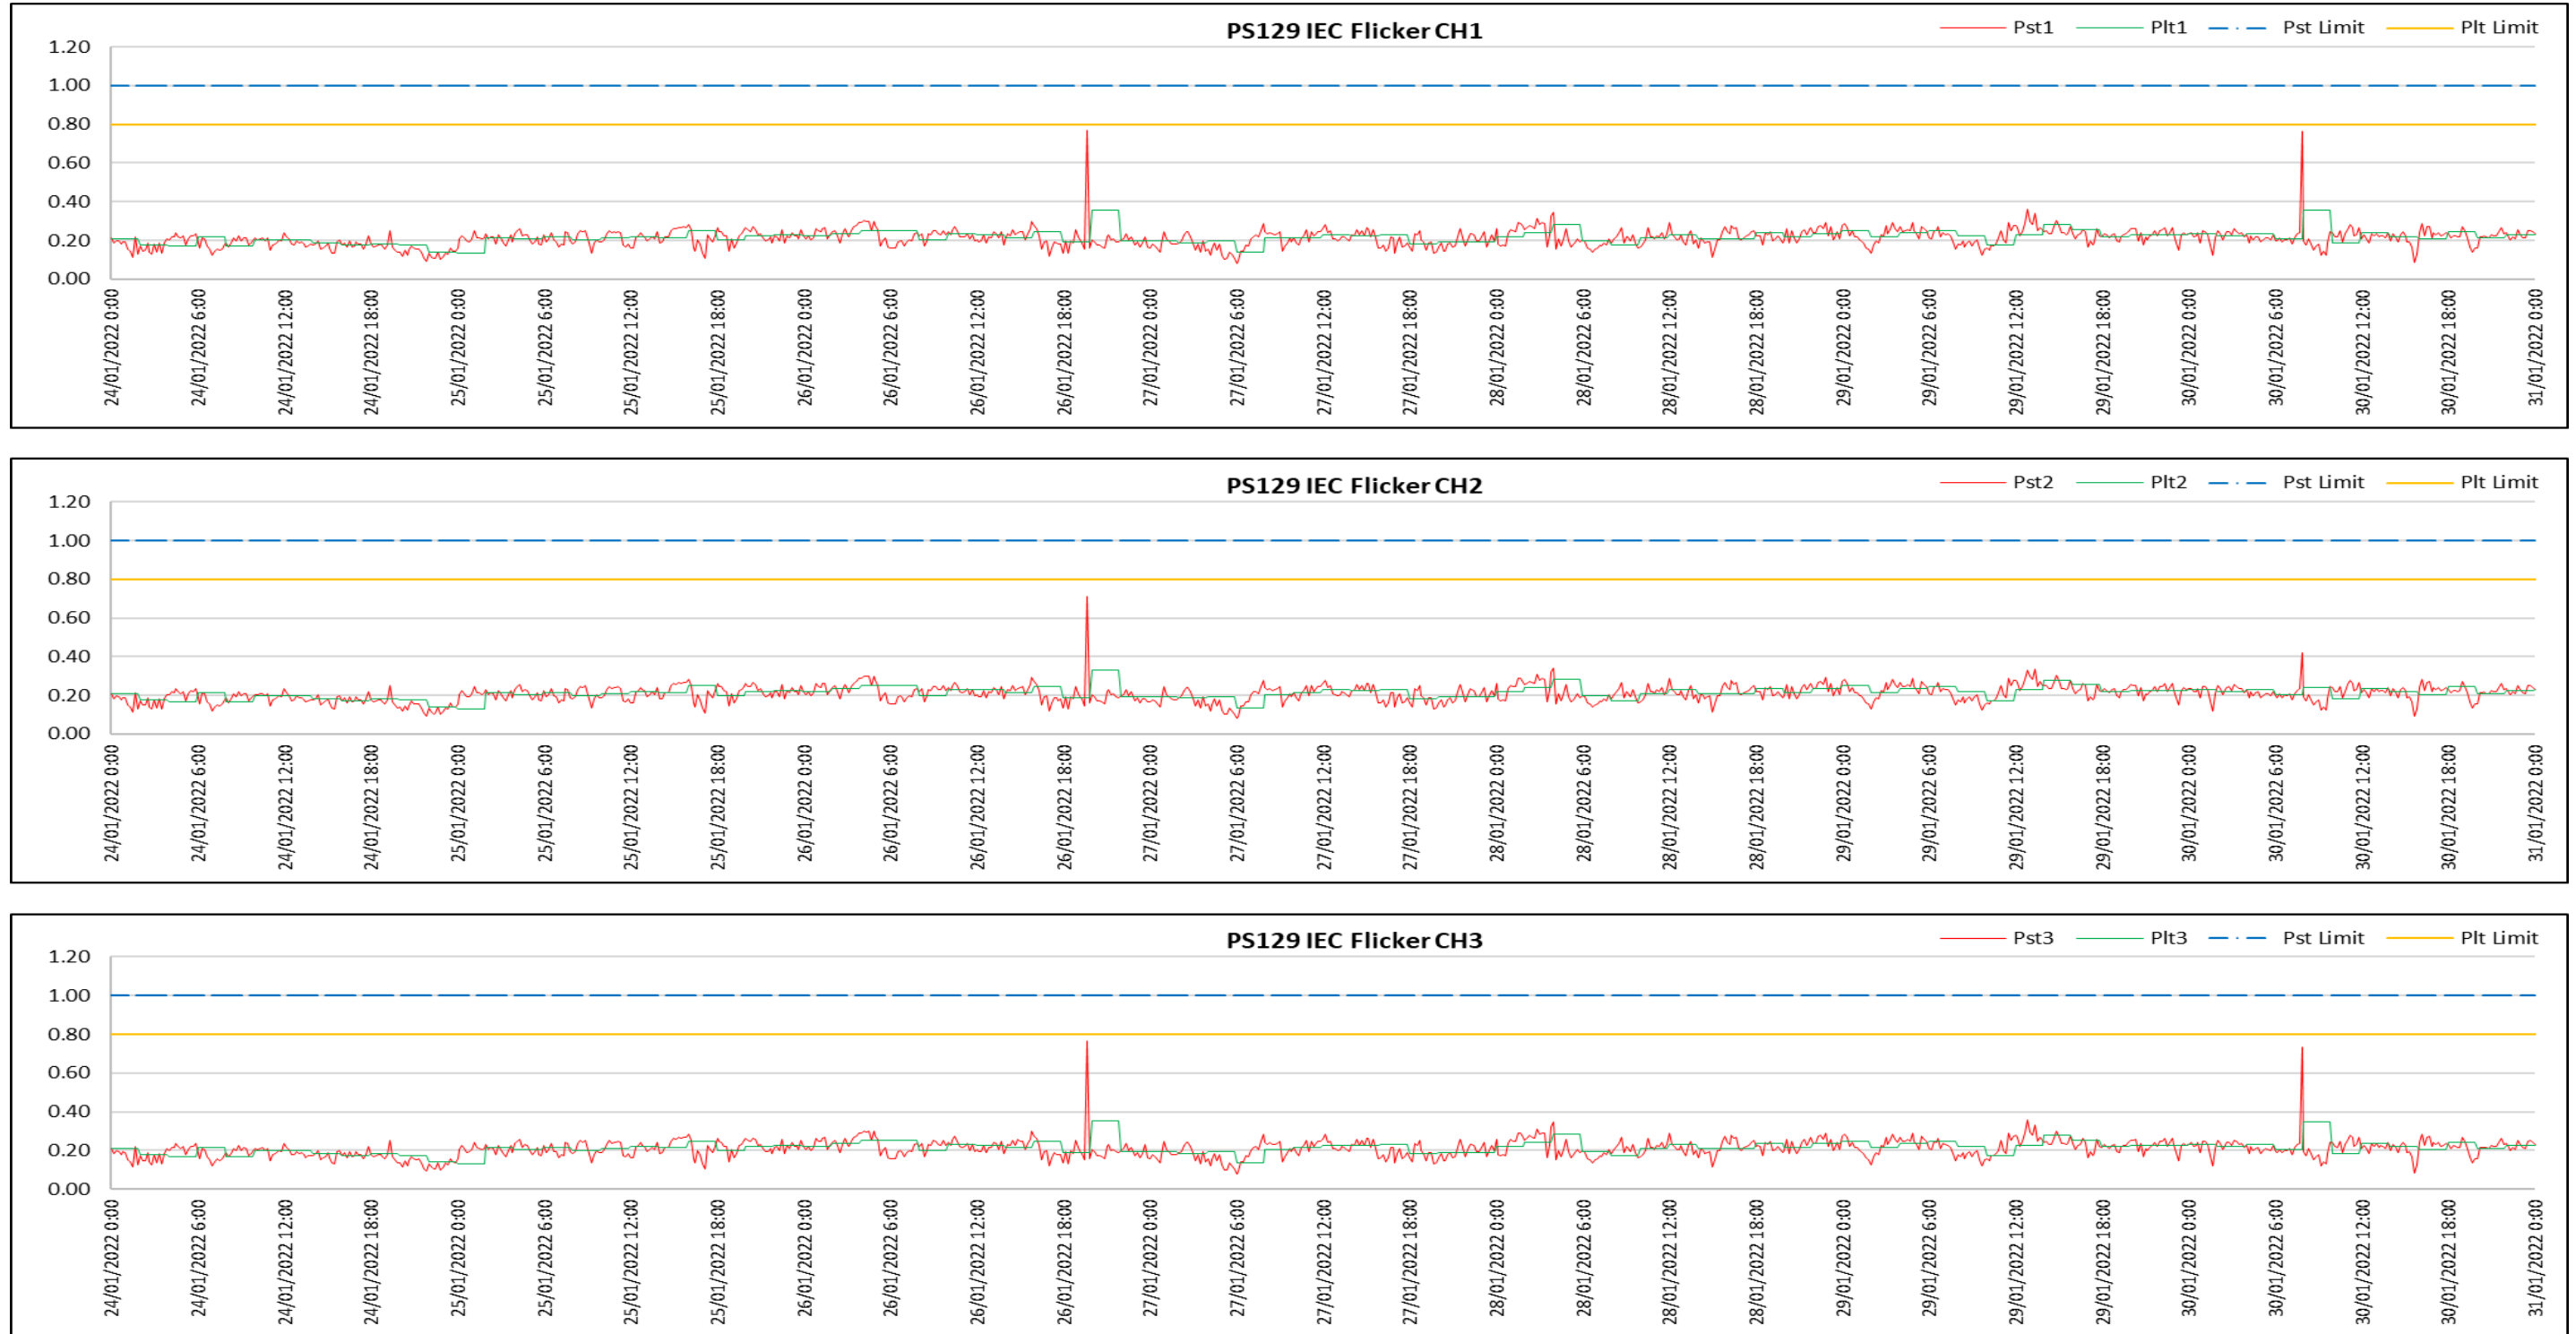
Figure 73 | STS6 Start Flicker measurements

The logged flicker data for the start and end of the STS6 feeder is shown from Figure 73 to Figure 74 in Appendix A.8. There were no recorded flicker limit events causing the flicker level to breach the Code's limits (i.e., full compliance with the Code requirements).

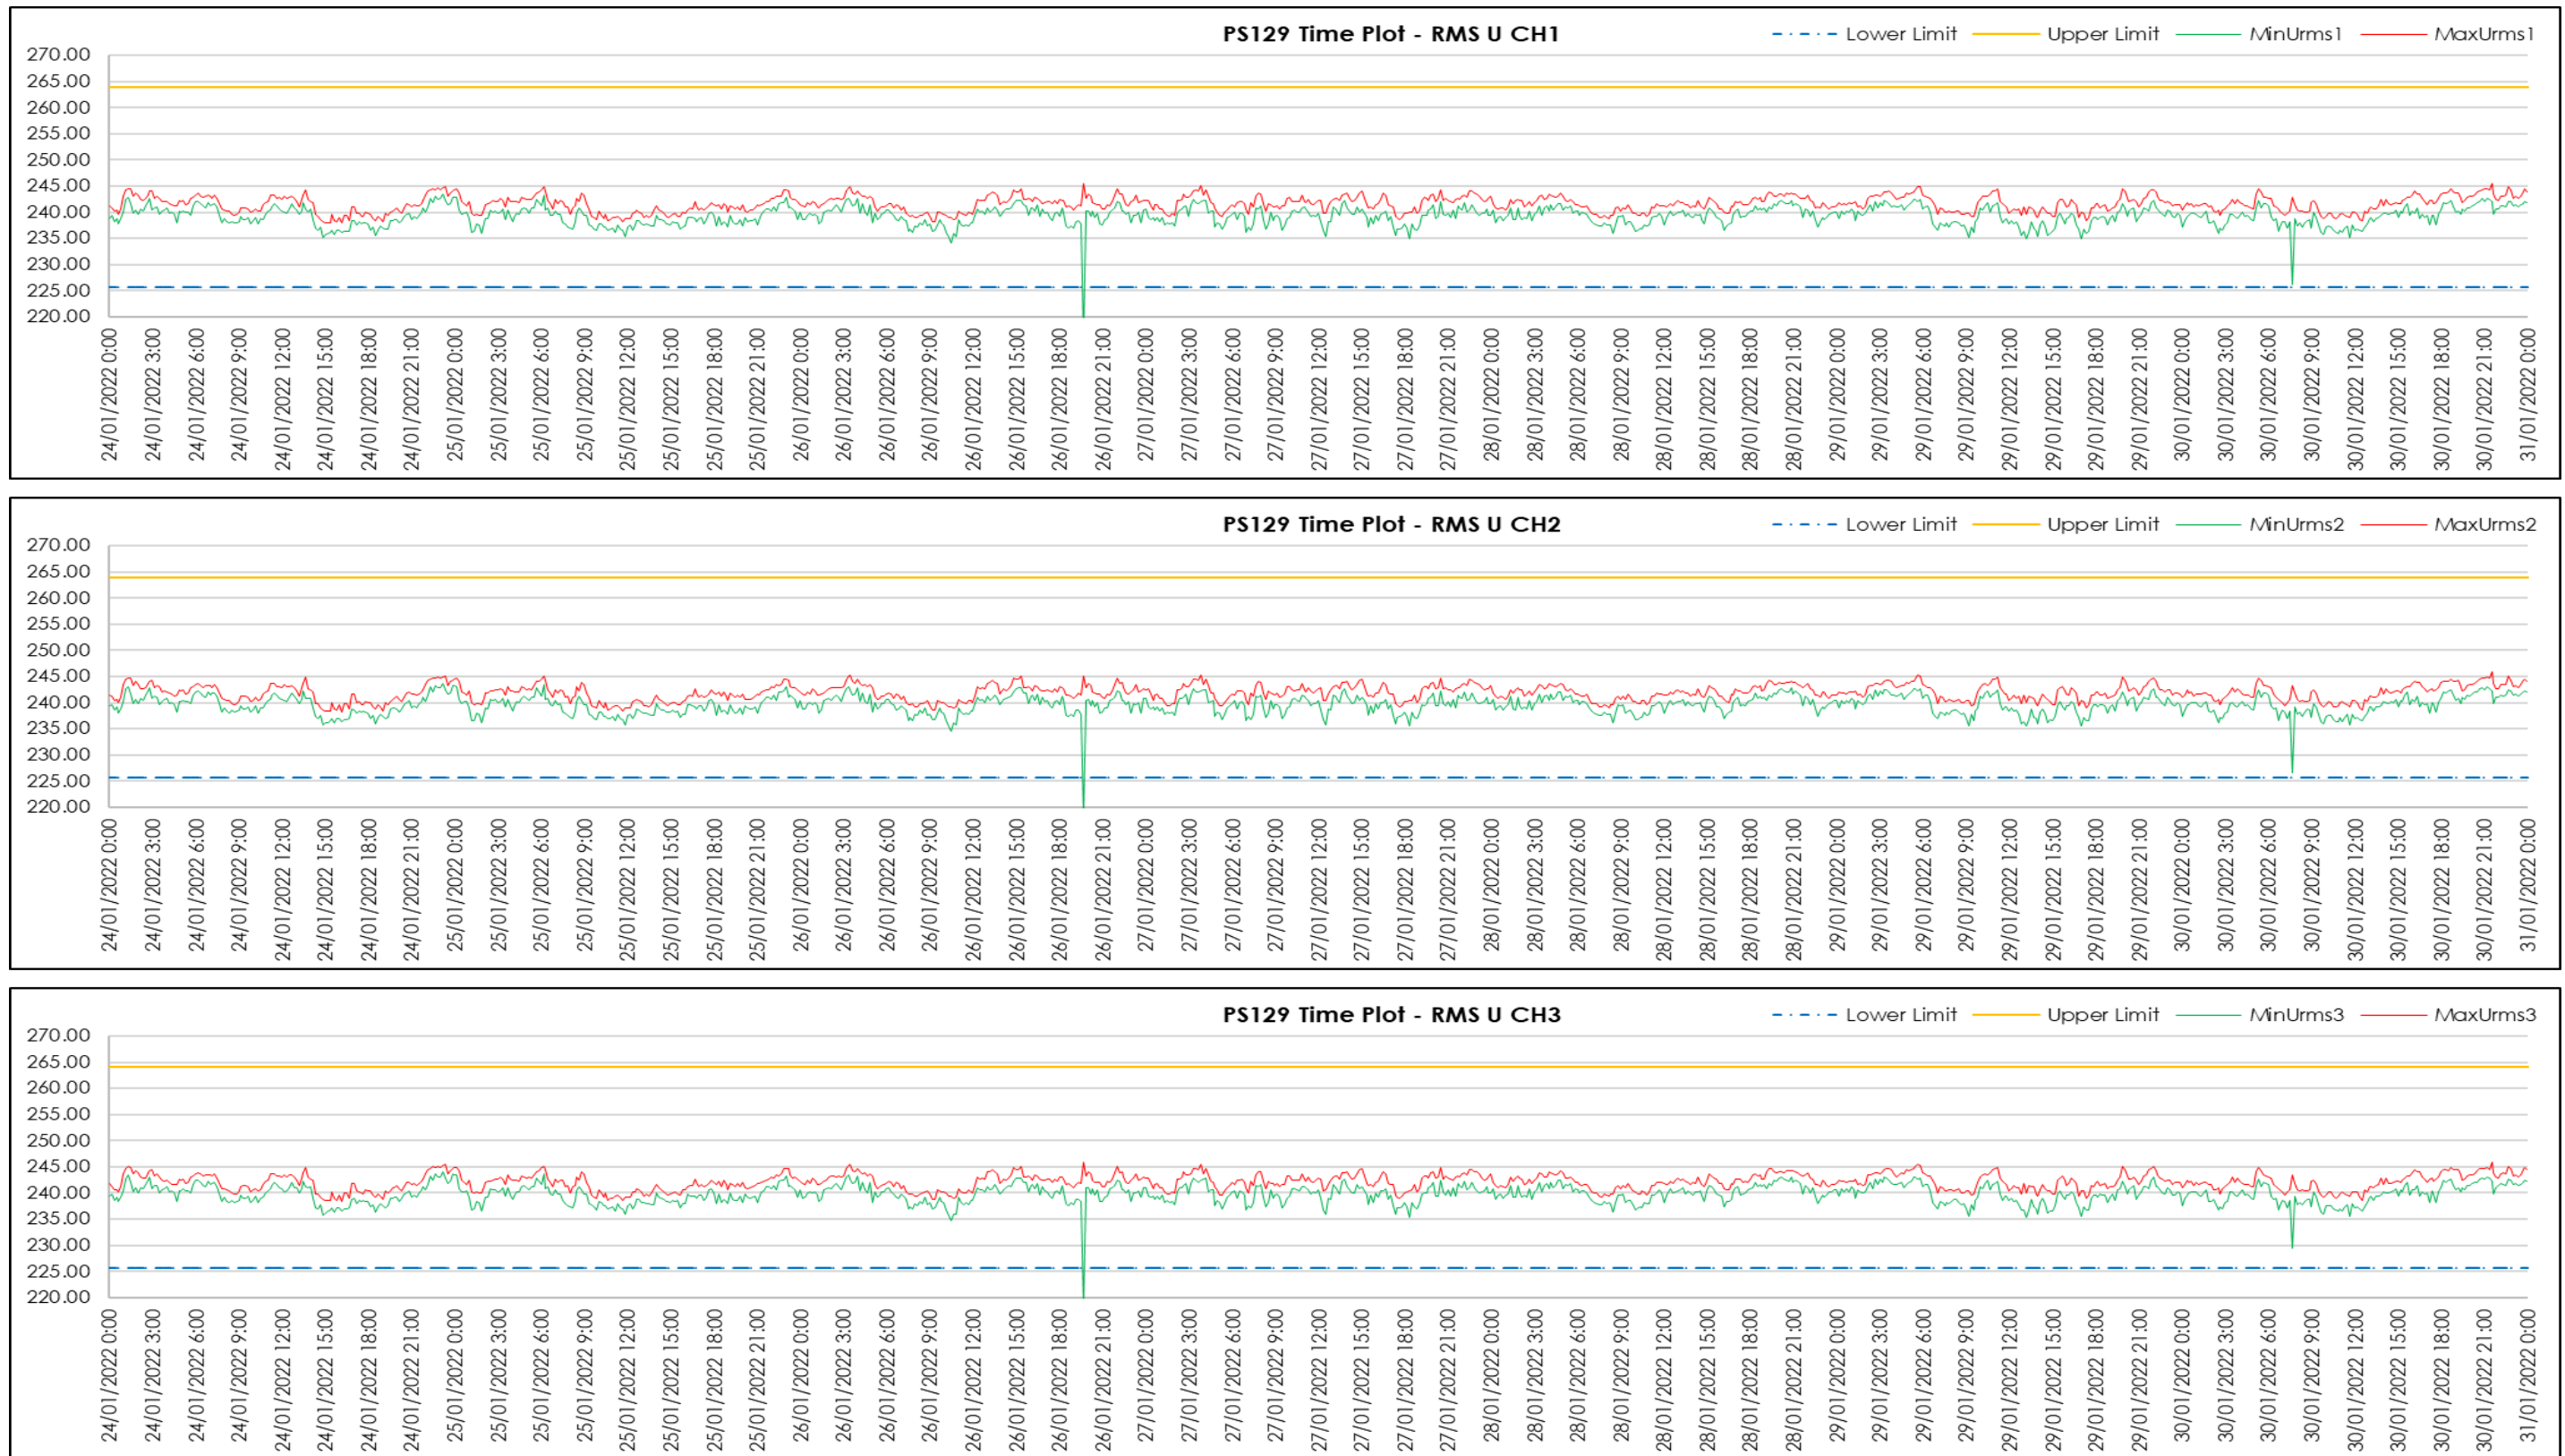
Figure 75 | STS6 Start Voltage measurements

The logged voltage level data for the start and end of the STS4 feeder is shown from Figure 75 to Figure 76 in Appendix A.8. **Table 11** below shows the recorded breach events during the logging period.

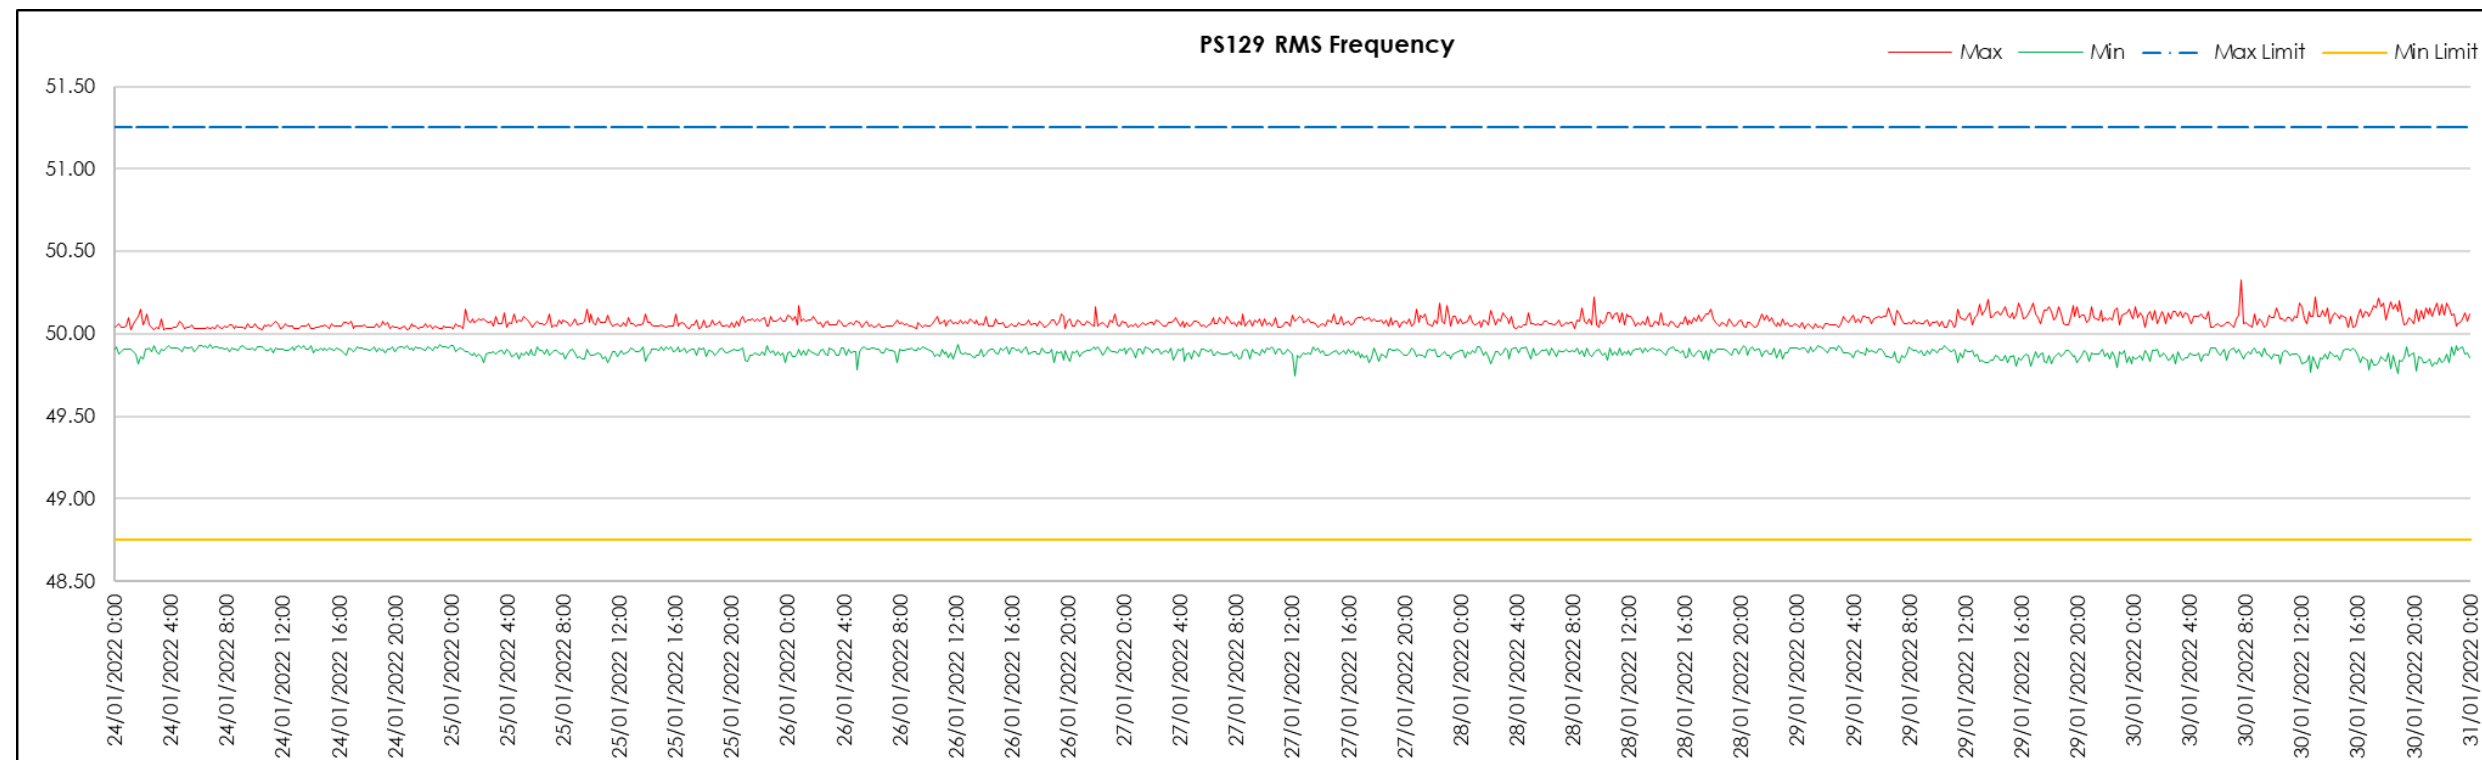
Figure 77 | STS6 Start Frequency measurements

Figure 77 to Figure 78 in Appendix A.8. There were no recorded frequency limit events causing the frequency level to breach the code's limit. (i.e., full compliance with the Code requirements).
