APD
ENGINEERING

BHP NEWMAN TOWNSHIP ELECTRICITY SUPPLY
ANNUAL COMPLIANCE REPORT
2021/2022

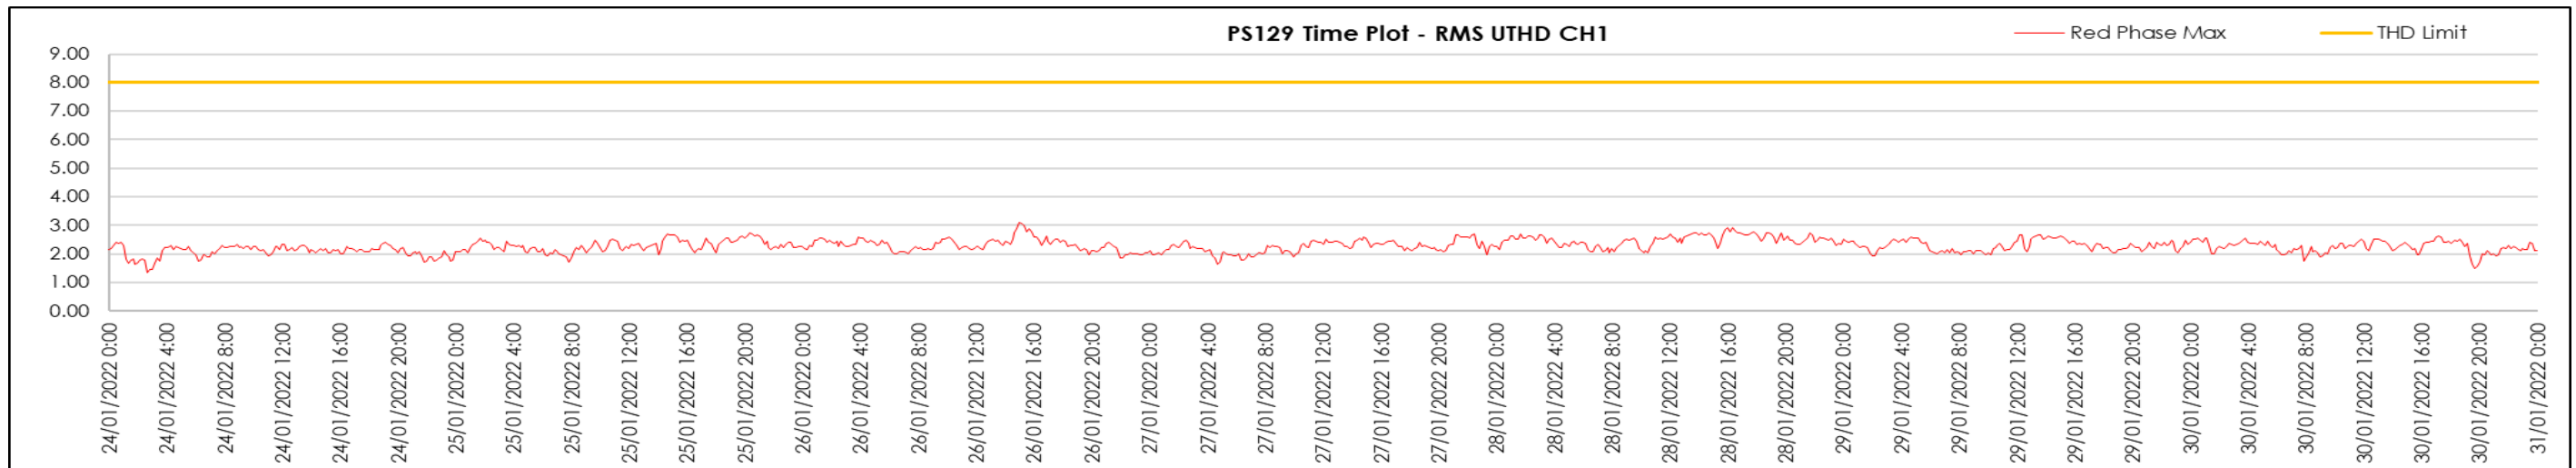
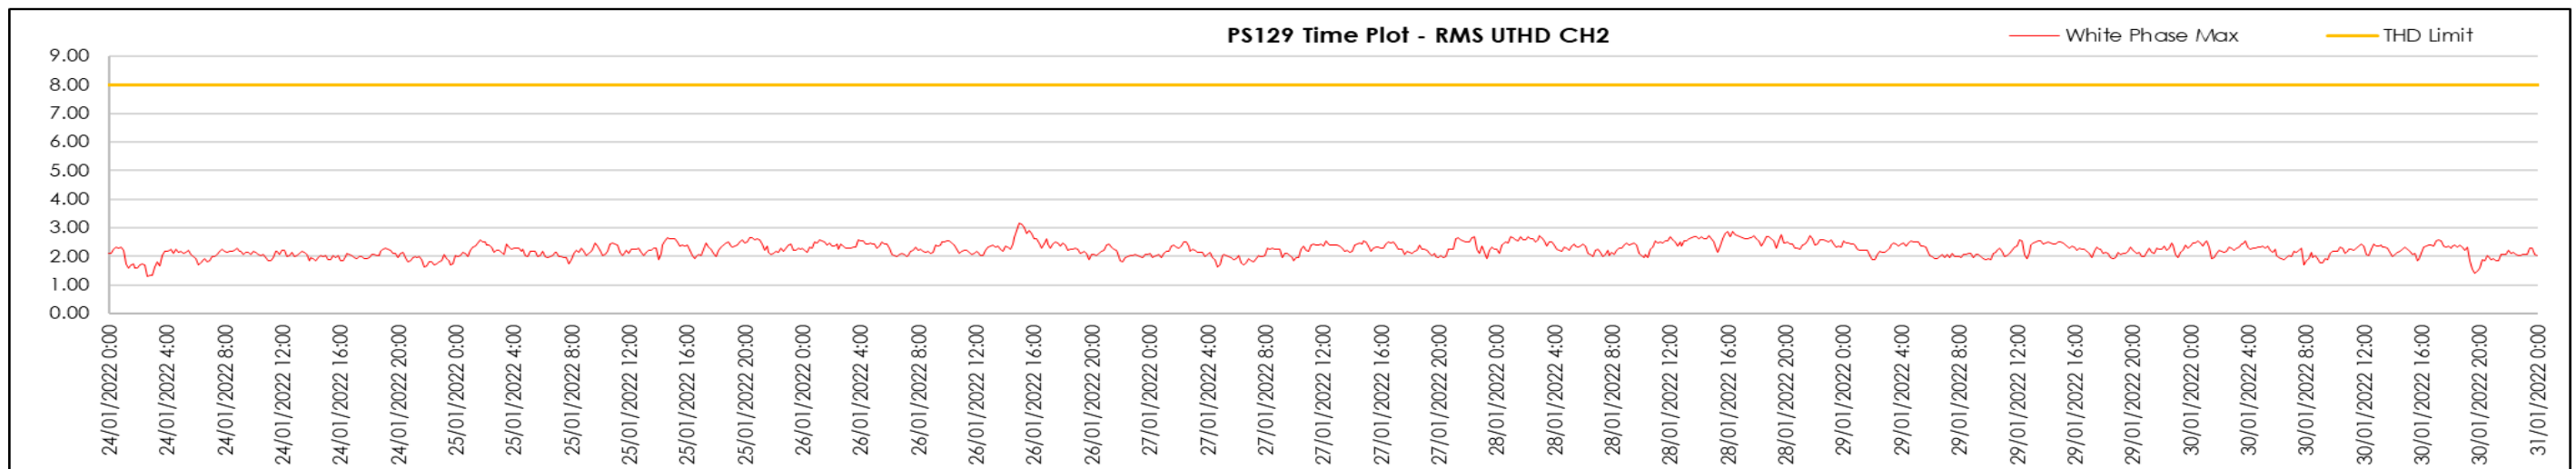
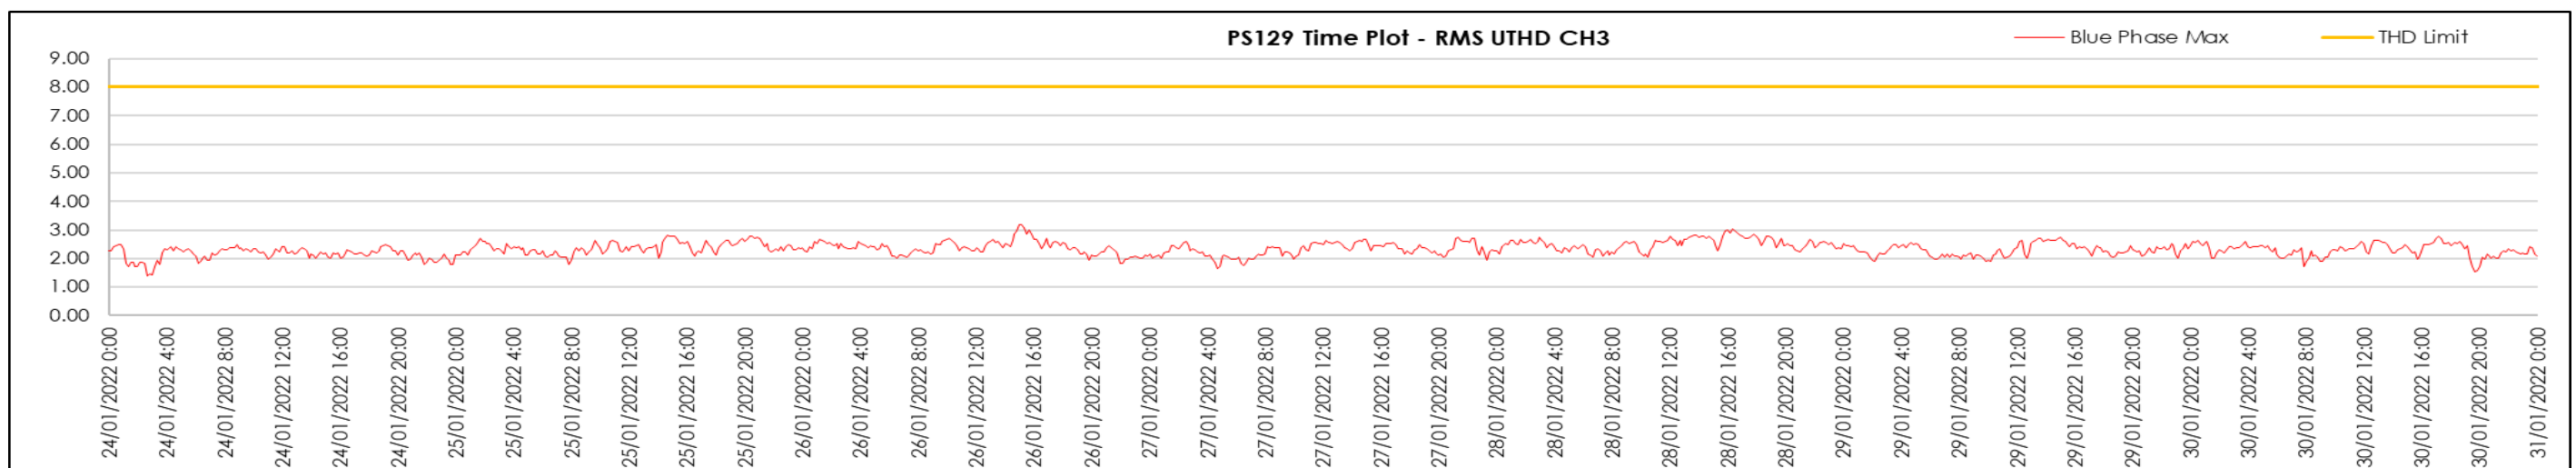
Figure 79 | STS6 Start U-THD measurements

The logged voltage THD level data for the start and end of the STS6 feeder is shown from Figure 79 to Figure 80 in Appendix A.8. There were no noted voltage THD limit events causing the voltage THD level to breach the Code's limits (i.e., full compliance with the Code requirements).

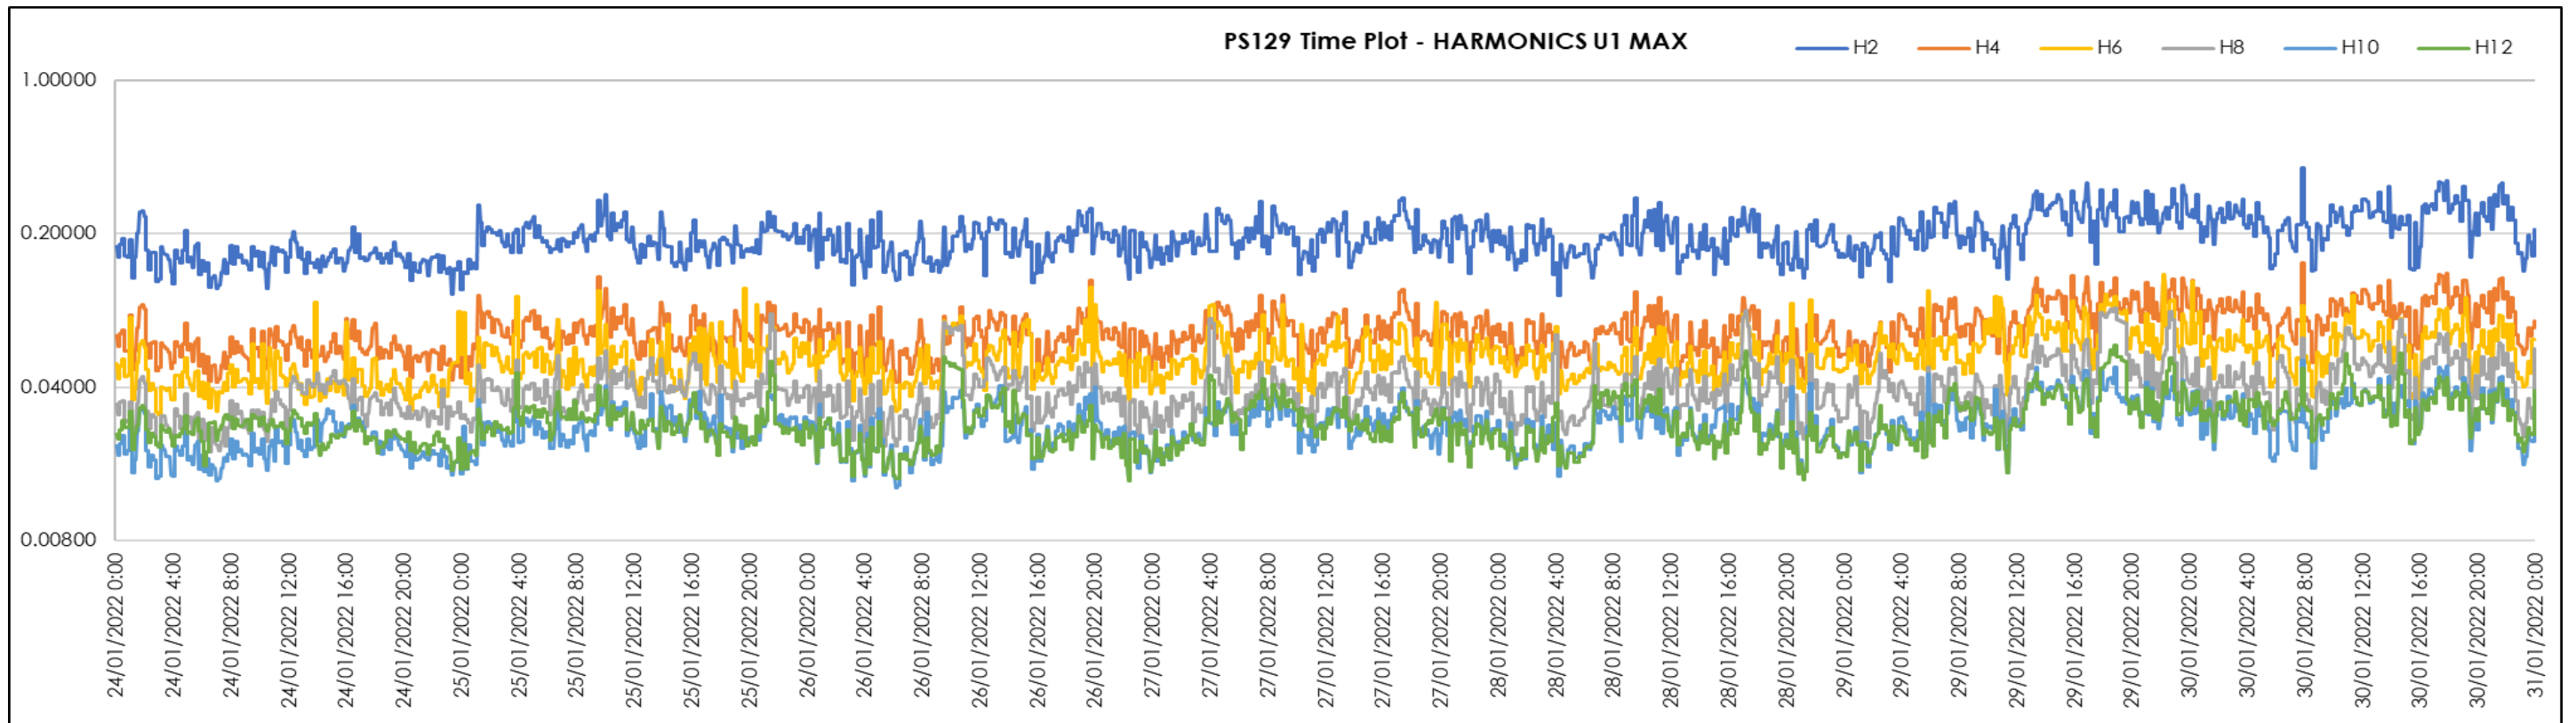
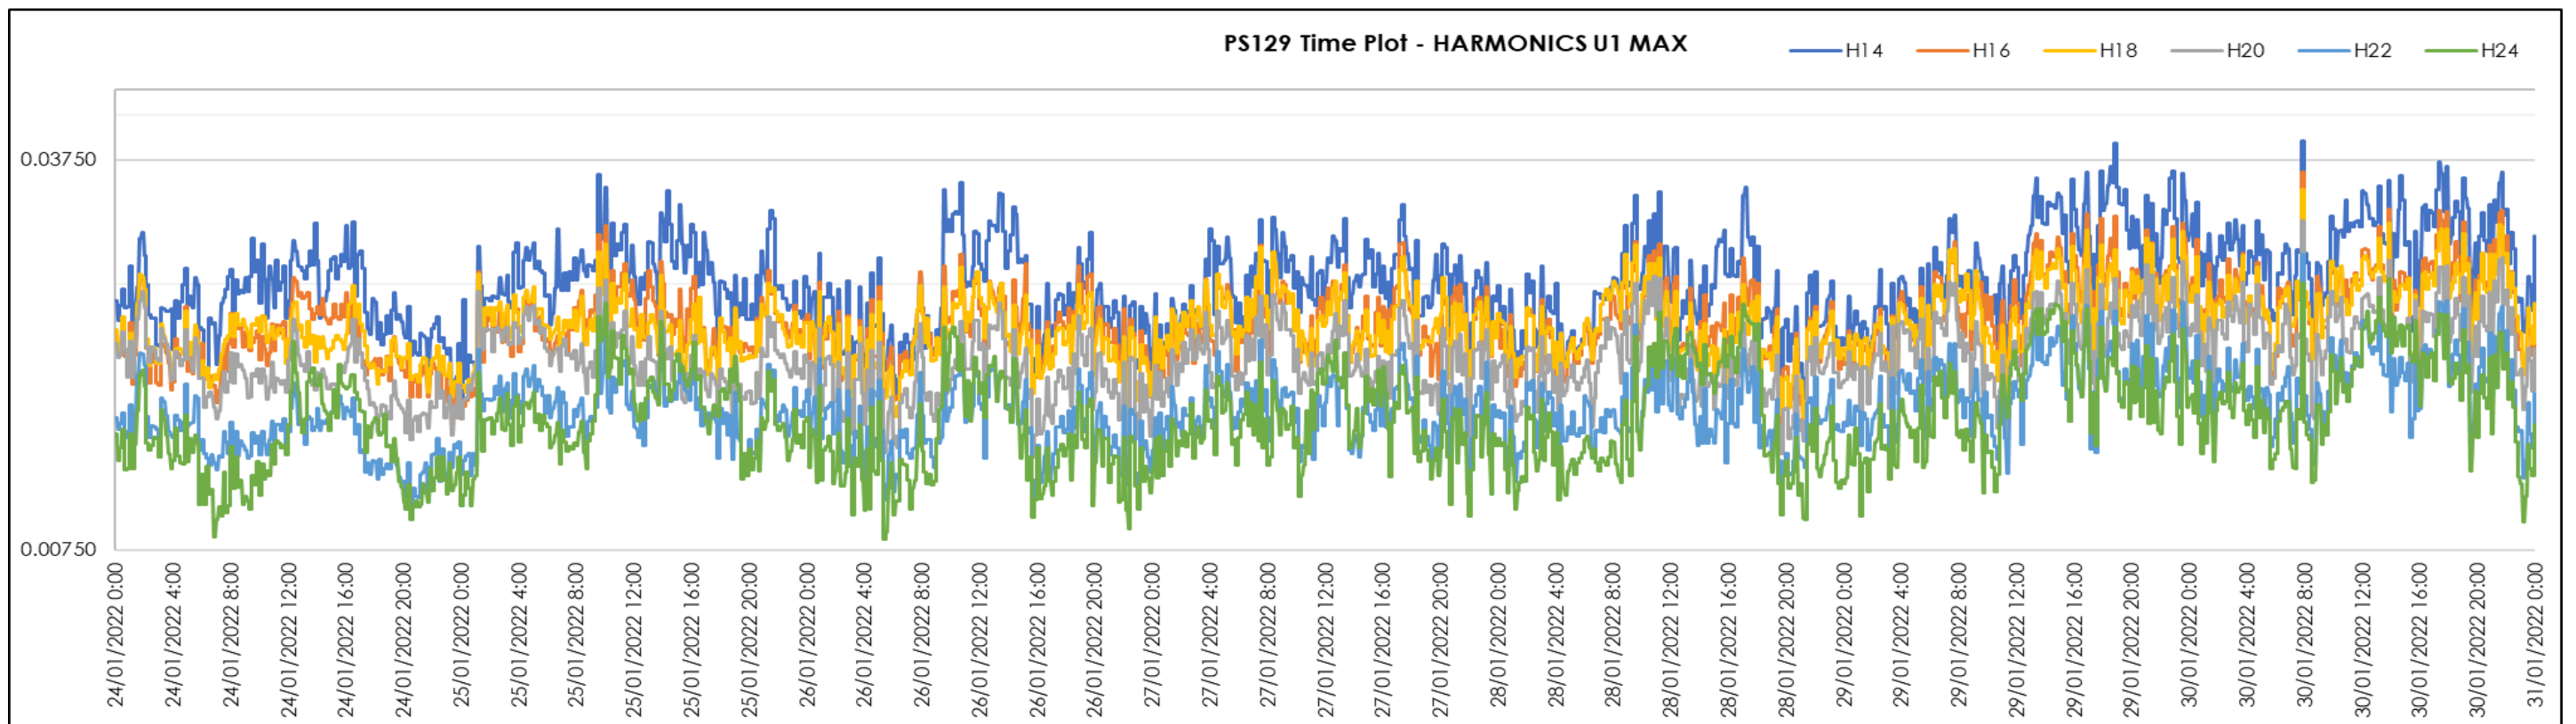
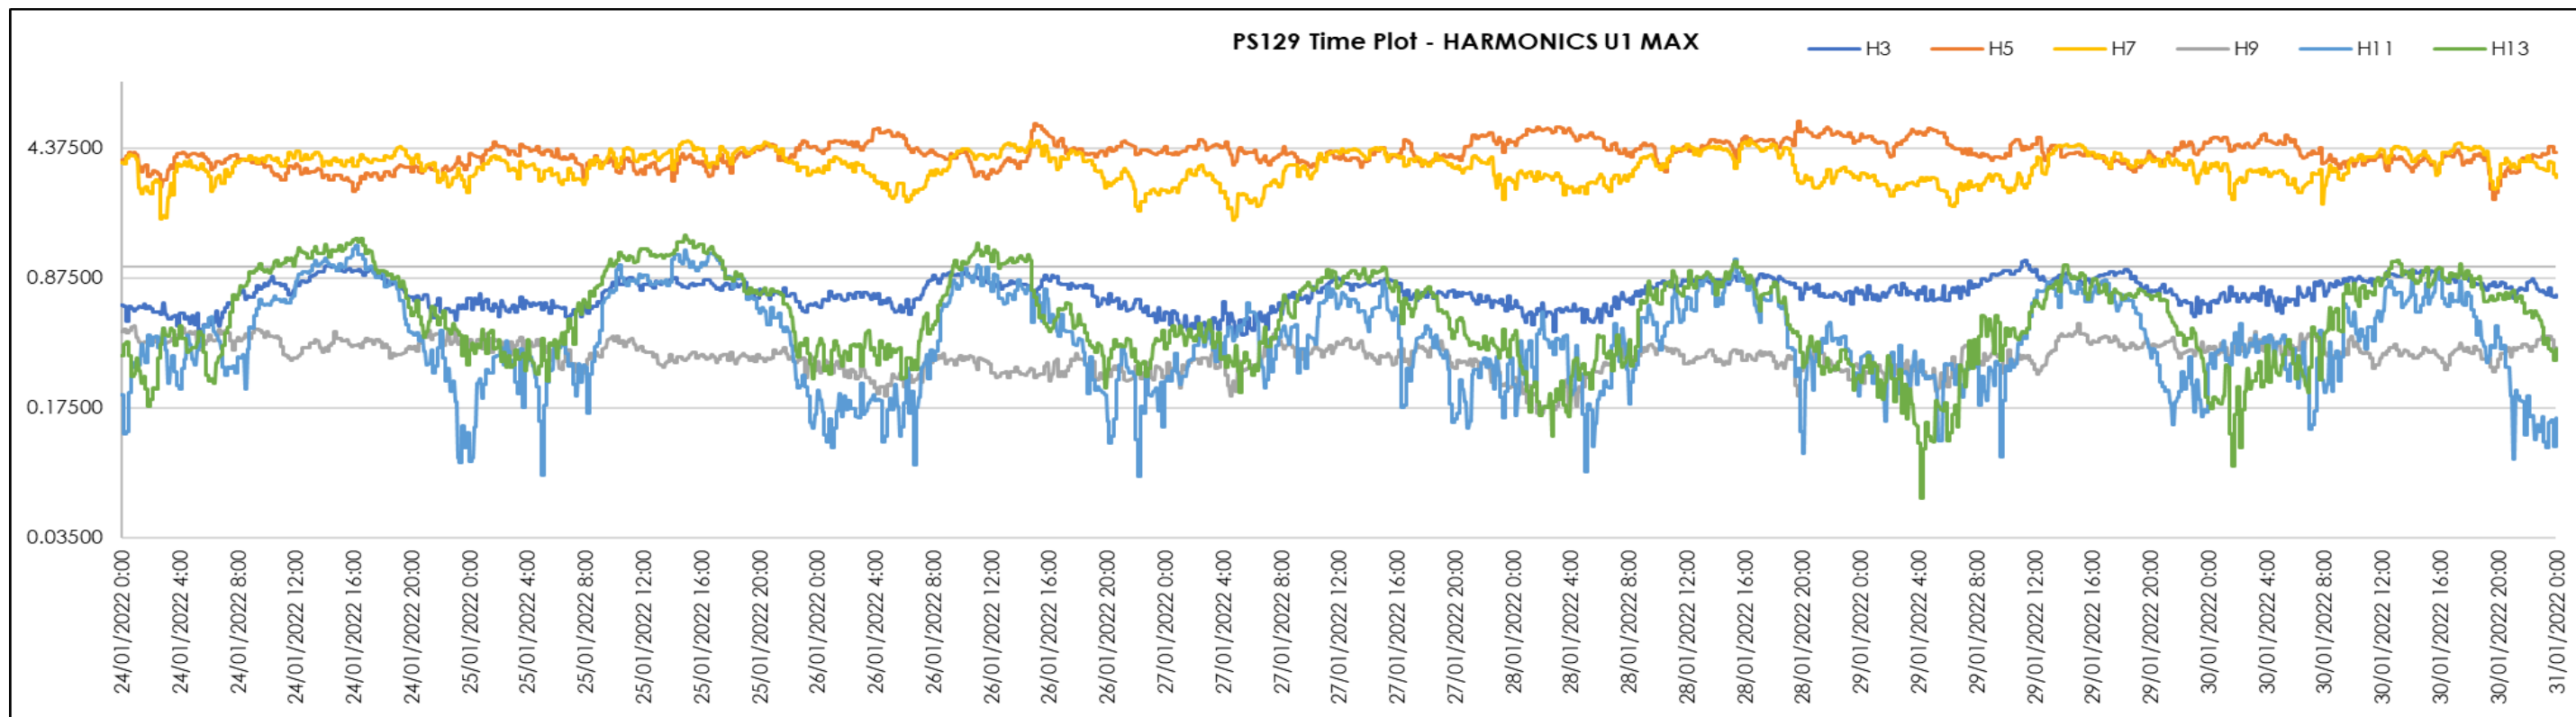
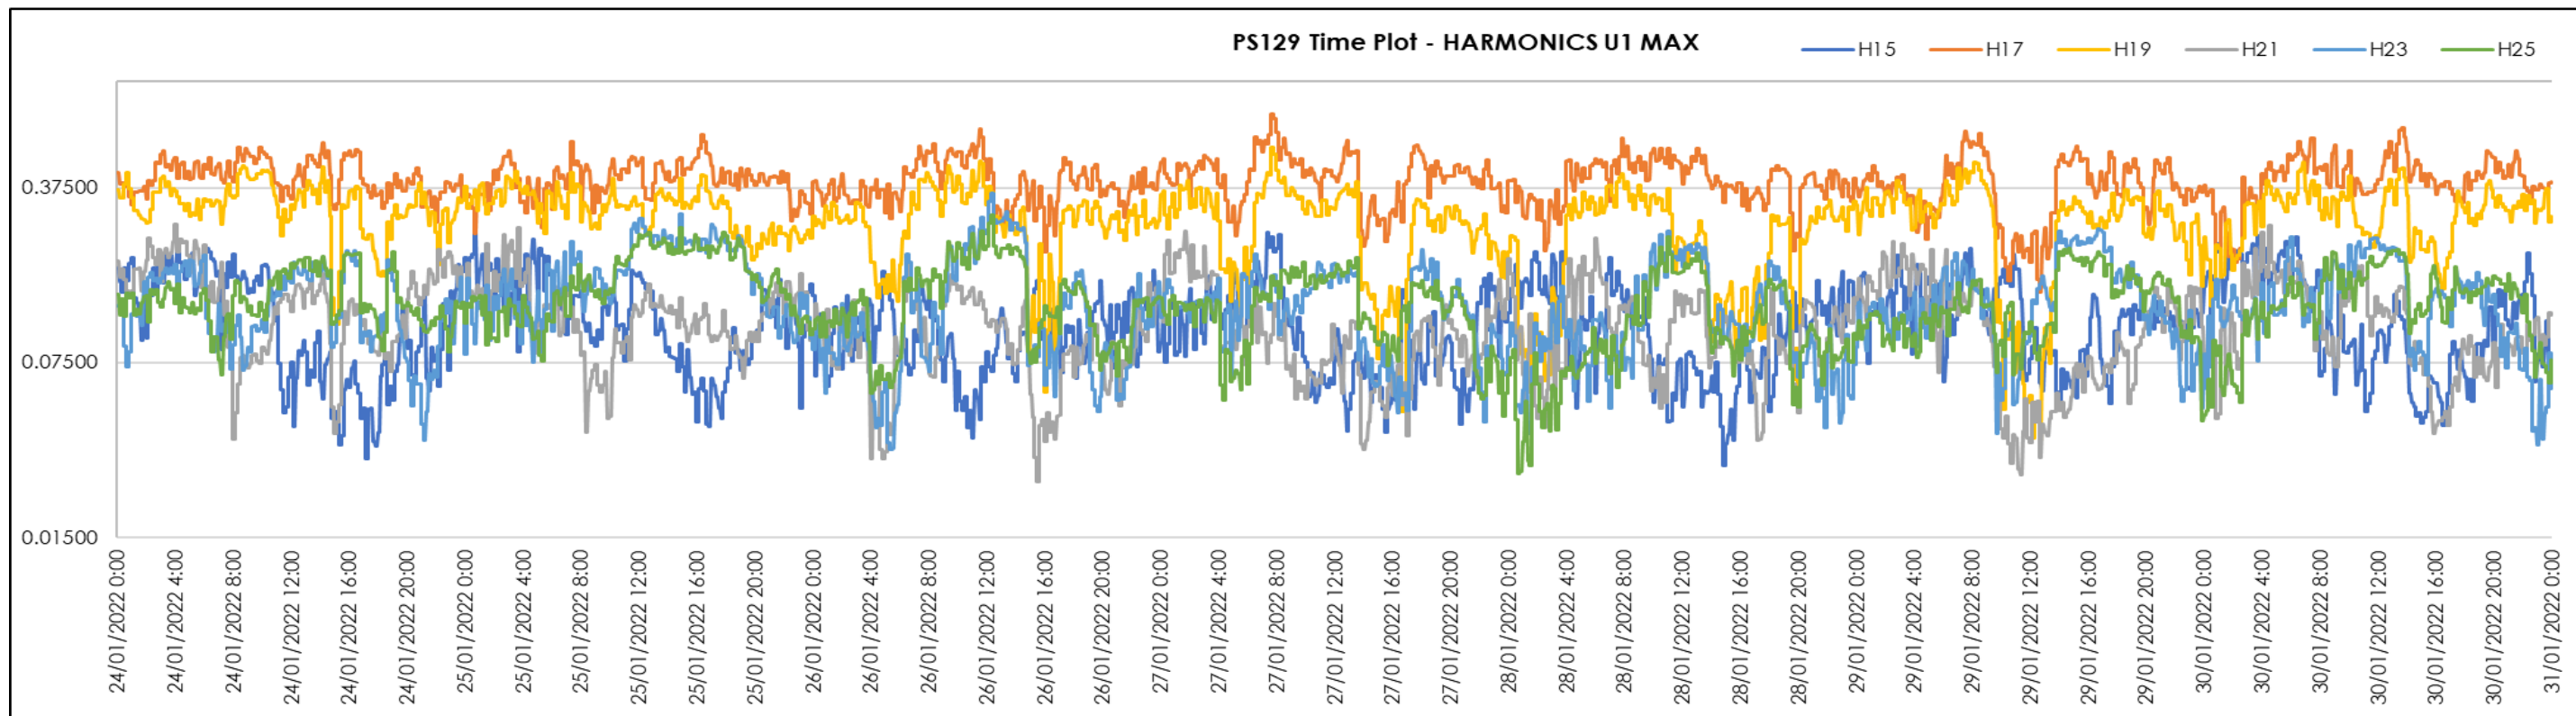
Figure 81 | STS6 Start Harmonics

The logged harmonic data for the start and end of the STS6 feeder is shown from Figure 81 to Figure 82 in Appendix A.8. No non-compliant harmonics were recorded on the feeder.1
