APD
ENGINEERING

BHP NEWMAN TOWNSHIP ELECTRICITY SUPPLY
ANNUAL AUDIT REPORT
2020/2021

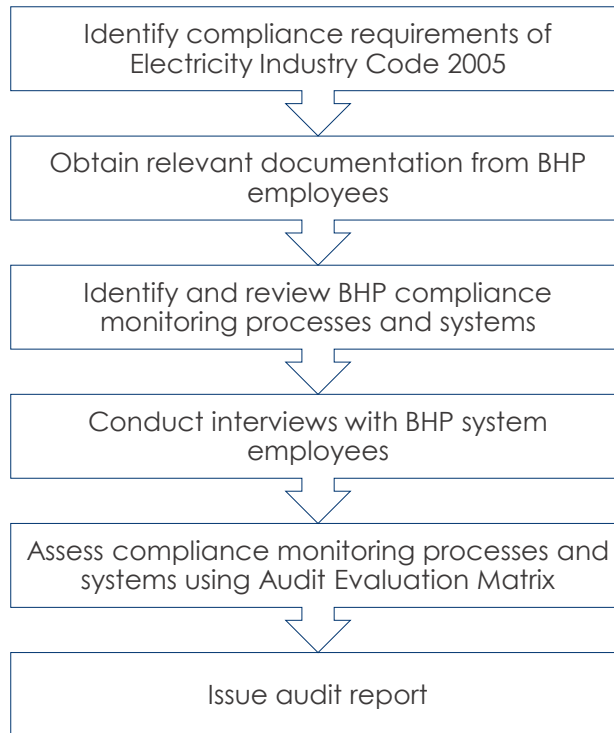
Figure 1 | Audit Methodology Flowchart

The methodology applied to perform the audit is as per the following flowchart:

Figure 1 | Audit Methodology Flowchart..... 11
