BHP NEWMAN TOWNSHIP ELECTRICITY SUPPLY
ANNUAL AUDIT REPORT
2021/2022

EXECUTIVE SUMMARY

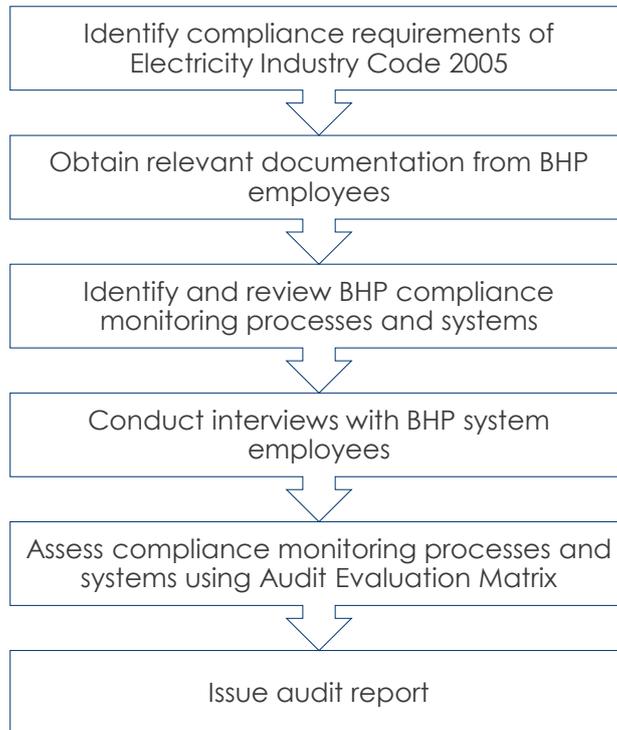
Figure 1 | Audit Methodology Flowchart

The methodology applied to perform the audit is as per the following flowchart:
